DISPUTE REVIEW BOARD RECOMMENDATION

RE: State Job No. 47010-35919/56010-3520
W.P.I. No. 31111042\3116849
Contract # 19197
Liberty & Calhoun County
State Road 20 Apalachicola River Bridge

Subject: Issue No. 2 - Repair of Expansion Joints

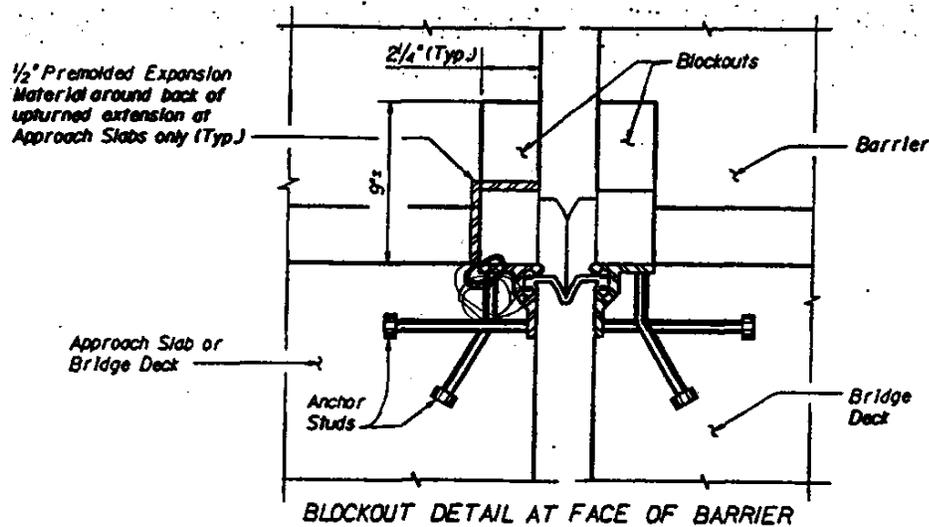
The expansion joints at Piers No. 57 and No. 60 apparently failed in a manner similar to the mode of the failure experienced and discussed by the Texas D.O.T. in their memo of February 12, 1998, that being that the welds between the anchor studs and the armor angle failed.

There is considerable correspondence concerning the presence of voids under the armor angle, but in the information presented to the DRB there is nothing to substantiate that voids, if present, contributed to the failure of the anchor stud welds. The mode of failure is still in question since no evidence has been submitted to show if the welds failed in tension or in shear. However, the supporting evidence indicates that the SEJ-S type of armored expansion angle has been prone to failure of the anchor studs weld when subjected to heavy traffic loads. The solution reached by the Texas D.O.T. was to go to larger studs at a closer spacing to generate more weld area per lineal foot of armor angle.

The situation at Piers No. 57 and No.60 was probably further aggravated in the expansion angles due to those two (2) spans having a four (4) inch opening allowing more wheel load into the angle and more potential movement in the angle. The expansion joints at Piers No. 57 and No. 60 were unique in three (3) areas. One, they were the only joints specified to have a four (4) inch opening. Two, they were the only joints that joined a continuous three (3) span steel superstructure unit. Three, they were the only joints that conclusively failed.
