Agency of Transportation

**Report on
Spring 2006 Evaluation of
Detectable Warning products
installed 2003- 2005**

July 12, 2006

**Produced by the Bicycle and Pedestrian
Program, Local Transportation Facilities
section of the Program Development Division**

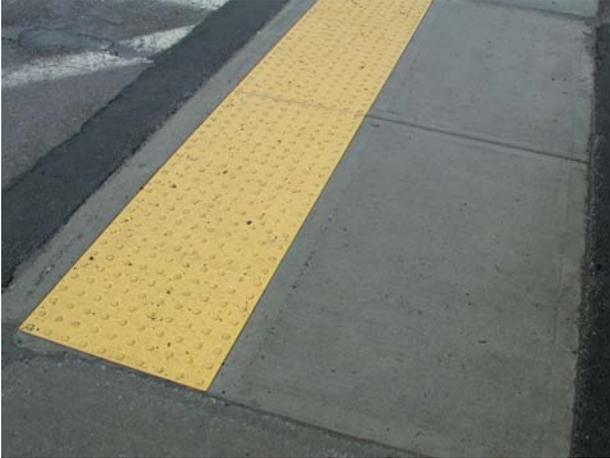
Overall condition of this product is good. There is some damage to the panels. No evidence of separation from underlying concrete.

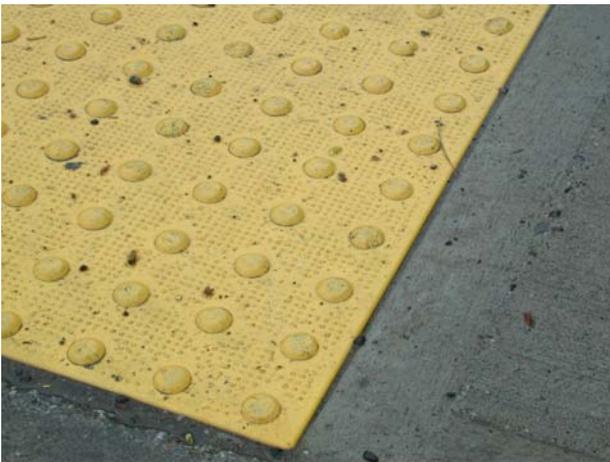
A few full domes are missing. The tops of quite a few domes have been scraped off.

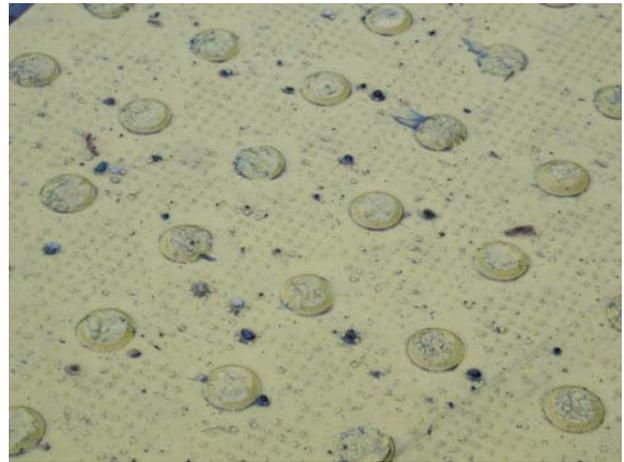
Individual domes are chipped and broken. It is likely that many domes no longer meet the ADA standards for dome height.

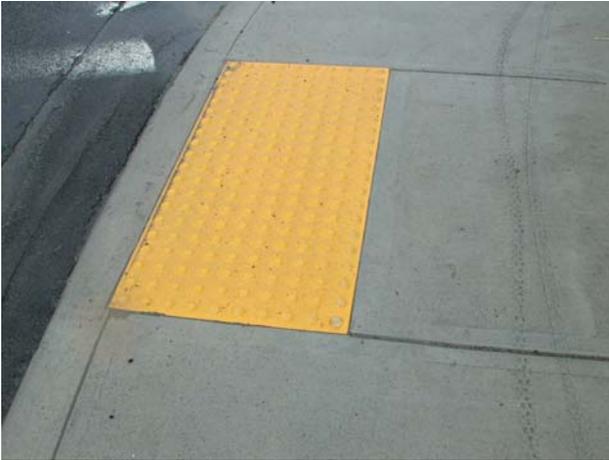
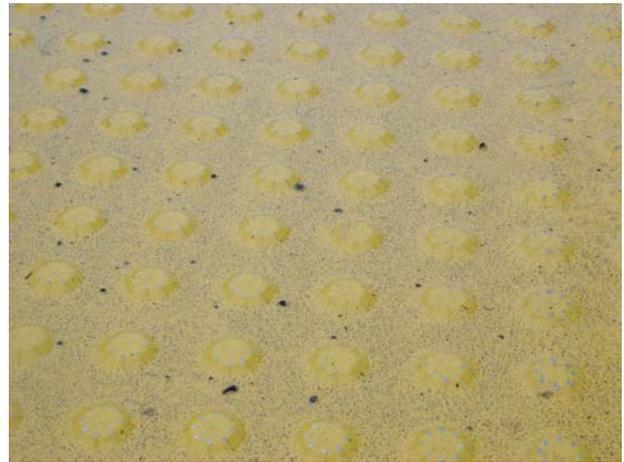
The integrity of the dome field was very good.

The overall durability of this product is very good. An early installation showed problems with the coating that is adhered to the stainless steel panel. The product in place incorporates a new coating process and small ridges on the domes that are intended to cause any plow blades to ride above the normal dome top.

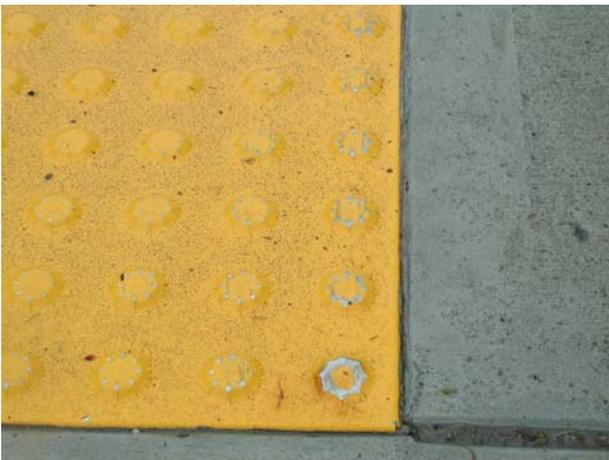
Some of the small ridges had been removed by the plow and there are signs of complete removal of the coating, exposing the underlying stainless steel. One dome on a leading edge of the panel was partially crushed.

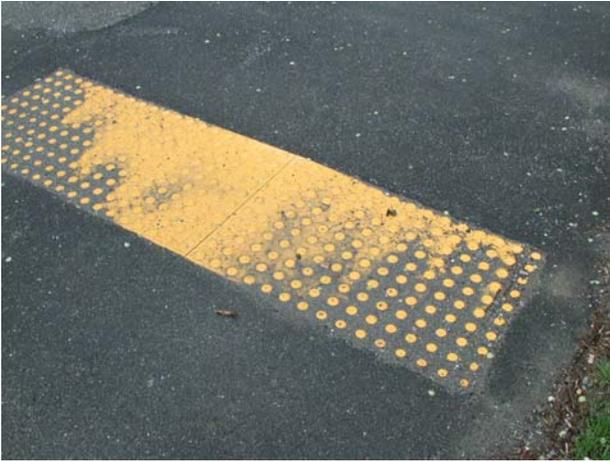
Sand and gravel from the adjacent road and winter maintenance had accumulated between the domes on portions of the panels. The panels were in very good shape overall.

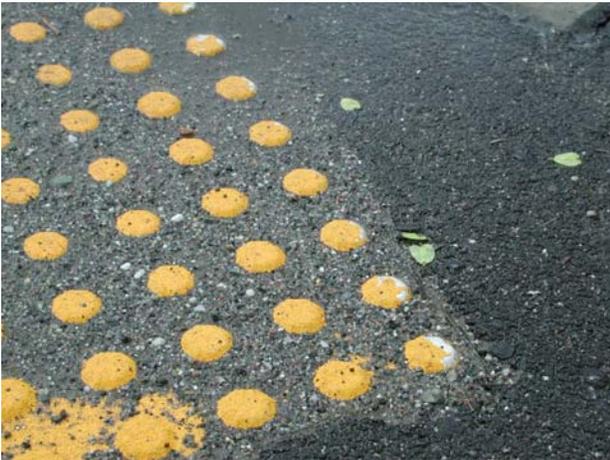
As with almost all products evaluated, the leading edge of the panel is where the majority of damage was observed.

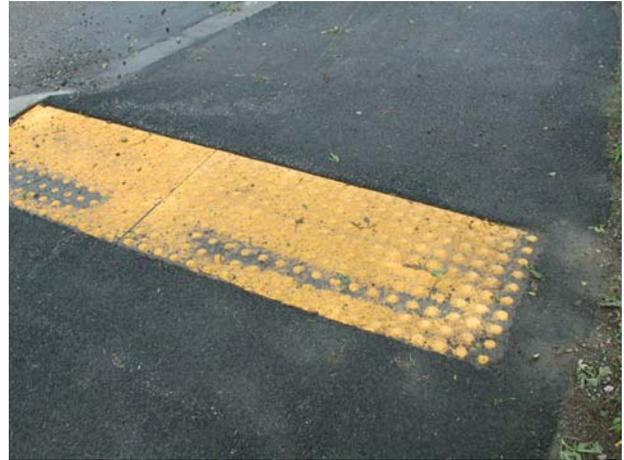
It was noted on one of the panel installations that a void had formed under the panel, allowing it to deflect when stepped on. Installation of these panels on asphalt must be done carefully to avoid such voids. Continued deflection may cause the panel to crack over time.

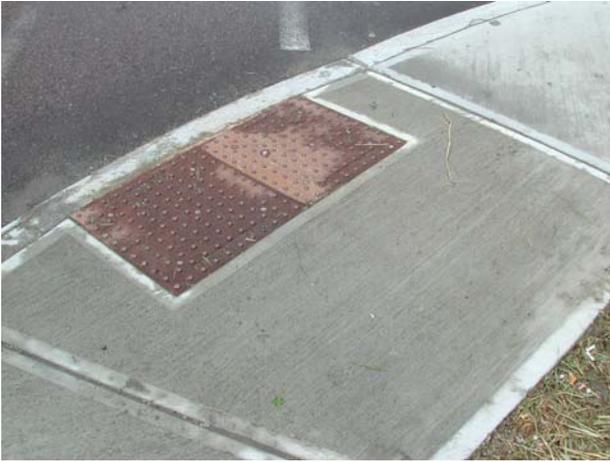
The natural rust color of these panels appears to provide adequate contrast to the surrounding concrete, even when the concrete is wet.

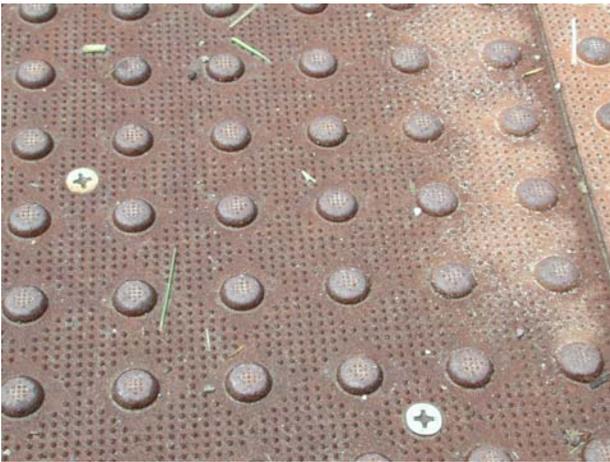
This product showed virtually no damage from snow plows. All domes were intact.

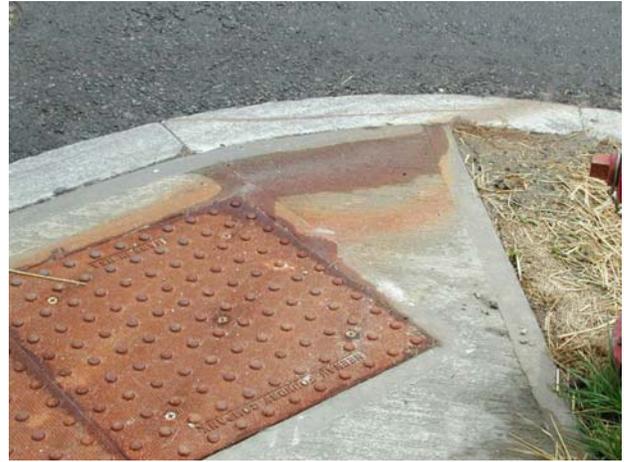
The one feature of this product that will need to be monitored is the extent to which the rust “bleeds” onto adjoining surfaces. Some bleeding was observed on this ramp, but generally was very limited.

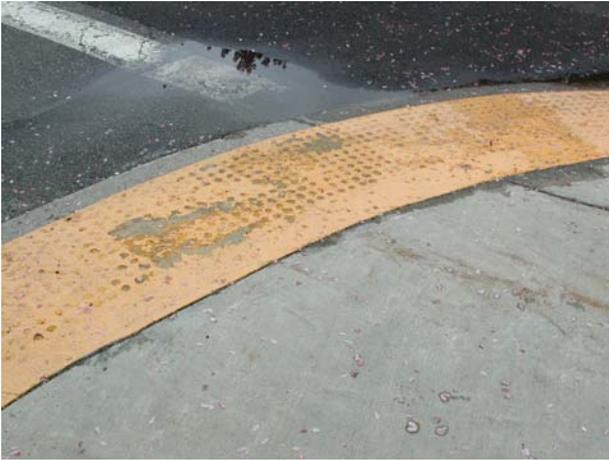
Large sections of the coating have been completely removed from the ramp surface.

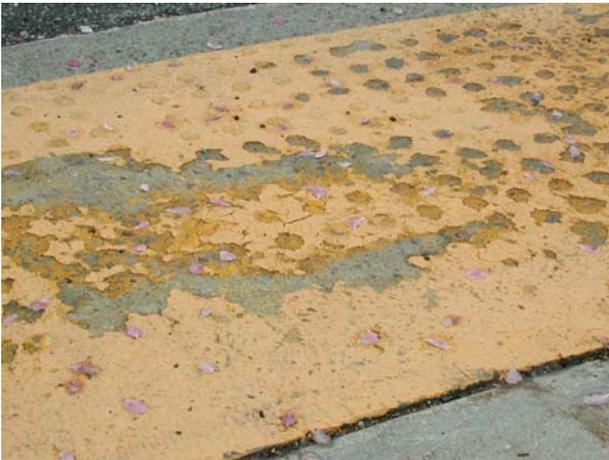
In addition to entirely missing sections, many individual domes have been removed.

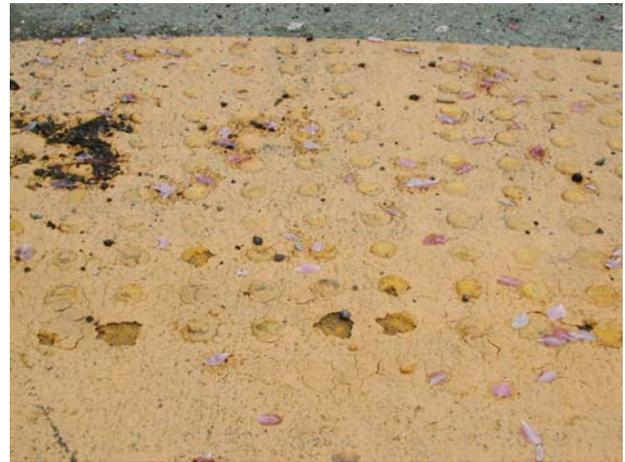
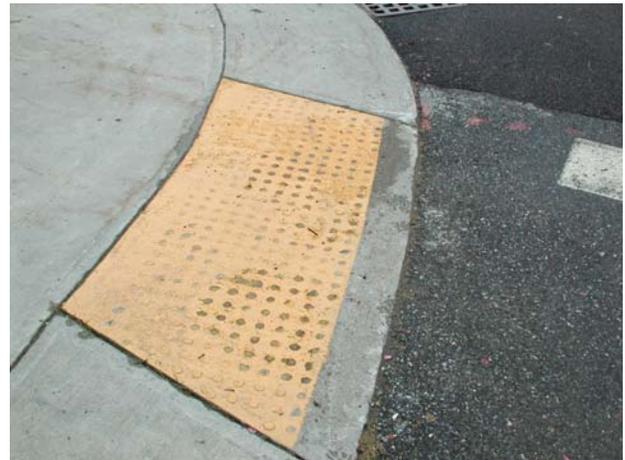
Overall assessment of this product is that it has failed.

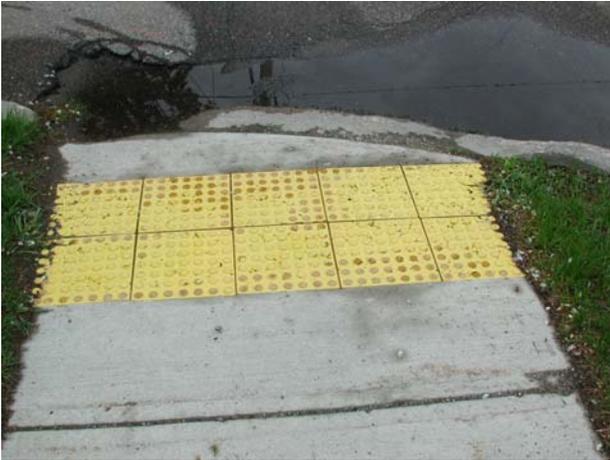
At least 50% of the domes have been lost or severely damaged. The overall condition is fair to poor. The tiles are intact and have not separated from the surrounding concrete.

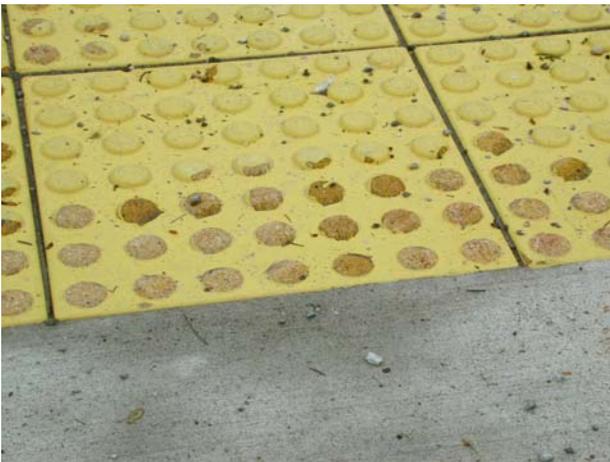
Based on the continued damage that this product has sustained each winter, it is considered to be a failed product.

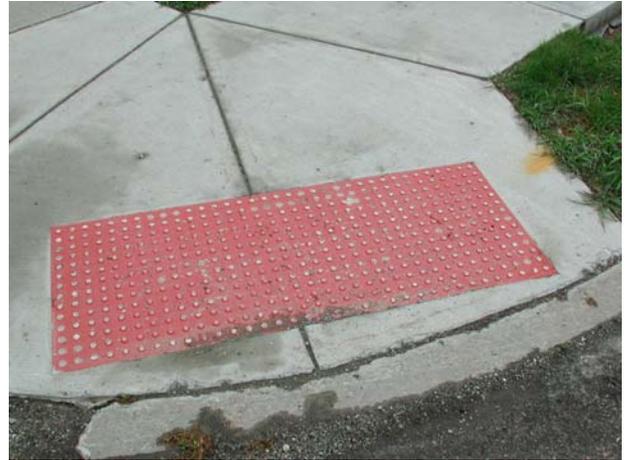
The panel is adhered well in the surrounding concrete. However, at least 50% of the domes have been lost or severely damaged.

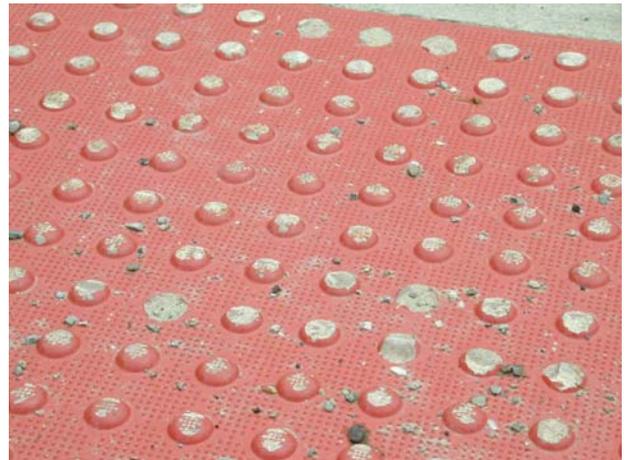
Based on the continued damage observed with this product each winter, it is considered to have failed. A three year life span for these materials is not acceptable.

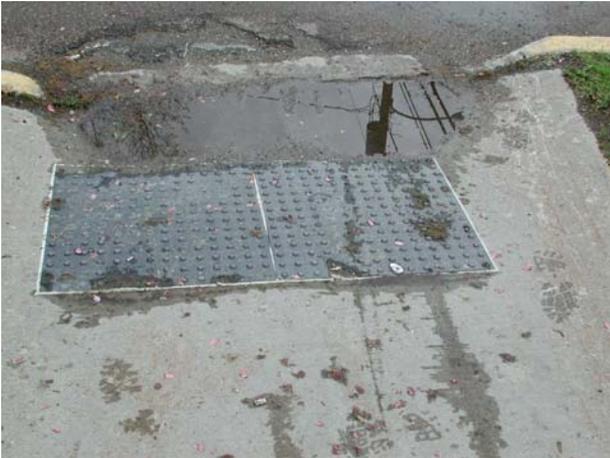
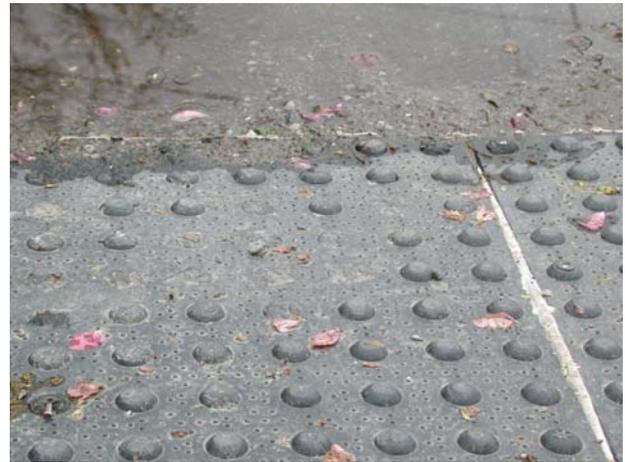
A number of domes have been completely removed. Based on the overall condition of this product only 3 years after installation, it will be recommended to remove it from the Approved Products list.

The overall condition of these panels is fair to good with some continued damage being evident.

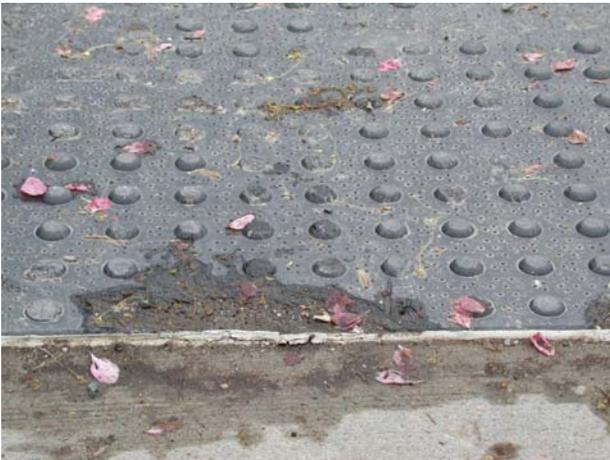
Some small sections of panel have been completely removed and. Many dome show signs of scraping.

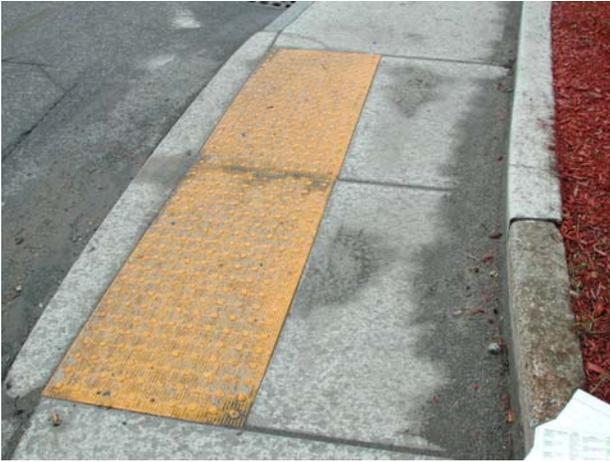
In general this product is showing minimal damage, although it has only been in place for one winter.

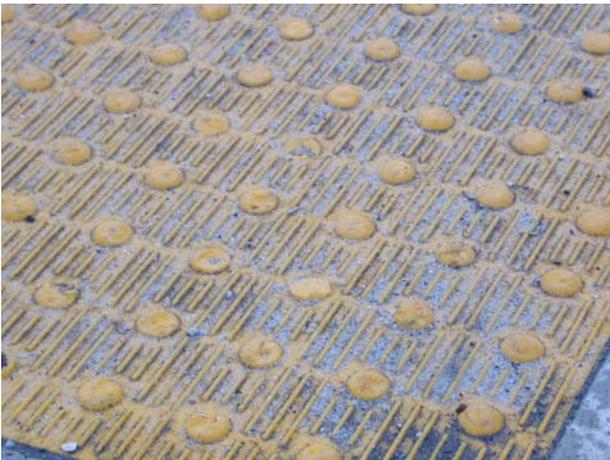
A few domes have been chipped or fully removed. This product will have to be monitored for one or two winters to see how well it holds up. It is expected to show continued wear like other plastic compound products.

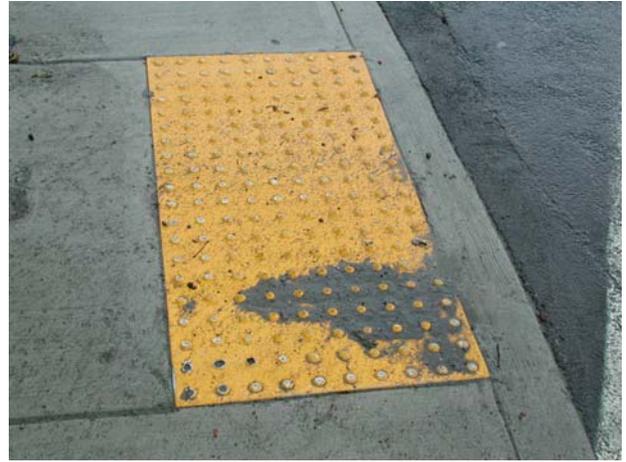
The overall condition of the panel is good, yet it is showing signs of wear after one winter season.

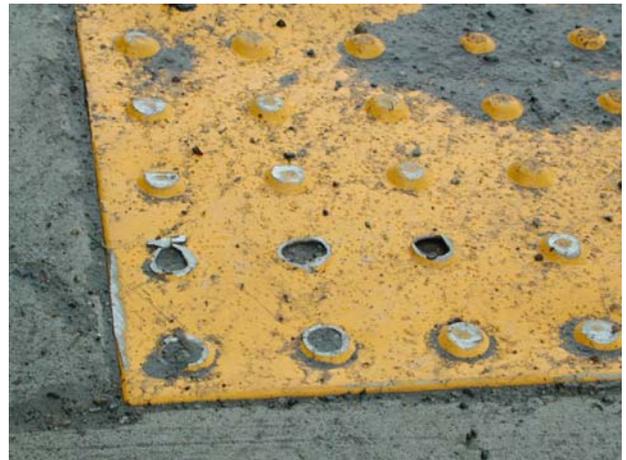
Of most concern with this product is that where complete domes have been removed, a hole in the panel surface has resulted. This will allow water to accumulate under the panel surface and may cause problems when subjected to the freeze-thaw cycle. It is likely that this product will not be recommended for use on Agency projects.

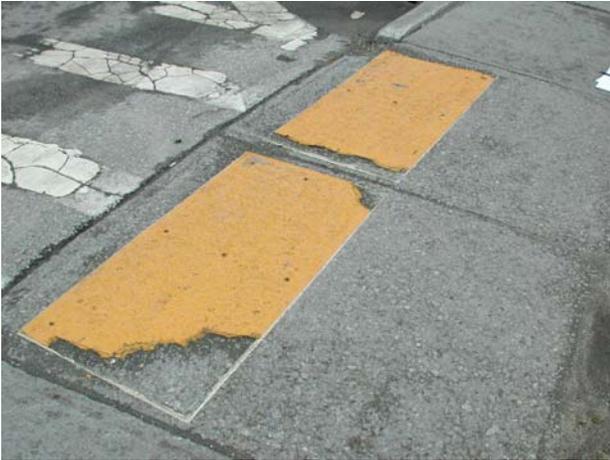
After one winter, the product is showing considerable signs of wear and exhibits a poor bonding to the substrate.

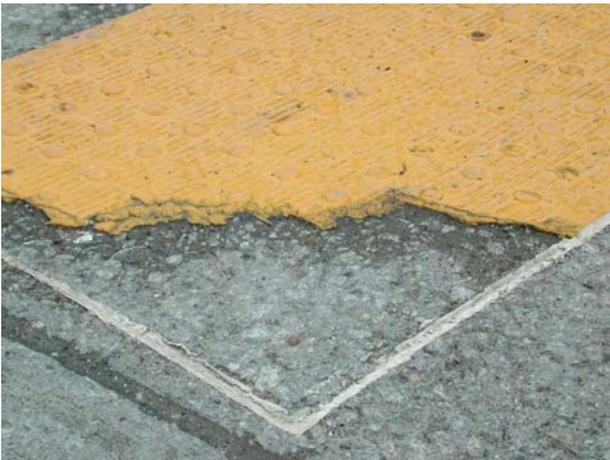
It appears that the sidewalk plow blade lifted one corner of this semi-rigid panel and broke the piece of panel off.

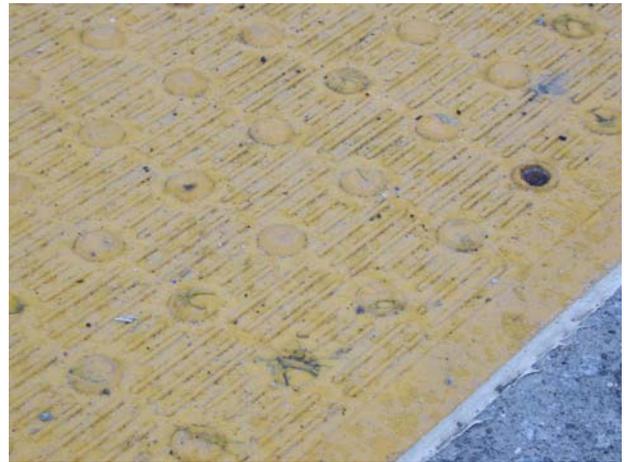
In addition to the wholesale removal of sections of this product, individual domes were crushed and sheared off. This product is considered to have failed.

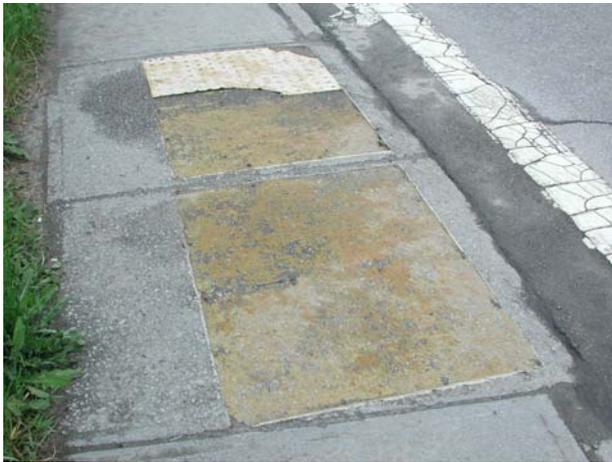
This flexible product experienced almost complete removal after being exposed to one winter of sidewalk plowing, demonstrating a poor bonding to the underlying concrete.

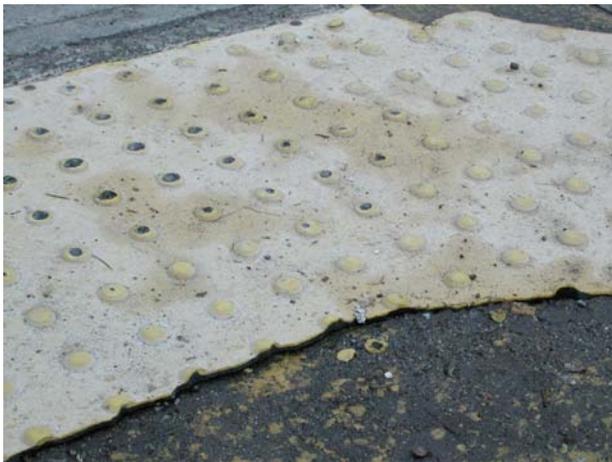
The remaining portion of this product showed extreme fading of the color and damage to domes. This product failed.

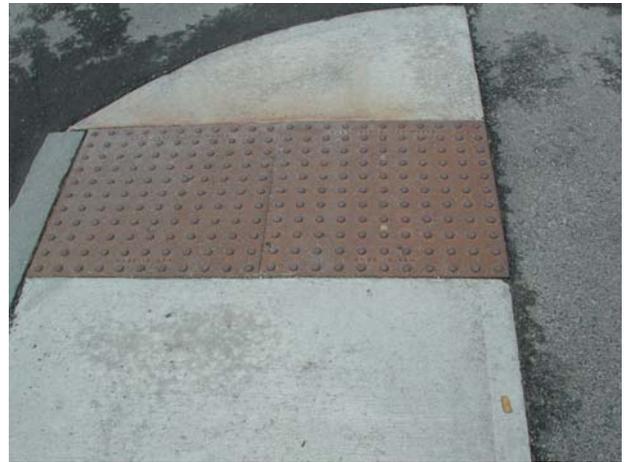
These panels showed virtually no damage and all domes were intact. There was good color contrast to the surrounding concrete. Some minor bleeding of rust onto the adjacent concrete was observed.

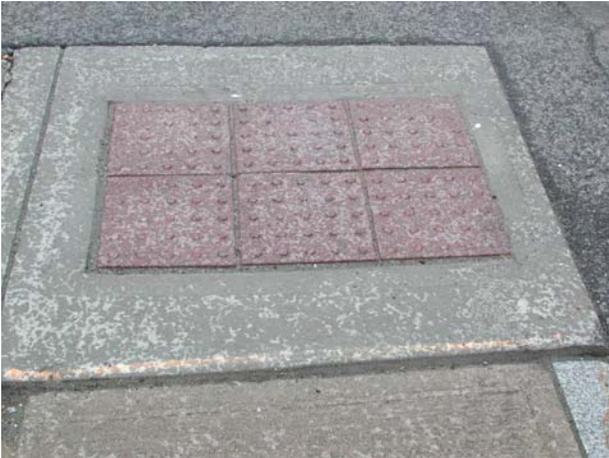
Overall, this product is in fair to good shape. The color contrast to the adjacent concrete is fair but diminishes when wet.

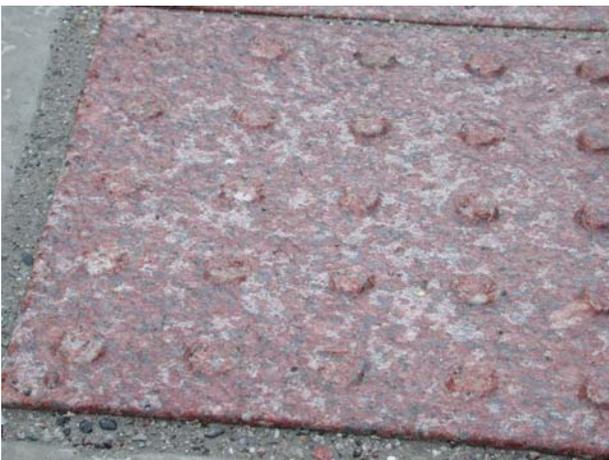
Approximately 25% of the domes show signs of chipping or crushing as a result of winter maintenance. It is expected that continued deterioration would take place with this product.

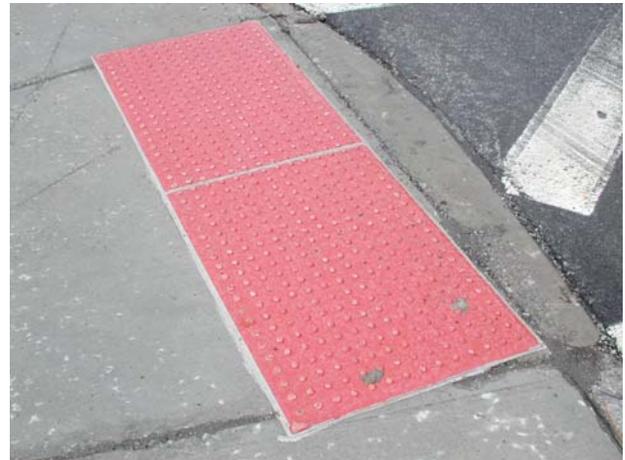
The overall condition and appearance of this product is very good. Color has not significantly faded since its original installation. Joint seams are intact.

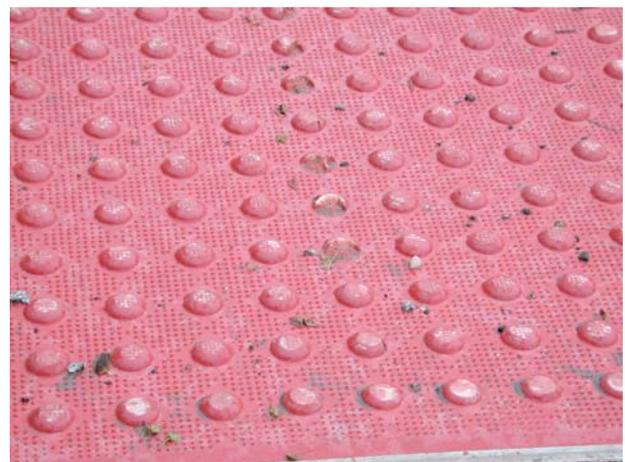
There are a few missing domes and some scraping of dome tops is evident, especially on the leading edge of the panels.

Although some continuing damage has been observed, this product is holding up well.

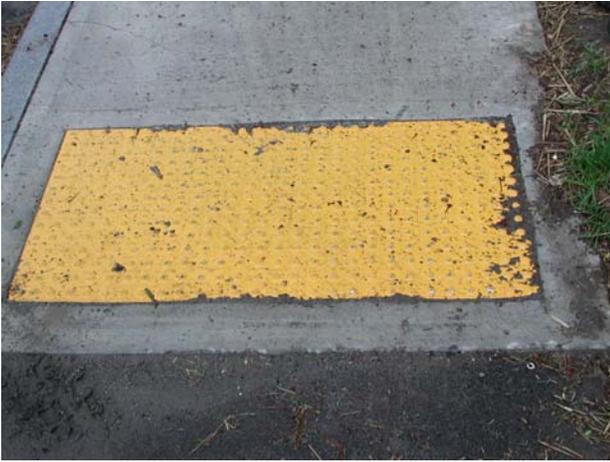
The overall condition and color fastness of this product is very good.

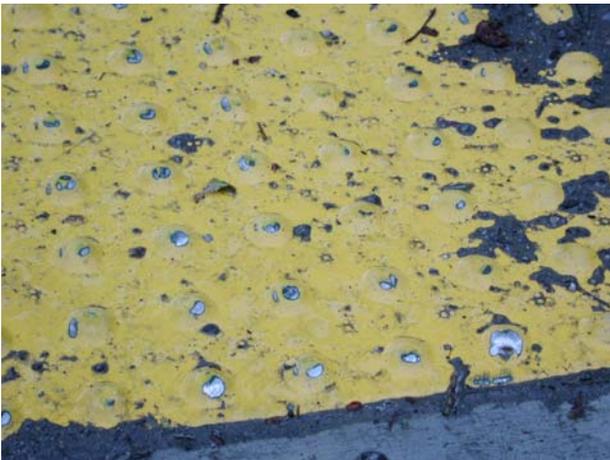
The panel surface is showing the impact of one winter of sidewalk plowing in that some of the coating has been removed from the panel, exposing the underlying stainless steel. Some minor dome damage was present.

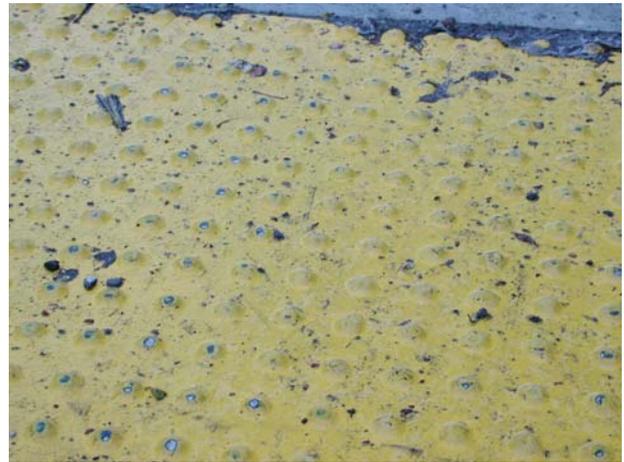
The removal of surface coating was noted on some internal domes, not just the leading edge.
