Maintenance Practices for Stormwater Runoff - Phase 2

Phase 2 Final Report
Submitted May 2015

Stormwater Management Academy
University of Central Florida
4000 Central Florida Blvd. P.O. Box 162450
Orlando, Florida 32816-2450

Agency Number: BDV24-977-02

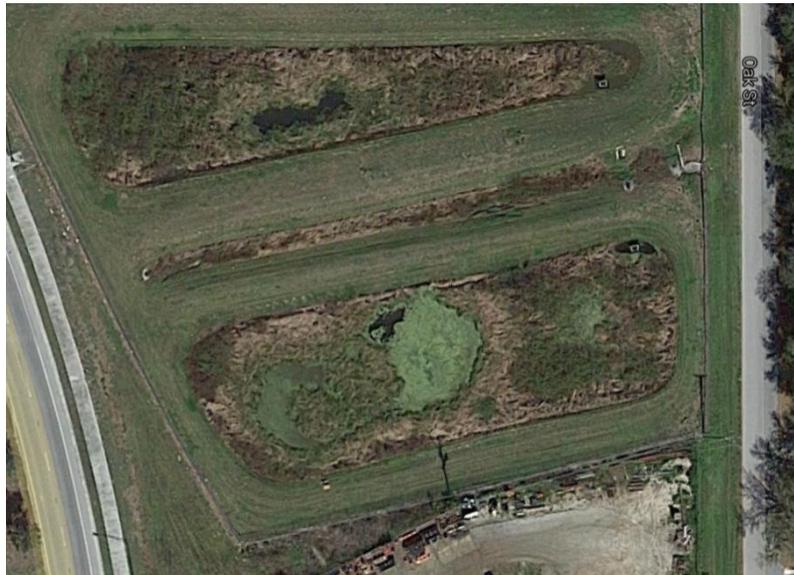
This 0.49-acre pond is immediately adjacent to a forest to the east. North of the pond lies a residential area, and a piping warehouse is uphill of the pond to the south. State Road 35 borders the western edge of the pond. Surrounding the pond are grass swales and as the pond reaches max capacity, the excess water is carried through a culvert into the central ditch. The water then flows from the central ditch into the grass swales to the north, east, and west of the pond. Immediate intake locations that feed into the pond are placed along State Road 35. No intake locations were observed on the roads to the north and east of the pond. Apparent algal growth was the only maintenance issue reported for this pond. During the initial site visit the algal growth was readily

visible. In addition to the algal problems, there was a heavily overgrown littoral zone. An image of the Zolfo Springs pond is presented in Figure 2.

Figure 2: Zolfo Springs pond

The BMP chosen for this pond was a Sloped Media Bed Reactor (SMBR). The treatment media bed reactor was designed to remove nutrients at the Zolfo Springs pond. The media mixture used in the SMBR was 50% 5/8^{ths} expanded clay and 50% tire chunk. The SMBR was chosen for this pond because of its nutrient removal capacity as well as simplicity in installation and operation. The SMBR utilizes solar energy for pump operation, therefore cutting down on potential future expenses and utilizing clean renewable energy. A cross-sectional side view of the SMBR is given below in Figure 3 and a picture of the SMBR in the field in Figure 4.

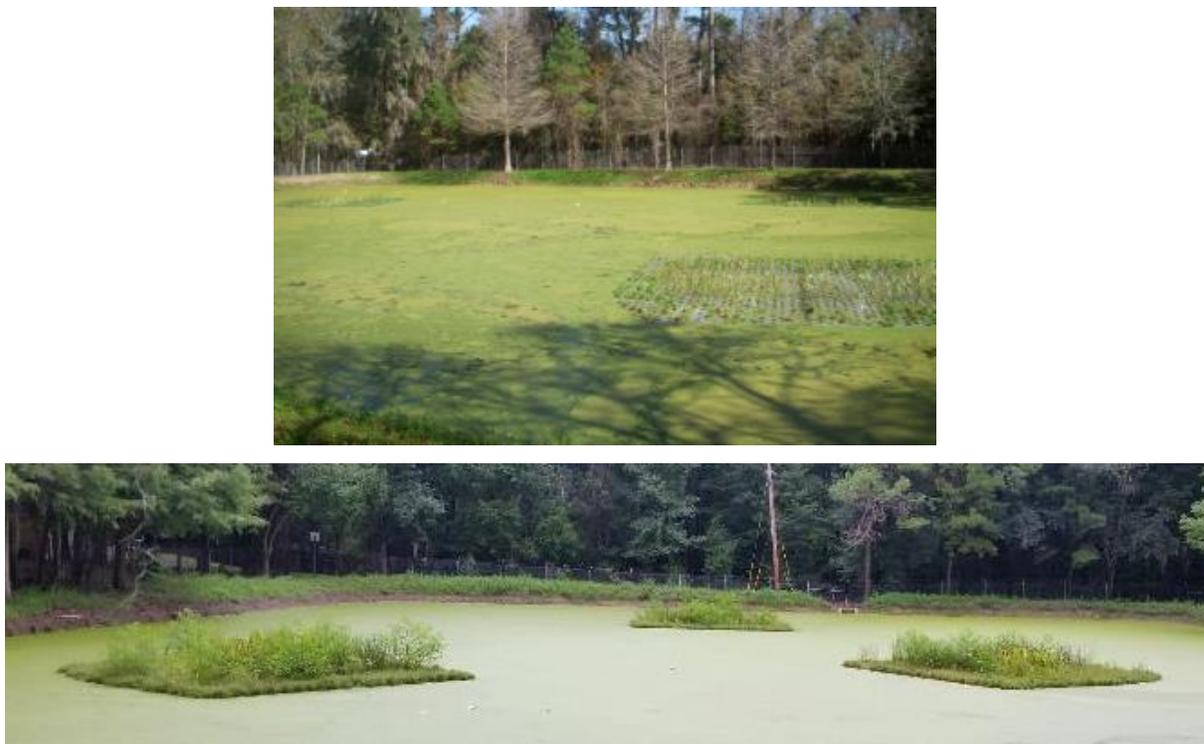
The only vegetative growth observed at the Gainesville pond prior to BMP deployment was severe algal growth. Since BMP deployment the algal presence in the pond has transitioned to a thick layer of duckweed that covers the entirety of the pond surface. Although the duckweed is still well-established in the pond, suggesting that nutrient levels are still high enough to support their population, it has not established growth on the floating mats, and hence has not interfered with FTW growth. In addition, the placement of the mats in a staggered formation and the use of a single anchor per mat has proven to be effective and no maintenance concerns have been observed to date. A side-by-side comparison of the FTWs from deployment to before plant replacement provided in Figure 13.

Figure 13: FTW plants right after deployment (above) and prior to plant replacement (below) that shows the growth of the plant species

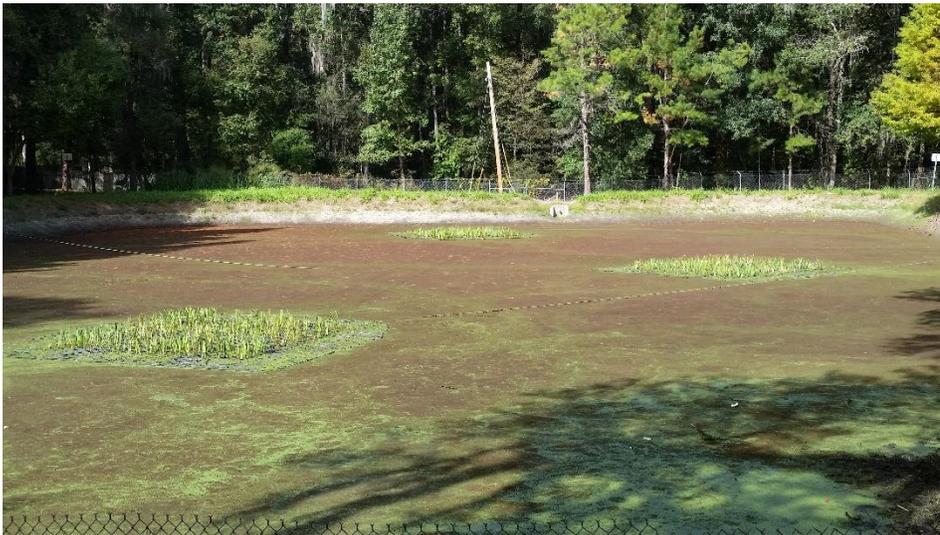
Figure 14: FTW plants after plant replacement

A complete replacement of the FTW plants was performed on October 10 and November 5, 2014. On October 10, 2014 all mature plants were removed from the FTWs and bagged for later disposal. On November 5, 2014 seedlings were delivered to the Gainesville pond, placed into the FTWs and the previously collected mature plants were taken away for disposal. The FTWs after plant replacement can be seen in Figure 14. Replacing the plants on FTWs allows us to observe nutrient removal throughout the FTW plant lifecycle and also prevents mature plants that may have otherwise died from falling into the pond, which would re-introduce nutrients back into the water column.

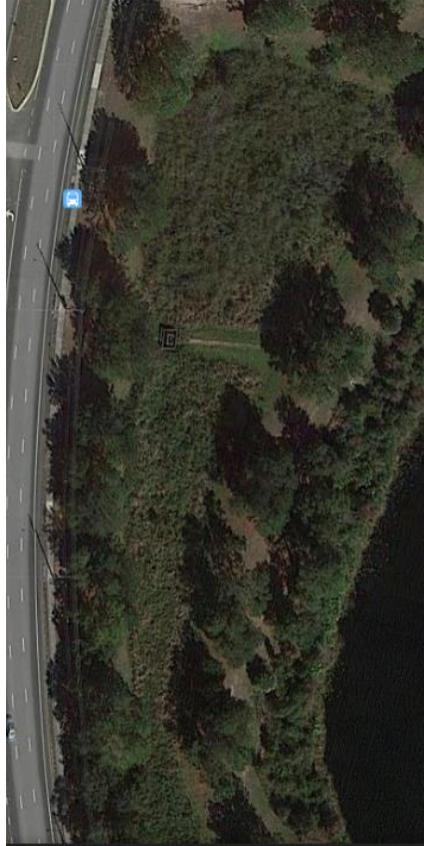
This 0.98 acre pond is located in Orlando and the primary maintenance issues reported for the pond were algae and cattail growth as well as a heavily overgrown littoral zone. The initial site visit revealed that the pond was split by a berm. The pond section south of the berm suffered from algae and cattail growth. The pond section north of the berm was heavily overgrown with vegetation and small trees. It was recommended that the nuisance vegetation be removed prior to any BMP implementation. An image of the Orlando pond is presented Figure 23.

Figure 23: Orlando pond

The BMP chosen for this pond was a Horizontal Media Bed Reactor (HMBR), which was installed at the site on April 1, 2014. The media mixture used in the HMBR was 50% 5/8ths expanded clay and 50% tire chunk. The HMBR was chosen for this pond because of its nutrient removal capacity as well as simplicity in installation and operation. The HMBR utilizes solar energy for pump operation, therefore cutting down on potential future expenses and utilizing clean renewable energy. A cross-sectional view of the HMBR is given below in Figure 24 and a picture of the HMBR in the field in Figure 25.

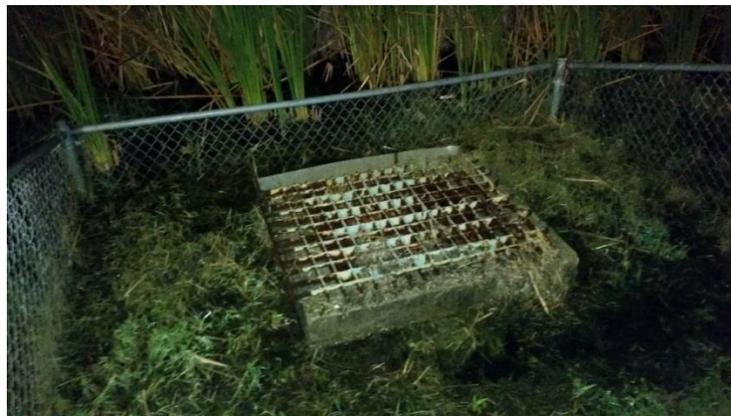
The final storm sample for Clearwater was collected on November 8, 2014. During the sampling trip a large quantity of grass clippings were observed in and around the pond outlet. These clippings may contribute to high organic nutrient concentrations, Figure 36 shows that there was a large spike in both TP and TN sediment concentrations near the outlet. A photo of the excessive grass clippings is shown below in Figure 33.

Figure 33: Grass clippings in Clearwater pond outlet

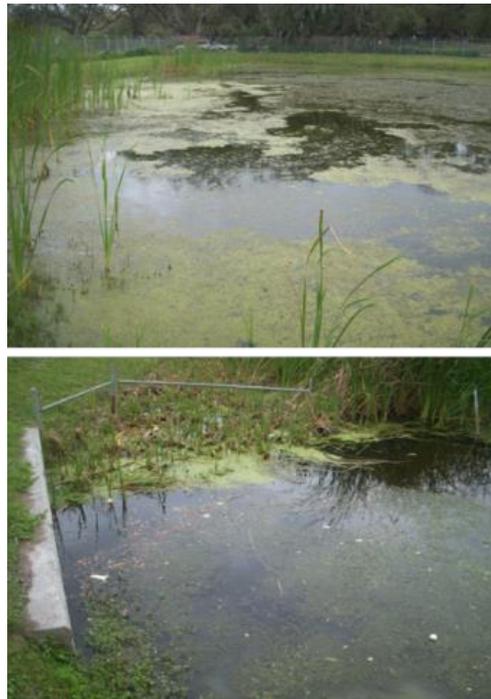
Early observations of the pond after the removal of the cattail showed that hydrilla and filamentous green algae took hold of the pond, as seen in Figure 34. This could explain why the increase in nutrient removal efficiency was so dramatic after cattail removal. The chlorophyll-a levels at the inlet, shown in Figure 35, did show an increase from February to May 2014, however this is most likely a seasonal fluctuation, attributed to the warmer temperatures. If it is the case that algae are the primary consumers of the nutrients, then the presently observed removal will likely decrease some overtime as the pond ecosystem returns to equilibrium.

Figure 34: Filamentous green algae and hydrilla observed at the Clearwater pond

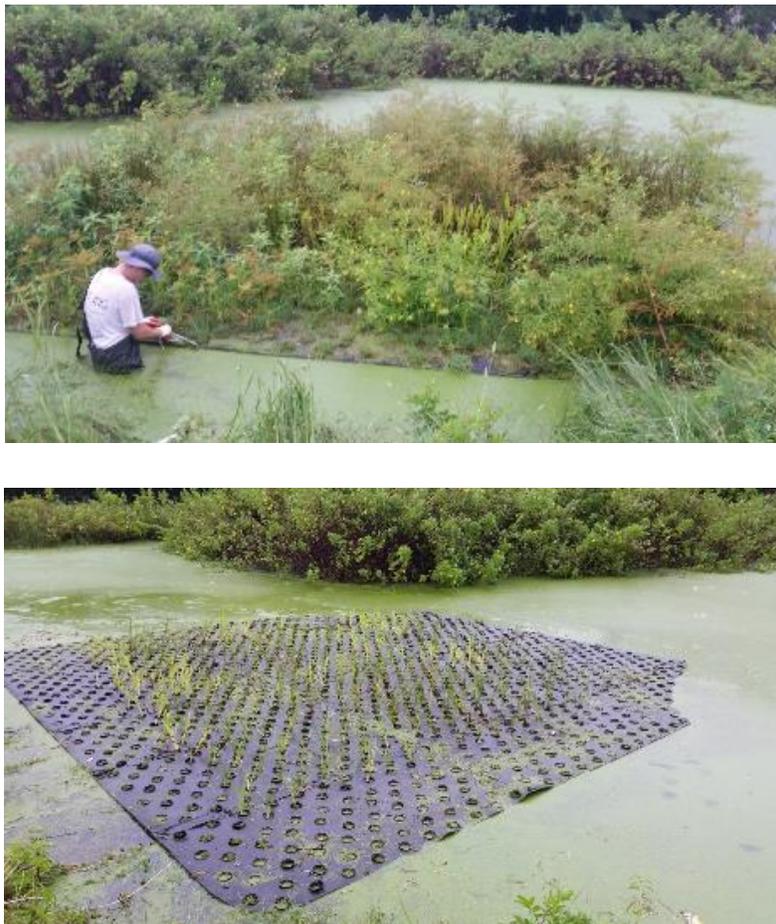
Figure 41: Plant replacement of Ruskin FTW, before (above) and after (below)

On September 17, 2014 a plant replacement of the FTW for Ruskin was conducted. This plant replacement entailed removing all mature plants from the FTW and replacing them with seedlings. Pictures of before and after the plant replacement can be seen below in Figure 41. This plant replacement allowed us to compare the efficiency of the FTW through two plant life-cycles and provided information on the optimal point for replacing plants on a FTW. One of the concerns and reasons for conducting this plant replacement was the invasion of unwanted plants onto our FTW. These plants, which can be seen all around the banks of the pond, began growing on the FTW and may have created unwanted competition between the different plant species and possibly impacted the removal of nutrients.

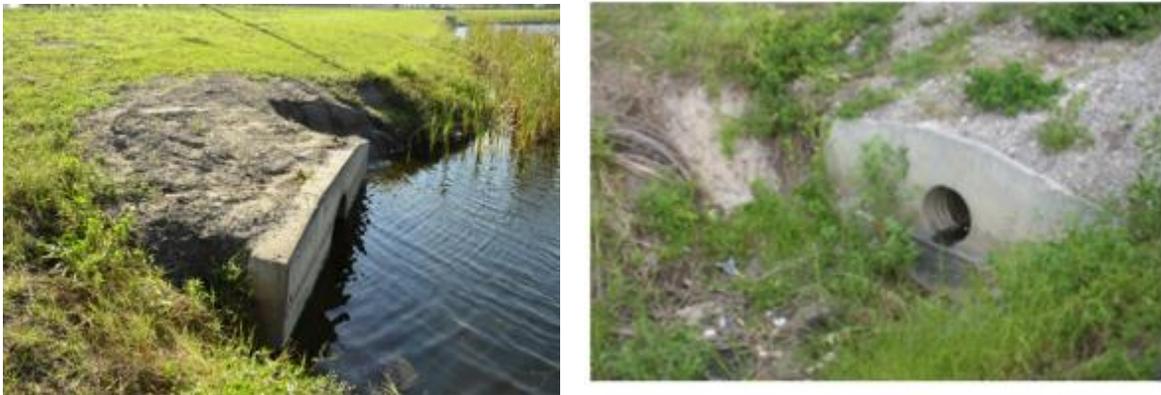
Figure 44: Pre-BMP conditions at S-139 (left) and S-145 (right), respectively

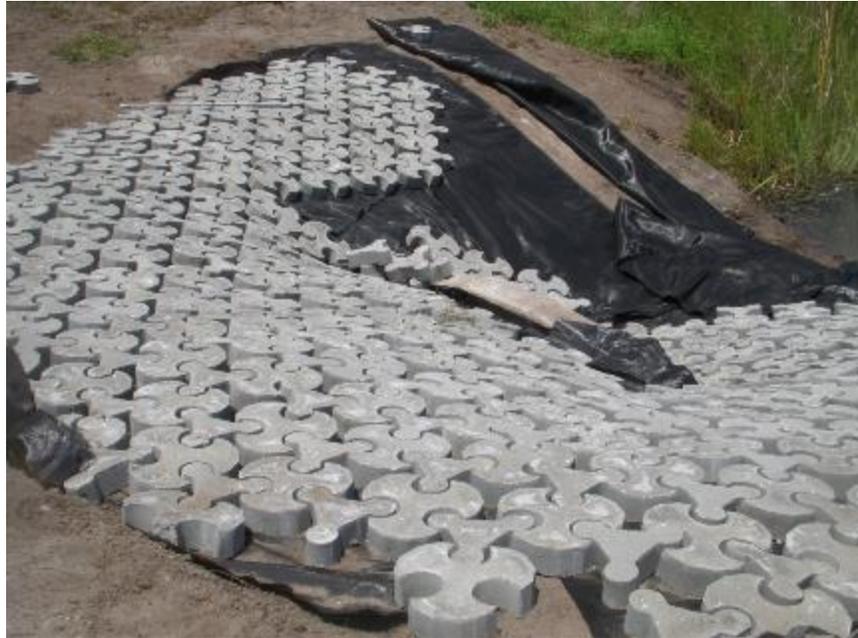
Figure 45: Tri-Lock installation around S-145 at the conclusion of the first day of work

On June 23 and 24 FDOT staff conducted the site preparation. On June 25, two representatives directed and assisted a crew of 2 UCF students and 6 FDOT workers in the installation. The site proved to be challenging due to the steep slopes, which were prepared to minimum specifications as constrained by the existing site conditions, and the geometry around S-145. After 5.5 hours of work, about 35% of the installation was completed, as shown in Figure 45.

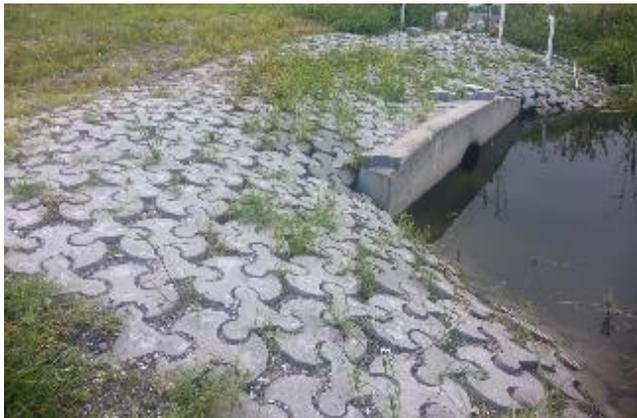
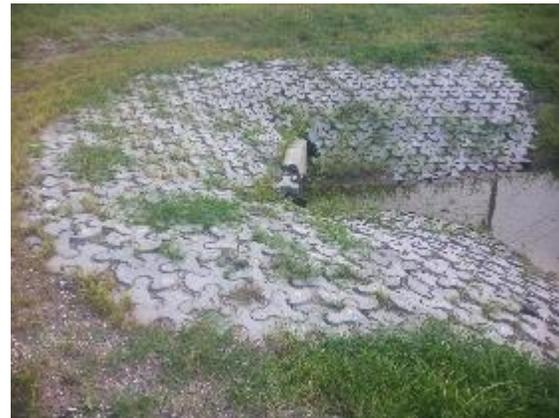
Figure 49: Tri-Lock erosion blocks around S-139 and S-145 80 days following installation

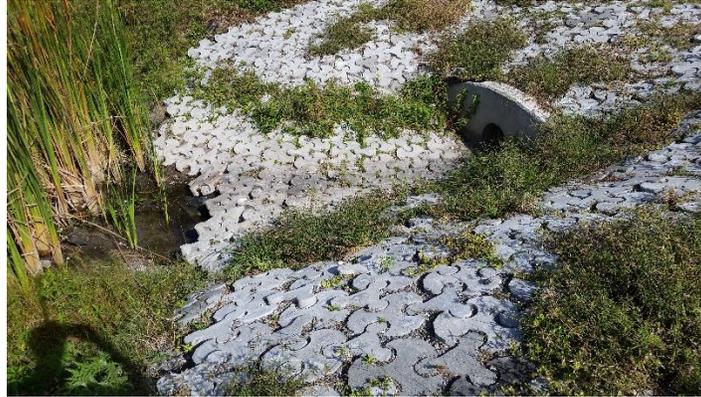
A site visit to the pond on January 19, 2015 showed continued vegetation growth in and around the Tri-Lock installation area. Pictures of the Tri-Lock and surrounding conditions are presented in Figure 51 and Figure 52. It is interesting to note that the water level has fallen below the level of the Tri-Lock at inlet 1 shown in Figure 51, however the Tri-Lock is still intact and no

signs of structural damage were noticeable. Regrowth of vegetation in and around the Tri-Lock blocks is encouraged as the vegetation root systems will aid in bank stabilization, as well as giving the pond more natural looking aesthetics.

Figure 51: Tri-Lock and vegetation growth around inlet 1

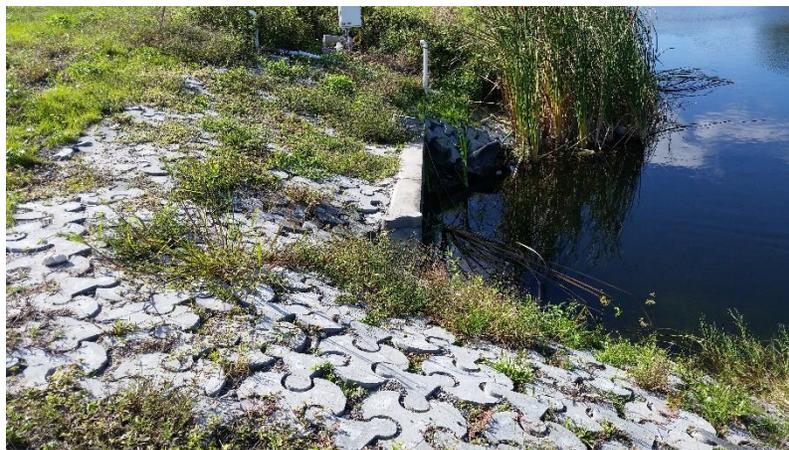
Figure 52: Tri-Lock and vegetation growth around inlet 2
