**REPLACEMENT PRIORITIZATION OF PRECAST
DECK PANEL BRIDGES**

Final Report for:

MARCH 2005

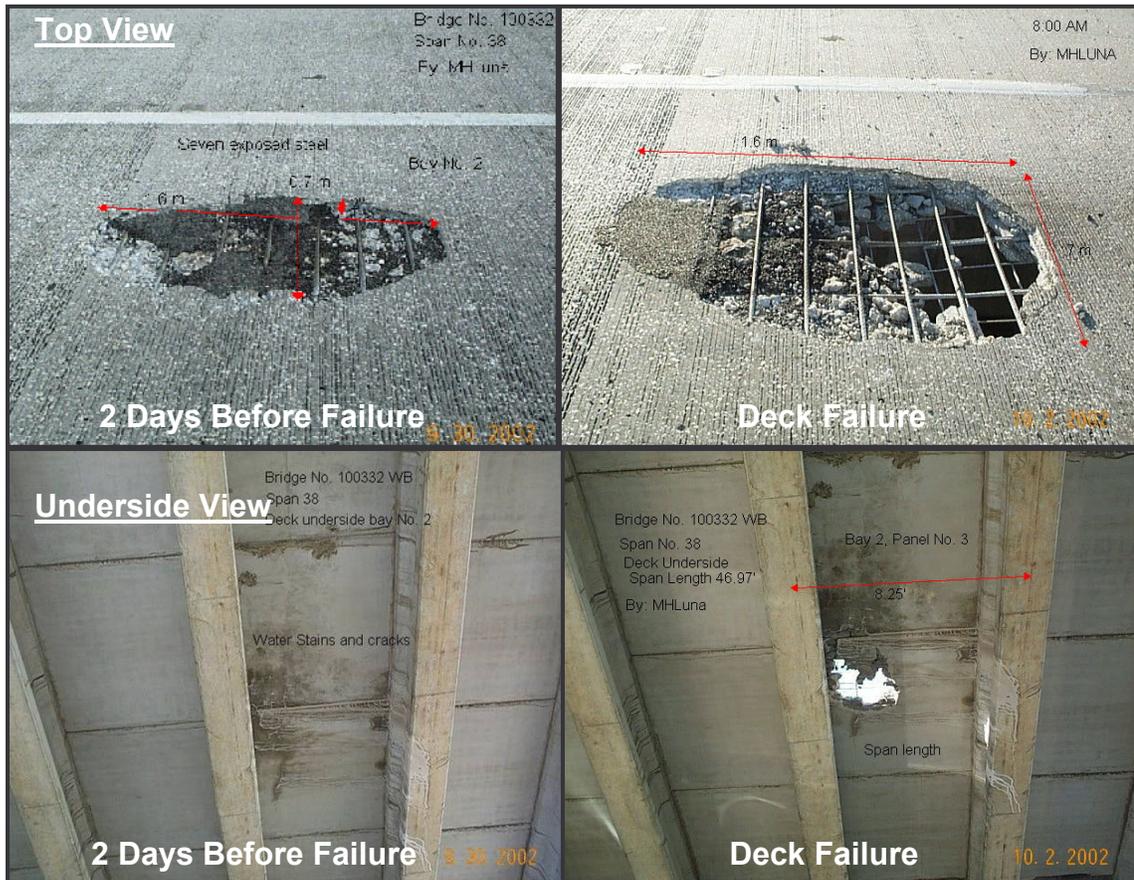
Figure 3.14 Localized Deck Failure. Bridge #100332, Span 38

This failure was first noticed early morning on Wednesday, October 2 2002. It was located on the right lane close to mid-span. A gaping 5 ft 3 in. by 2 ft 6 in. hole formed (see Fig. 3.14). The same figure shows photos of the failed region and its underside two days prior to failure. Staining of the underside is visible. The concrete and repair material separated from the reinforcement which did not rupture. Fig. 3.15 provides a sketch showing the failure location on the deck.

This damage was repaired by demolishing the whole bay where the failure occurred and placing a new deck using full depth cast in place concrete.

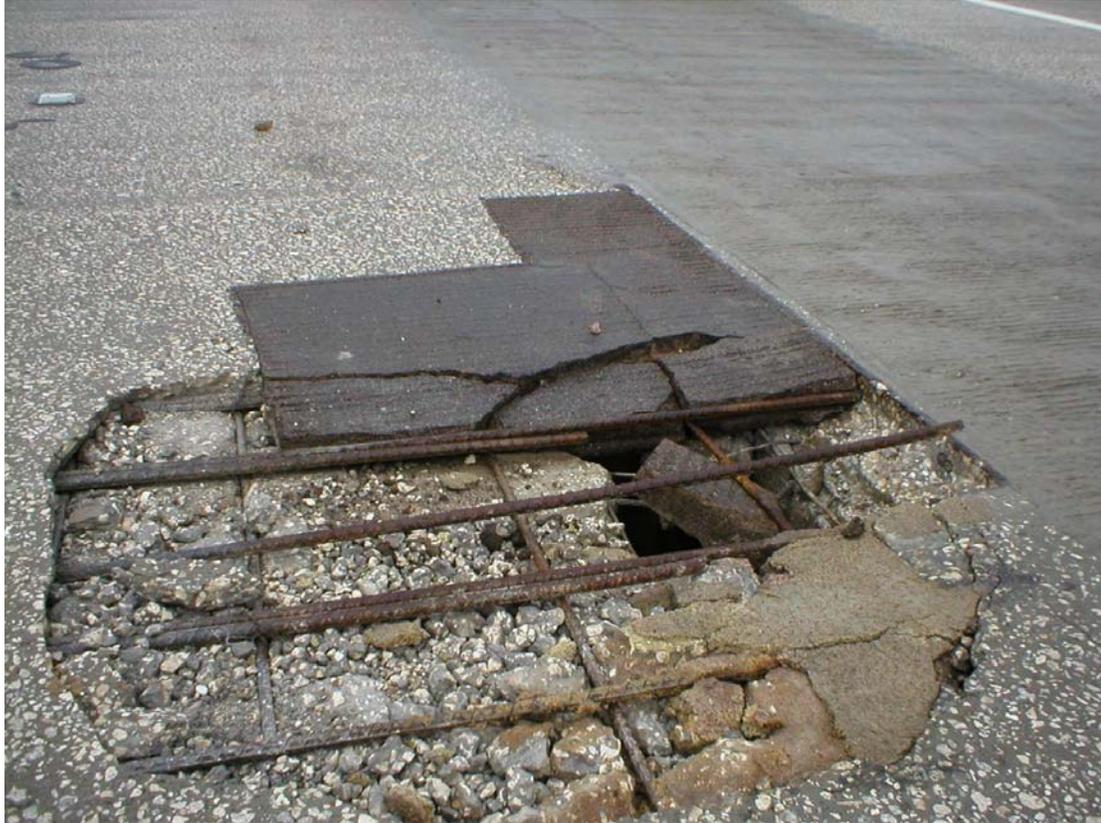
Figure 3.19 Localized Deck Failure, Bridge # 100332, Span 70

Fig. 3.19 has three photos. The main photo is a close-up plan view of the damage from the top of the deck. Note that the rebar are not broken nor plastically deformed. Small sections of concrete just separated from the reinforcement. One of the prestressing strands can be seen to be intact. A second photo provides an overview of the deck. The third photo shows the extent of the opening in the deck from the underside. Water staining is clearly visible. This failure was repaired by demolishing the whole bay where the failure occurred, and the one adjacent in the left lane, and placing a new deck using full depth cast in place concrete.

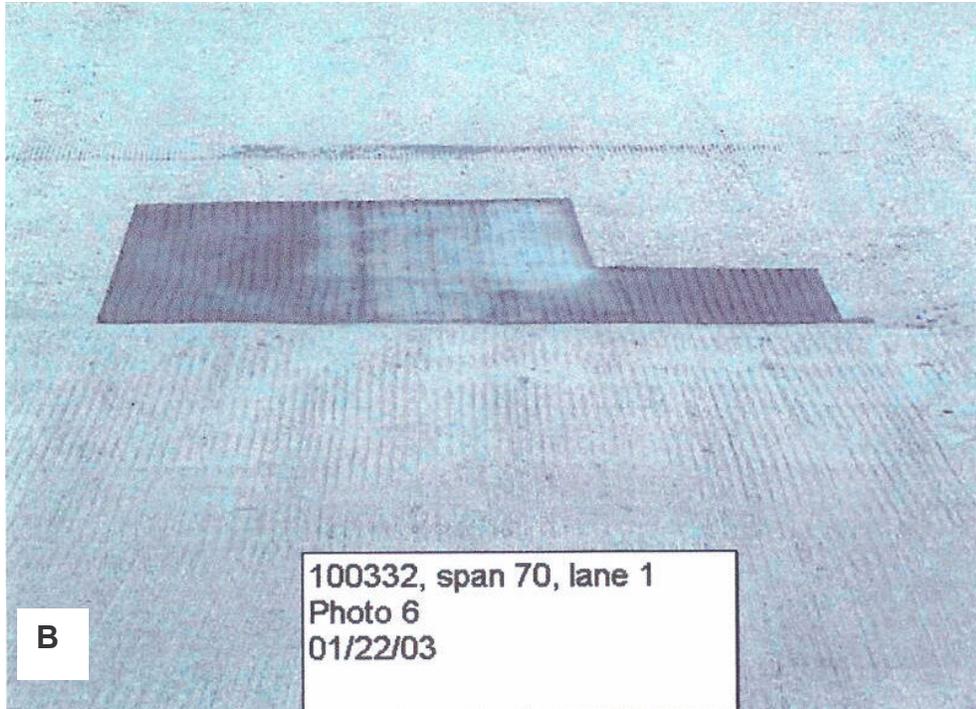
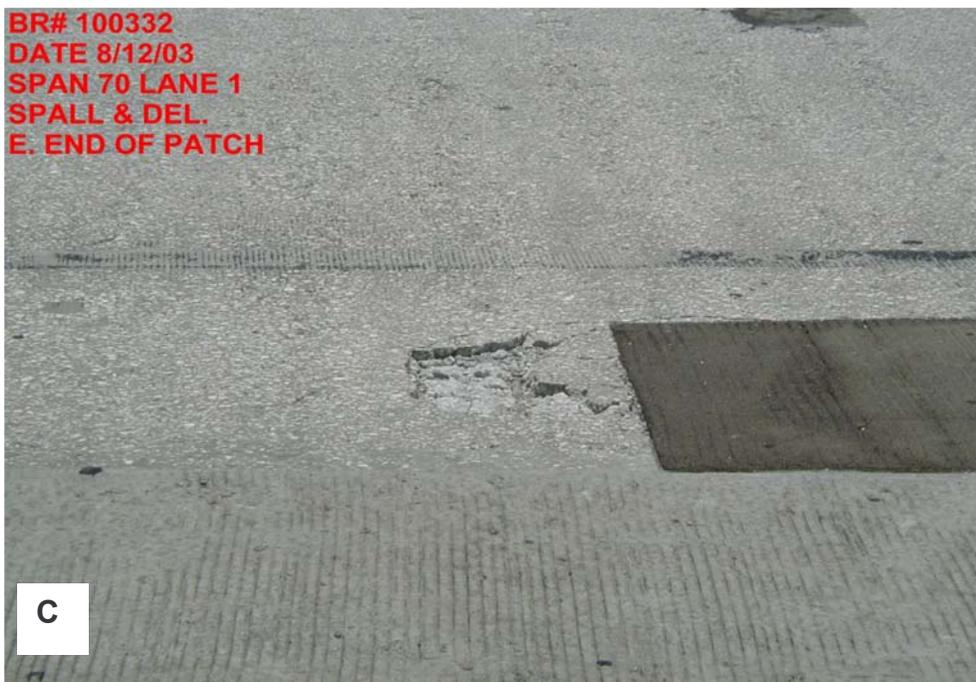
Figure 3.21 Deck Spall Bridge # 100332, Span 70. A) Initial spall 14 months before failure B) M1 repair over initial spall 8 months before failure, C) Spall next to the M1 repair, 23 days before failure.

Figure 3.21 (continued) Deck Spall Bridge # 100332, Span 70. A) Initial spall 14 months before failure B) M1 repair over initial spall 8 months before failure, C) Spall next to the M1 repair, 23 days before failure.

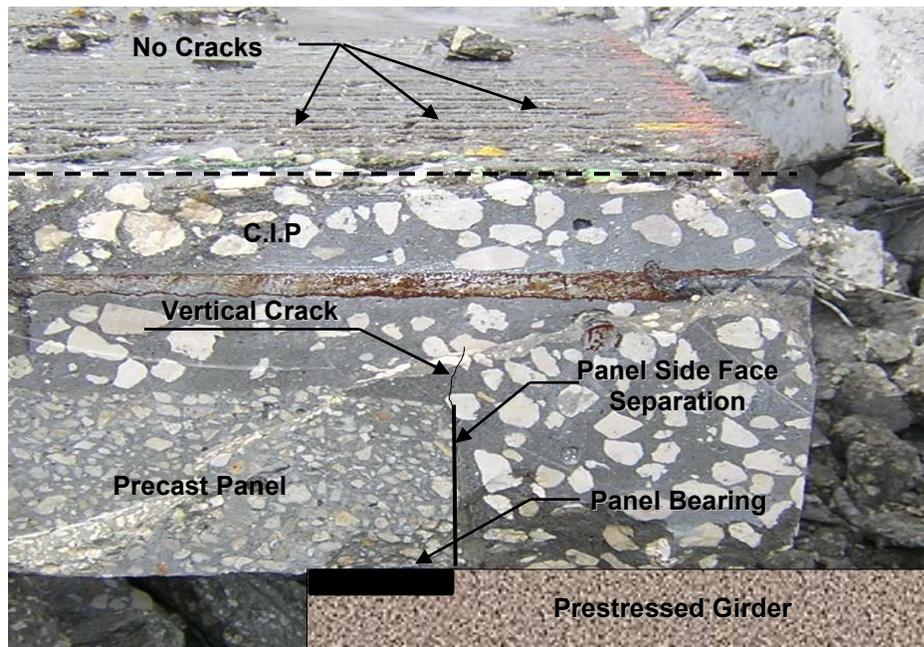
Figure 4.7 No Deck Surface Cracking

Fig. 4.7 shows a retrieved panel with no surface cracking. The location of the prestressed girder support and the bearing pad has been drawn to provide better understanding.

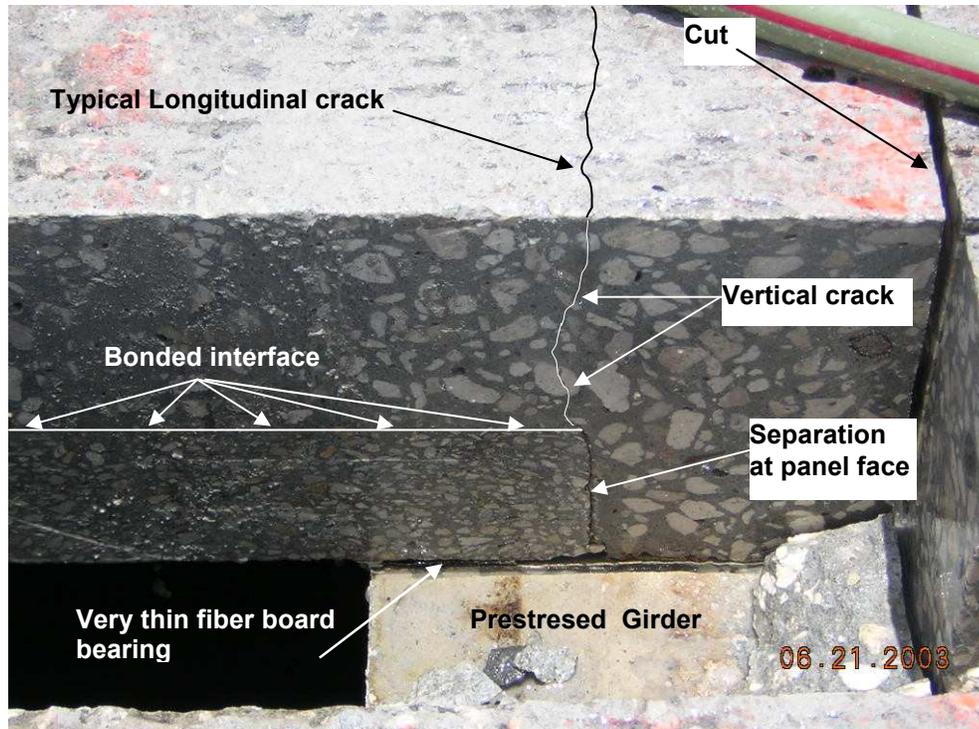
Figure 4.8 Development of Deck Surface Longitudinal Crack

Fig. 4.8 shows how a typical longitudinal crack develops. This picture was taken with the panel in place in the bridge after the adjoining panel had been removed. The prestressed girder shown is the actual girder which supported the panel. The fiberboard bearing support is also visible.

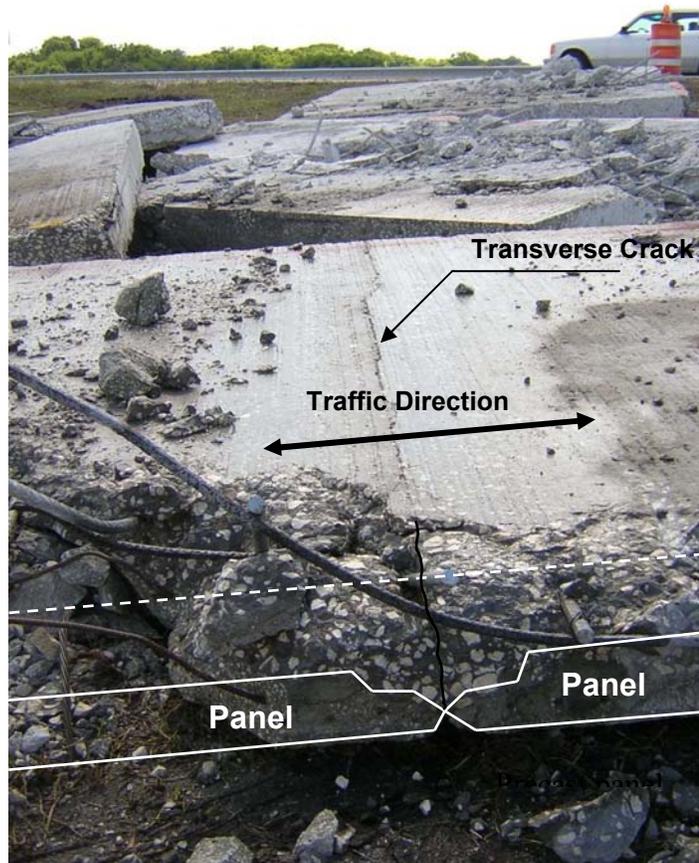
Figure 4.9 Deck Surface Transverse Crack

Transverse deck surface cracking is not as common as longitudinal cracking. In most cases this is a hairline crack and it tends to remain stable without causing any further damage. In the forensic examination it was only detected in sections that were removed (Fig. 4.9).

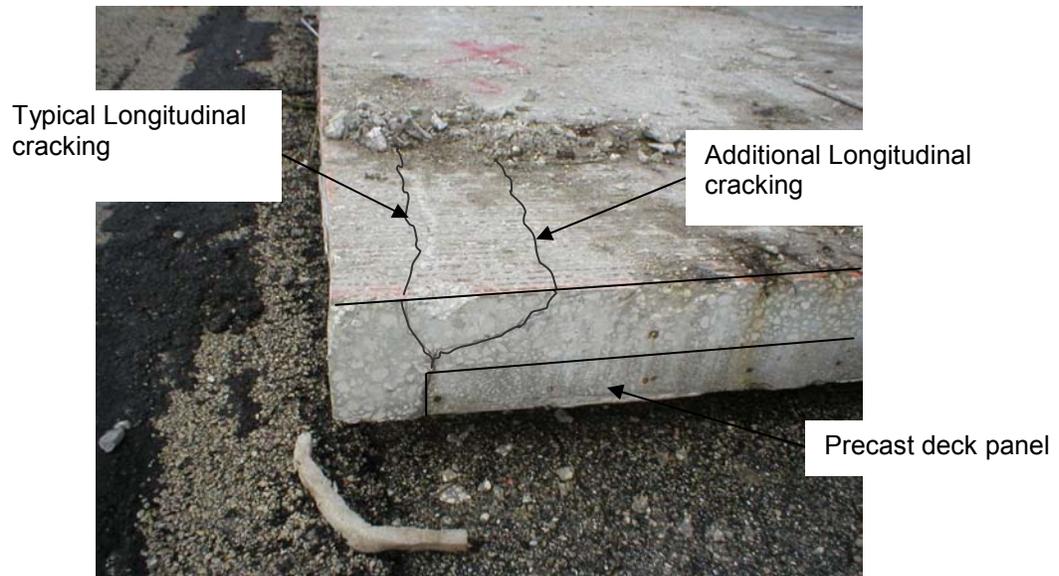
Figure 4.10 Additional Longitudinal Cracking

In addition to the typical longitudinal crack running over the edge of the panels (See 4.3.3.2) another type of longitudinal cracking was found. This crack runs about 4 in. parallel to typical longitudinal cracks (Fig. 4.10).

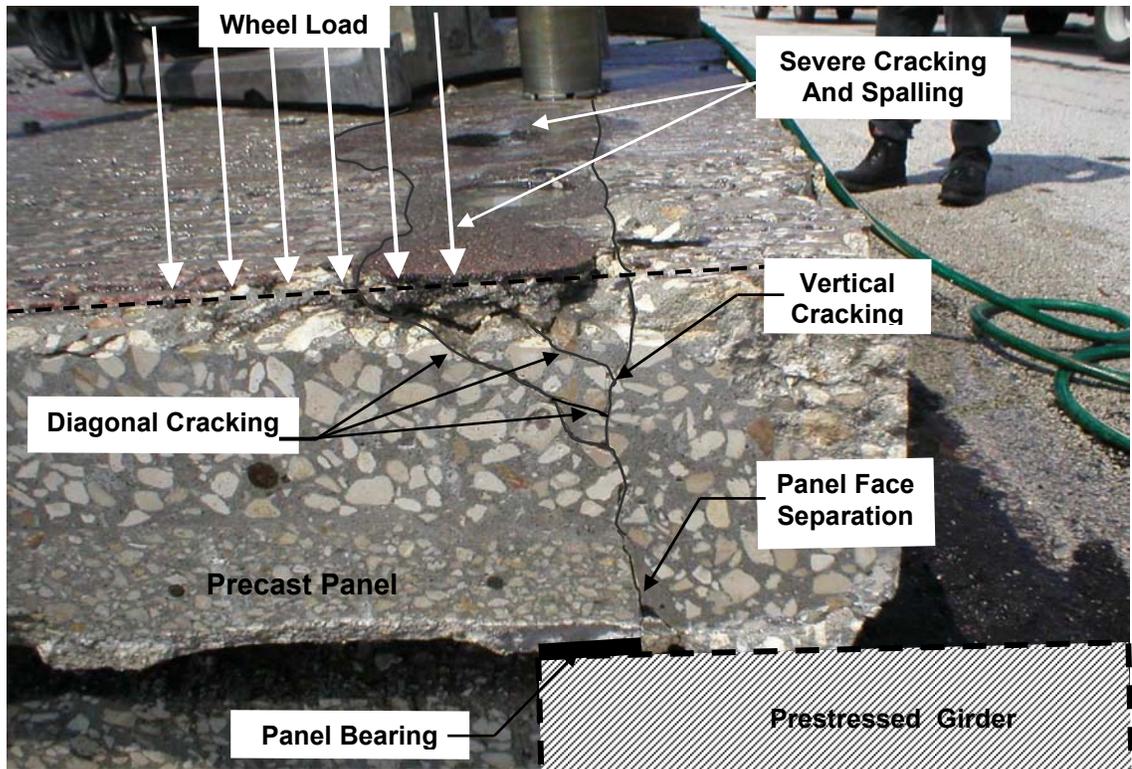
Figure 4.11 Development of a Deck Surface Spall

In this specific case, the spalled area studied was located next to an existing M1 repair. This is a common deficiency in deck panel bridges; it is also known as a “walking spall” because it always occurs next to a spall patch or repair.

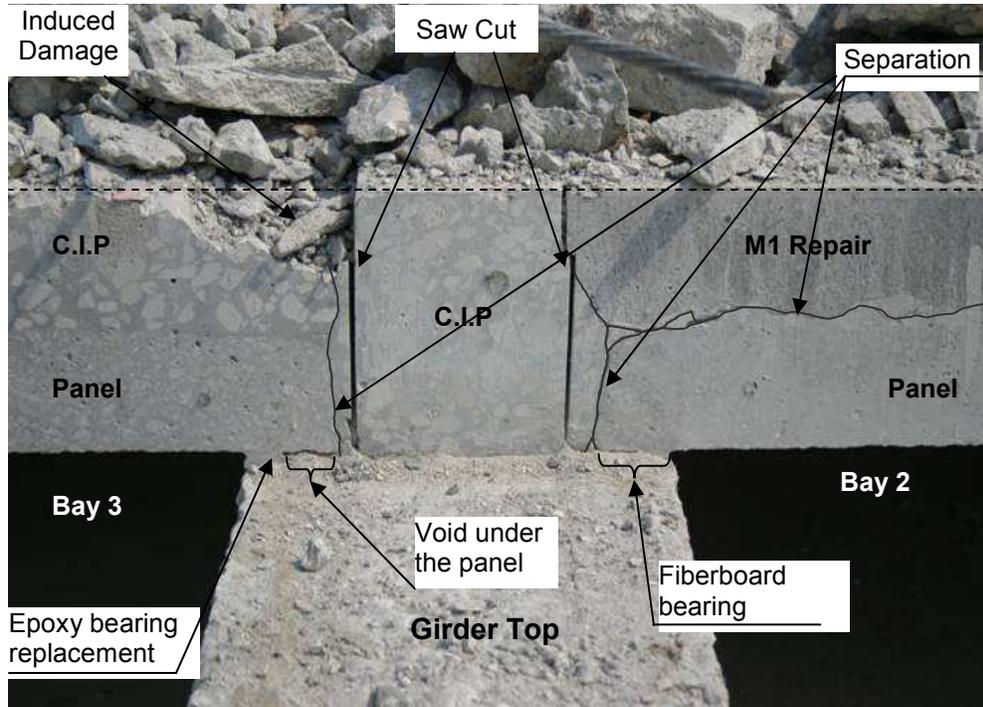
Figure 4.20 Deck Cross Section View over Girder # 3

Fig. 4.20 is a view of a section of the deck panel and the prestressed girder. The panel on the left is supported by epoxy while the section on the right is on fiberboard. Thus, the replacement was partial and not over the entire deck as recommended in a previous research study [4.3]. Inspection of Fig. 4.20 shows that when epoxy was used to replace the fiberboard bearing it only penetrated over approximately one third the bearing width leaving a region that was unsupported (bay 3). Note the emergence of a vertical crack from this unsupported region. A similar crack appears from the edge of the fiberboard support on the right (bay 2). This was more heavily loaded and required an M1 repair. The divergence of the vertical crack caused separation of the interface between the M1 repair and the panel that cannot act compositely under flexural loading. The deterioration was more severe in bay 2 because of a combination of heavier loads and fiberboard supports.

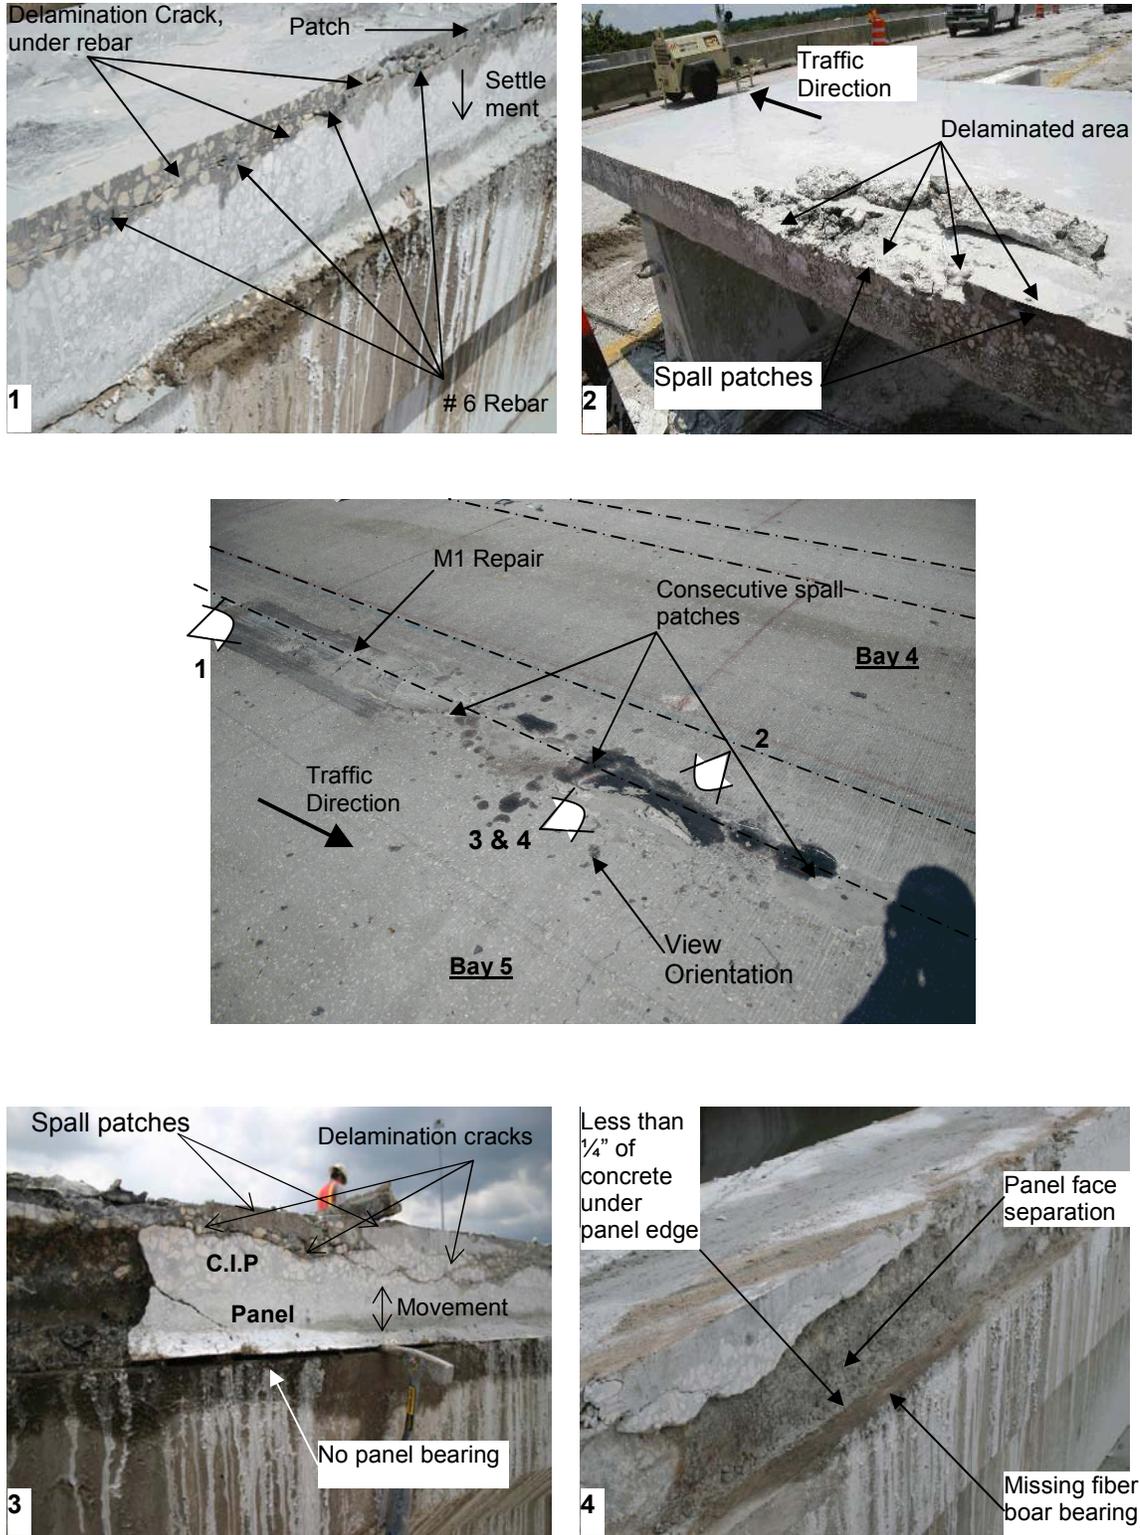
Figure 4.25 Examination of a Deteriorated Deck Section on Bridge #100415

Fig. 4.25 shows the location of the M1 repair and the walking spalls in bays 4 and 5 in span 2. There are four numbered locations 1-4 in the plan view. These identify elevation views of the supporting girder and deck section after the panel had been cut out. The top left figure marked 1 shows the support for the panel at the M1 repair location. Note the longitudinal delamination in the cast-in-place (CIP) slab near the top. The figure marked 2 is a view of the panel after it was removed and placed on temporary barrier supports. The patch repairs and regions adjacent to it separated readily indicating loss of bond. The figure marked 3 is same as the one marked 1 except that it is located at a deteriorated region. A hammer head can be easily inserted indicating lack of bearing support and separation (also shown in the figure marked 4 where the concrete was removed. Separation of the vertical face (not visible) is also marked.

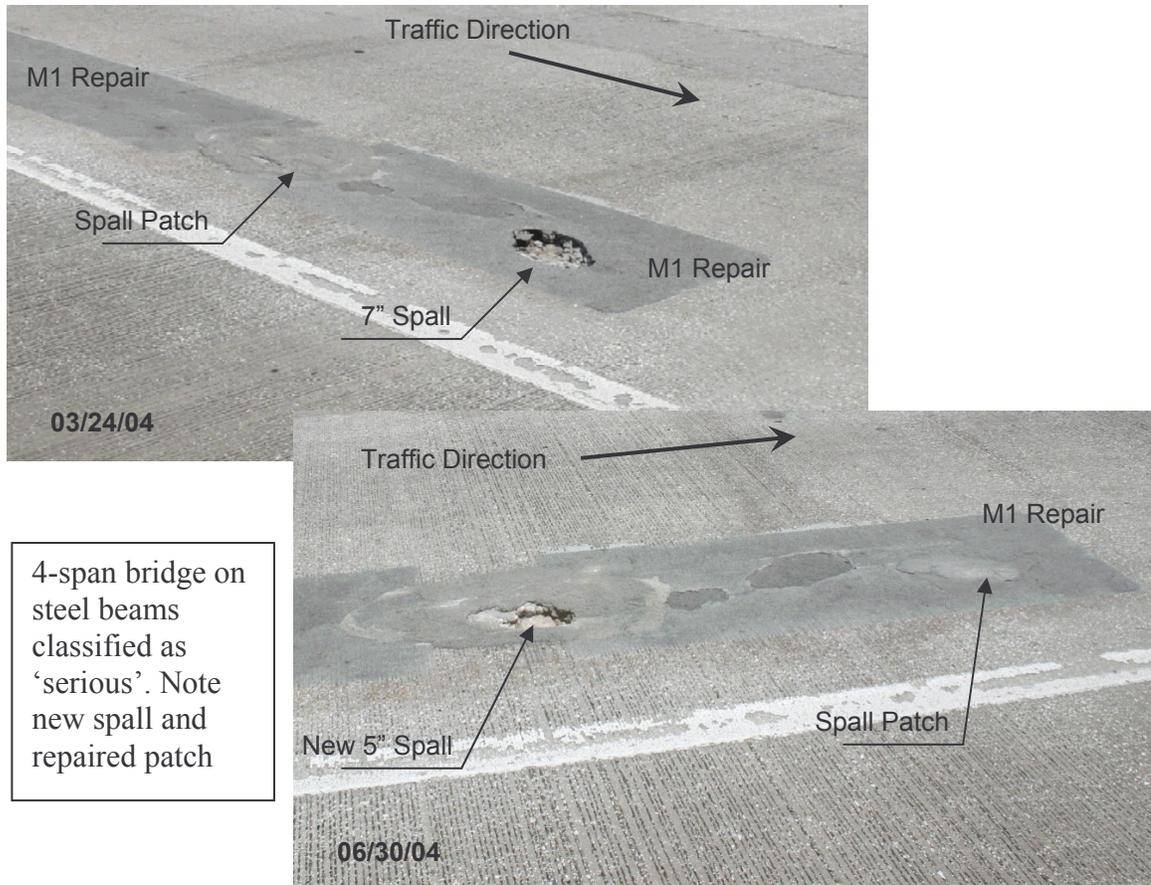
4-span bridge on steel beams classified as 'serious'. Note new spall and repaired patch

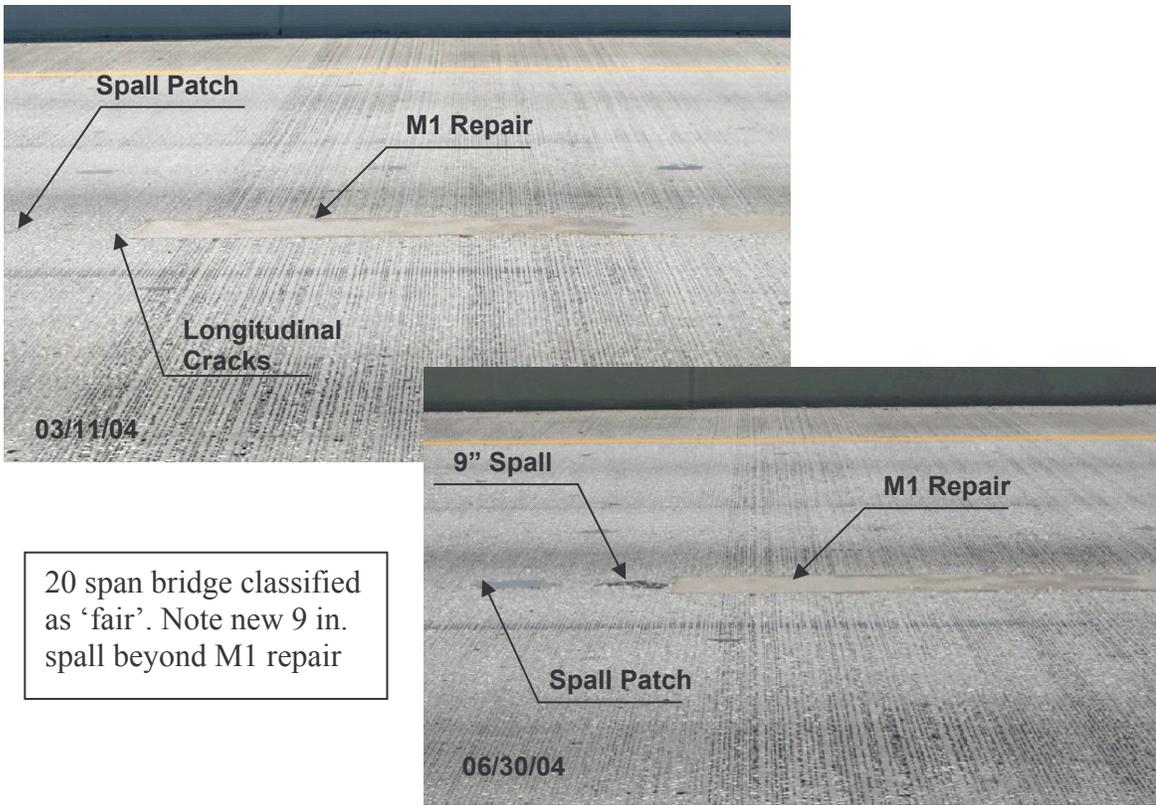
20 span bridge classified as 'fair'. Note new 9 in. spall beyond M1 repair

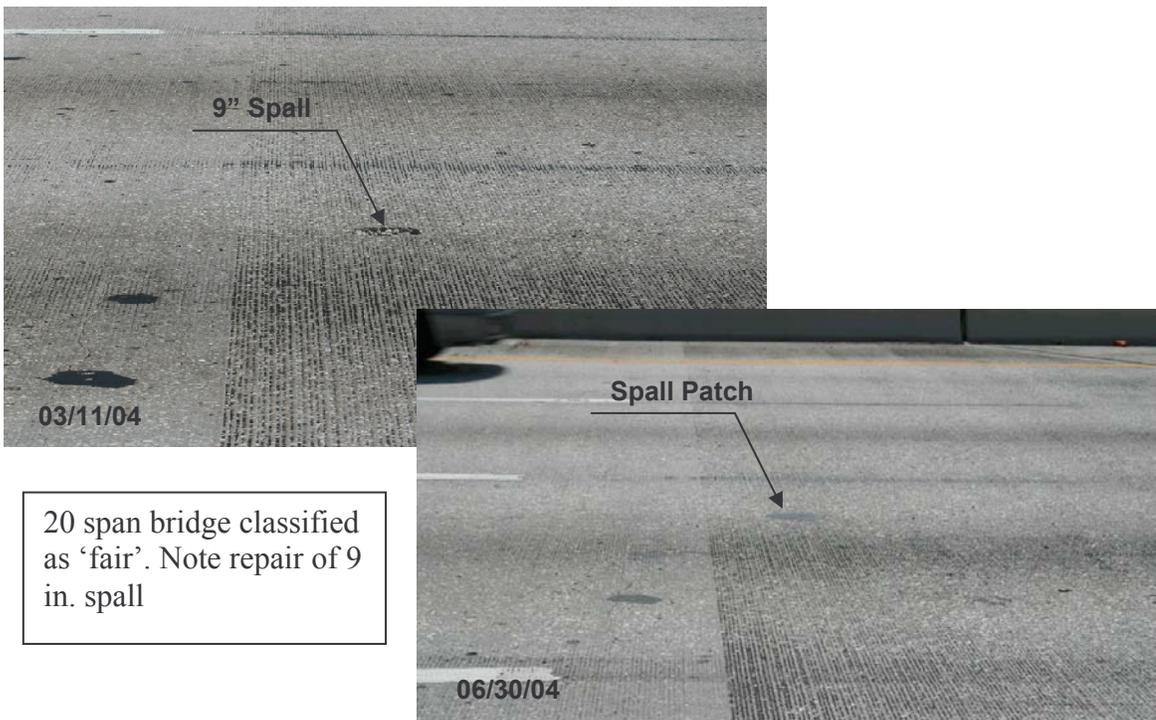
20 span bridge classified as 'fair'. Note repair of 9 in. spall

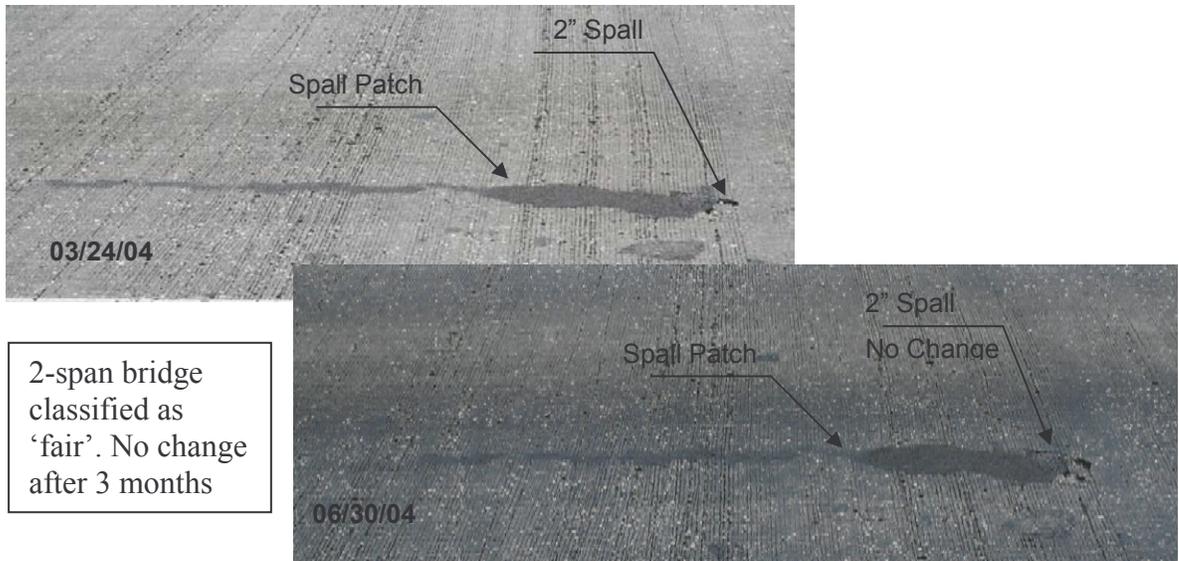
2-span bridge
classified as
'fair'. No change
after 3 months

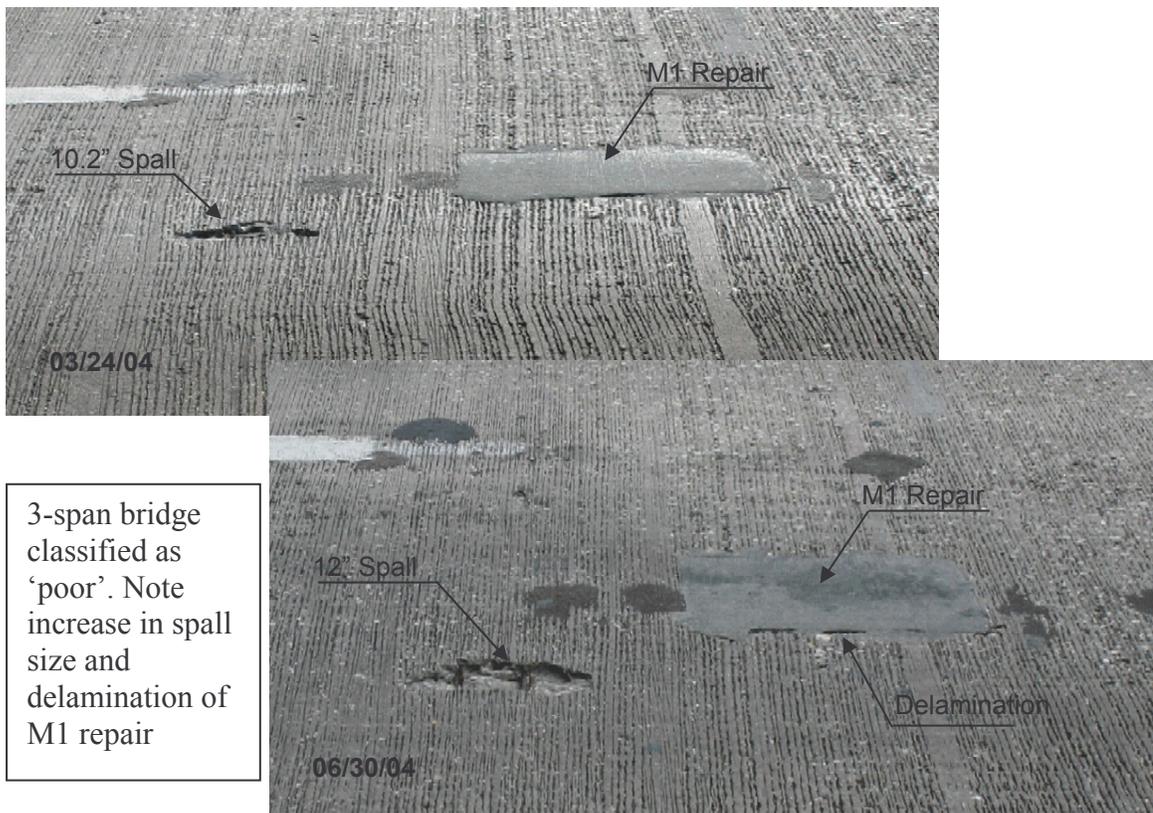
3-span bridge
classified as
'poor'. Note
increase in spall
size and
delamination of
M1 repair
