Durability Performance of Submerged Concrete Structures - Phase 2

Contract No. BDV25 977-12

Final Report to Florida Department of Transportation

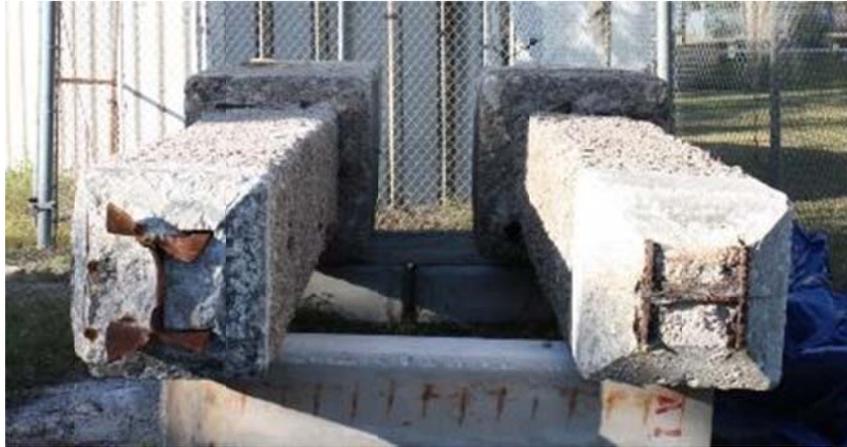
Figure 2. Piles, end view. Note marine organisms and muck accumulation on each pile's exterior surface everywhere except area below the mudline (foreground).

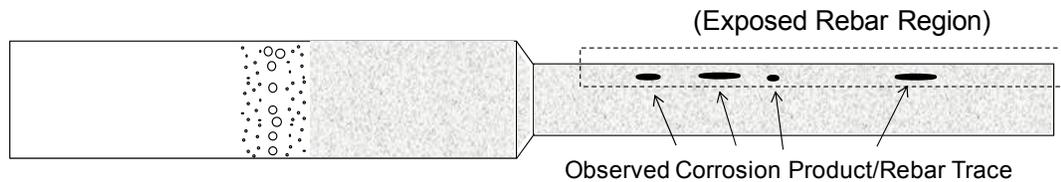
Most of the exposed region of bar 1 was free of visible corrosion but several portions, with a combined surface area that amounted to approximately 19% of the total, showed evidence of corrosion. The approximate locations of corroded regions are shown in Figure 6. The corrosion was sufficient to leave a distinct rust-colored trace on portions of the removed concrete (Figure 7).

Figure 6. Approximate locations of observed corrosion products and rust trace on removed concrete bar 1.

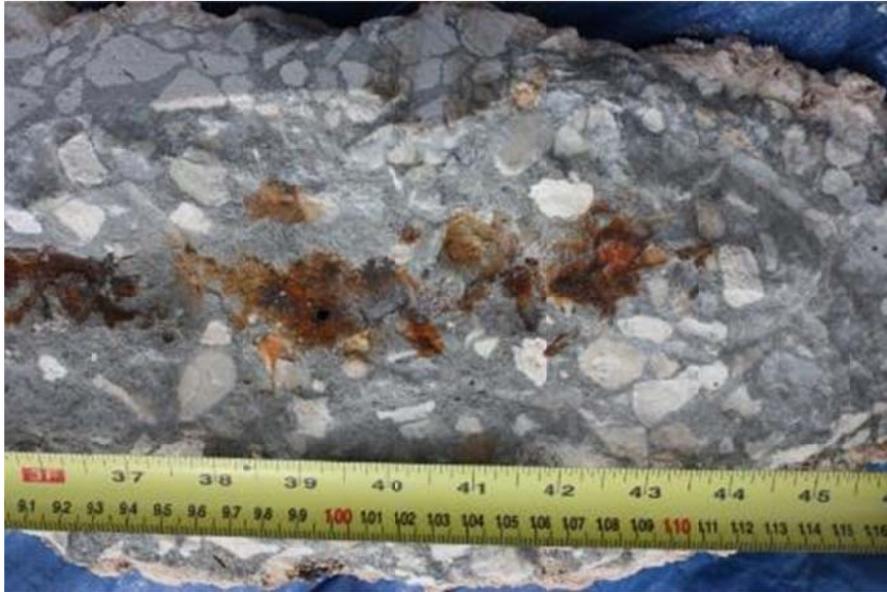
Figure 7. Rebar rust trace on portion of concrete removed from Pile #1. Tape measure indicates distance from bottom of pile.

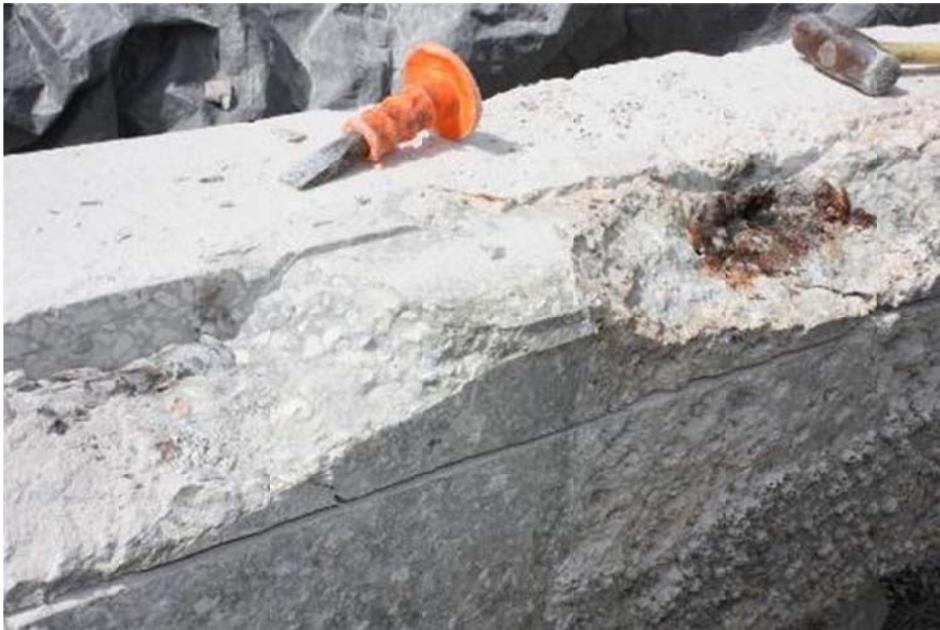
A hammer and chisel were then used to fracture the concrete beyond the saw cut and expose the embedded bar. As the concrete cover was fractured and removed, several oxide-stained regions were observed as shown in Figures 9 and 10.

Figure 9. Oxide stains in concrete cover observed during removal of embedded bar.

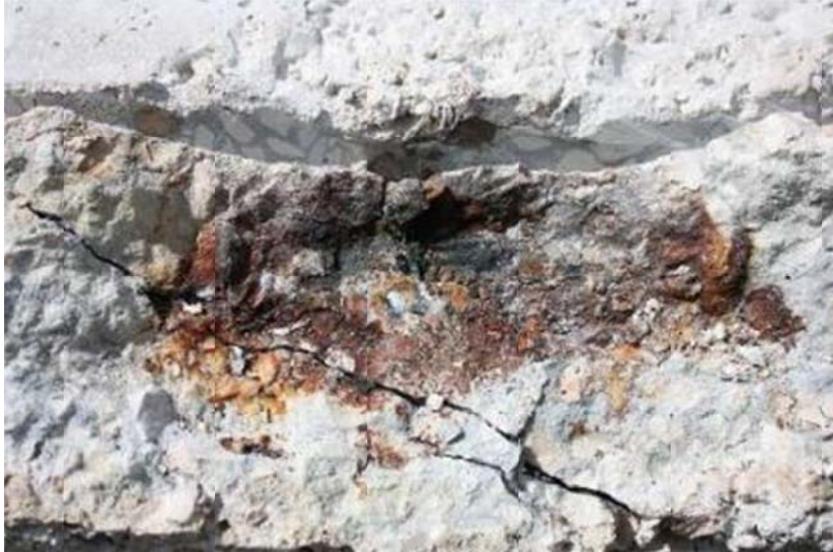
Figure 10. Close-up view of oxide stains in concrete cover observed during removal of embedded bar. Note that a small portion of the bar itself can be seen in the center of the photo.

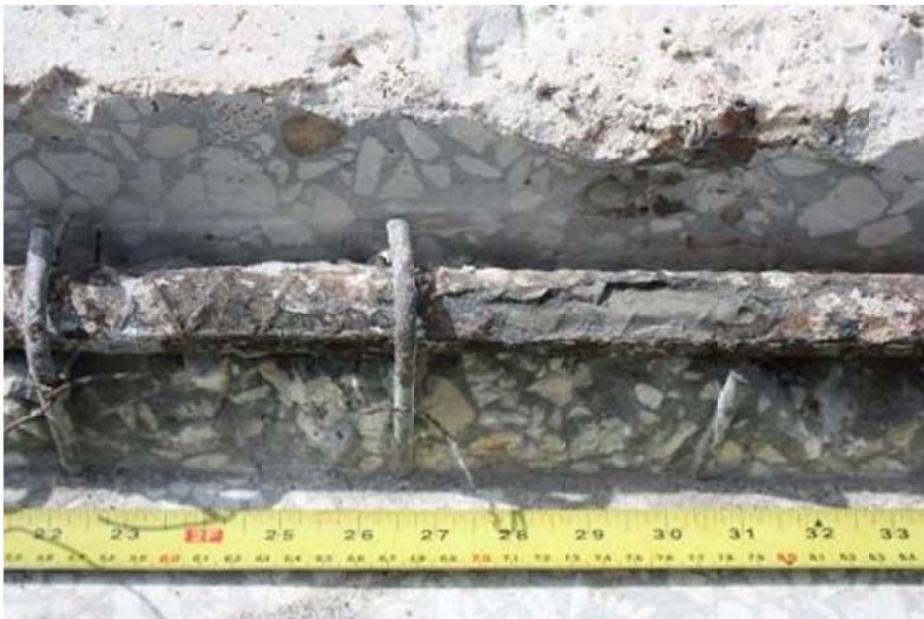
The exposed bar (in each case) showed some areas of apparent significant section loss as shown in Figure 11. The corrosion products appeared to have spread into corrosion-induced cracks that radiated from the bar, although some extent of corrosion product penetration was present also in the bulk of the concrete near the bar.

Figure 11. Rebar in situ following removal of the concrete shown in Figures 9 and 10.

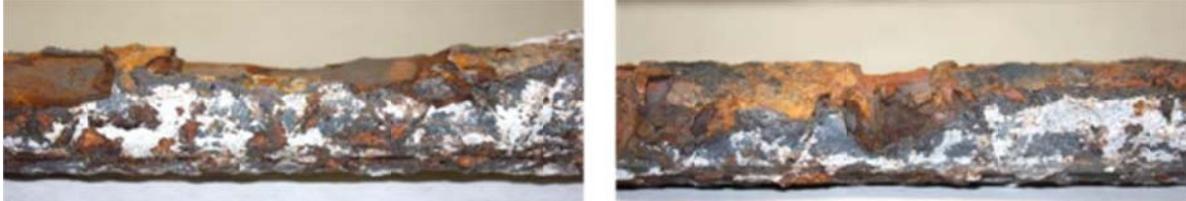
Figure 12. Apparent corrosion-related cross-section loss observed in bar #1.

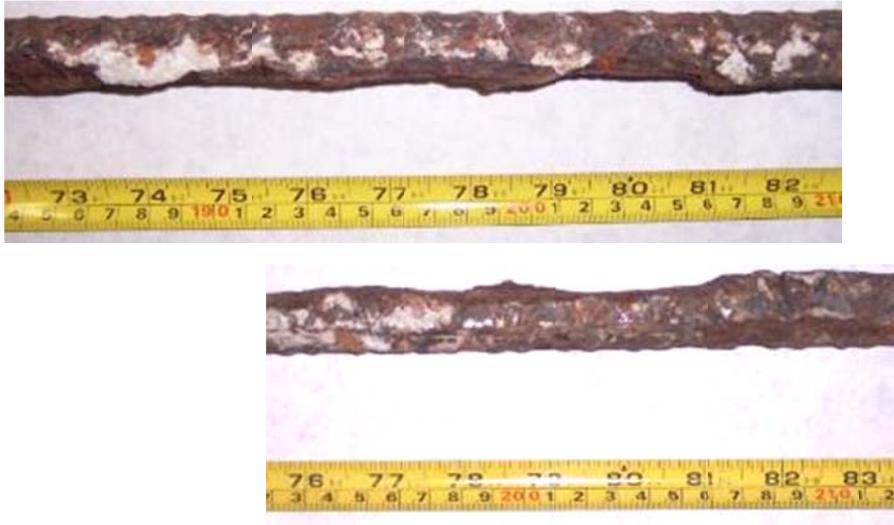
Figure 15. Corrosion-related cross-section loss in Bar #5.

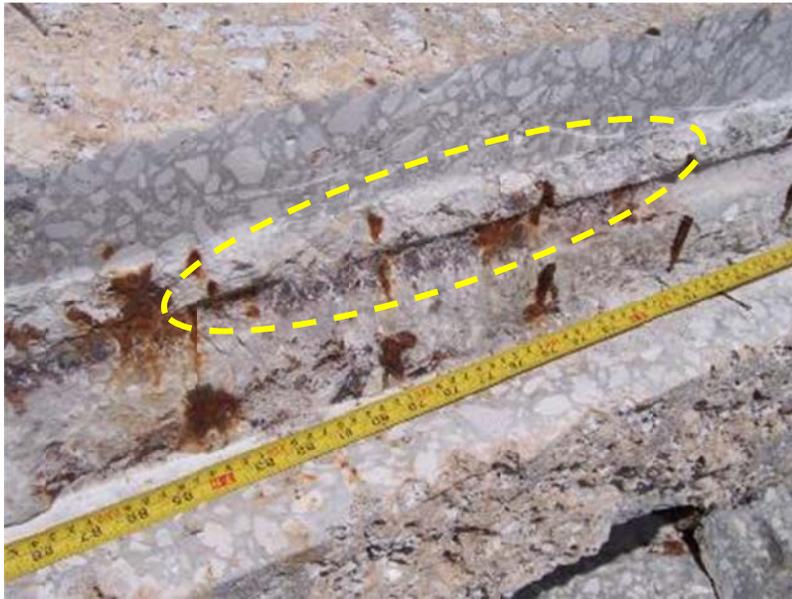
Figure 16. Rebar trace corresponding to underside of the corroded region of Bar #5.
Marked zone corresponds approximately to bar segments pictured in Figure 15.

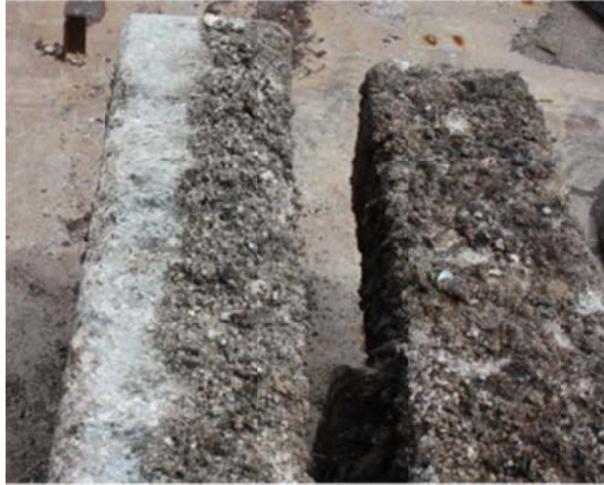
Figure 23. Marine growth on the submerged regions of two piles. Note that some growth has been removed from the surface of the pile on the left in preparation for autopsy/saw cutting.

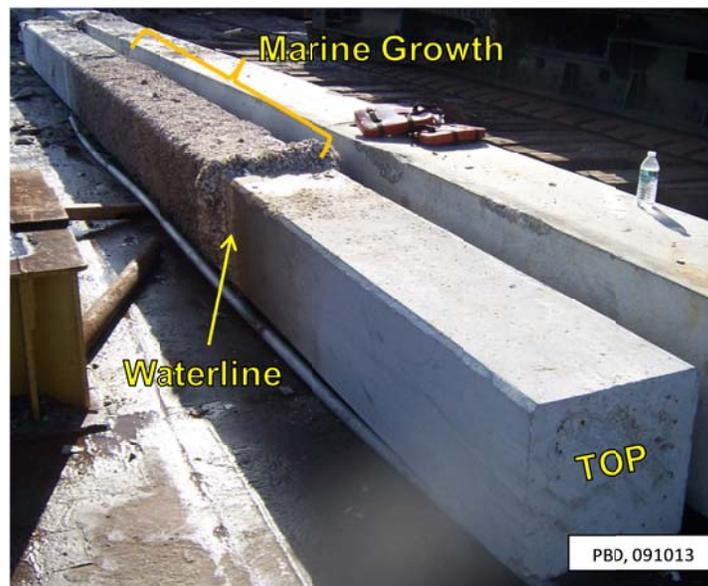
Figure 26. Pinellas Bayway Drawbridge pile selected for autopsy. Atmospheric air-exposed end of pile (i.e., top) is in the foreground. Note marine growth between waterline and mudline.

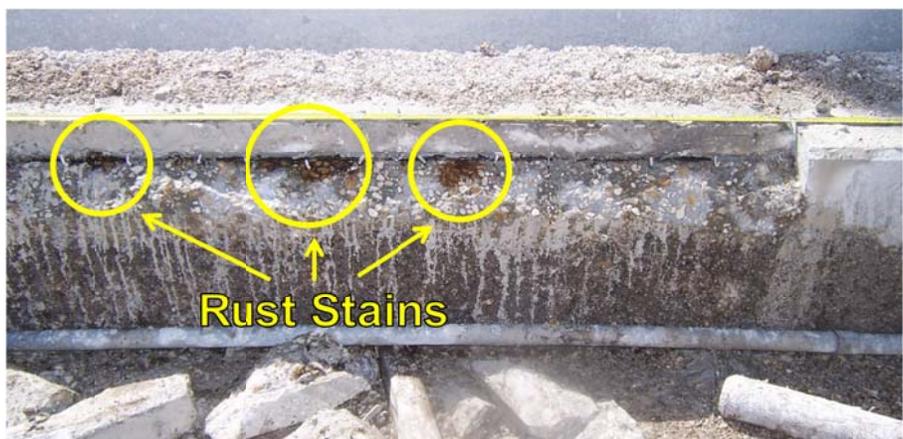
Figure 28. Exposed strand in uppermost region (nearest waterline) of autopsied pile. Note rust stains. (Photo was taken immediately after strand was exposed.)

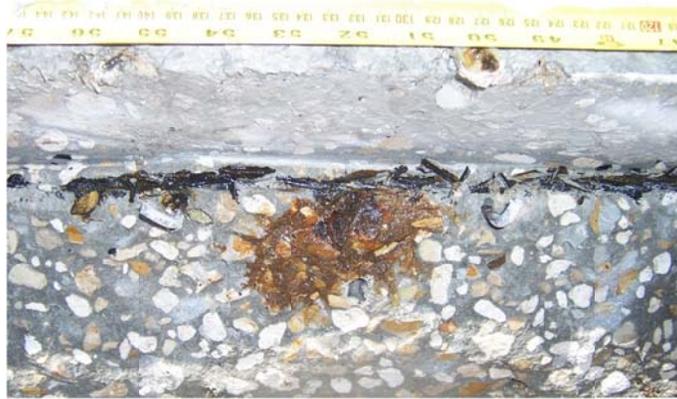
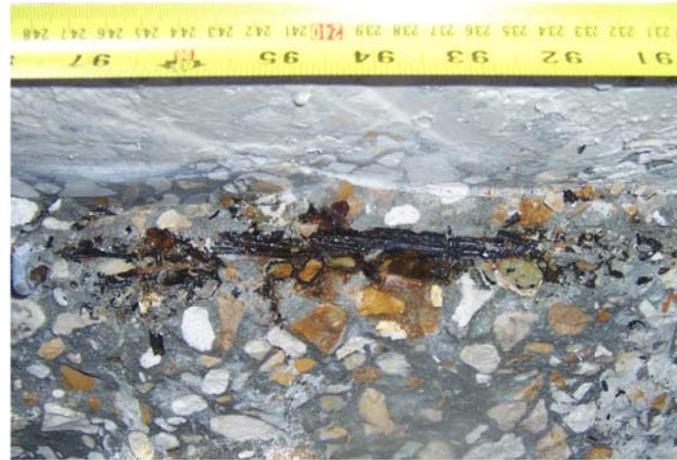
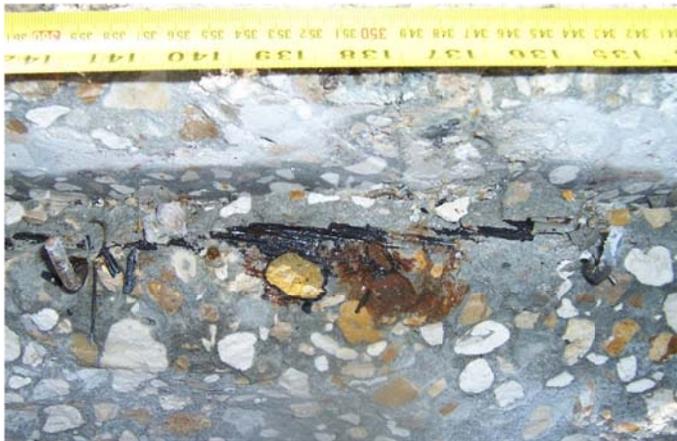
Figure 29 top, middle, bottom. Three different instances of localized corrosion. Note that the measurement datum for the indicated distances was the waterline.

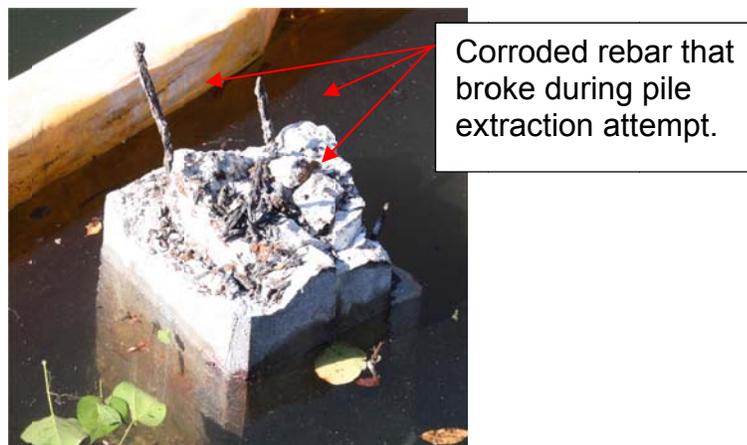
Figure 32. Bottom half of pile left in place as a result of breakage during extraction attempt. Visible rebar corrosion and section loss in splash zone.

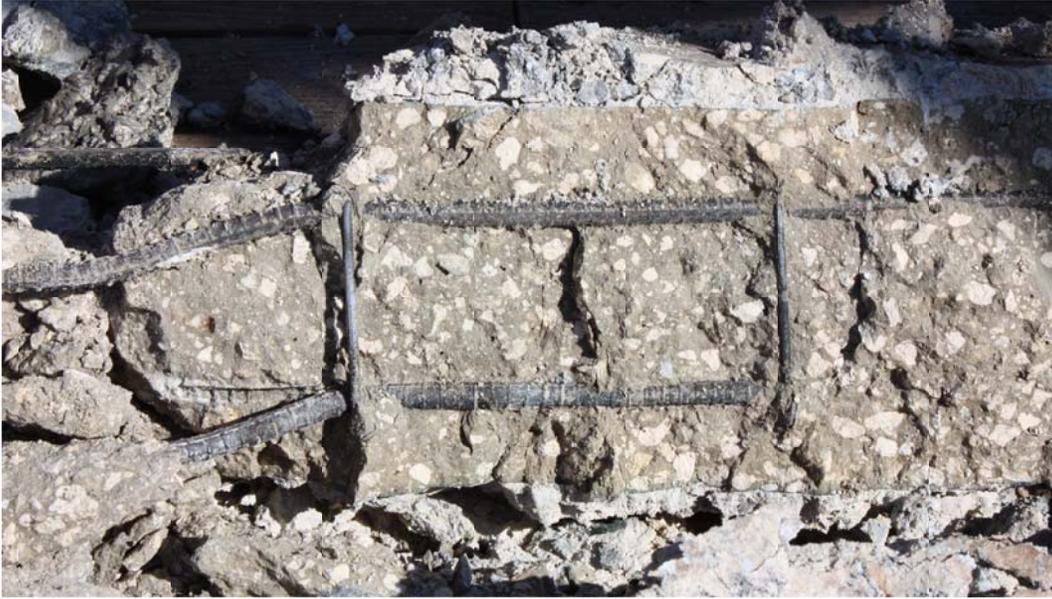
Figure 33. Corrosion-free steel in much of the submerged region. Note that pile in photo was lying on its side.

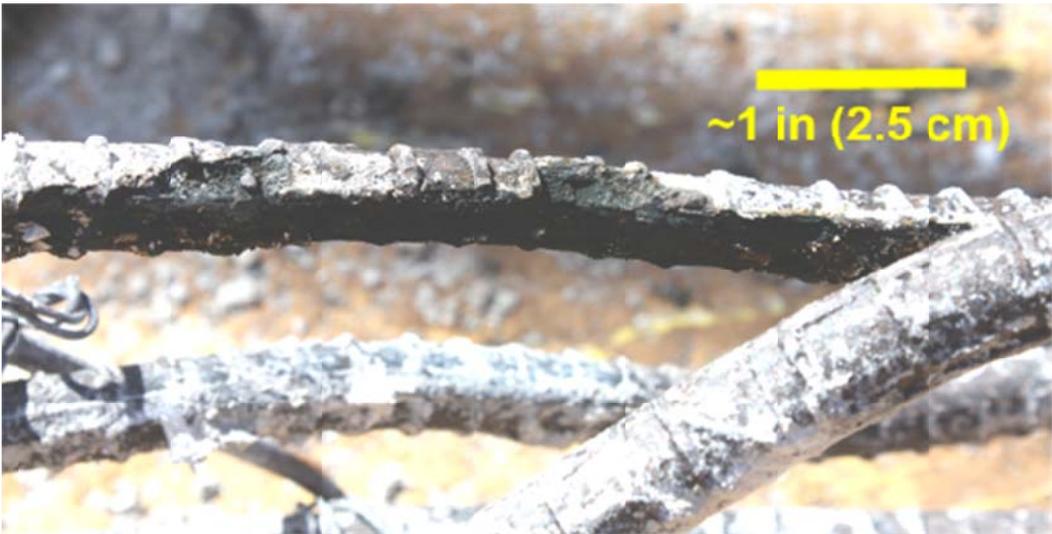
Figure 34. Locally corroded steel in region below mudline. Note corrosion-related cross-sectional area decrease of bar near top of photo.

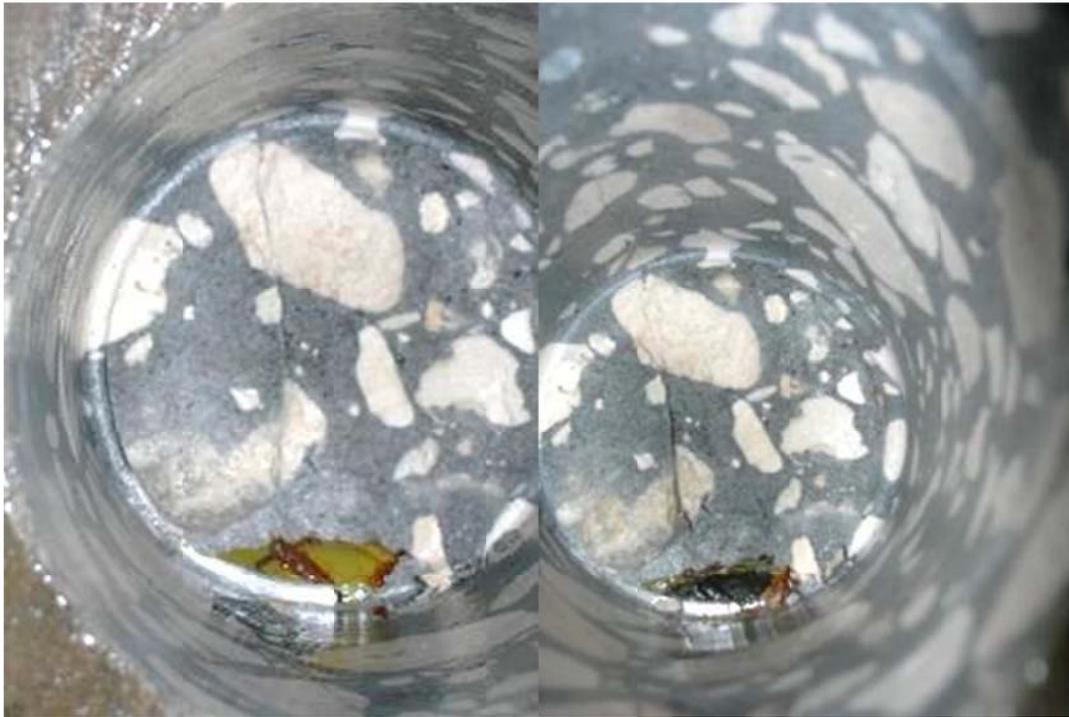
Figure 36. Rebar at the bottom of hole at core #1; before and after scraping epoxy coating.

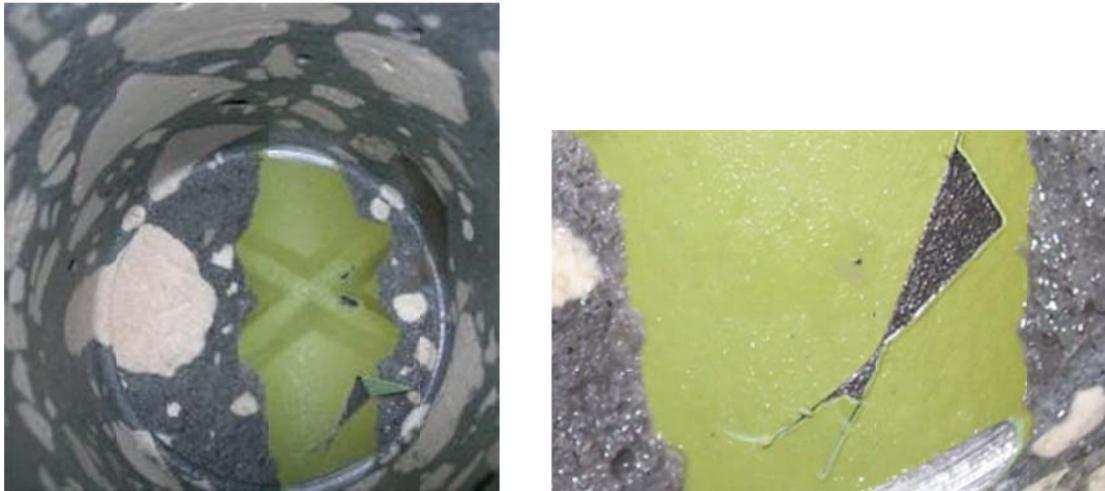
Figure 37. Rebar at core #4 site; Note epoxy cut and easily peeled showing poor adhesion.

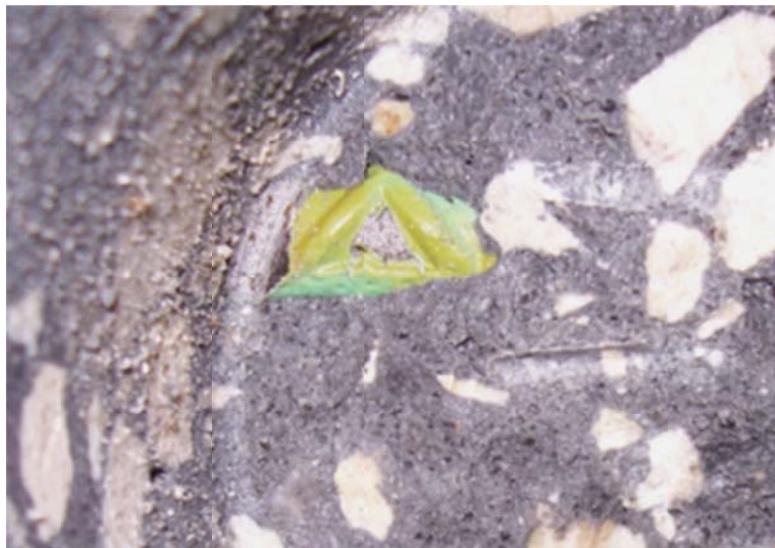
Figure 38. Rebar at core #5 site. Note poor adhesion.
