## Repair Of Impact Damaged Utility Poles With Fiber Reinforced Polymers (FRP), Phase II

### University of Central Florida

**FINAL REPORT**

*June 2015*

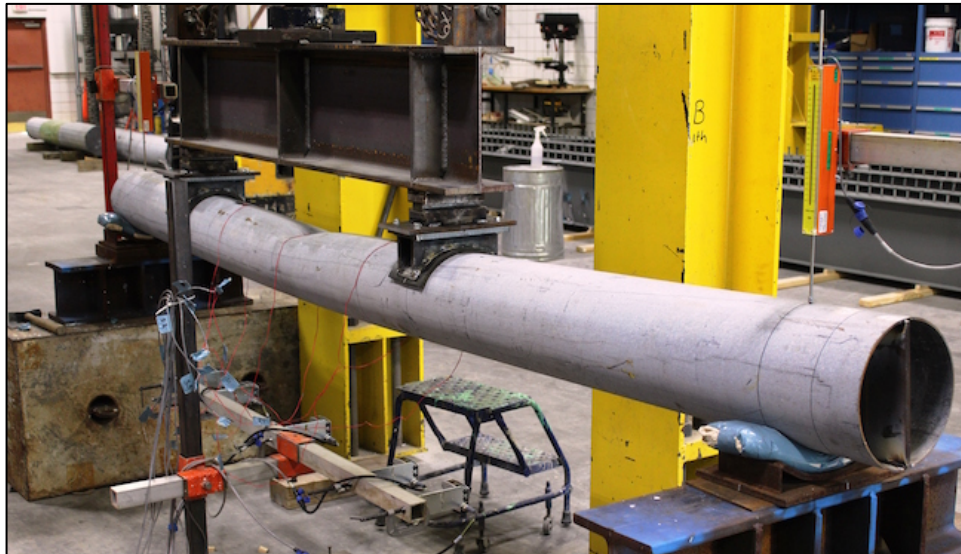
Figure 73. STu-1.d failed shape

The greatest load carried by this pole before failure was 43.5 kips, or 61.3 kip-ft at the dent location. The predominant failure mode was plastic hinging of the steel pole at the dented section. This is illustrated by the strain data plotted in Figure 72. The gauges at the dented section, S4 and S5, give the extreme strains of  $-11079 \mu\epsilon$  and  $14796 \mu\epsilon$ , respectively. The maximum displacement of 2.18 in was measured at gauge D4, also positioned at the dent center. The failed section is shown in Figure 73. The measured capacity of this dented pole was approximately 75% of the theoretical capacity of the undented pole.

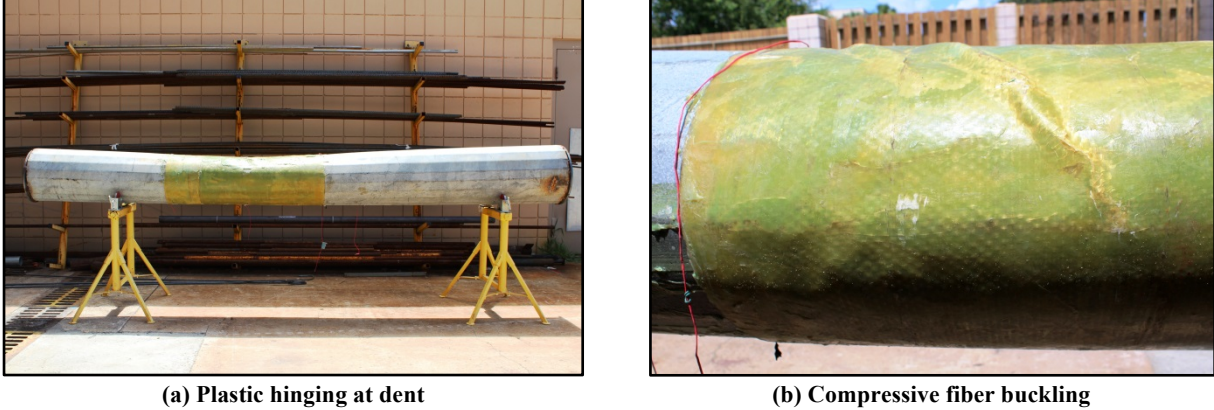
Figure 106. STw-3.a failure modes

can be seen in Figure 106. The final pole failure mode was plastic hinging near the center of the dent. The maximum deformation measured during this test was 1.57 in. This pole underwent extended deformation at or near the peak load before the load began to decrease, as compared to the unrepaired poles. This was likely aided by the confinement provided by the FRP repair.

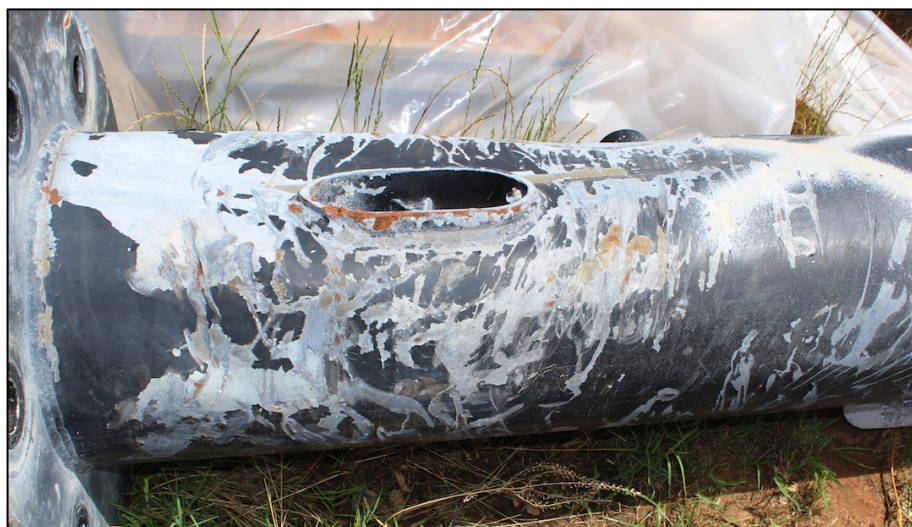
Figure 135. Original vehicular damage to access port region in FD-1

The first field-damaged pole specimen is a multi-sided steel pole that was severely dented by a vehicle collision. The pole's access port is within the dented area, which extends approximately from 3.5 in to 3 ft above the base plate, as shown in Figure 135. The diameter of the pole is approximately 16.125 in at the base, and the wall thickness transitioned from a value of 3/16 in at the pole tip to 5/16 in at the pole base. The dent was repaired with a single-layer FRP wrap over an epoxy fill. The access port was capped in order to allow the dent to be filled. For cases such as this in the field, it would be possible to cut a new access port on the undented face and design the wrap accordingly; however, this was not performed due to time limitations.

The FRP system consisted of glass fibers and a polyurethane resin. The geometry of the FD-1 pole and repair are shown in Appendix A. A main wrap laminate was used which extended approximately halfway around the pole's circumference, and 46 in from the base plate. Three transverse circumferential wraps were placed on top of the main wrap that encompassed the entire circumference of the pole and were 10 in, 6 in, and 6 in wide, from the bottom, respectively. The FRP reinforcing ratio at the base was approximately 25% (area of FRP was not adjusted for fiber volume fraction). The transverse wraps on the opposite face to the dented region are shown in Figure 136 (a). An interior view of the pole indicating the extent of damage in the existing access port region is shown in Figure 136 (b). The hole in the base metal in the photos was due to removal of metal for thickness testing after monotonic testing.

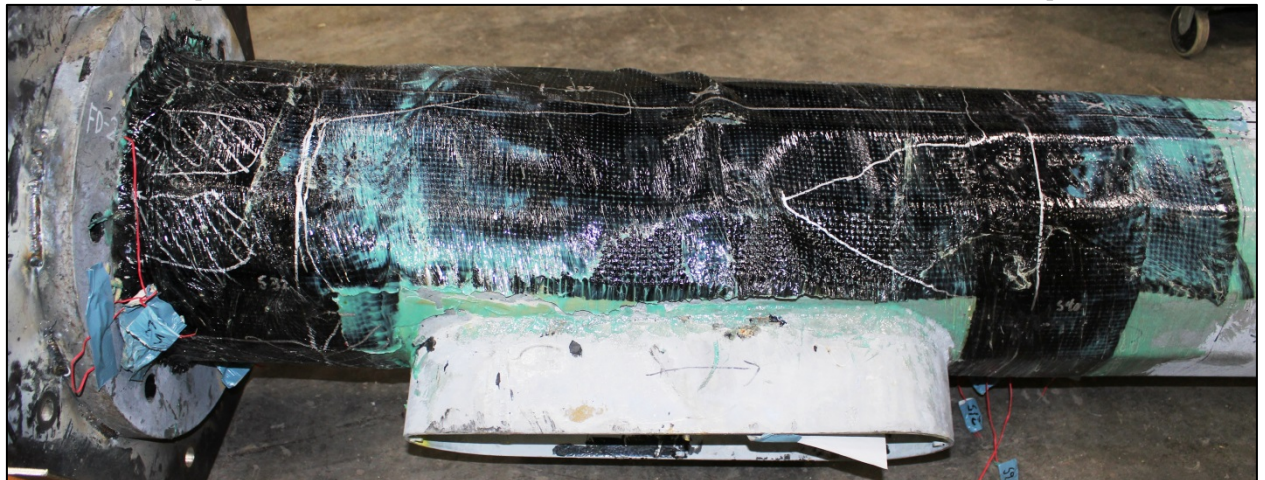
(d) West face – debonded and ruptured FRP

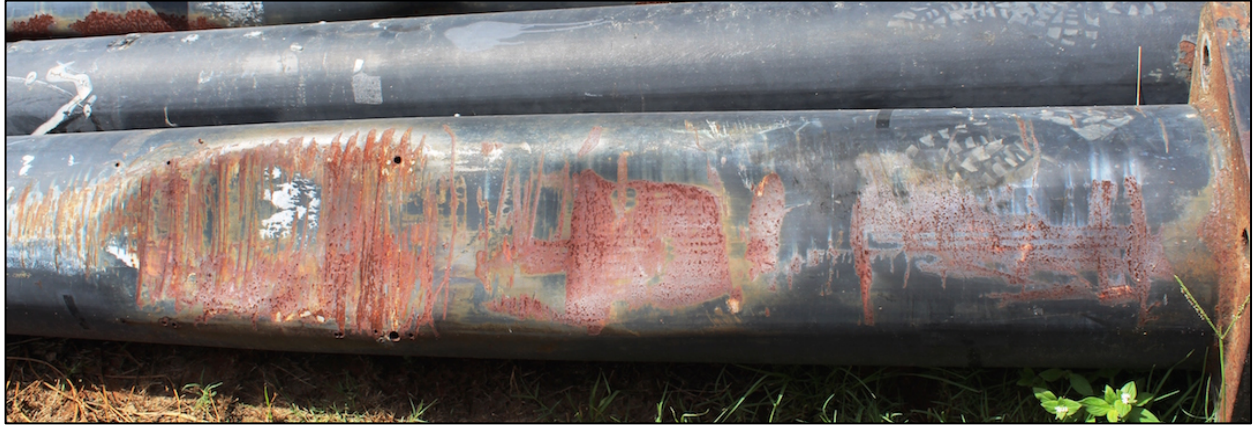
**Figure 149. Vehicular dents present in FD-3 prior to repair**

Pole FD-3 is circular and has two pedestrian crosswalk signal buttons and an access port (see Appendix A). This pole has two major dents, as shown in Figure 149, in addition to some minor damage closer to the base. The deepest dent is located approximately 4 ft above the base plate and is 2.56 in deep (21% of the undented diameter). The dent center is approximately 145° from the access port centerline. The pole was repaired with a single-layer of glass fibers saturated with a polyurethane matrix. The wrap geometry consists of a main 20 in wide 5 ft long laminate beginning at the base of the pole and four circumferential wraps located 0', 2' 3.5", 4' 2.5", and 5' 5.5" above the base plate. The bottom three transverse circumferential wraps were 9 in wide and the last one 6 in wide. These full-perimeter wraps protect against premature delamination of the main wrap. The FRP reinforcing ratio at the base was approximately 40% (area of FRP was not adjusted for fiber volume fraction). The pole is shown in the cantilever test configuration in Figure 150.

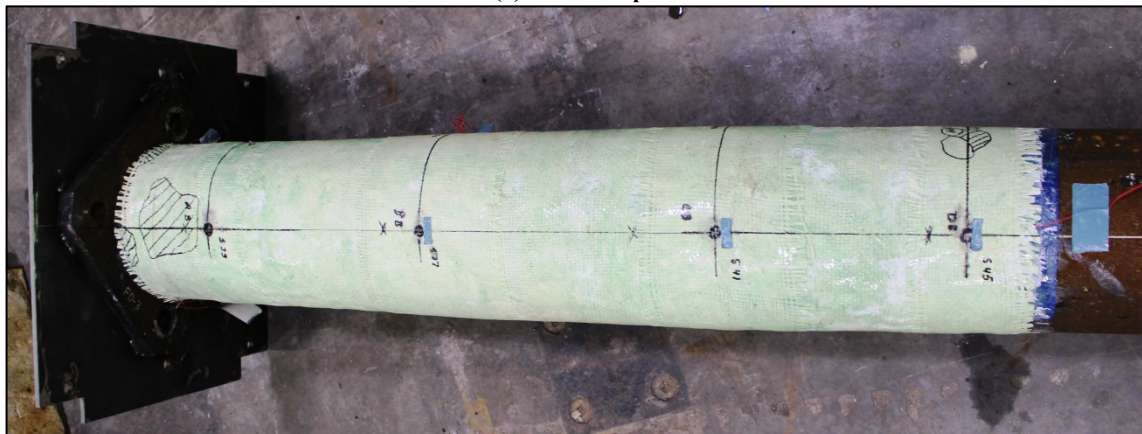
(b) Compression face of FRP  
Figure 156. FD-3 failure modes

stress concentration at this location may be limiting the capacity of the pole. Inspection of the pole indicates some bulging of the wrap at the base; however, no debonding is evident, except from the potential area on the compression face shown in Figure 156 (b). The bulging may be due to the compressive failure, or may be due to accumulation of primer during the original repair in the presence of the minor damage at the base. Compression damage is corroborated by the FRP compression strain readings at gauge S37.

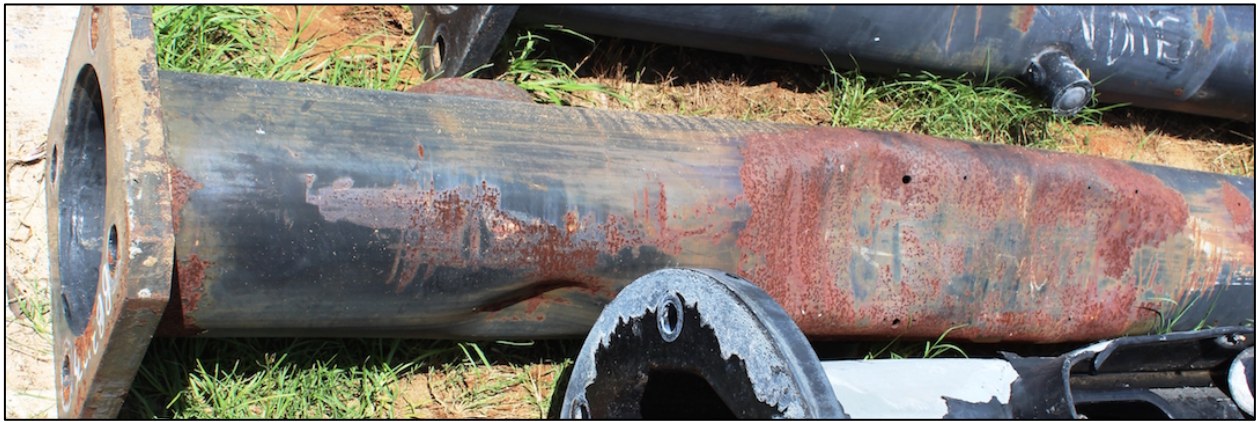
Figure 157. Vehicular damage to FD-5 prior to repair

Pole FD-5 was dented quite severely in the field to a depth of approximately 2.56 in, or 24% of its outer diameter. The dent is centered 3'-8.5" above the base plate, and approximately 125° from the centerline of the access port (see Appendix A). The pole has both a small access port and a pedestrian button. The extents of the damaged region are large, as shown in Figure 157. The dent was repaired with a single-layer of basalt/polyurethane FRP wrap over an epoxy fill. A main wrap laminate was used which extended 20 in around the pole's circumference, beginning 6 in above the base plate and extending 5'-7". Four transverse circumferential wraps were placed on top of the main wrap and were 6 in, 12 in, 9 in, and 6 in wide, from the bottom, respectively. The FRP reinforcing ratio at commencement of reinforcement (~6 in above the base) was approximately 40% (area of FRP was not adjusted for fiber volume fraction).

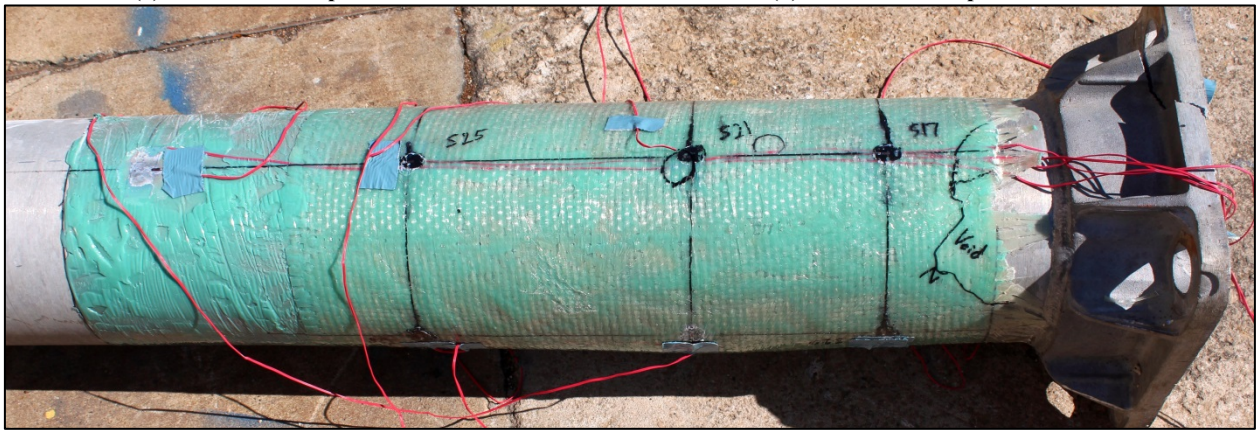
(c) FRP repair after testing with typical delaminated areas  
Figure 191. AL-1.c failure modes

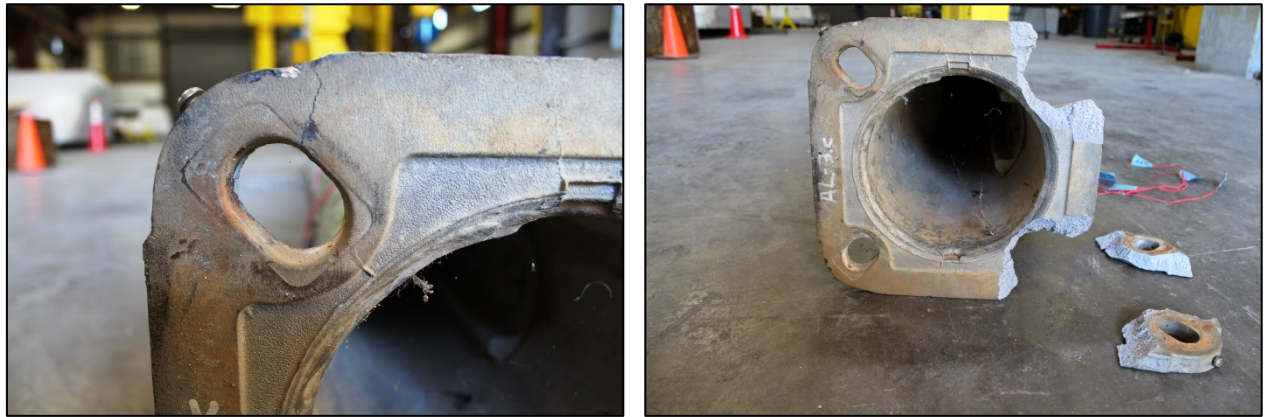
(a) Fractured base plate

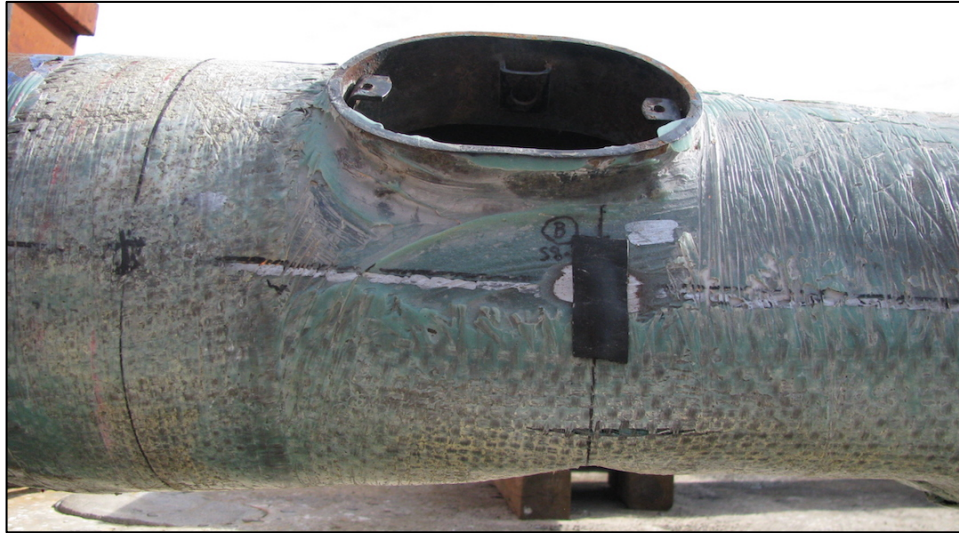
**(a) Deformation of the access port and rupture in FRP**

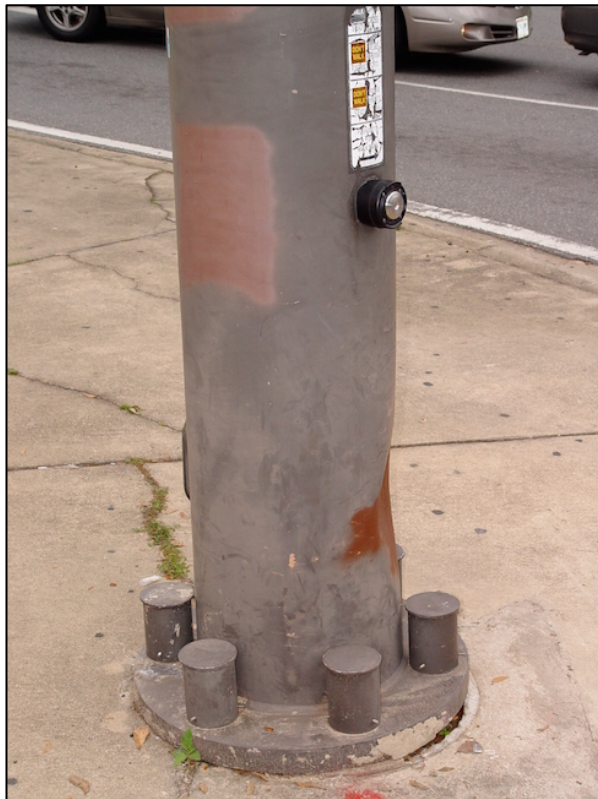
(a) Pole damage at base
