Durability Evaluation of Florida's Fiber-Reinforced Polymer (FRP) Composite Reinforcement for Concrete Structures

Final Report

March 2017

Florida Department of Transportation (FDOT)
David Wagner, P.E. – Project Manager

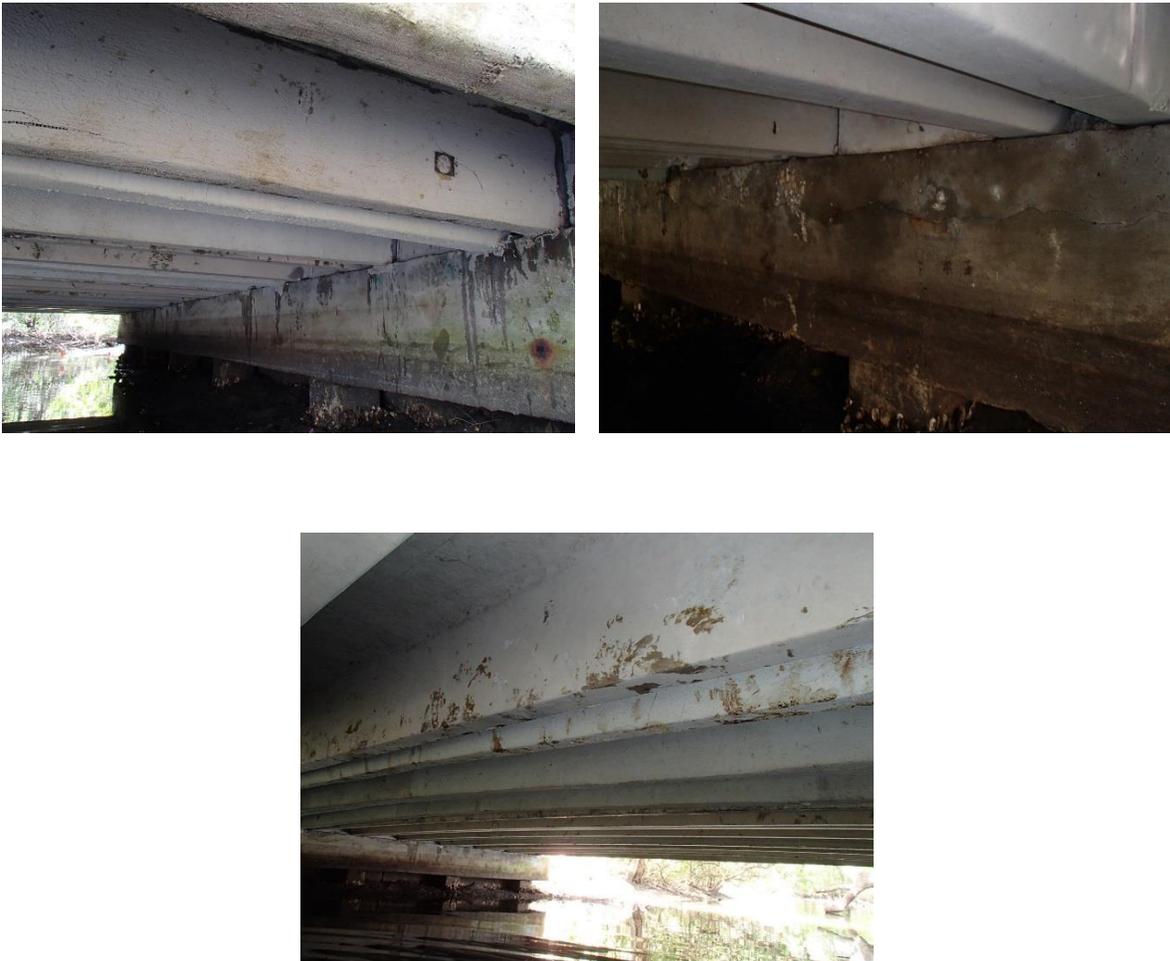
Phillips Lane bridge experienced significant corrosion damage (brackish water environment), and was repaired with CFRP wraps in 2001. No significant deterioration of the composite wrap was observed (Figure 64), with an exception of one girder where an entire side of the wrap was debonded as observed during the visual inspection (Figure 65) based on visual inspection. The debonded CFRP was located on one of the vertical faces of the concrete channel girder; close proximity of adjacent webs would have made accessing the concrete for surface preparation and CFRP installation difficult. Observation of multiple pull-off test locations (performed in the past) revealed rust staining and adhesive failure modes (Figure 66). The inspection was performed in 2015.

Figure 64—Girders with external FRP on Phillips Lane Bridge

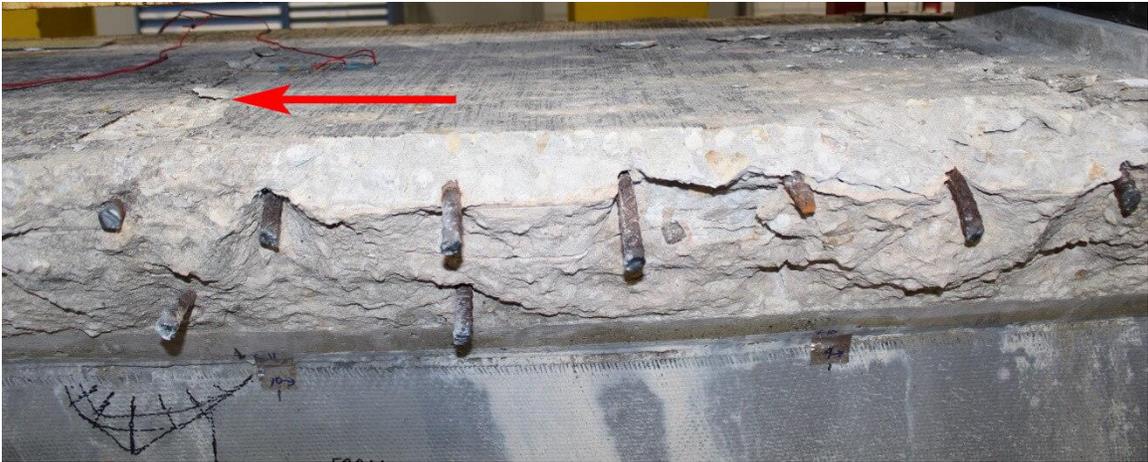
Figure 112—Failure of concrete in compression indicated by red arrow

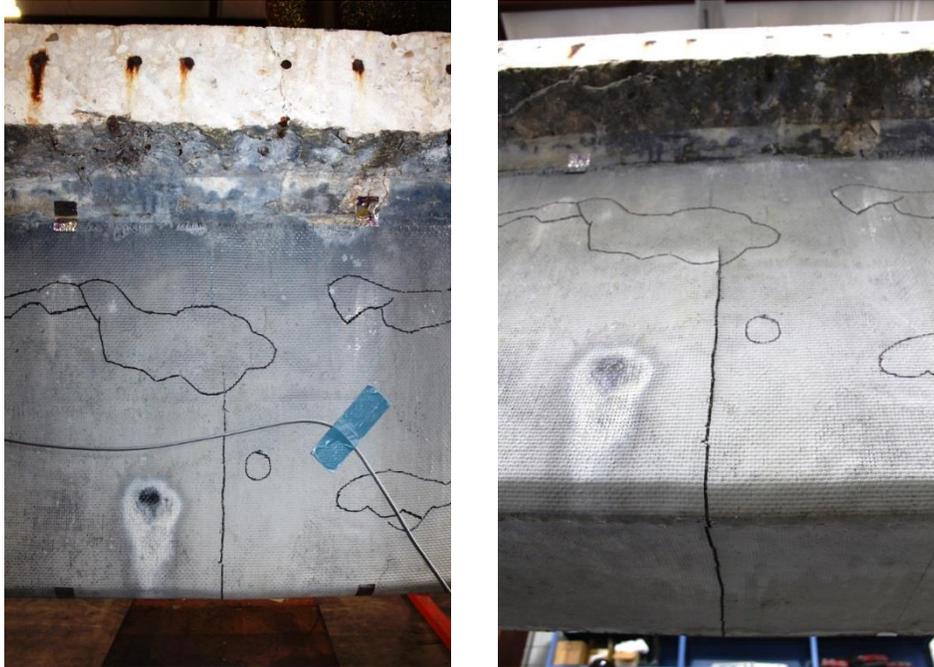
Figure 113—Rupture of CFRP near midspan

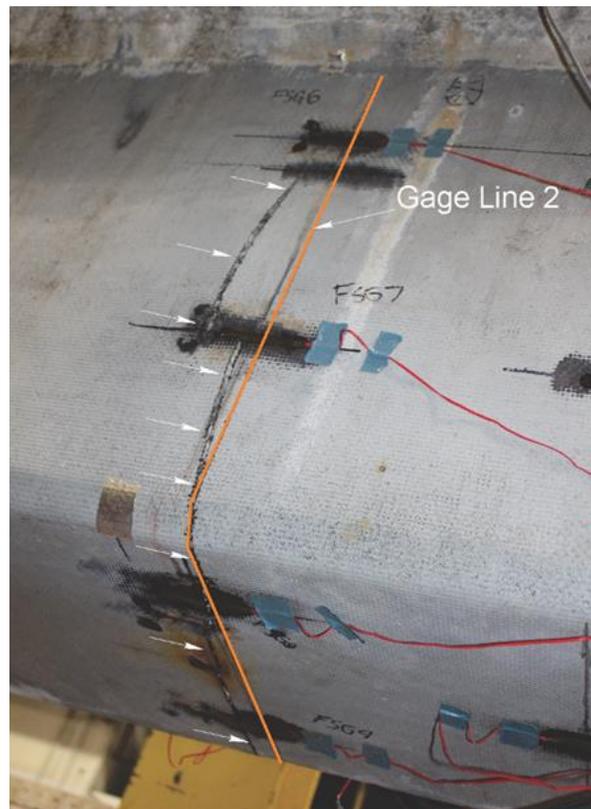
Figure 117—CFRP rupture relative to Gage Line 2 on Girder #1

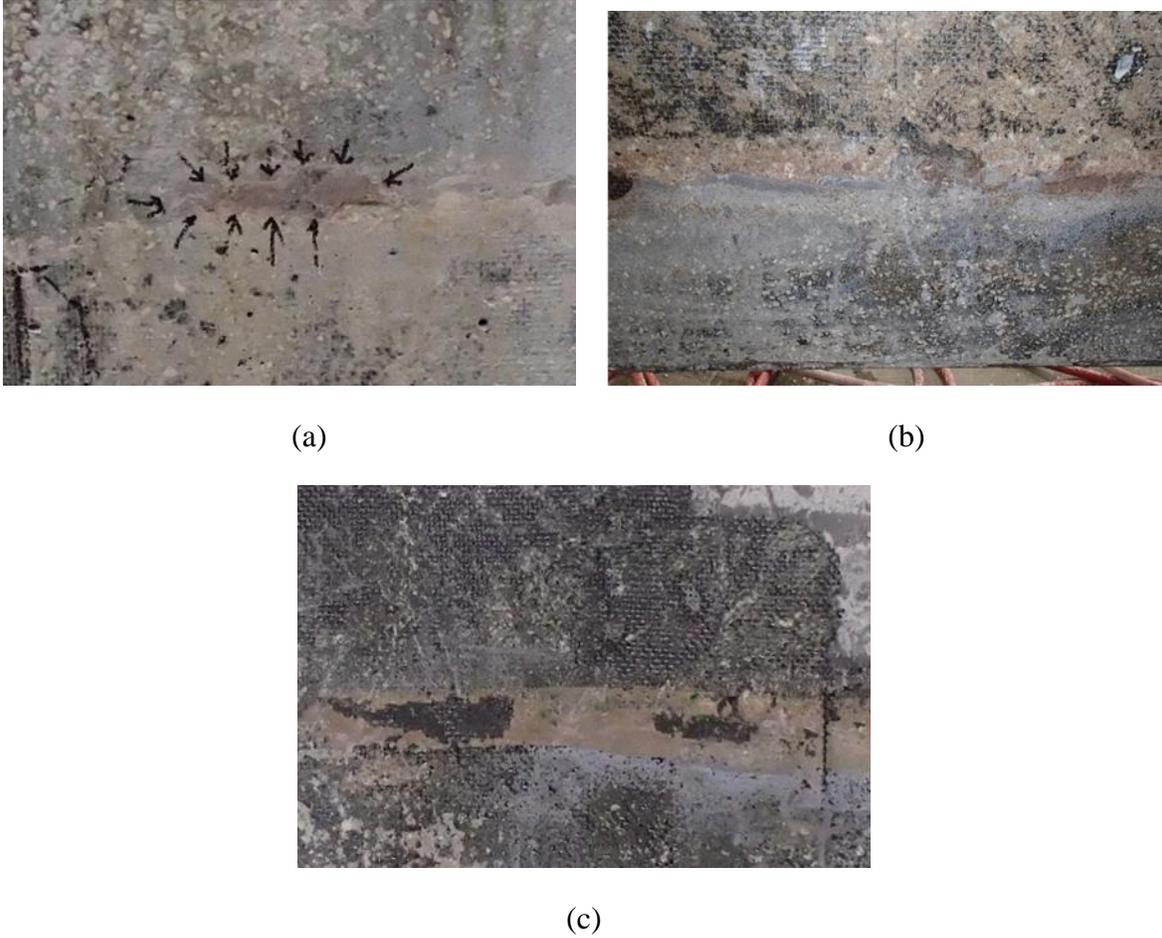
A few areas on each girder were found to be repaired with a cementitious repair material. Two such areas were identified on Girder #1, and were surrounded by severely debonded CFRP. The debonding occurred at the CFRP-epoxy interface (Figure 123), which is unusual; the most common type of debonding occurs at the concrete-epoxy interface.

Figure 122—Evidence of primer at the new–old concrete interface

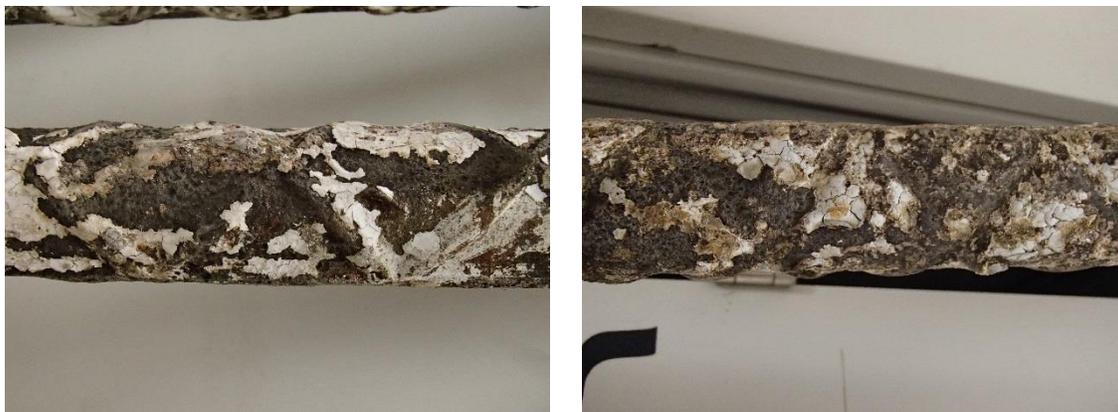
Figure 126—Close-up images of corroded reinforcement

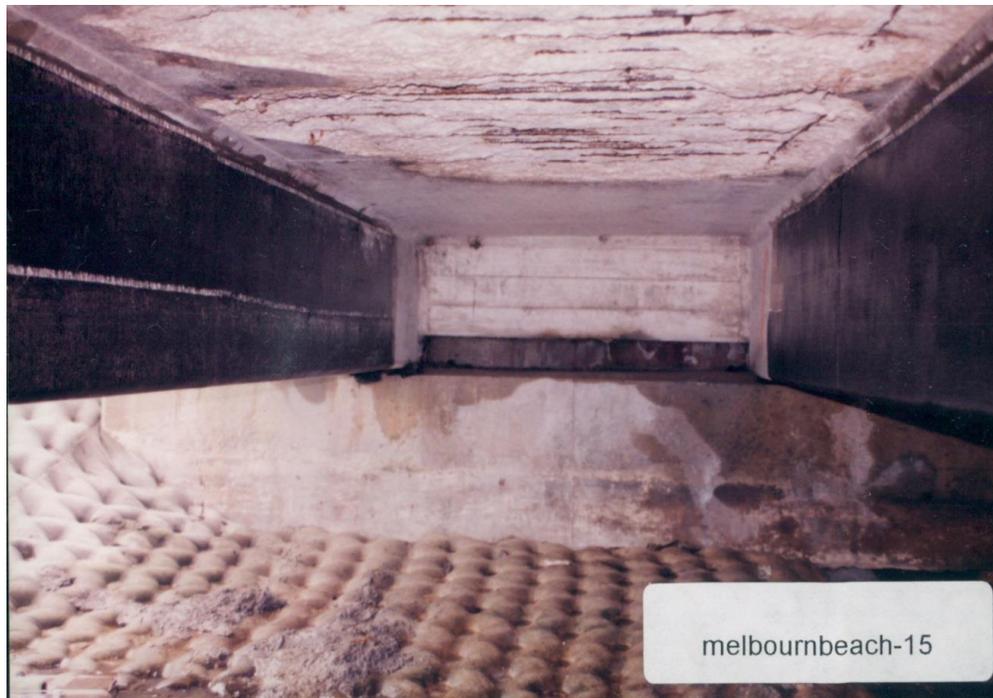
Figure 130—Example of wetting caused by wind and wave action

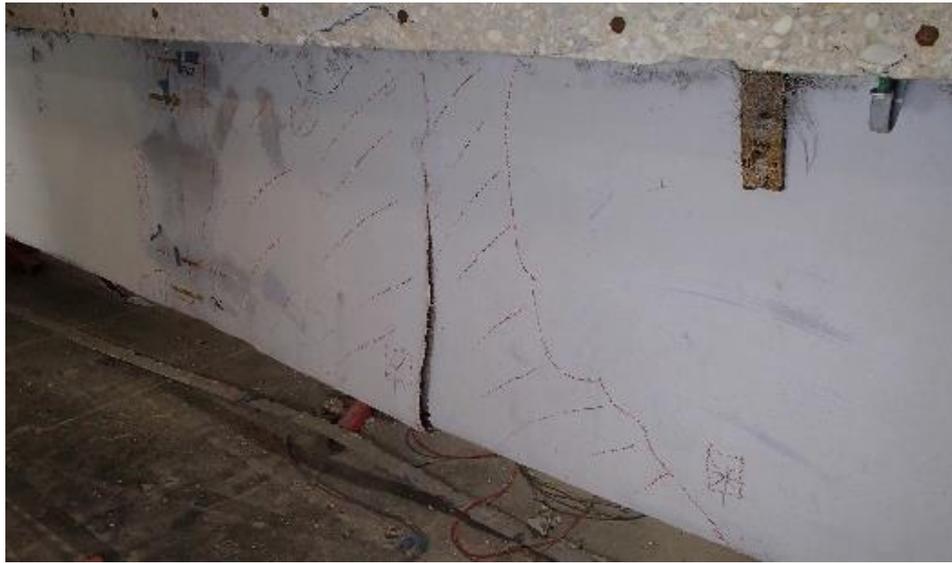
Figure 174—GFRP rupture (Girder 3-4)

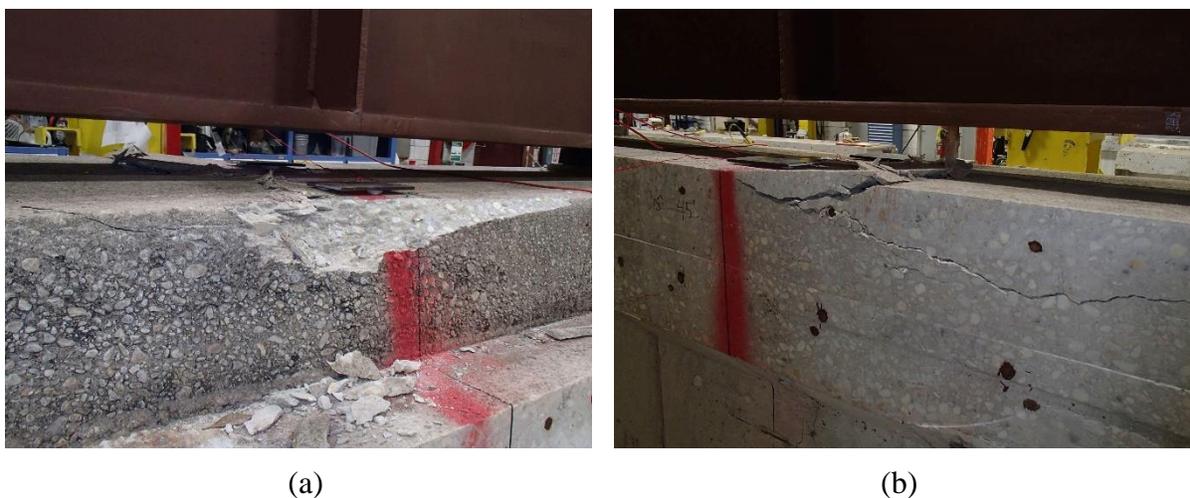
Figure 181—Damage to Girder 4-1 including (a) compression failure on east elevation (b) compression failure on west elevation

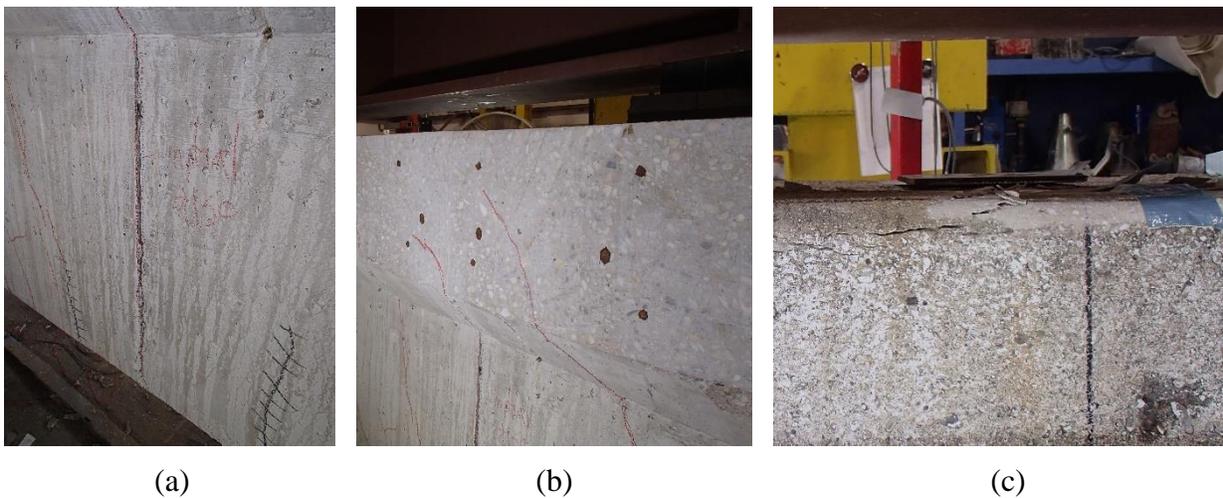
Figure 185—Damage to Girder 4-4 including (a) cracking at formwork joint (b) crack at formwork joint extended to compression zone in east elevation (c) crushing of concrete in west elevation

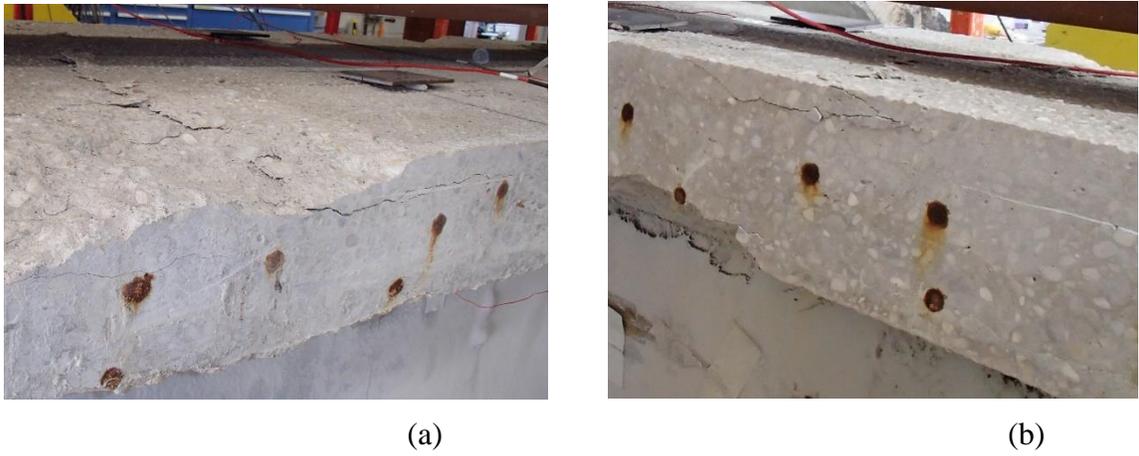
Figure 196—Crushing of concrete in compression (Girder 4-3): (a) west elevation (b) east elevation

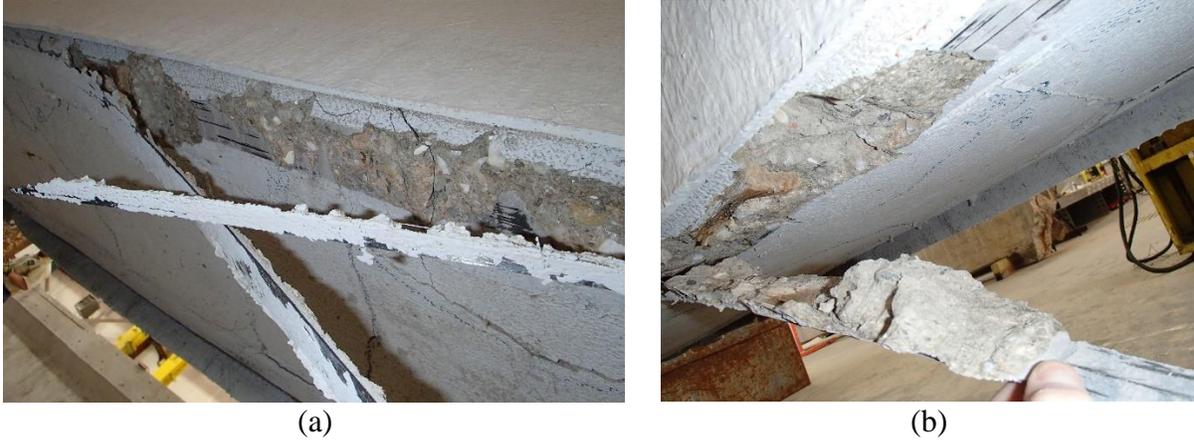
Figure 198—CFRP on east elevation (Girder 4-3): (a) ruptured (b) debonded

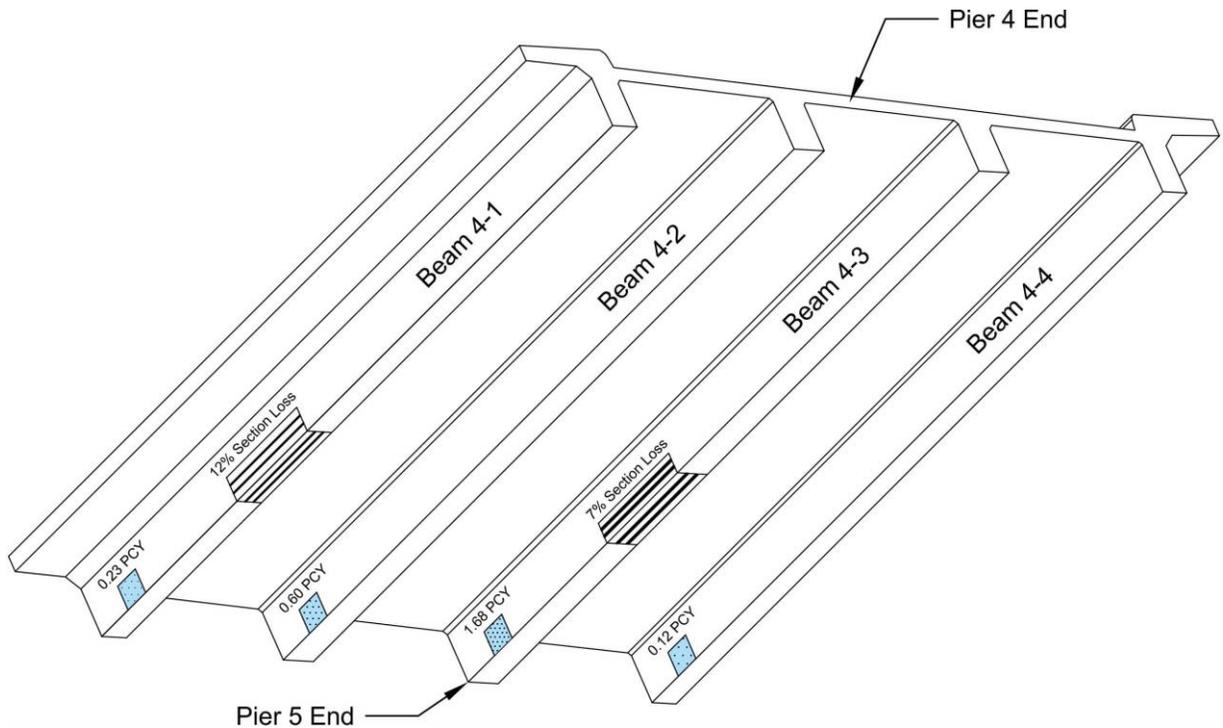
Figure 222—Chloride ion contamination levels and section loss in steel reinforcement in Span 4

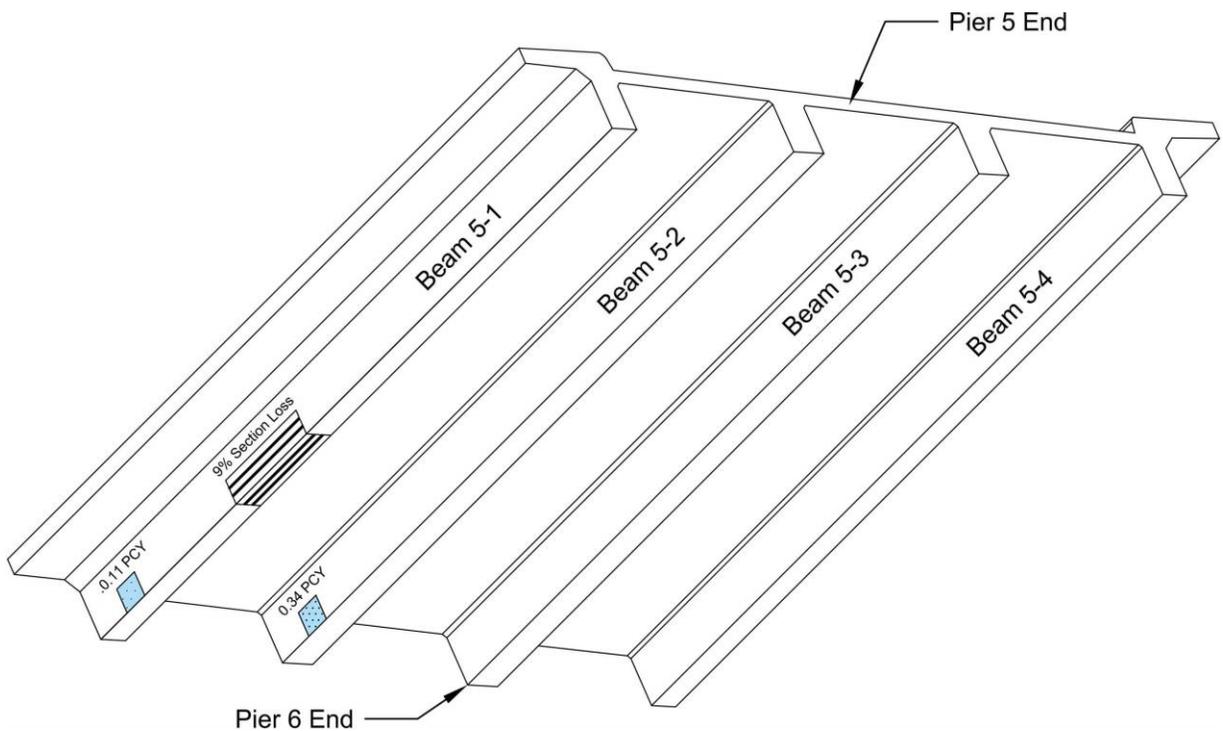
Figure 224—Chloride ion contamination levels and section loss in steel reinforcement in Span 5

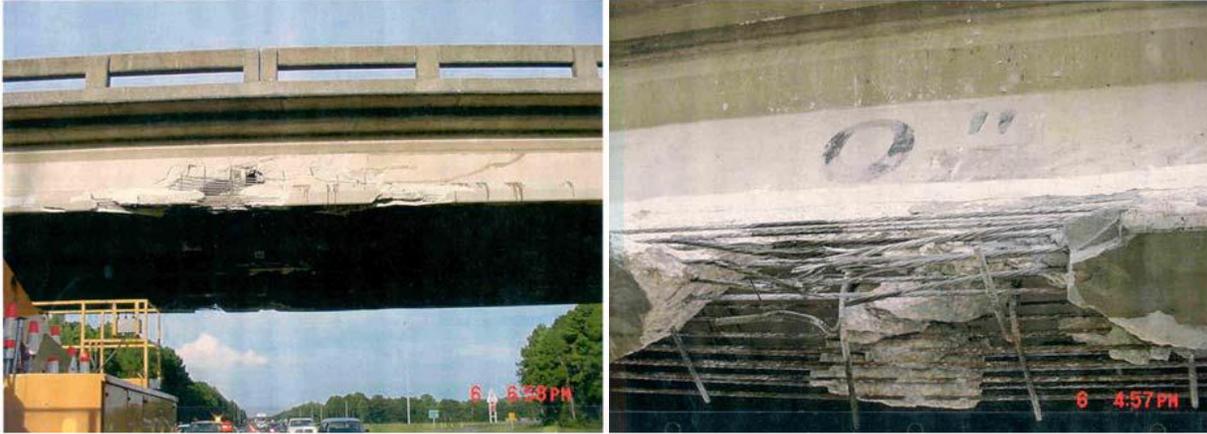
Figure 227—Girder damage from vehicle impact in July of 2001

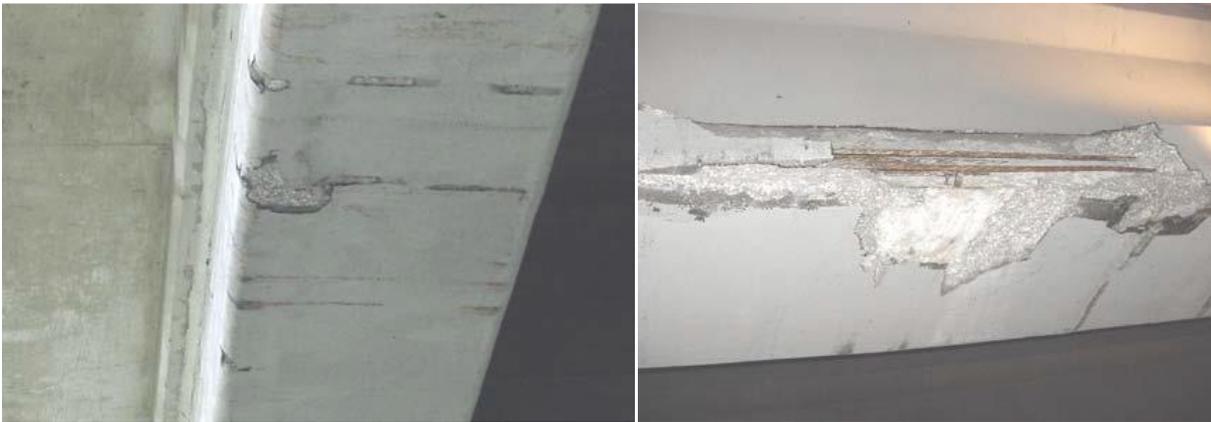
Figure 229—Condition of girder before and after vehicle impact in June of 2003

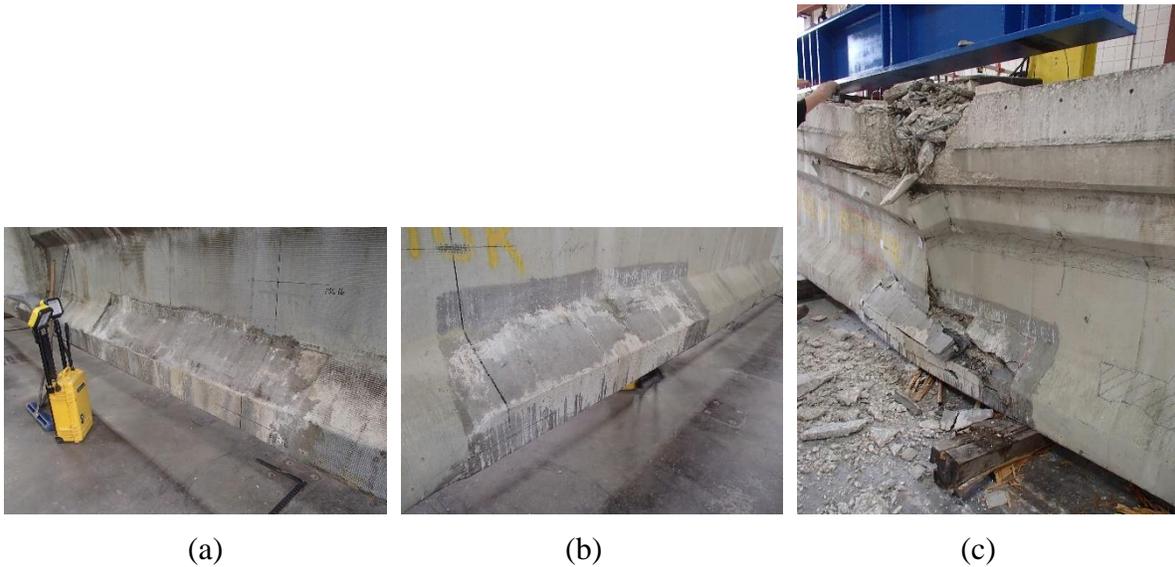
Figure 249—Repaired region of Girder 2: (a) west face initially before testing (b) east face initially before testing (c) east face after failure
