# Florida Department of Transportation Research

## Develop Epoxy Grout Pourback Guidance and Test Methods to Eliminate Thermal/Shrinkage Cracking at Post-Tensioning Anchorages, Phase 2

December 2015

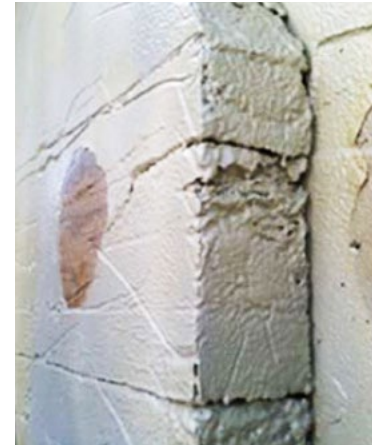
Based on the full-scale test data and observation, full-depth cracks were found on specimens with V/S ratio of 0.37 ft and on the S-type specimen with V/S ratio of 0.32. The cracks appeared within the first 24 hours and concentrated in regions with high exothermic temperature, suggesting that these cracks were caused by exothermic temperature rather than shrinkage. A finite element analysis was used to perform a parametric study to clarify the cracking mechanism of epoxy grout pourback systems and the influence of V/S ratio. The model was calibrated and validated using full-scale test data. Behavior of the full-scale pourbacks and the simulated pourbacks was correlatable, showing a general correspondence. Study results led to recommendations for the design and construction of epoxy grout pourbacks.

Serious cracking can be observed in this epoxy pourback, which encases a post tensioning anchorage (marked by the dark spot).
