# An Evaluation of Asphalt Treated Permeable Base

Research Report FL/DOT/SMO/07-511

December 2007

# STATE MATERIALS OFFICE

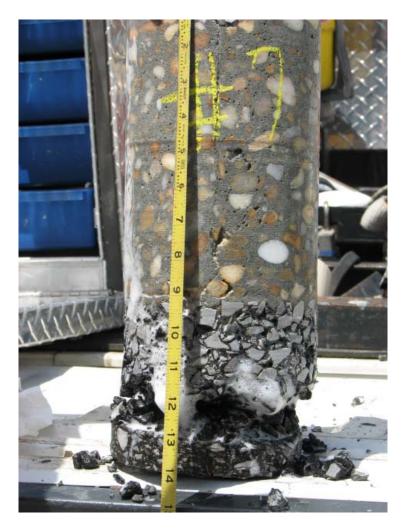
Four of the seven cores exhibited moisture damage, though the magnitude of the damage varied among the four cores. Figure 2 shows a core that exhibits moisture damage and Figure 3 shows a core that does not exhibit moisture damage. In one area of the pavement, water filled the core holes to within two inches of the pavement surface after the cores and coring water were removed. The cores removed from this area exhibited severe moisture damage. It is likely that the drainage system had been non-functional for an extended period of time and the ATPB layer was continuously saturated, resulting in the observed moisture damage.

Another area of the pavement adjacent to the truck scales resulted in cores that displayed a moderate amount of moisture damage. It should be noted that the pavement in this area was cracked and it is not known whether the damaged pavement was a result of the moisture damage in the ATPB or whether the moisture damage in the ATPB was due to excessive moisture intrusion through the cracked pavement.

Figure 2 – Core Exhibiting Moisture Damage; I-10 Weigh Station - Jackson County

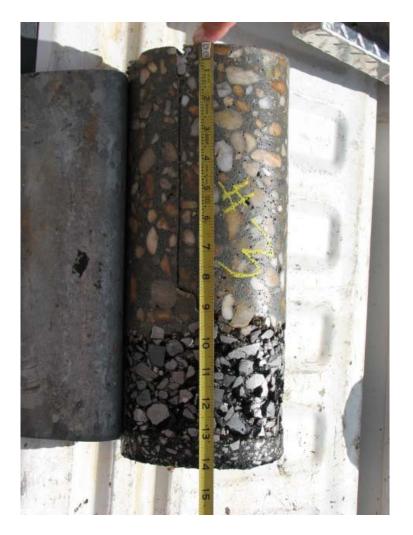
None of the other cores exhibited moisture damage.

Figure 3 – Core Exhibiting No Distress; I-10 Weigh Station - Jackson County

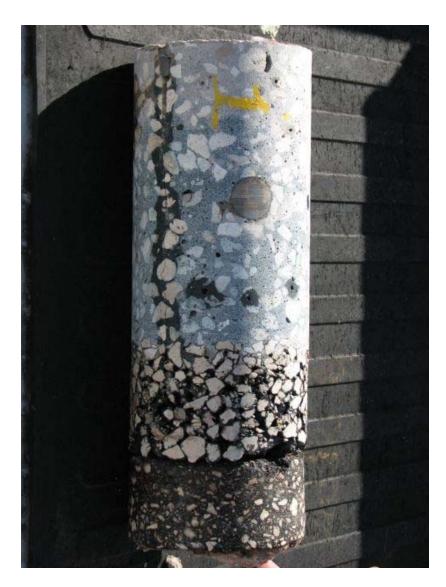
None of the cores revealed any signs of damage in the ATPB layer (see Figure 5). The edge drains appeared to be working correctly, as there was no standing water in the core holes. It should be noted that this pavement has only been in service for approximately two years and the cores were obtained in lesser-trafficked areas, which could explain the lack of observed distress in the ATPB.

Figure 5 – Core Exhibiting No Distress; I-95 Rest Area - Martin County

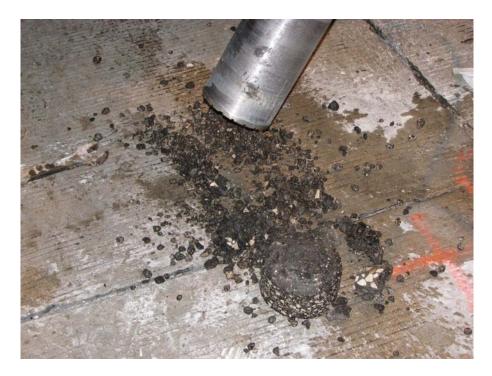
Two of the four cores, one with ATPB containing Florida limestone aggregate and one with ATPB containing Nova Scotia granite aggregate, showed no indications of moisture damage. However, the other two cores, which contained ATPB with Florida limestone aggregate, showed severe moisture damage (see Figures 7 and 8). When the cores were removed from the core bit, the ATPB mixture completely fell apart. A significant portion of the large aggregate particles from the ATPB were not coated with asphalt binder. However, an attempt was made to pry some of the ATPB aggregate particles loose from within the core hole utilizing a screwdriver, but the particles were bound together tightly. Most likely this was due to the upper and lower confining forces acting on the ATPB in the pavement structure.

Figure 7 – Core Exhibiting Moisture Damage; SR-60 and North 22nd Street -Hillsborough County

1. The asphalt binder content of the ATPB mixture should be established at the high end of the design range (2.0 to 3.0% by weight of the mixture). It is recommended to use a design asphalt binder content of 3.0% for non-absorptive granite aggregates and 3.5% for absorptive limestone mixtures. This will ensure that there is adequate asphalt to bind the aggregates together.

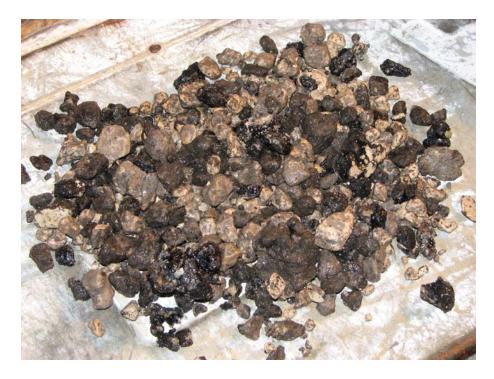
Figure 8 – Uncoated Aggregate from ATPB Layer; SR-60 and North 22nd Street -Hillsborough County

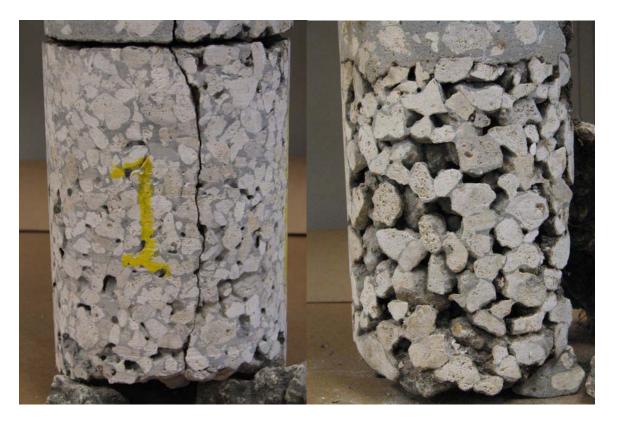
There were no signs of deterioration within the CTPB at any of the core locations. However, the composition and porosity of the CTPB varied widely among the cores (see Figure 10). Regarding composition, the aggregate size varied widely between core locations. Some cores had very large aggregate (one inch top size) while other cores had much smaller aggregate (half inch top size). Additionally, the cement and fines content varied widely. With respect to porosity, some of the cores appeared to be nearly impermeable. This is due to the smaller aggregate size and high cement and fines content. Other cores appeared to be more open graded and permeable. Also, it was observed that the concrete joint had propagated through the CTPB, as a crack, in all of the cores.

Figure 10 – Variation in CTPB Composition; Marion Street - Hillsborough County
