CORROSION OF POST-TENSIONED TENDONS IN FLORIDA BRIDGES

Research Report No. FL/DOT/SMO/04-475

By: Rodney G. Powers¹ Alberto A. Sagues² and Yash Paul Virmani³

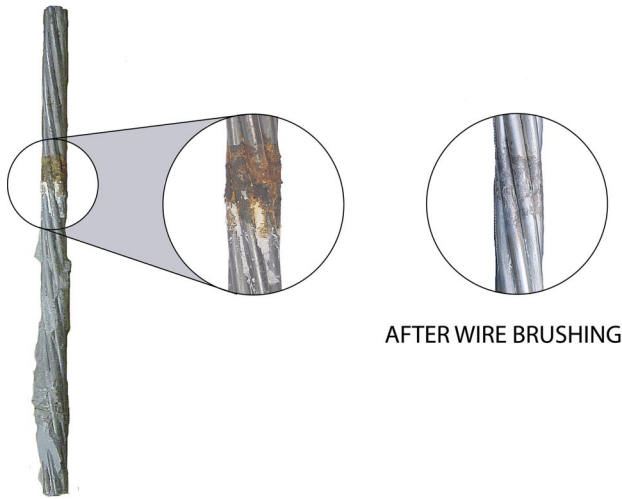
Condition of the Strands: The surfaces of the strands in contact with the grout were found to be unaffected during the experiment except for the area beginning approximately 2.5cm below the top of the grout and 2cm above the top of the grout. The area beginning approximately 2cm above the top of the grout and extending downward to approximately 1cm below the grout had heavy deposits of red to dark brown colored corrosion products (Figure 11). Extensive corrosion pitting was noted on the wire surfaces in the area coinciding with ~0.5cm above and below the

Figure 11 – Typical appearance of the strand upon removal from the mock-up.
