## **Tensile Test Results of Post Tensioning Cables From the Midbay Bridge**

The Midbay bridge, located on State Road 293 between State Road 20 and U.S. 98 in Niceville, Florida is a concrete segmental box bridge with approximately 140 spans. The bridge uses a total of six external post-tensioning cables as the primary live load resistance system, with three of the six cables on either side of the boxes. Each cable is composed of 19 – 0.6” diameter steel cables that are stressed to 31,000 pounds each at the time of construction. The cables are held in place between steel anchors and surrounded by a protective sleeve. The primary anchorage system consists of end steel blocks with post-tensioning wedges, while the secondary anchorage system relies on a grout that is pumped into the casing surrounding the strands.

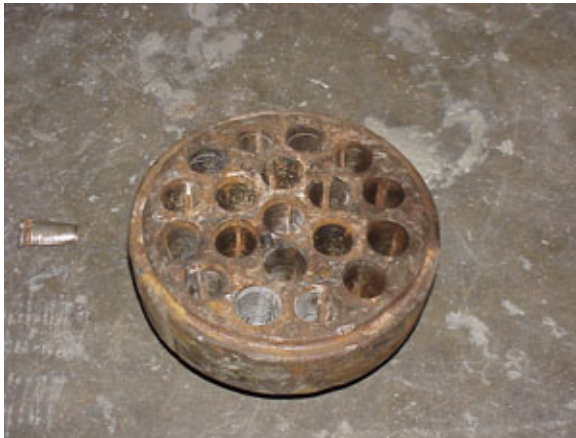
Visual inspection of the anchorage assembly revealed corrosion of the anchor wedges, both inside the grip area and between the anchorage plate and the wedges (See Photos 1 – 3). No sign of slip was apparent in the wedges. The strands that were still connected to the anchorage assembly had enough corrosion to cause pitting of the steel surface for approximately the first 8" of length outside the anchor region (See Photos 4 – 7). The strands were removed from the anchor plate preserving the entire length of the cable that was provided to the Structures Research Center.

**Photo 1** – End View of Anchor Plate

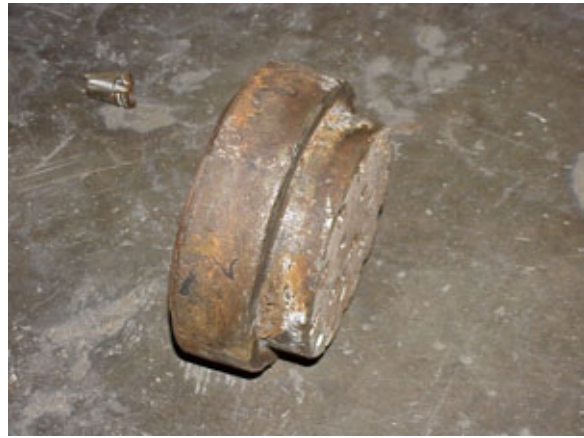
**Photo 2** – Side View of Anchor Plate

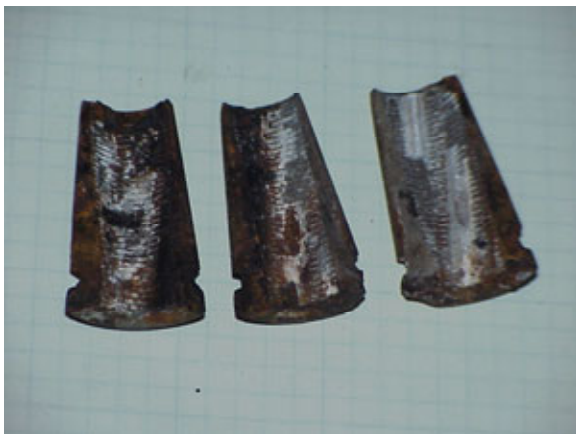
**Photo 3** – Anchor Wedges With Corrosion

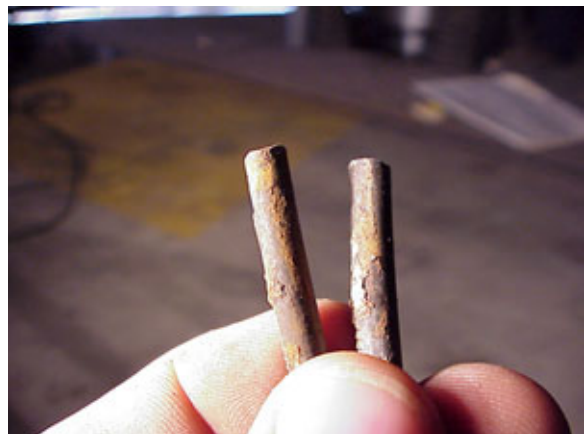
Each corroded cable was cleaned using an abrasive pad to determine the extent of the pitting. In all cases the deepest pitting reached a maximum average depth of 0.0015".

**Photo 4** – Close-up Of Pitting Corrosion

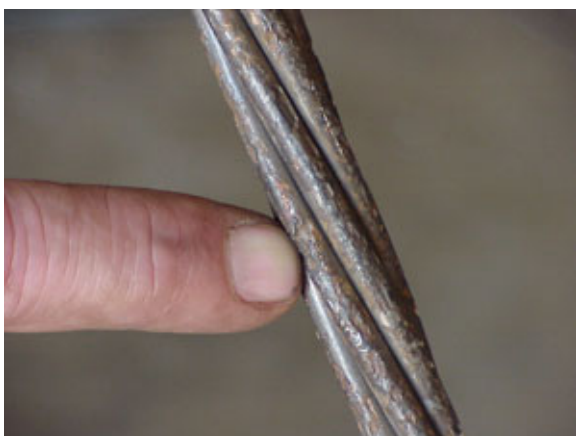
**Photo 5** – Pitting Corrosion

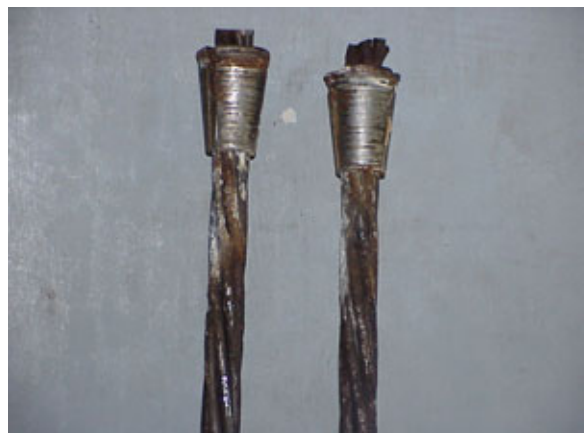
**Photo 6** – Strand Ends After Removal From Anchor

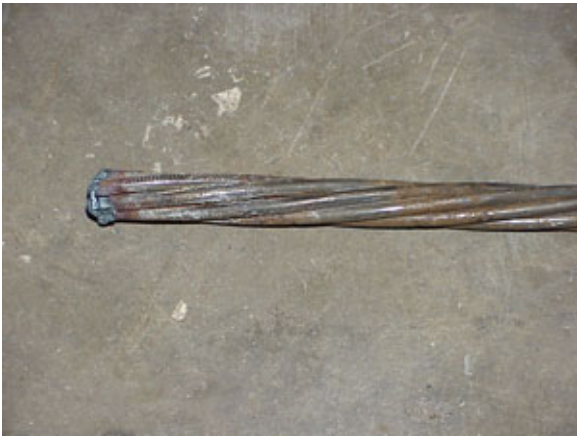
**Photo 7** – *Strand After Removal From Wedge*

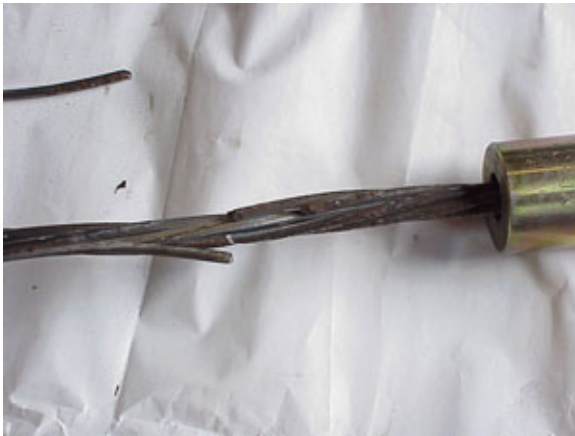
For the corroded specimens, failure always occurred within the pitted portion of the strand, with the exception of Specimen CORR-4, which failed in a manner similar to that of the control specimens. Photos 13 – 18 show the condition of the strands at failure for all corroded specimens except CORR-4.

**Photo 13** – Failure of Corroded Specimen # 1

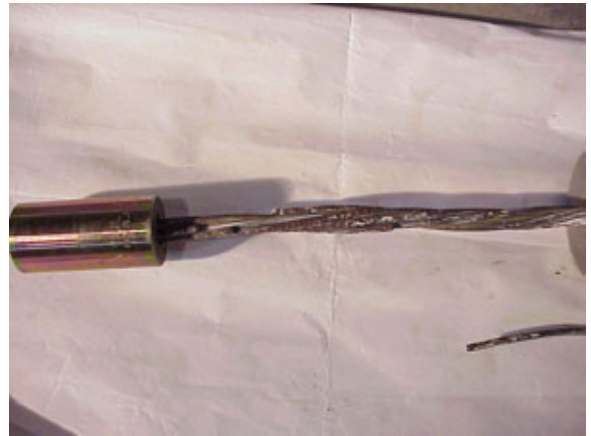
$F_y$ , according to the AASHTO test procedure is achieved at a 1% extension of strain or 10,000  $\mu\epsilon$ . For specimens CORR-2 and CORR-3, this extension is not achieved until after rupture of the first wire, which is defined as failure for the specimen.

**Photo 14** – Failure of Corroded Specimen #2

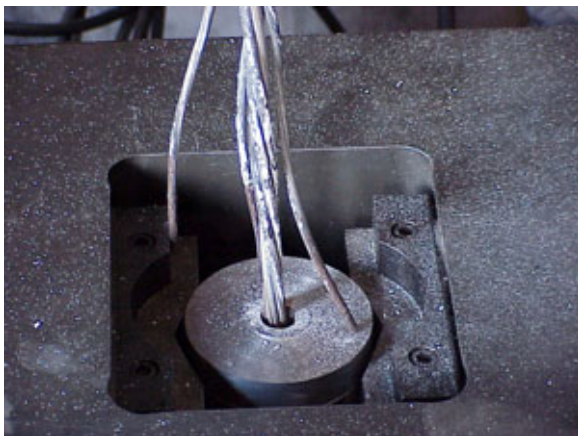
**Photo 15** – Failure of Corroded Specimen #3

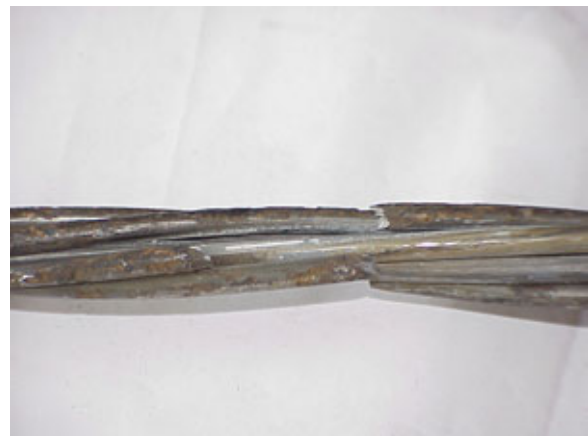
**Photo 16** – Failure of Corroded Specimen #5

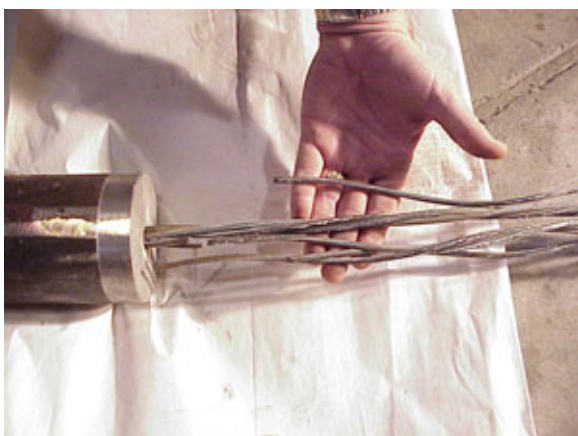
**Photo 17** – Failure of Corroded Specimen #6

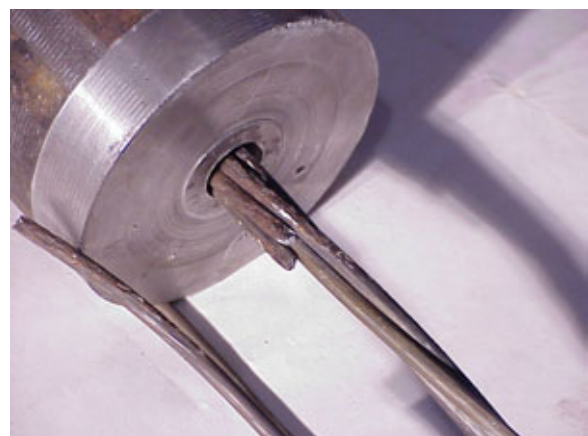
**Photo 18** – Failure of Corroded Specimen #7

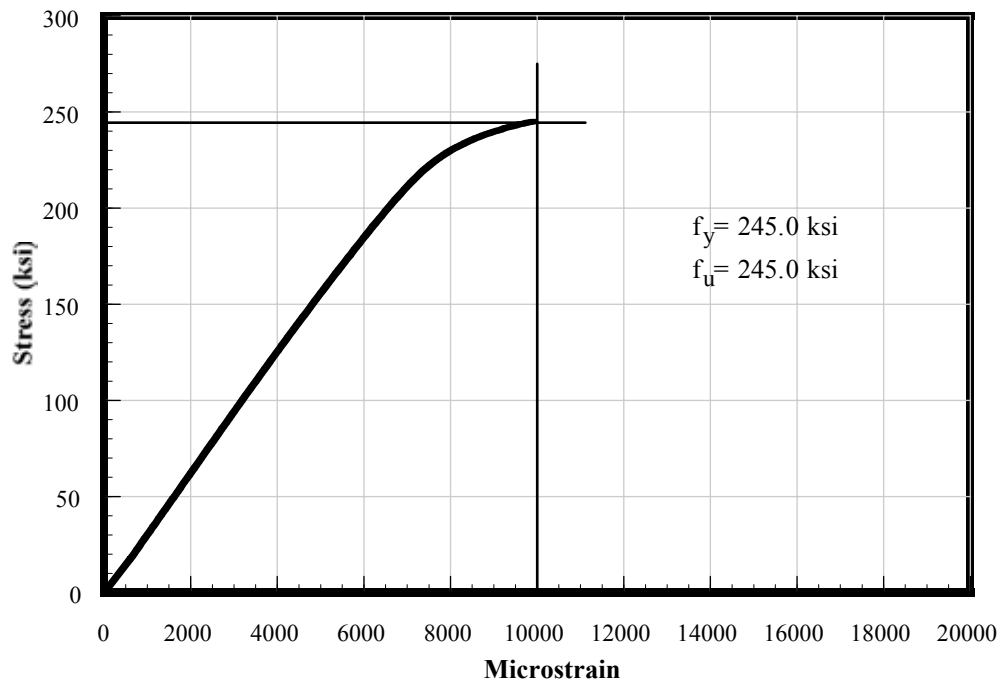
**Figure 9 - Stress vs. Strain  
Specimen CORR-7**

\* Note: The value reported in this table of yield strength for the corroded strands does not include specimens CORR-2 and CORR-3 since they did not achieve the requirements of the AASHTO test procedure. Additionally, note should be made that specimen CORR-7 fails at the yield point (See Figure 9).
