# Initial Report on Testing of Simulated Skyway Trestle Span Beams

December 12, 2006

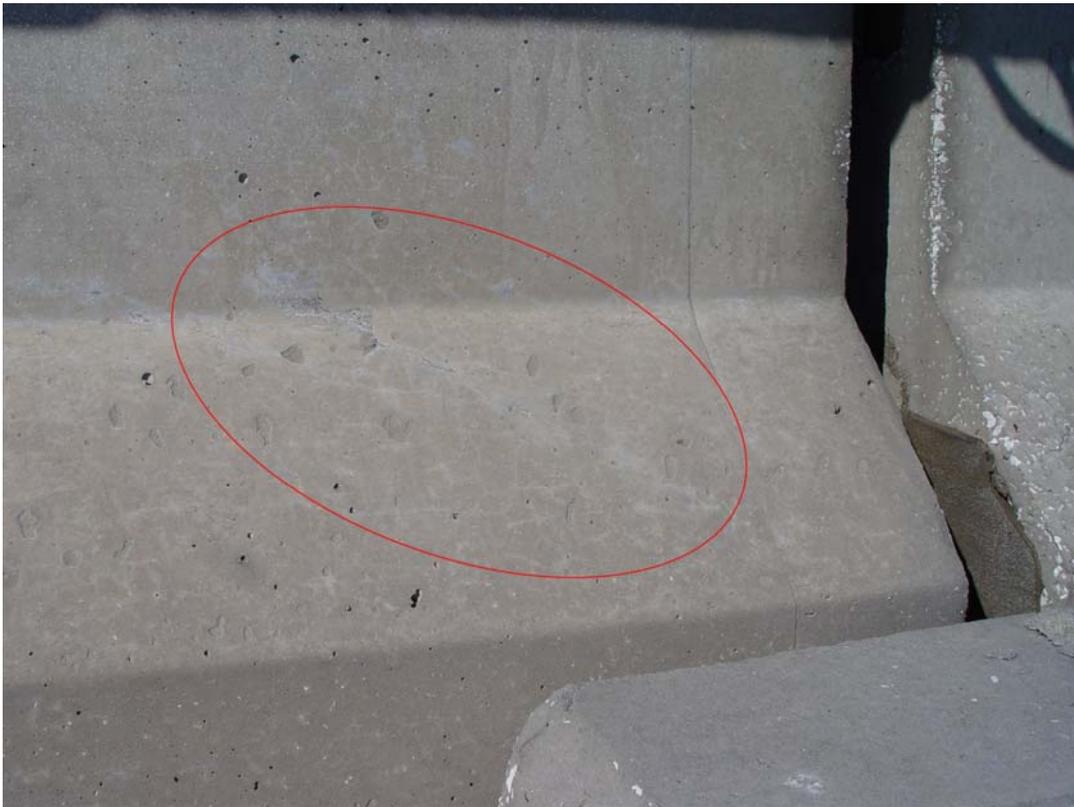
**Figure 1**

During the Spring of 2006 two 60 foot long Type IV AASHTO girders were constructed in the Dura-Stress yard in Leesburg, Florida to simulate the existing beams on the Skyway approach spans, in particular, the exterior girders that have cracking near the supports as shown in Figure 1. In late summer, eight-inch deep slabs were cast on these beams. A few weeks later, one end of each beam had the CFRP (carbon fiber reinforced polymer) wrap applied, as per the contract documents in the proposed repair. The materials and procedures complied with the winning bid. The beams were then tested to failure after allowing the carbon repairs one to two weeks to cure. Each end of each beam was tested thereby providing a test of the carbon wrapped section and an unwrapped section which functioned as a control.

This leads to bursting forces that result in strand slip and the loss of the tension tie and beam integrity. The strand slip failure is obvious for all of the tests from a review of Figures 6 through 9. The cracking for all of the tests was very similar and very similar to the crack in the field shown in Figure 1. In addition, tests were conducted on the original Skyway beams during the time of construction. Figure 14 is the result of one of these tests and the similarity with Figure 13 is apparent.

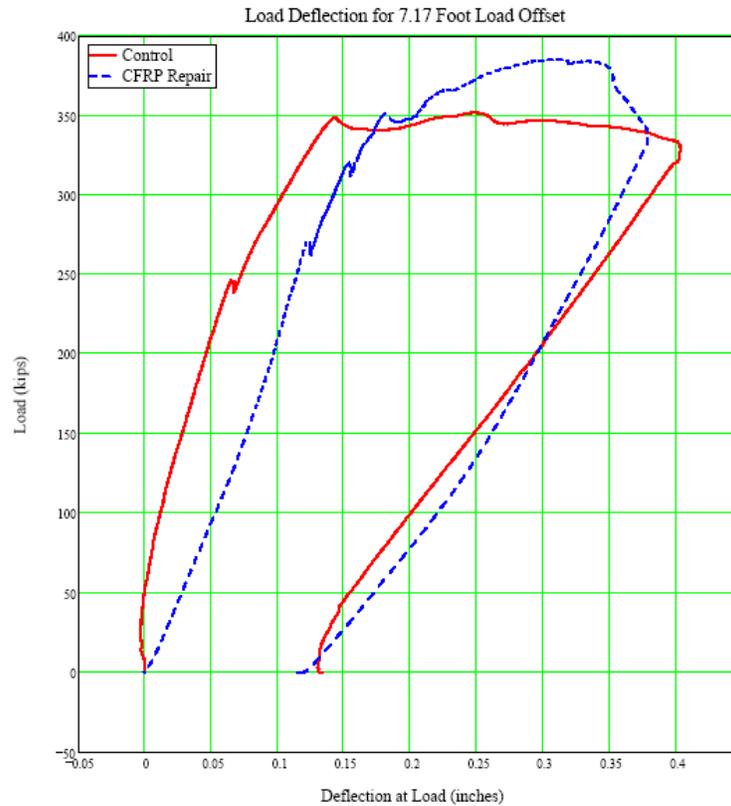
**Figure 4**

Figure 4 shows the load deflection curves for the two tests with the load offset 7 feet 2 inches.

The breaks on the ascending portion of the curves are locations where the loading was stopped and the beams were examined for cracks. Figure 5 is the load deflection graph for the two tests with the load offset 15 feet.

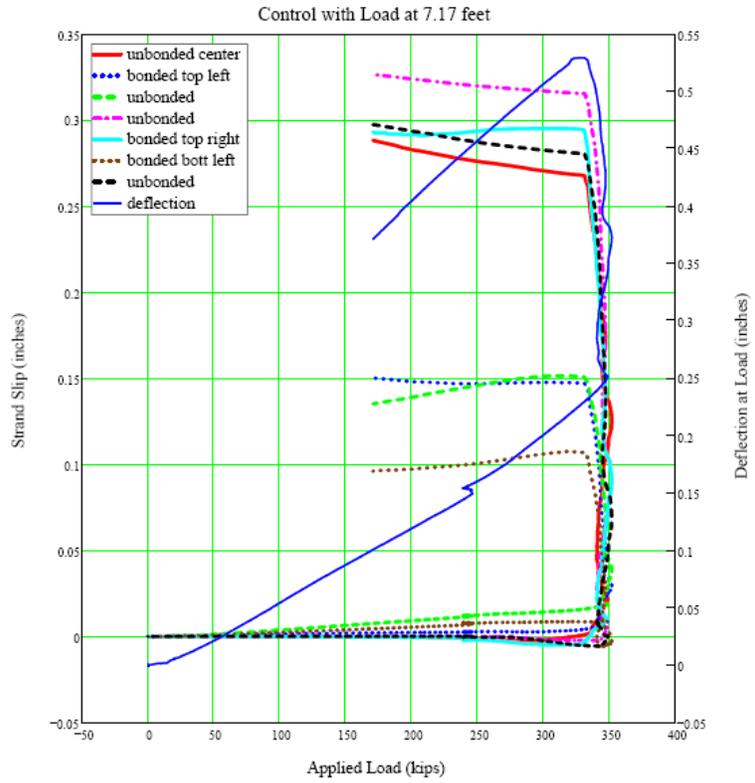
**Figure 6**

Strand slip was monitored during testing. A bracket was attached to the beam flange and displacement transducers were attached such that strand movement relative to the end of the beam could be recorded. Figures 6 through 9 provide the results from this monitoring concurrent with the deflection at the load location.

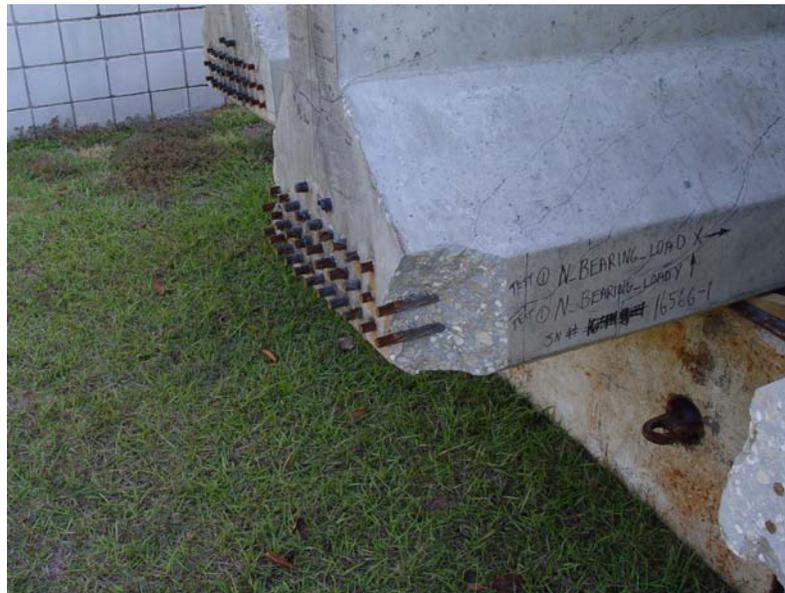
**Figure 10**

Prior to testing a handling mishap broke off a corner of one of the beams as shown in Figure 10.

It was decided to use this end for the 15 foot offset Control test since the anticipated failure modes meant that this damage would not adversely change the results. A review of the failure modes and Table 1 indicates that this is probably not the case. Even including this test, the coefficient of variation of the maximum reaction for the four tests is less than 8 percent.

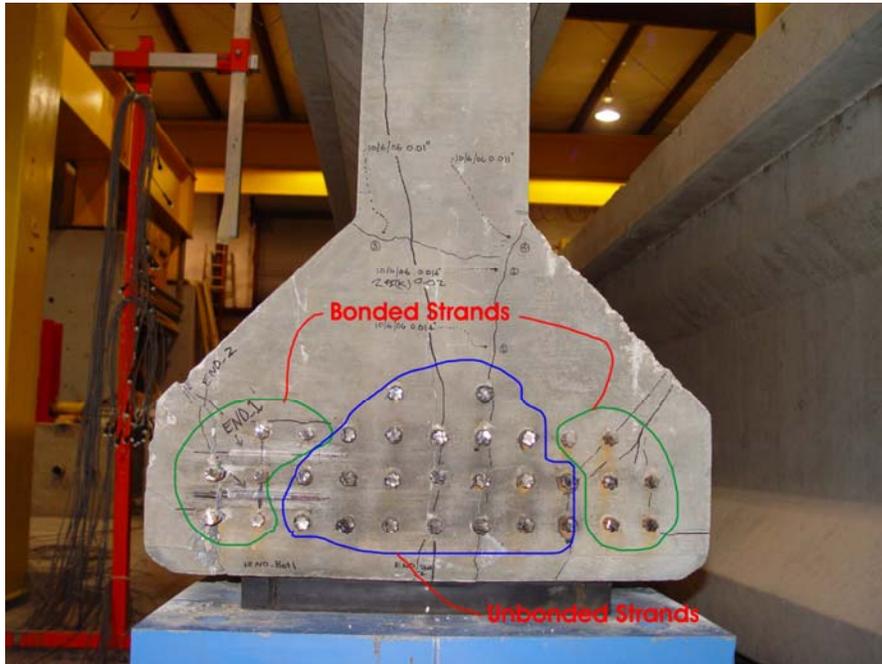
**Figure 11**

All four tests exhibited the same failure mode. Figure 11 shows the layout of the strands and the associated debonding pattern.

This pattern violates current policy by amount and distribution and is the direct reason for all of the failures. In addition, there is no confining steel around the strands contrary to current FDOT requirements.

Our testing indicates the CFRP repairs provide modest increases in the capacity from 9 to 19 percent. Due to the ship impact restraints, the repair is offset from the bearing location, diminishing its effectiveness. To eliminate this tie failure mode would require additional confinement at the bearing location, the node location shown in Figure 12. This could be accomplished in several ways but would probably require removal or modification of the ship impact restraints at the repaired beams.

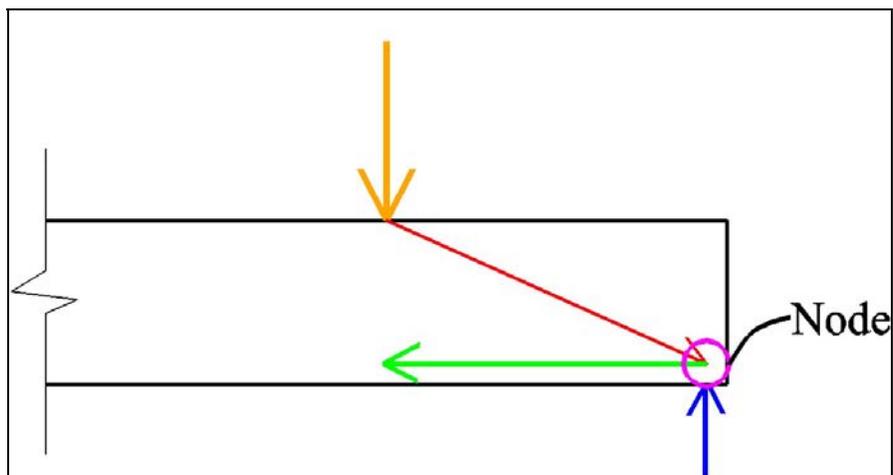
**Figure 12**

The forces at the end of the beam must be resolved at the node as shown in Figure 12.

This green arrow represents the tension tie, which in the Skyway beams are the bonded prestressing strands. The unbonded strands do not become integrated into the beam structurally until they are some distance along the beam and outside the node. Therefore, they cannot carry the tension tie forces. The bonded strands are located on the outside of the flange of the beam as shown in Figure 11. The local forces must flow as shown in Figure 13 to allow the compressive forces to be resolved with the tie.
