# **CFRP REPAIR OF IMPACT-DAMAGED BRIDGE GIRDERS**

## **VOLUME II – INSPECTION OF FRP COMPOSITE REPAIRS USING INFRARED THERMOGRAPHY**

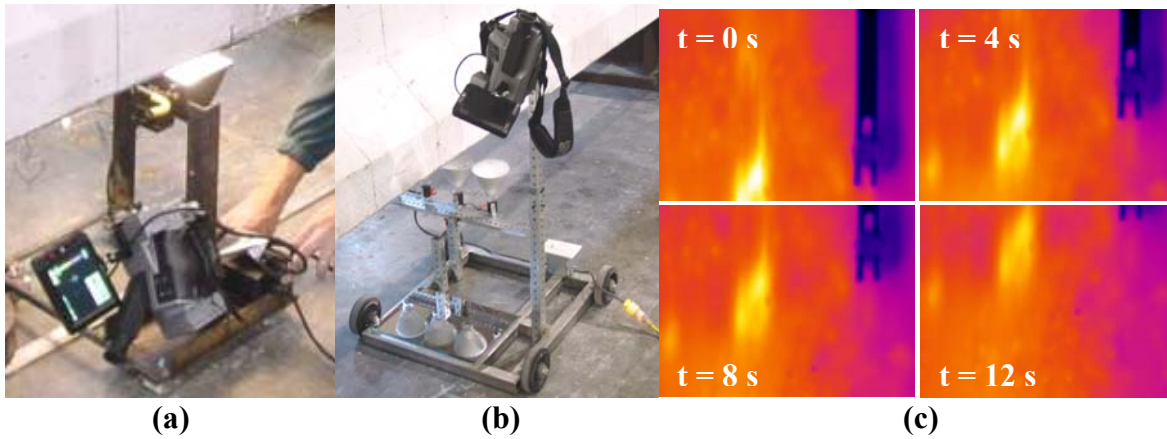
Laboratory results indicated that IRT is a potentially powerful tool for identifying unbonded areas in FRP systems (figure 1). However, as the thickness of the FRP system increases, detection of unbonded areas at the FRP/concrete interface becomes increasingly difficult. IRT was not successful in detecting defects at the FRP/concrete interface in the systems applied to girder 3, 4, or 5. Near surface defects, however, were detected in all of these systems. IRT was capable of detecting defects throughout the thickness of the composite applied to girder 6.

Figure 1: Data collection in laboratory (a) and (b) scanning cart configurations and (c) typical thermal images

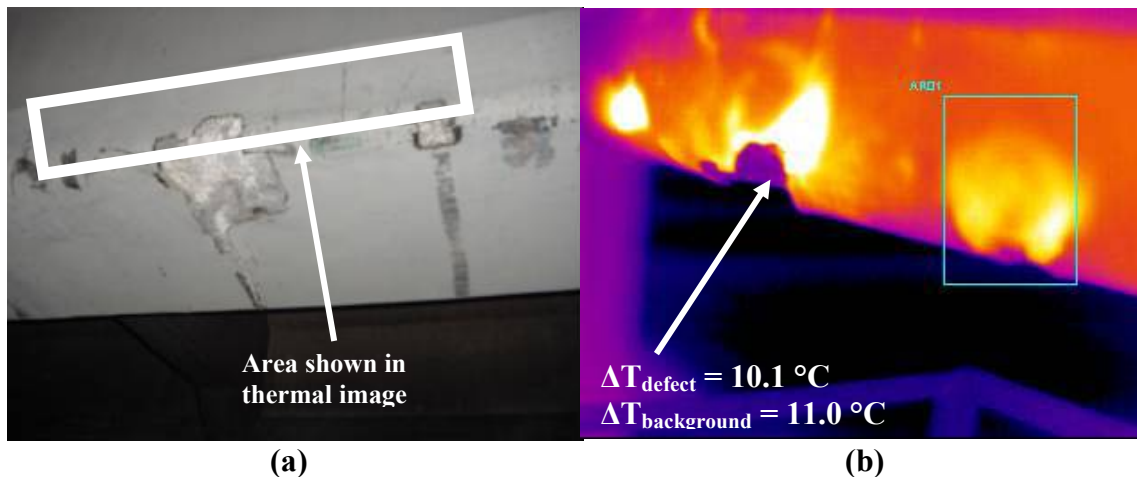
The IRT inspections performed on the in-service bridge identified several installation defects (figure 2). Researchers also inspected a portion of one girder with additional impact damage to the FRP system. Thermography results indicated that the detected damage was limited to the vicinity of the impact. Further research is needed to (1) improve data collection efficiency and (2) develop a standardized inspection procedure that can be used for a wide variety of FRP system types.

Figure 2: Field inspection of Chaffee Rd. Bridge (a) visible impact damage to FRP system (b) thermal image
