Structures Research Report No. 879  
Final Project Report

UF Project No. 4504-879-12  
Contract No. BC-354 RPWO #55

**CFRP REPAIR OF IMPACT-DAMAGED  
BRIDGE GIRDERS  
VOLUME II - INSPECTION OF FRP COMPOSITE  
REPAIRS USING INFRARED THERMOGRAPHY**

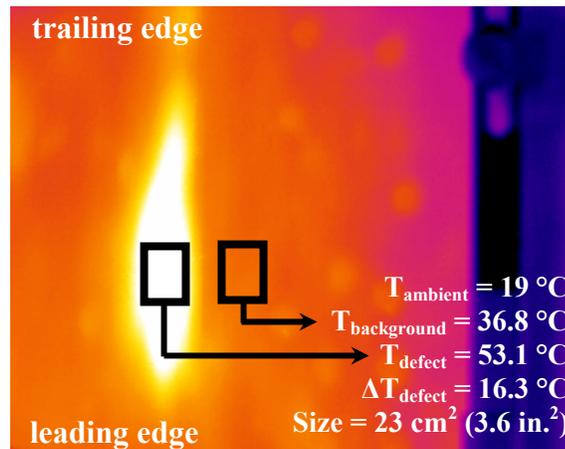
**Figure 4: Subsurface defect found on girder 3**

The inspection of girder 3 revealed 11 minor subsurface defects ( $< 12.9 \text{ cm}^2$ ) and three moderate subsurface defects ( $> 12.9 \text{ cm}^2$  but less than  $161 \text{ cm}^2$ ). Thermal images for two of

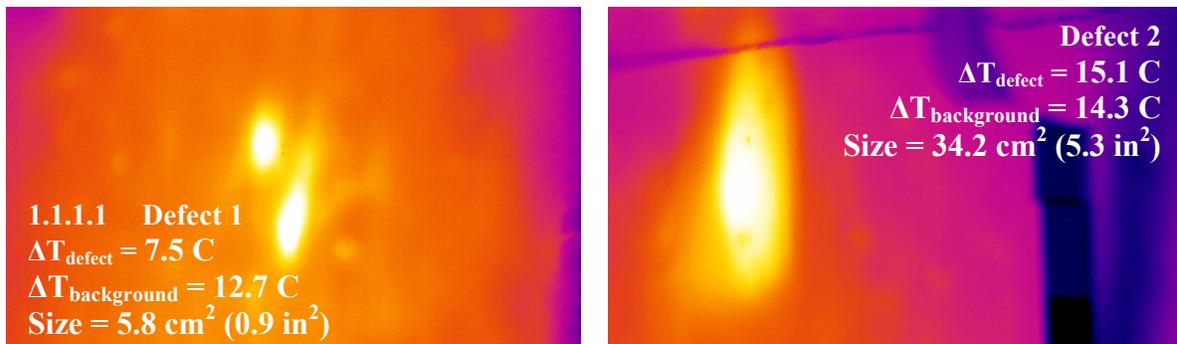
**Figure 5: Subsurface defects found on girder 3**

these defects are shown in Figure 5. These images were recorded approximately six seconds after the area was heated.

The computed signal strength for defect 1 and 2 was 7.5 C and 15.1 C, respectively. The difference in signal strengths could be due to several factors: defect depth, amount of heat applied to the surface, and the size of the defect. Stronger signal strengths are expected for defects that are closer to the surface (signal strength is inversely proportional to defect depth). Applying more heat to the surface will also result in higher signal strengths. Finally, a larger surface area will result in higher defect signal strengths since the heat applied above the defect must travel farther before being absorbed by the concrete.

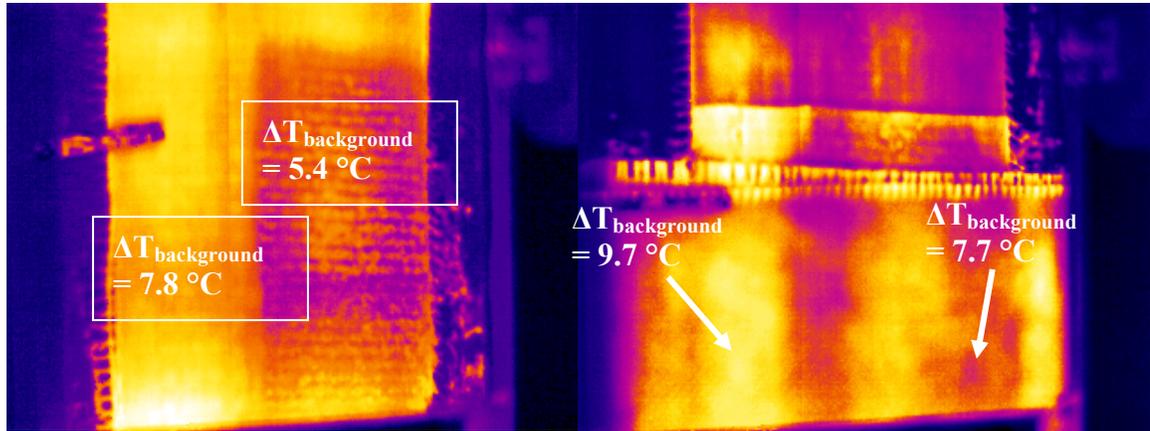
**Figure 6: Non-uniform surface heating of girder 4**

No defects were detected during the initial inspection of girder 4. There were, however, two interesting observations made regarding the polyurethane matrix material and the uniformity of heating perpendicular to the girder's length. Some areas of the FRP surface were covered with excess polyurethane matrix, which had the visual appearance of a thin layer of foam. The color of this layer was also much lighter than adjacent areas, which appeared black. An example of this occurrence is shown in Figure 6. The resulting  $\Delta T_{\text{background}}$  for the light colored area was 5.4 C while the  $\Delta T_{\text{background}}$  for the dark color was 7.8 C. Another source of non-uniform heating was

streaking due to the narrow beam width of the IR heat lamps (also shown in Figure 3). The resulting  $\Delta T_{\text{background}}$  for the area directly in-line with the heat lamp 9.7 C while the  $\Delta T_{\text{background}}$  in the area between lamps was 7.7 C.

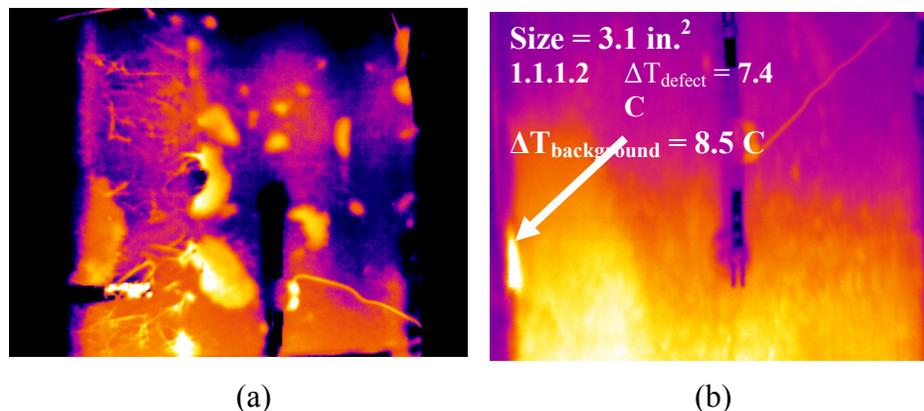
**Figure 7: (a) Thermal images from girder 5 and (b) girder 6**

Following application of the chopped fiber system, it was noted that layers of saturated fibers had pulled loose from the bottom surface before the resin set. This resulted in an extremely rough surface texture along with a large number of debonded areas just below the surface of the composite. In some cases, the defects were caused by lack of fiber saturation. The presence of such a large number of imperfections made the IR inspection difficult. A typical thermal image is shown in Figure 7(a). All of the defects that were visible in the thermal image were also visible to the naked eye.

Only one subsurface defect was detected during the initial scan of girder 6 (shown in Figure 7(b)). The recorded defect signal strength was 7.4 °C and  $\Delta T_{\text{background}}$  was 8.5 °C. This defect occurred on the edge of the laminate and was not considered to be significant.

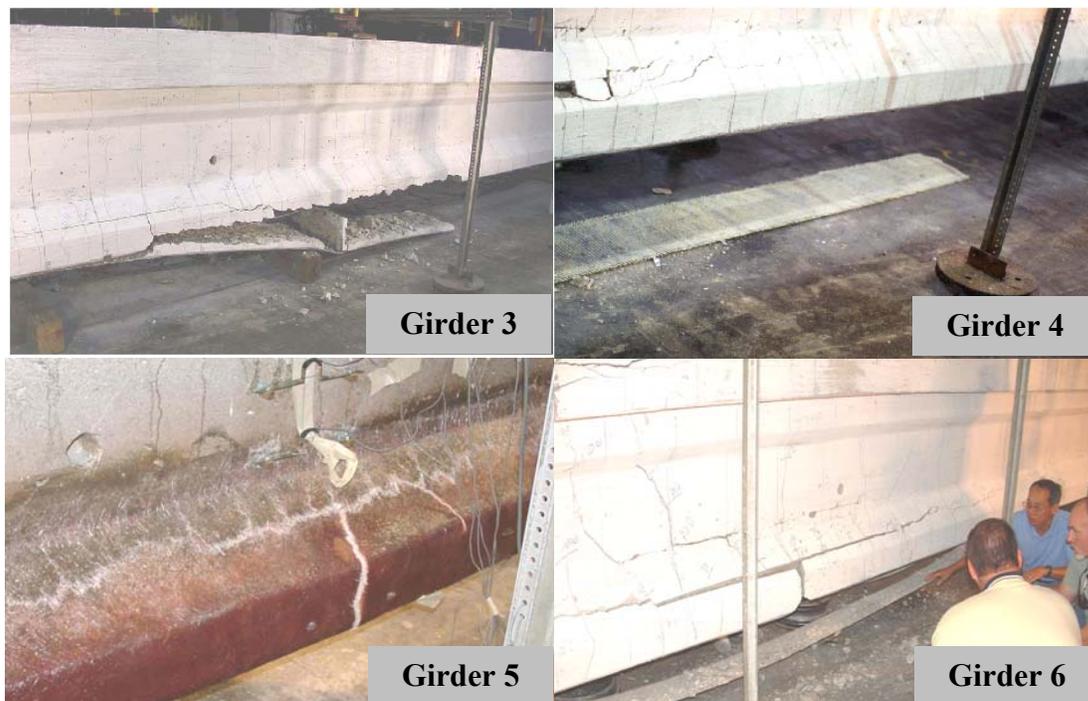
**Figure 9: Girder failure modes**

The failure mode for girder 3 was delamination of the concrete cover at the level of the girder's pre-stressing tendons (see Figure 9). There were no visual or audible indications of FRP debond during the loading. A 90 cm x 45 cm piece of the delaminated cover was recovered after load testing to perform a thorough IR inspection. This section did not contain any defects that were identified in the initial inspection, however, debonded areas were formed as a result of the delaminated cover concrete and FRP striking the floor after the girder failed.

The failure mode for girder 4 was debonding of the FRP laminate. Debonding began at midspan and progressed outward towards both ends of the girder. At the north end of the girder, debonding caused the anchorage FRP to rupture and then continued to end of the laminate. On the south end of the girder, the FRP system ruptured in tension before the debonding reached the anchorage point.

The failure mode for girder 5 was tensile rupture of the FRP laminate at the girder's midspan. There were no audible indicators during loading that the FRP system ever debonded from the surface of the concrete.

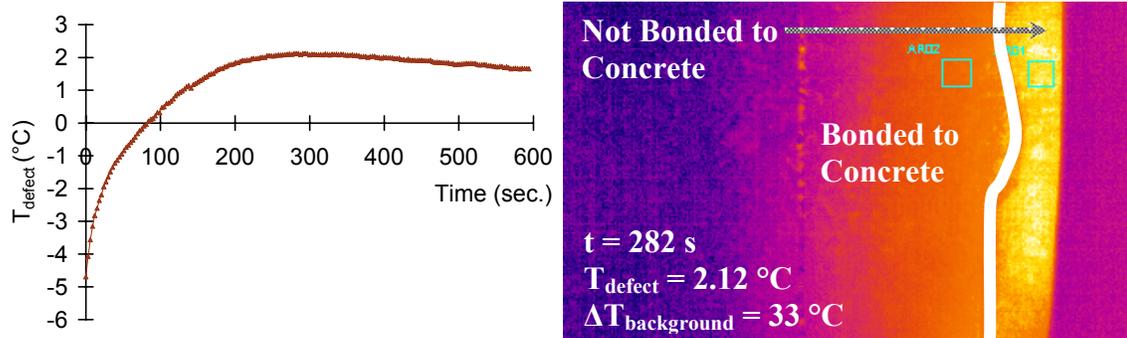
**Figure 10:  $T_{\text{defect}}$  vs. time for known debonded area (girder 3)**

Figure 10 shows results from an additional experiment performed on the delaminated cover in which a  $\Delta T_{\text{background}}$  of 33.3 °C was generated above the known bonded area. Immediately following the removal of the heat source, the temperature increase above the debonded (non-bonded / overhanging) area was 28.6 °C. This resulted in a thermal signal of -4.61 °C at t = 0 seconds. This initial negative temperature difference was likely due to improper lamp positioning that resulted in non-uniform heating of the surface. After 282 seconds of cooling, the thermal signal achieved its maximum value of 2.12 °C. Measurements were terminated after 594 seconds with a thermal signal of 1.69 °C.

If the sample had been heated uniformly, the maximum signal would likely have approached  $6.7\text{ }^{\circ}\text{C}$  ( $2.12\text{ }^{\circ}\text{C} - (-4.61\text{ }^{\circ}\text{C})$ ). It is important to note that this would occur after 4.7 minutes of cooling. These results stand in sharp contrast to the measurements obtained during the initial IR inspections (defect signal strengths between  $10\text{ }^{\circ}\text{C}$  and  $15\text{ }^{\circ}\text{C}$  that were visible after less than 2 seconds of cooling).

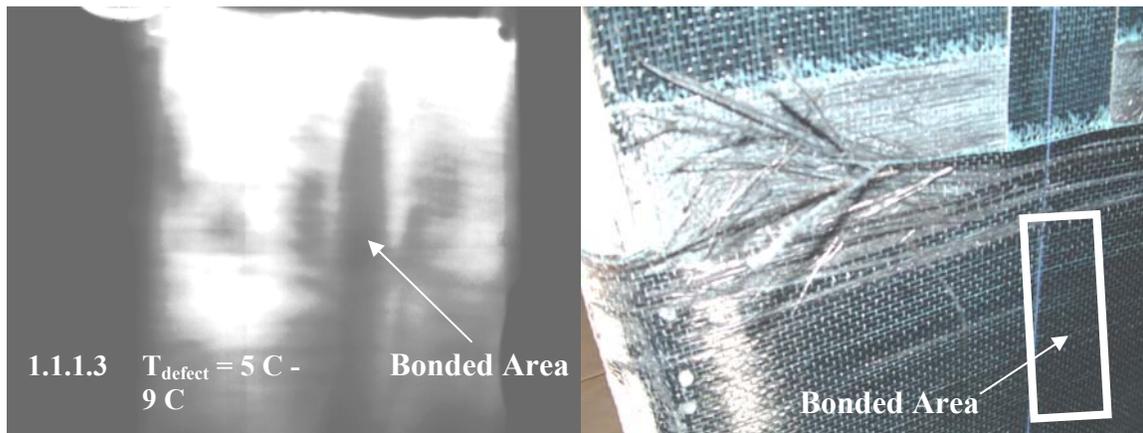
**Figure 11: Slippage at anchor in girder 6**

Results from an IR inspection performed on the tension face of the girder at the north anchorage point are shown in Figure 11. A thin strip (approx. 15 cm wide) in the center of the beam remained bonded to the concrete at the anchorage point. The adjacent debonded/delaminated areas are clearly distinguishable in the thermal image. The defect signal strength for the delaminated area varied from 5 C to 9 C.

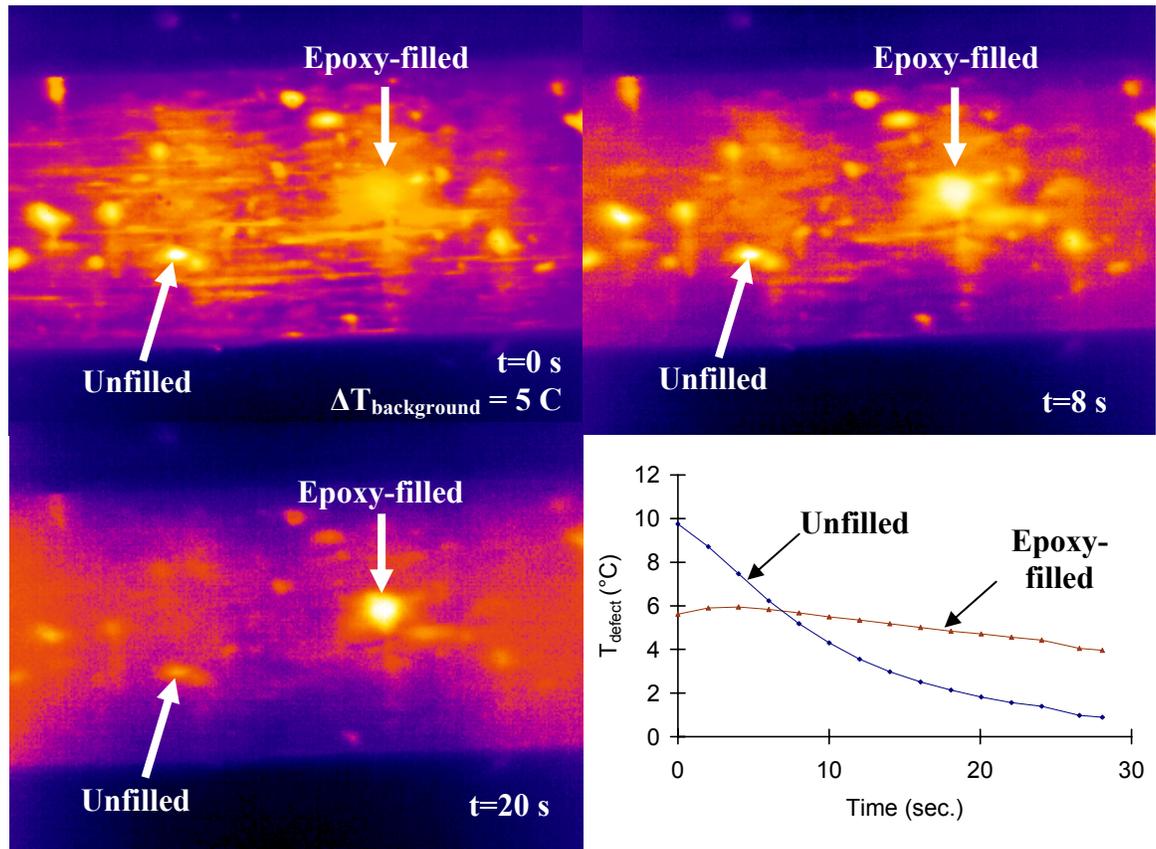
Figure 12: IR inspection of test patch on girder 6

A small FRP test patch (21.6 cm x 45.7) was constructed on the side of girder 6 near the support. This test patch consisted of a single layer of carbon-fiber fabric. The area chosen for the test patch contained numerous bug-holes and other surface imperfections. A single bug-hole near the center of the area was identified and filled with thickened epoxy paste prior to placement of the carbon fiber. The remaining bug-holes were left unfilled. The test patch area was heated for 18 seconds with an array of four 125 Watt IR heating bulbs. The resulting  $\Delta T_{\text{background}}$  above the defect free area was 5 °C. The bug-holes were visible immediately after the heat source was removed. The reference hole (unfilled), shown in Figure 12, had a defect signal strength of 9.5 °C. The signal strength above the epoxy filled hole was only 5.25 °C immediately after the heat was removed. After 8 seconds of cooling, the defect signal strengths above the filled and unfilled holes were equal at 5.0 °C. As the area continued to cool, the signal strength above the unfilled hole decayed rapidly, and after 20 seconds only the epoxy filled hole continued to possess a significant thermal signal.

This finding has several implications. Filling the hole with epoxy will ensure that the FRP is bonded to the concrete, however there is still a difference in thermal conductivity between the epoxy filler and concrete substrate. This results in the appearance of a debonded area in thermal images. Careful scrutiny of the thermal signal vs. time can differentiate the epoxy filled void from an air filled defect, however this requires a series of thermal images to be recorded with the camera in a static position. Also, it might be difficult to differentiate between these two thermal signals if a particular image does not contain both types for reference.

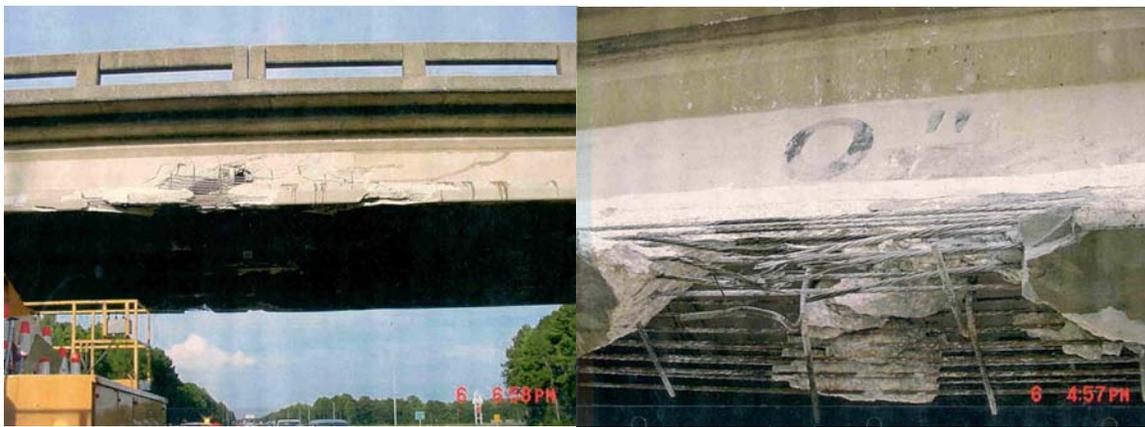
Chaffee Road has the unfortunate distinction of being the lowest overpass on I-10 westbound out of Jacksonville. As a result, a number of minor vehicle impact events occurred between the time the FRP system was installed and July of 2002. In June of 2003, another serious event of vehicle impact damage occurred (shown in Figure 15). Clearly the FRP system was in need of repair and the strategy adopted by the FDOT was to completely remove the existing FRP and restore the cross-section of the girder with concrete. After this was completed, a new FRP system would be applied to strengthen the girder.

**Figure 14: Original vehicle impact damage that prompted strengthening with FRP**

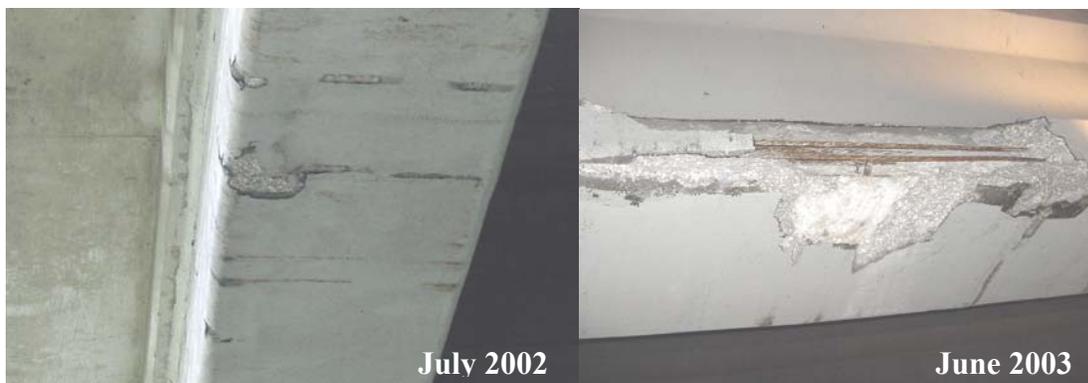
**Figure 15: Vehicle impact damage after strengthening with FRP**

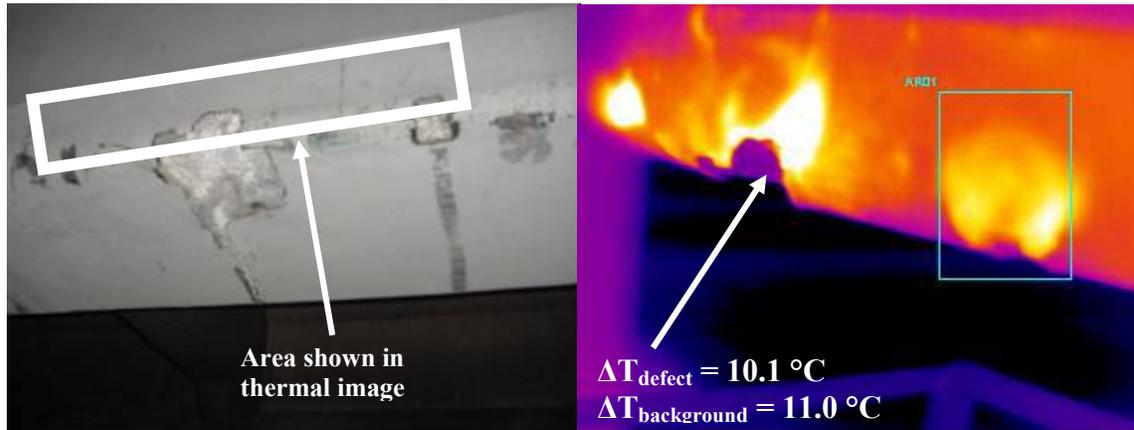
A typical thermal image collected during this inspection is shown in Figure 16 along with a visual image for reference. While there was some evidence of debonding, this thermal image indicates that significant damage was limited to the immediate area surrounding the point of impact. Similar results were obtained from an inspection of the damaged area shown in Figure 17. The debonded areas shown in the thermal image were verified with a coin tap inspection. This coin tap inspection also verified that areas appearing bonded in the thermal images actually were.

**Figure 16: Thermal image of FRP system affected by vehicle impact (side)**

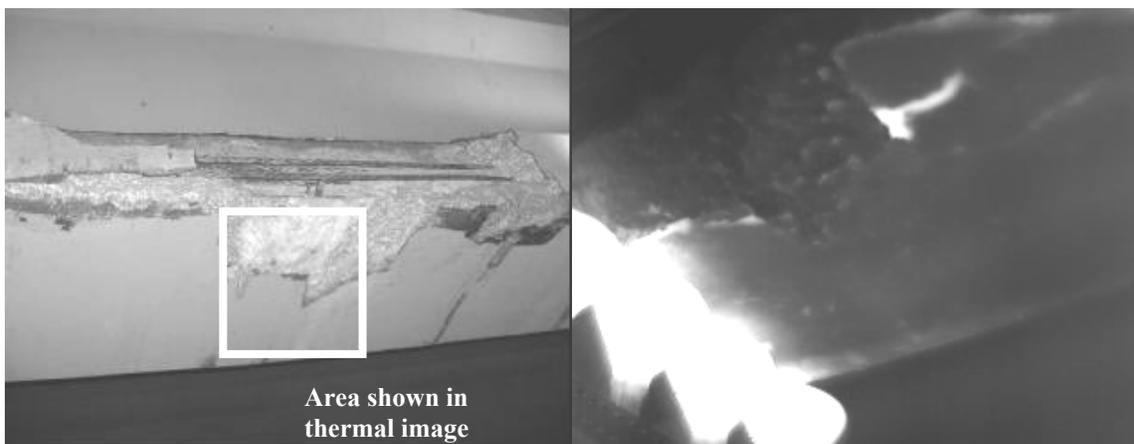
**Figure 17: Thermal image of FRP system affected by vehicle impact (tension face)**

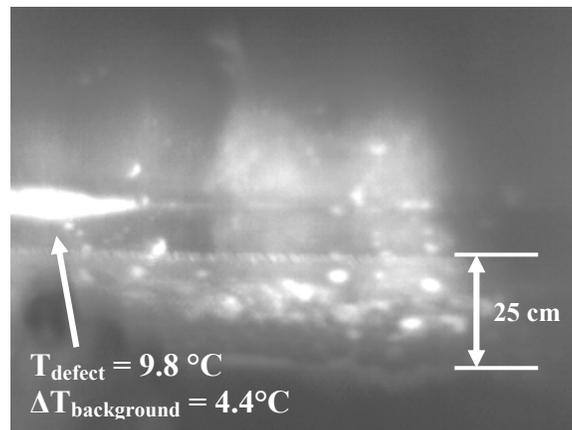
**Figure 18: Interior face of west girder**

While work was being done to apply the new FRP system to the east girder, the IR inspection team was able to evaluate the FRP system that was originally applied to the west girder. Access to the girder was achieved with a 2 m x 4 m scissor lift. The scanner cart configuration shown in Figure 3(b) was deployed on the scissor lift in an attempt to duplicate the experiments performed on the full-scale girders in the laboratory. Unfortunately, this met with little success. Unevenness of the scissor lift platform meant that the height of the lamps were in constant need of adjustment as the cart was pushed along the girder. Also the cart was not properly configured to account for the increased distance between the platform and the girder that was mandated by the platform's railing.

The IR inspection technique worked very well in this field inspection. A number of subsurface defects were identified in the original FRP system as well as a portion of the system that suffered additional vehicle impact damage. Overall, the IR inspection indicated that much of the FRP strengthening system was still bonded after the major impact damage. This was verified as the workers attempted to remove the existing FRP system with pneumatic jackhammers and encountered tremendous difficulty. Most of the system was so well bonded that it was left in place and the new system was installed on top (shown in Figure 19). An alternative repair procedure that might be considered is to remove the debonded laminate around the damaged areas and patch the damaged concrete. Once the patch is cured, apply new FRP composite over the repaired area with an appropriate overlap onto the existing FRP system. It is not known, however, how this repair technique would affect the strengthened flexural capacity of the girder.
