Final Report

December 2011

Damage Detection and Repair Methods for GFRP Bridge Decks

Florida Department of Transportation (FDOT)
Rodney G. Chamberlain, P.E. – Project Manager

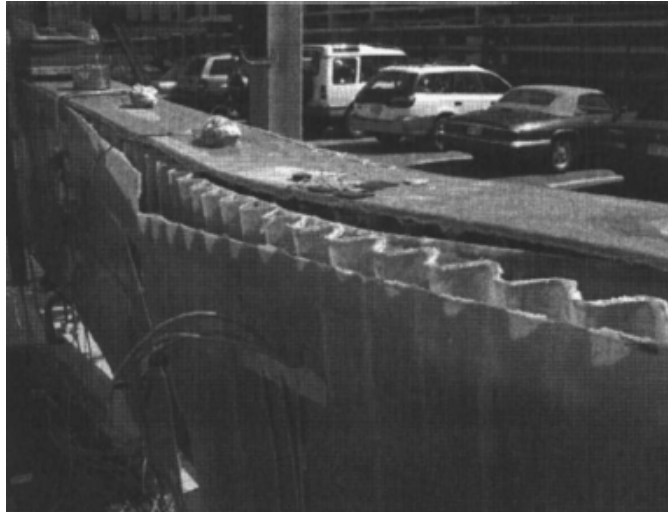
Figure 21 – Picture of the specimen after failure

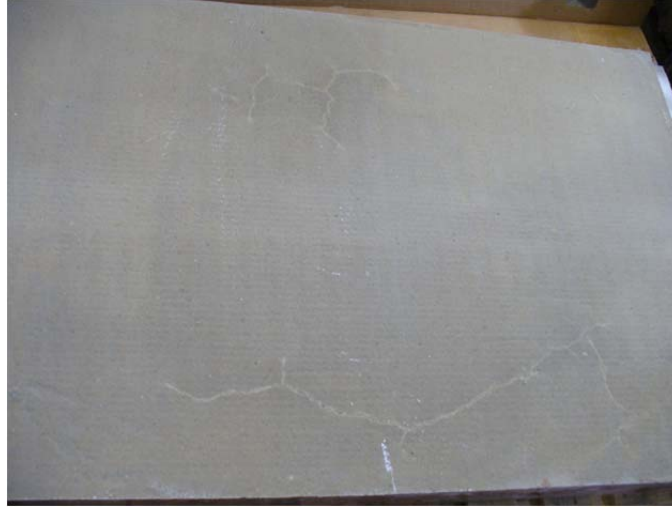
The positive bending specimen (B_P) was 36 in. wide and 55 in. long and had a wearing surface applied by the manufacturer. The negative bending specimen (B_N) had a significant amount of cracking on the wearing surface; this was present prior to testing as shown in Figure 42. The wearing surface was applied to the top of the deck specimen and was not a structural component of the deck according to the manufacturer. Due to the small number of specimens tested the effects of the cracked wearing surface could not be quantified in this investigation.

Figure 42 – Specimen B_N wearing surface cracking

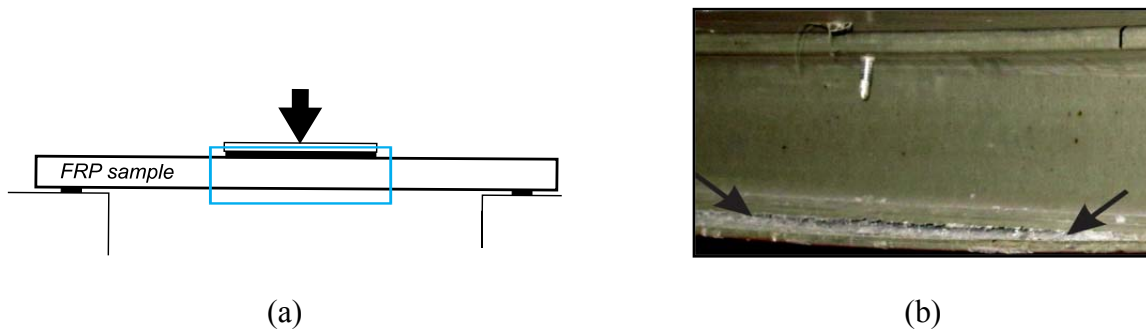
Post-test inspection, in which the top plate was removed, revealed that the concrete fill had cracks throughout the length of the specimen. It is speculated that the cracking occurred just before the 10 kip load level due to the bilinear characteristic of the load deflection curve. Further inspection revealed that the two outer webs delaminated from the bottom sheet at midspan (Figure 95).

Figure 95 – A1 failure (a) location and (b) detail

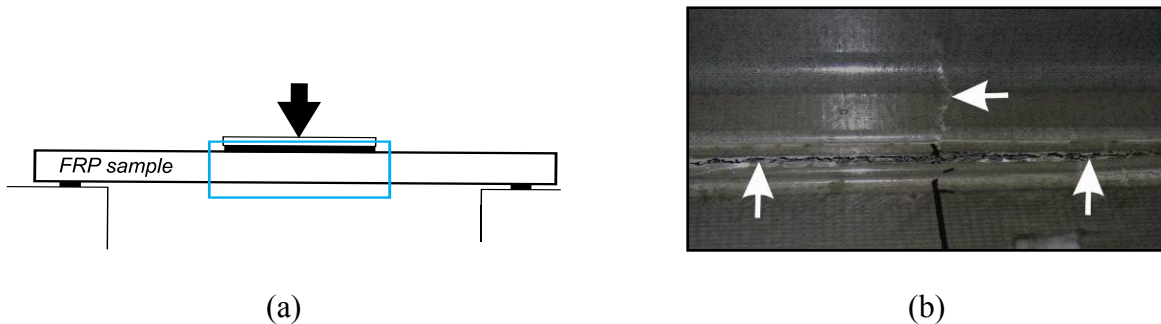
Figure 99 shows that the bottom flange of the outside webs has separated from the bottom of the panel and that the bottom flange ruptured due to the flexural tension. Figure 100 shows that web 1 and the top flange of web 2 delaminated. It is suspected that the addition of the glass wrap to the interior webs strengthened the interior of the specimen causing the failure of the outer portions of the specimen.

Figure 99 – A2 web-flange failure at midspan (a) location and (b) detail

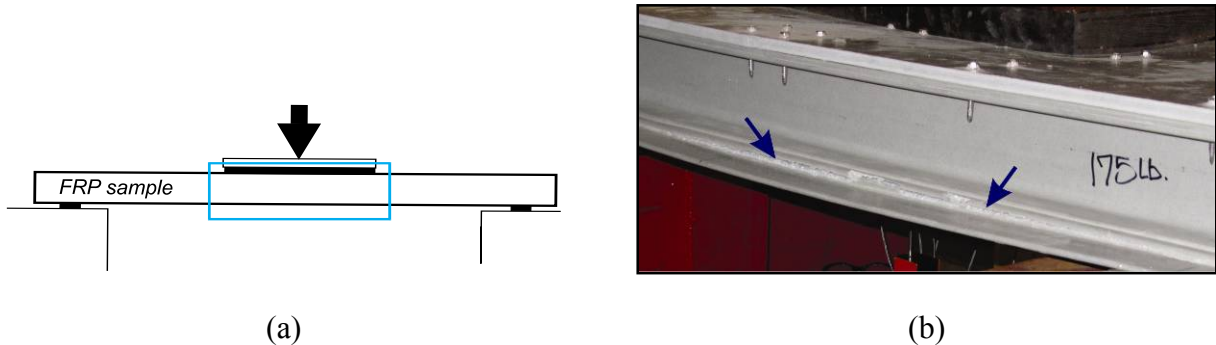
Figure 103 shows the location and the failure mode of the deck, which was delamination of the outer webs from the bottom panel. Because grout filled the cavities of the specimen, interior portions of the specimen were inaccessible for examination. Removal of the top plate after testing revealed multiple cracks in the grout in a pattern similar to that of A1.

Figure 103 – A3 failure (a) location and (b) detail

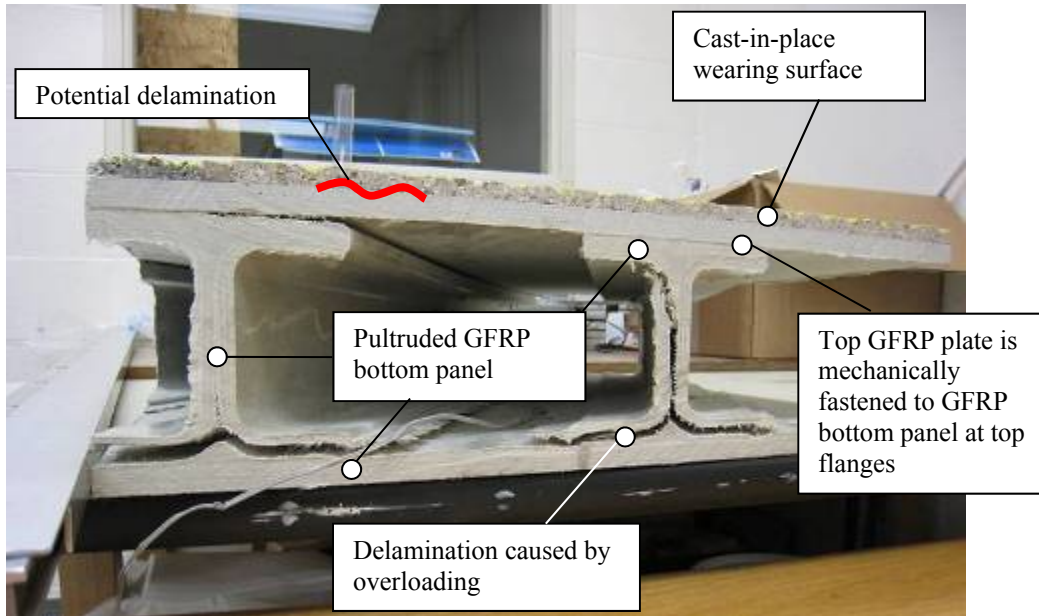
Figure 1-Section view of damaged GFRP bridge deck. Sample provided by UF/FDOT.

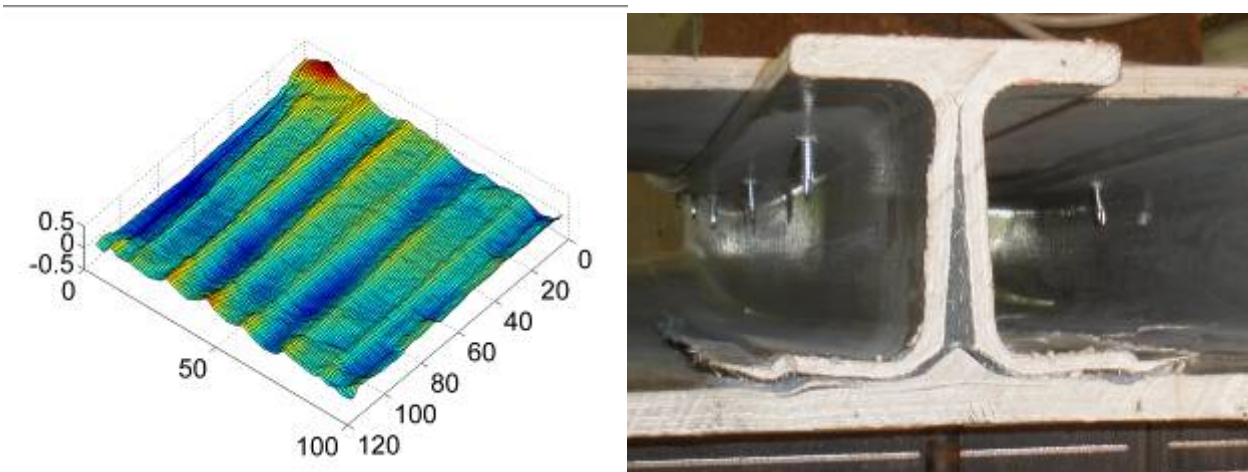
Figure 29-Phase image results for Deck A, specimen DS1 with severe bottom flange delamination.
