Progress Report: May to August 1998

Evaluation of Conventional Repair Techniques for Concrete Bridges

Principal Investigator: M. Arockiasamy, Ph.D., P.E.
Professor and Director
Center for Infrastructure and Constructed Facilities
Department of Ocean Engineering
Florida Atlantic University
777 Glades Road
Boca Raton, FL 33431-0991

December 1998

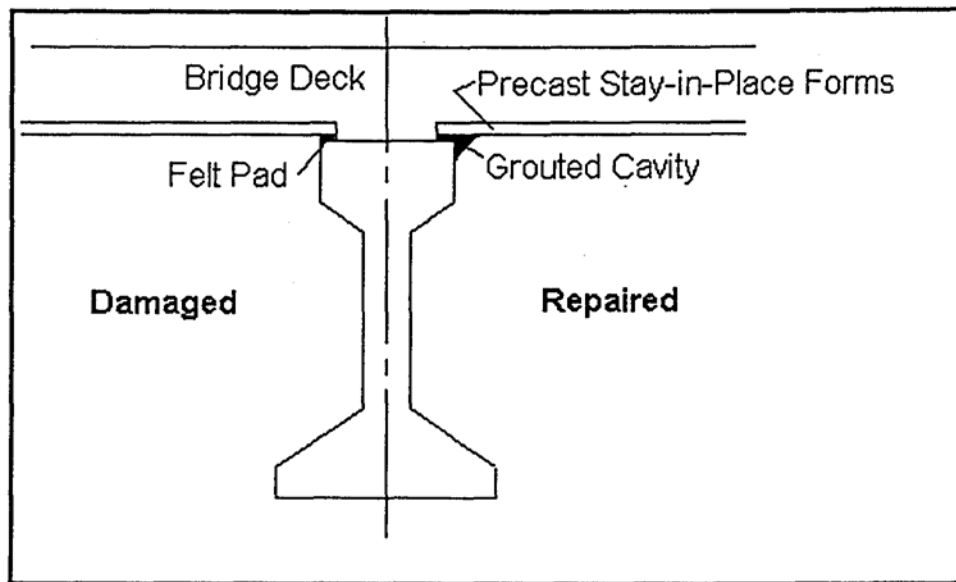
Figure 1 - Griffen Road Repair, Florida

This repair has been in place for 10 years and is working very well. A visual inspection of bridge performed on 4/7/98 found the repair in good condition. In fact, the existence of the repair is barely discernible from the original construction. Figures 2, and 3 show the repaired area under the deck.

Pressure grouting the cavity in this case was an effective way to remedy a poorly constructed bridge feature. District 4 of the Florida Department of Transportation performed this repair and stated that in order for this repair to be effective it is imperative that the area to be grouted be cleaned thoroughly. Also, all of the voids have to be filled during grouting process.

The repair under consideration for this case study is a pressure grout patching repair. The deck of this bridge was constructed using prestressed concrete stay in place forms which were placed on the beams with a thin felt pad to provide an even distribution of the load. The deck was then poured over the stay in place forms. The felt pads were not removed, and deteriorated over time. This caused the stay in place forms to rotate and the deck to crack. To remedy this situation, the gap left by the deterioration of the felt pads was cleaned thoroughly and the remaining cavity pressure grouted as shown in Figure 1. This type of repair was done on several bridges in this area that used the same deck construction technique.

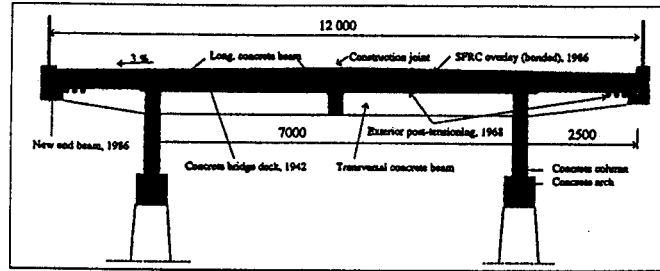
Figure 4 - Overboda Bridge at the repair in 1986

The Overboda bridge is a part of national road 76 and has average daily traffic (ADT) of 7,600 vehicles. Ten percent of the ADT is heavy vehicles, mainly loaded timber trucks, at high speed. The bridge is 12 m wide and has two lanes. Completed in 1942, it is a zero hinged concrete arched bridge. The concrete slab is reinforced in two directions and had a thickness of 170 to 230 mm in 1942, including an original bonded concrete overlay. The bridge has four main spans and two approach spans. In 1984, after 42 years in service, the end beams were suffering from scaling due to freeze-thaw action and weathering. The old concrete did not have an adequate air-void system. The increased use of deicing agents accelerated the deterioration. The top of the bonded concrete overlay (from 1942) was delaminated but the concrete at the reinforcement was sound. The concrete bridge deck was water jetted to remove damaged concrete and a bonded overlay of steel fiber reinforced concrete (SFRC) replaced the removed concrete and the asphalt wear course. Observation from the water jetting indicated that the concrete had good strength. The water jetted surface was carefully cleaned both after the water jetting and prior to overlay placement. In 1995, the overall impression from Overboda bridge was that the overlay had performed very well. The compressive strength has not degenerated. No contamination was found at the interface in any cores. Bond testing indicated a good bond between the overlay and the existing concrete. The failure took place mainly in the cement paste below the large aggregates and reinforcing steel, and in the aggregate in the old concrete. Moreover, the freeze-thaw resistance of the overlay was tested, and showed that a steel fiber reinforced concrete (SFRC) had very good freeze-thaw resistance after 56 and 112 cycles. The repaired deck is shown in Figures 4 and 5.

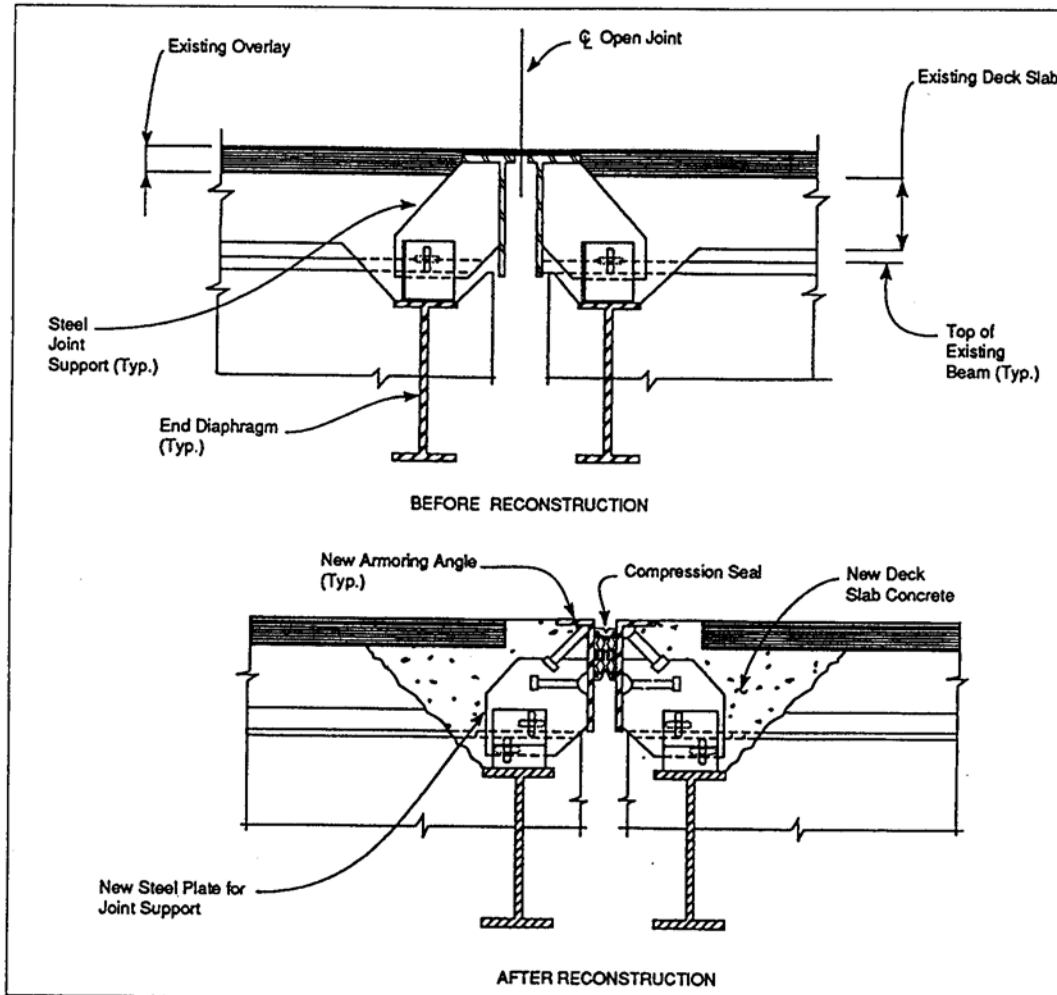
Figure - 18 Replacement of open joint by armored compression seal for joints on the Golden State Parkway Bridge

The three-span Garden State Parkway bridge is located in New Jersey, over local creeks. The existing obsolete armored open joints are to be replaced with more watertight joints-armored compression seals. Although the existing open deck joints were paved to achieve watertight joints during an earlier deck overlay work, cracking and deterioration in the overlay allowed the joints to continue to leak and promote deterioration at the pier ends of the steel girders and bearings. The planned joint replacement process involves removing the existing overlay and the portions of deck slab over the end diaphragms, then installing of a new joint assembly, consisting of compression seal and armoring angles, and connecting it to the existing end diaphragms using new steel plates and shapes. Finally, placing the concrete around the joint assembly completes the slab and joint reconstruction. The resulting joint gives superior water tightness with minimum slab removal. (Figure 18)

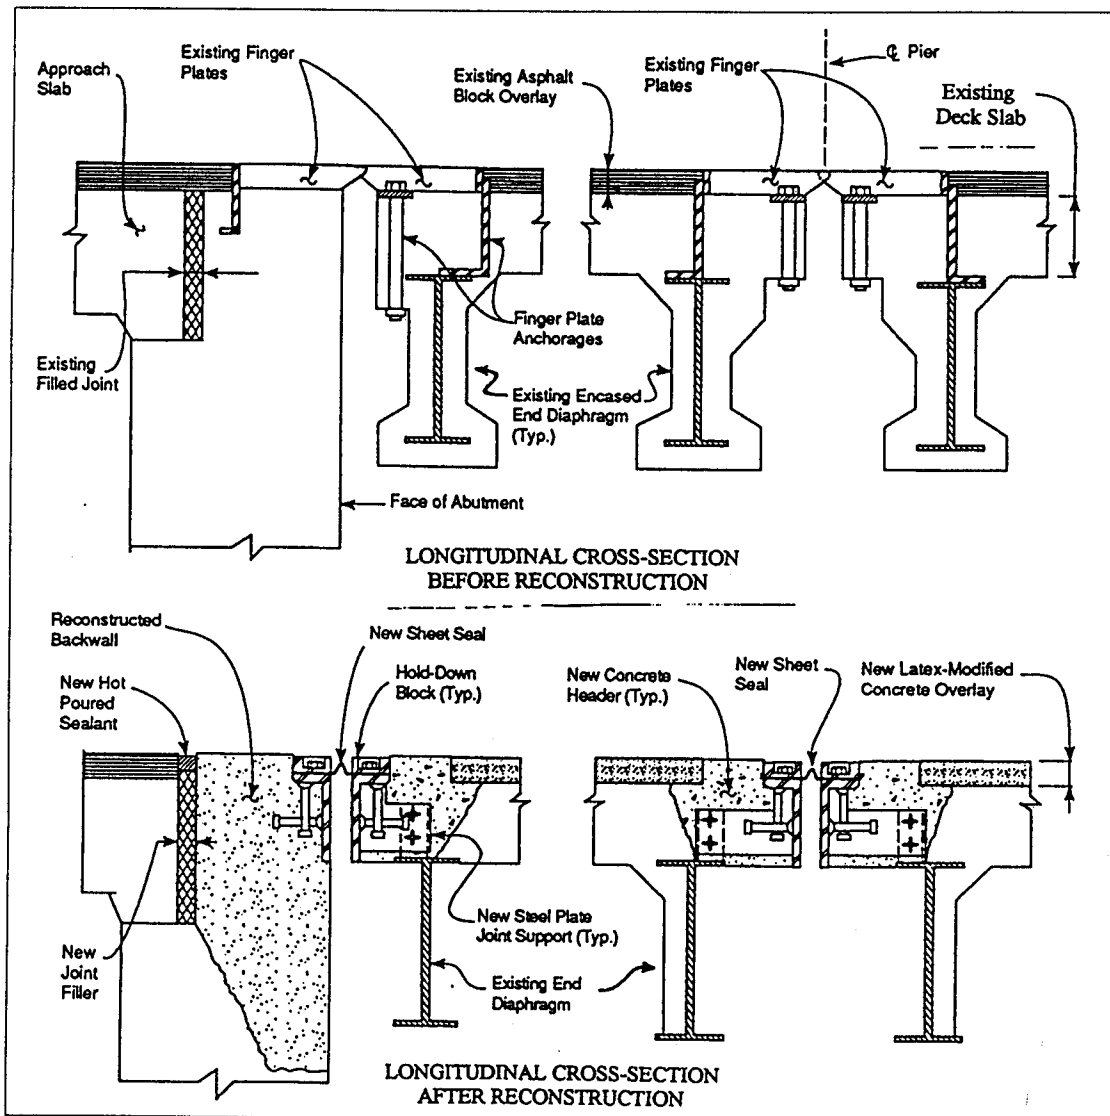
Figure 19 Replacement of finger plate joints by sheet seals on route 71 Bridge

The bridge is located on route 71 over the Shark River in New Jersey. The existing finger plate joints lacked a trough system and were permitting water to leak through and deteriorate surrounding bridge elements. To prevent further substructure deterioration and improve joint performance, the existing finger plate joints at the abutments and piers were replaced by sheet seals with steel hold-down blocks. First, portions of deck slab above the end diaphragms were removed, including the reinforced concrete encasement around the end diaphragms. The new joint substrate was formed by installing steel angles and placing concrete around them. Then the sheet seals were installed and joint restoration completed. In line with these replacements, the filled joint between the abutment backwall and approach slab was removed and replaced in kind. (Figure 19)

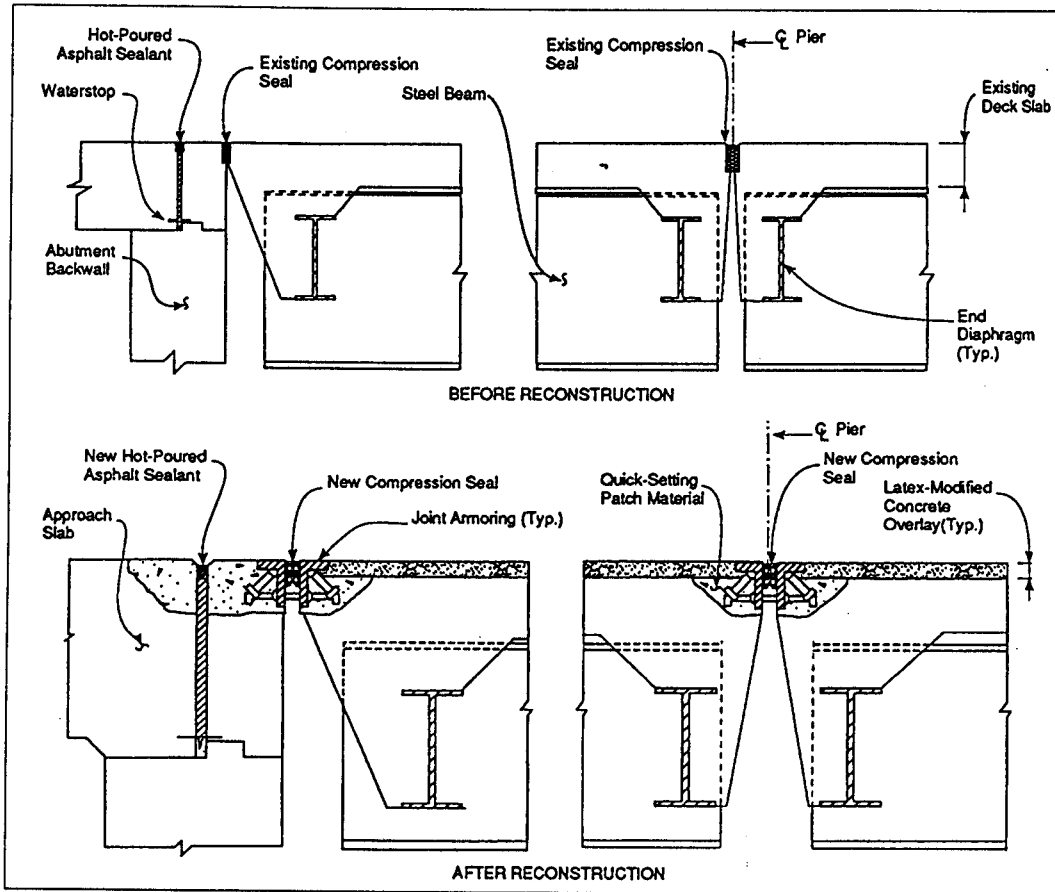
Figure 20 Replacement of compression seals in kind on Cherry Hill and Littleton Road bridge

The bridge is located over route 80 in northern New Jersey's Morris county. All deck joints on this 400 foot long four-span bridge were compression seal joints. After 20 years of service these seals were aged, brittle, and leaking. This was caused by spalling of the deck slab edge and loss of elasticity and debonding of the seal. Joint replacement was performed concurrently with deck rehabilitation and overlay. After removal of the existing compression seals and the surrounding portions of the deck slab, new compression seals with armoring

angles were installed at elevations even with the new deck overlay. The deck slab around the new deck joint was repaired with quick setting patch material before placement of the new deck overlay. (Figure 20)

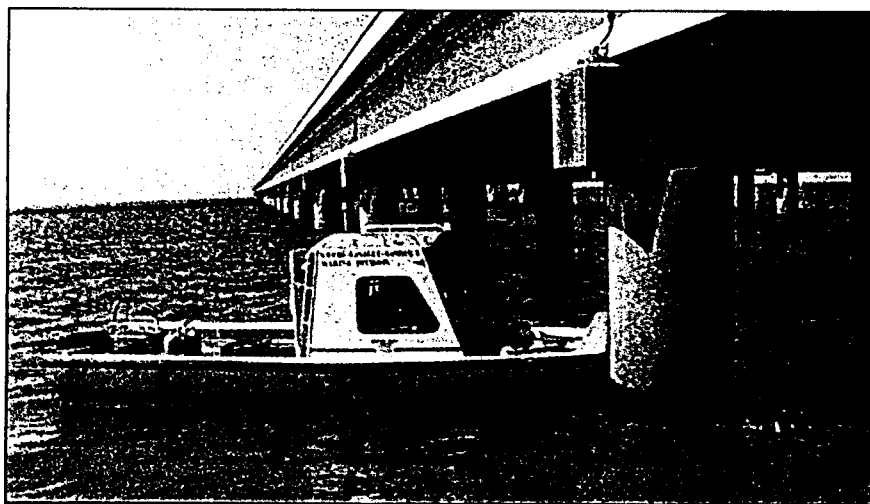
A joint between pile sections in the new bridge occurred a few feet under the water. The divers found numerous vertical cracks starting at this joint and extending downward into the mud. These cracks increased in size so that at the mud line many cracks were more than 1 inch in width. Very few of these cracks extended upward above this joint.

Again, a study of the methods of constructing the two bridges disclosed why, in the inspector's opinion, the newer piling showed more distress. The data collected supported the overdriving theory. A comparison of the driving records of the pilings under the two bridges convinced the inspectors that the problem was caused by driving the pilings to grade on the new bridge, which was less expensive to the contractor than cutting off approximately 1 ft of pile when design refusal was met. The cracking occurred in a number of pilings all across the length of this bridge.

Figure 25 - Pilings of the 24-mi. long bridges crossing Lake Pontchartrain

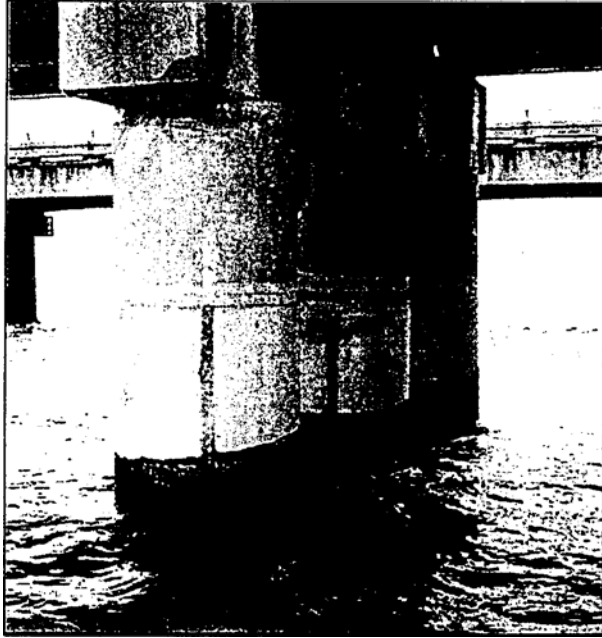
Figure 26 - A trio of A-P-E repairs found to be performing well after 8 years in service

After doing literature search and examining the existing encapsulation systems, the A-P-E process was considered the best available method of protection. A decision was made to encapsulate any pile with three cracks or more and to pressure inject epoxy into those cracks on piles that had two cracks or less.

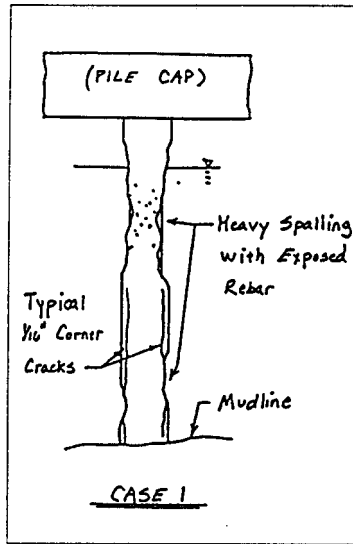
Some older marine structures such as Pier 1 at the Boston street terminal in Baltimore, have become virtual museums of pile jacketing failure. At various points of this structure's history, 299 of the 342 concrete piles supporting the structure were jacketed, using a variety of methods and materials. Following are the different cases from a report of substructure Inspection on Pier 1, that categorizes the various types of pile jacketing deficiencies found during the inspection. The report also examined the remaining 43 piles that had no previous jacketing. Their condition is shown in Figure 27 (case 1).

Figure 27 - No Previous

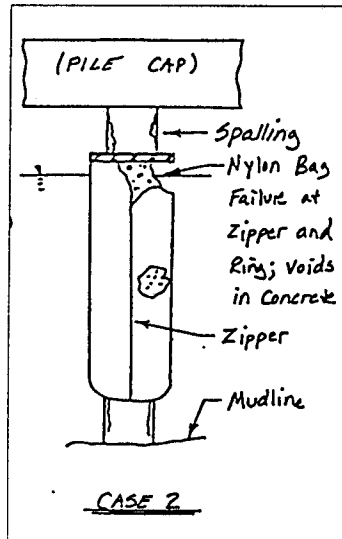
Fig 28 - Nylon Bag

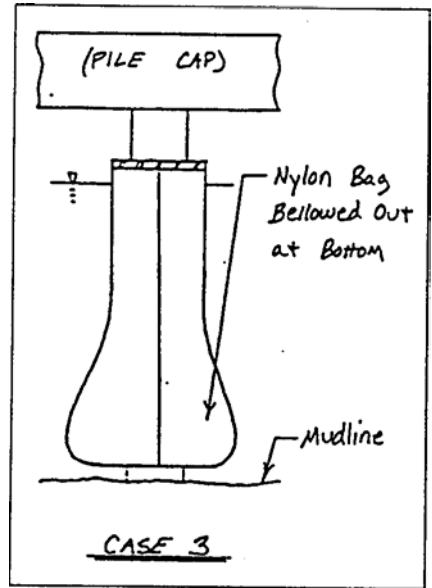
Fig 29 - Nylon Bag Bellowed Out at

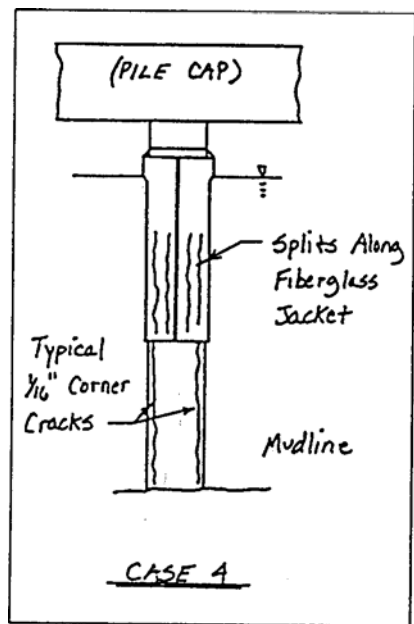
Fig 30 - Fiberglass Failure

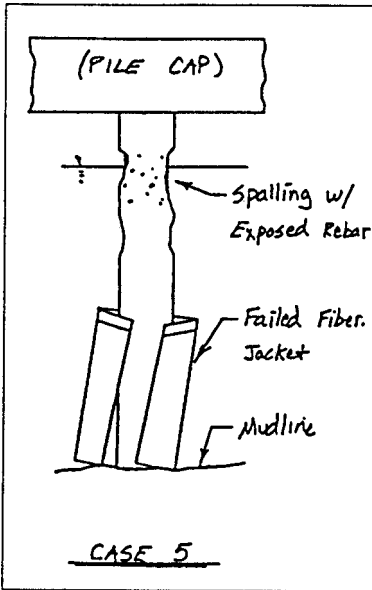
Fig 31 - Failed Fiber Jacket

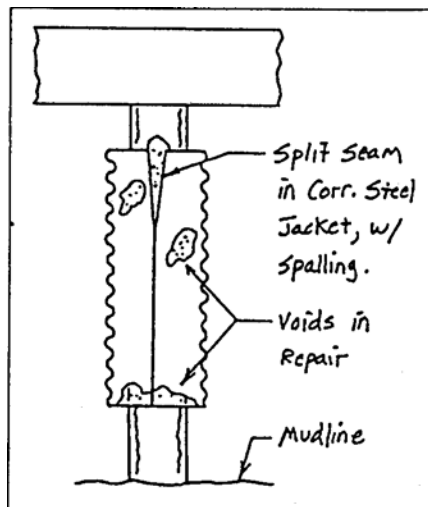
Figure 32 - Split Seam in Steel Jacket

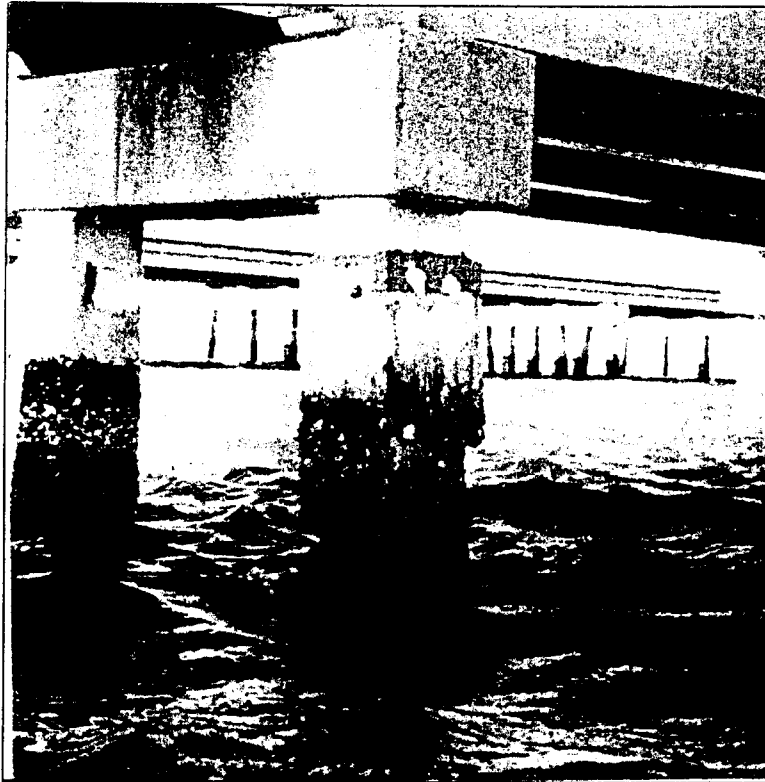
Figure 33 - FRP Jacket Missing

Figure 33 shows that the FRP jacket is completely missing and the cement grout is discontinuous in the splash zone. Lack of bond between the jacket and the grout is the principal cause of jacket failure and the presence of water in the jacket during the placement of the grout is the apparent cause of grout failure. This is typical of installations where the grout is poured into the top of the jacket, causing the grout to fall through water standing in the jacket. The specifications on this project require a 6" thickness of epoxy grout at the top and bottom of the cement grout, which was apparently not done correctly. Because the jacket was opaque, the defect could not be seen at the time of installation. Usually the first visible sign of failure is the jacket disbonding from the encapsulation grout. This sign of failure can be observed in (Figure 34). This lack of bond between the FRP jacket and the grout can be caused by many factors, such as, improper surface preparation of the jacket or marine micro-organisms on the jacket surface, but the most common cause is placement of the grout into the jacket from the top down, with at least some of the grout passing through water. Portland cement based grouts have a much lower bond potential with FRP jackets than polymer based grouts and, when poured through water, have virtually no bond at all. Once bond is broken, wave action quickly overstresses the jacket at the seams or corners and the jacket fails.
