Florida's 2004 Hurricane Season

Structural Impacts on the FDOT System

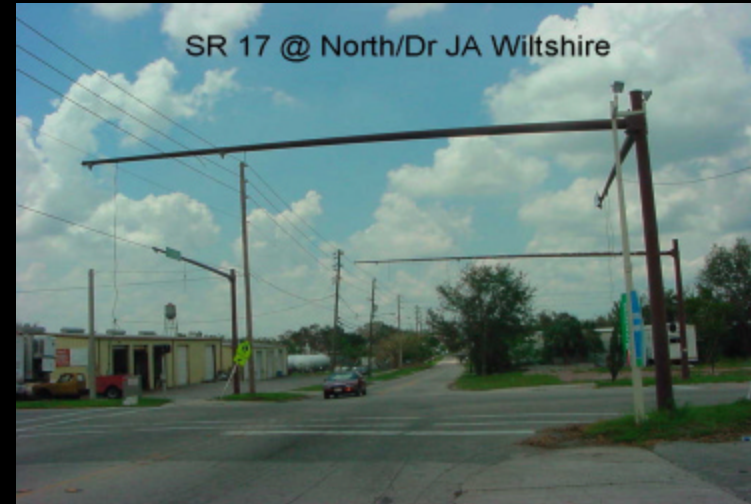
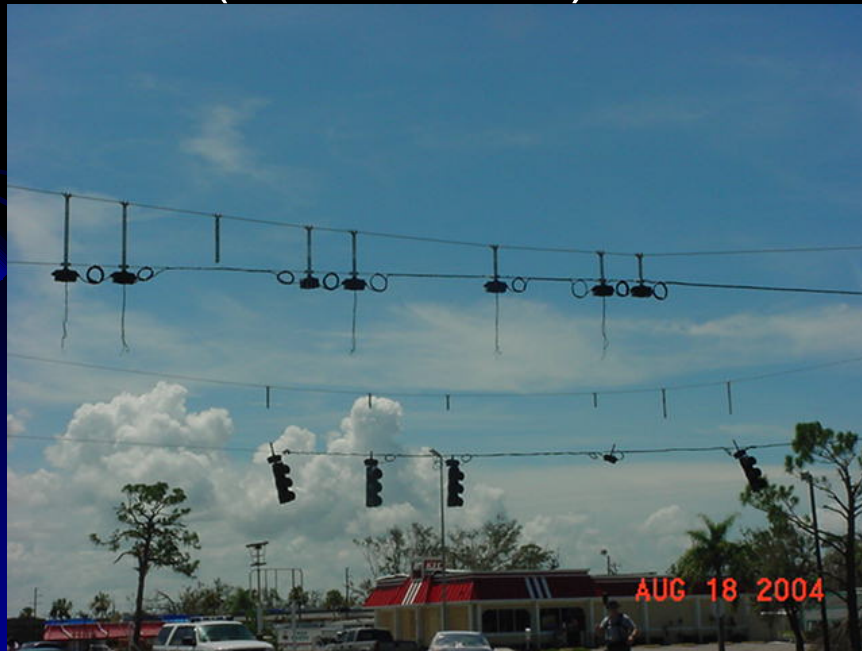
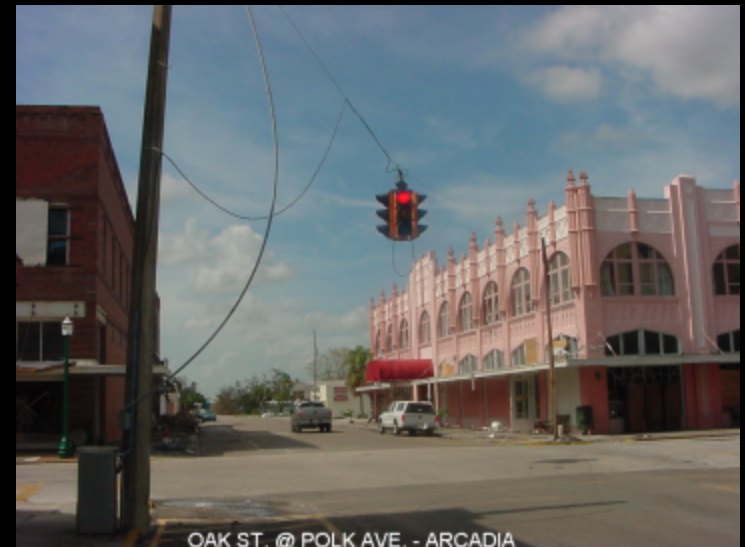
District 1 Traffic Signals & Supports

Considerable Damage to
Traffic Signal Hangers,
Disconnect Boxes, Clamps.

Some Damage to Strain
Wires (connections).

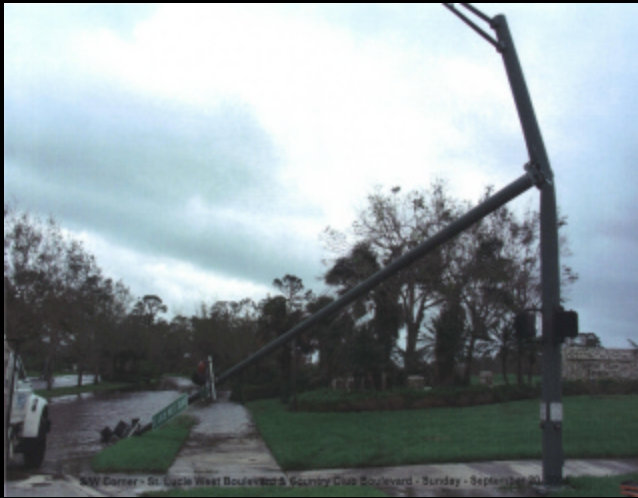
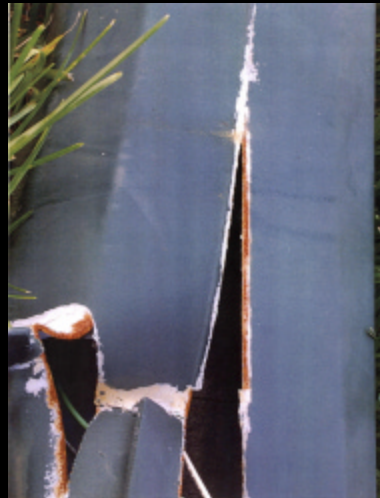
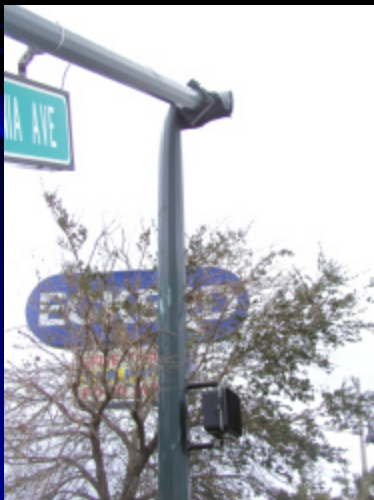
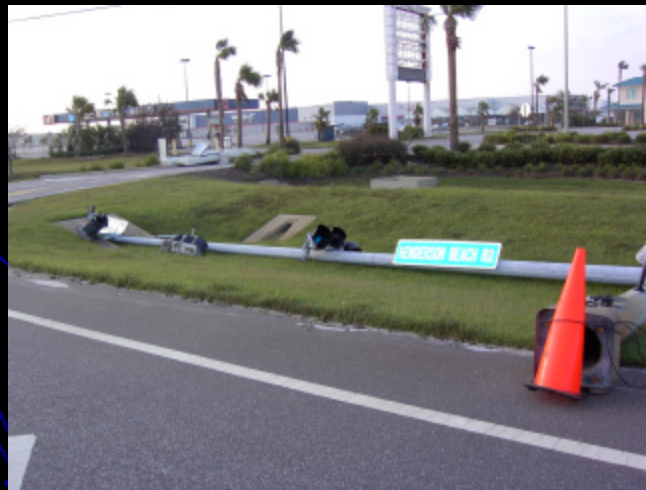
District 4 Mast Arm Failures

14 Failures

- All pre-standard structures.
- 3 base failures
- 4 anchor bolt failures
- 7 pole @ flange failures

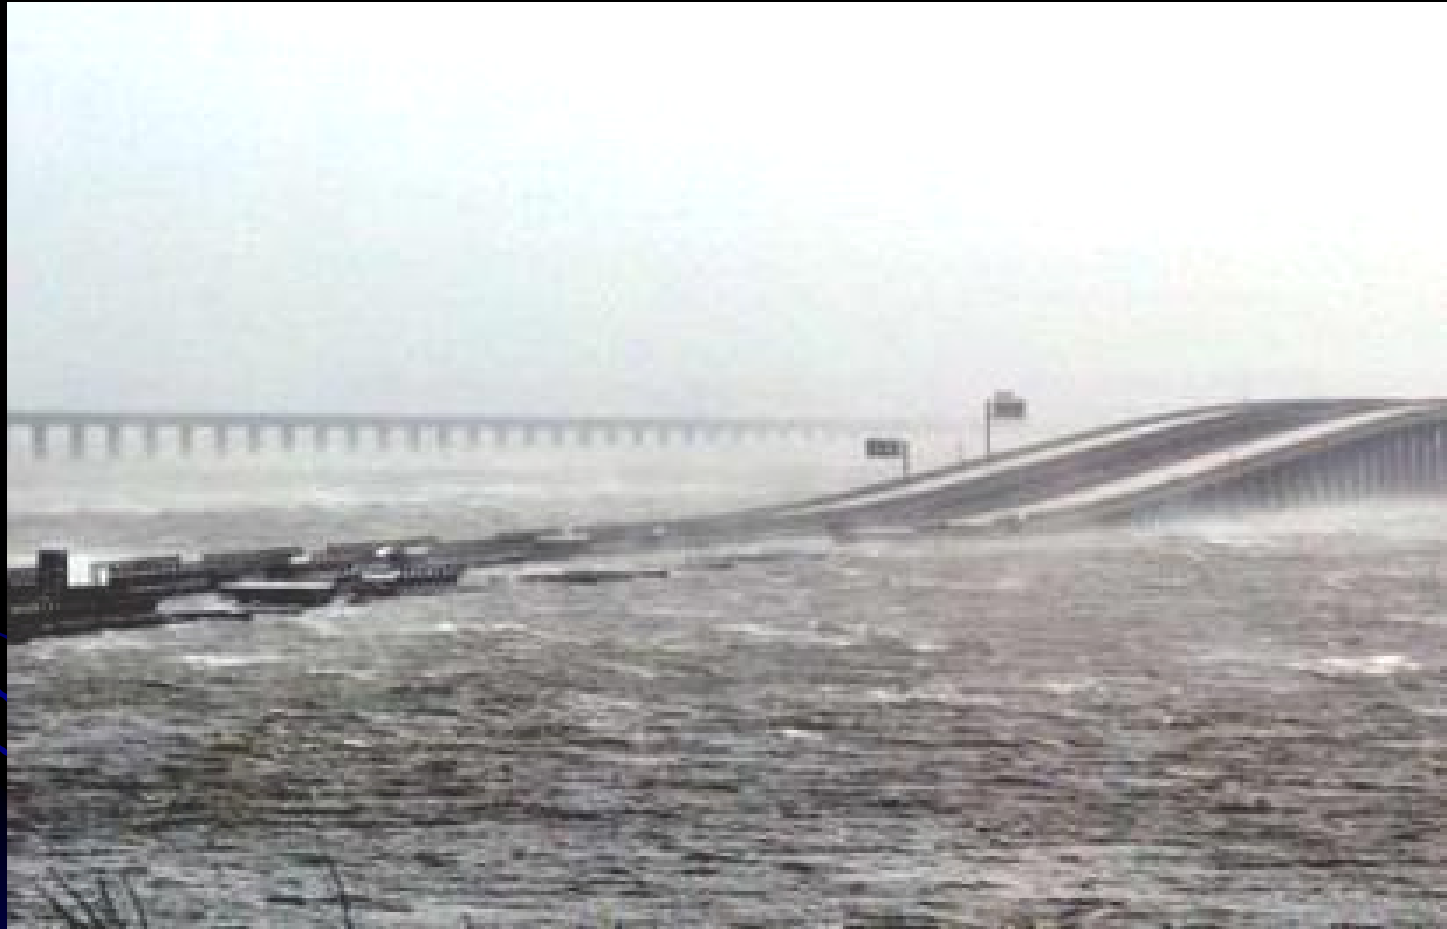
I-10 over Escambia Bay

Escambia Bay on 9/16/2004

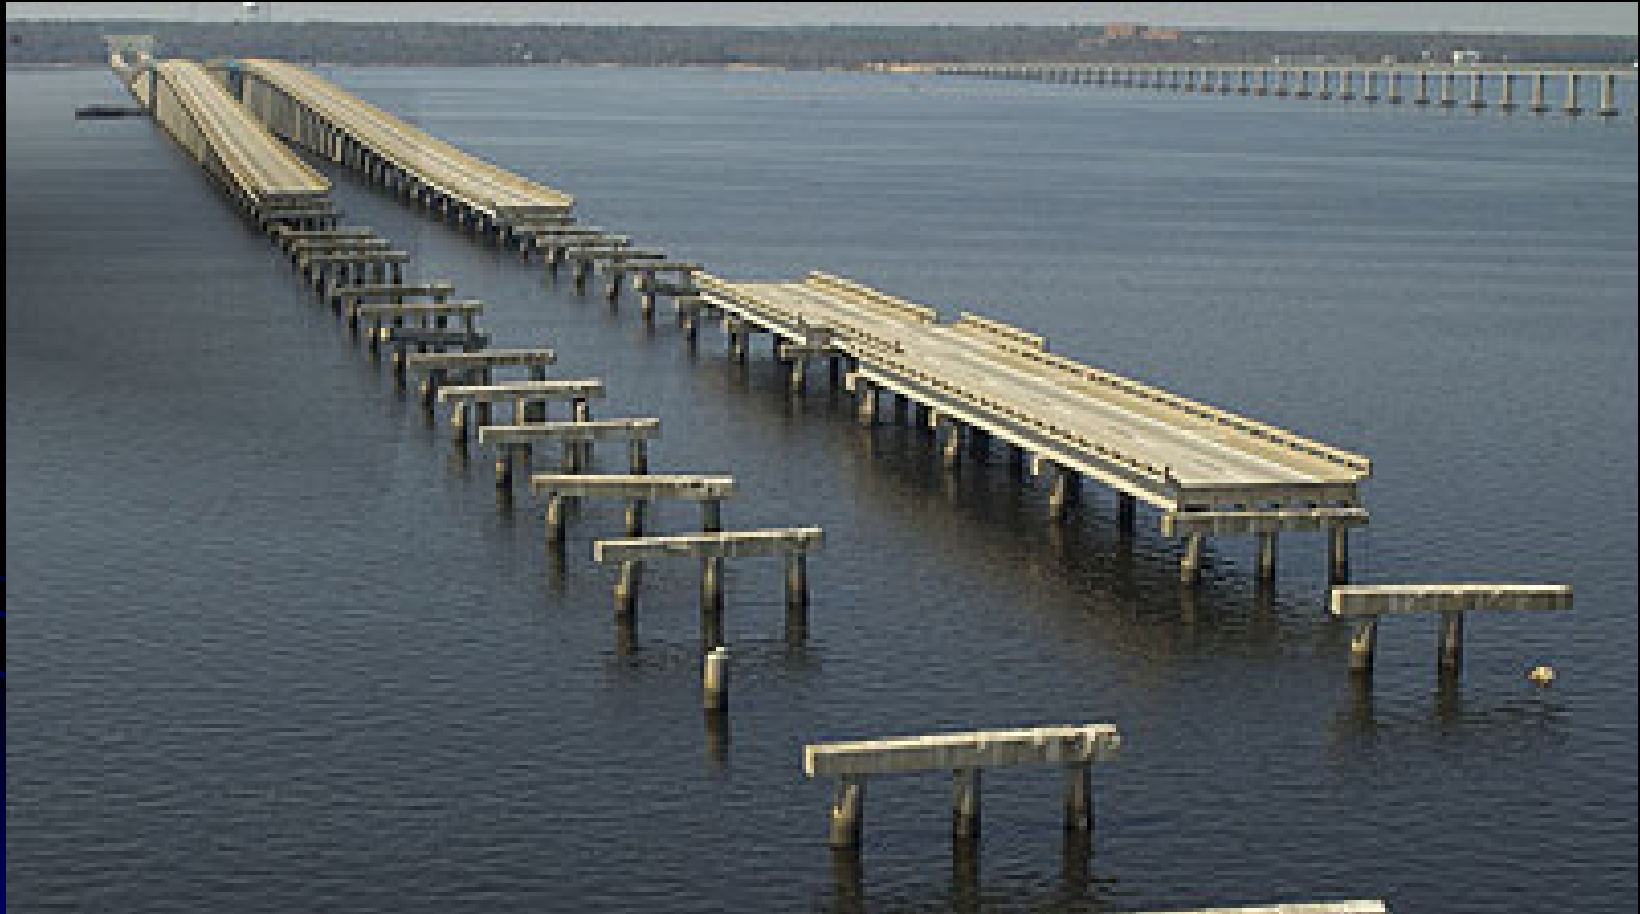
I-10 over Escambia Bay

60' Trestle Spans Missing: 46 EB & 12 WB

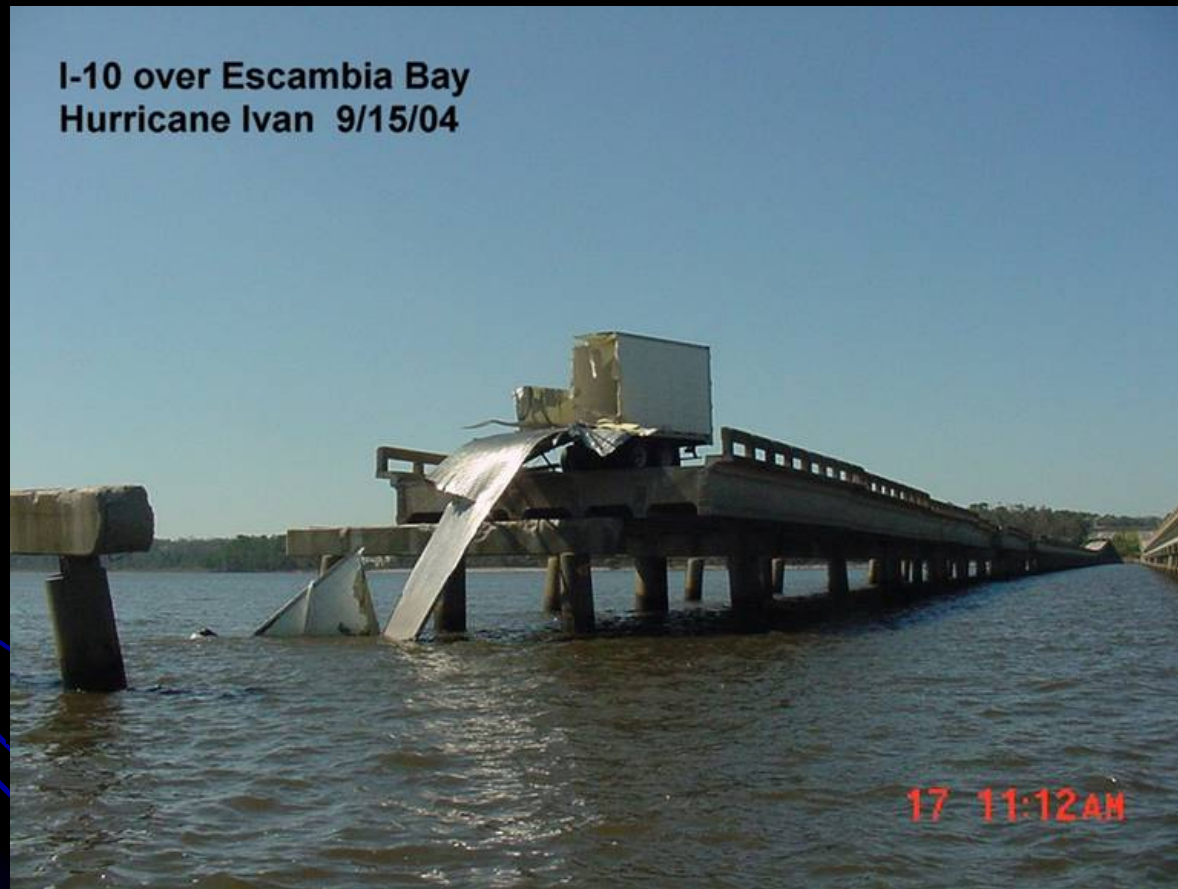
I-10 over Escambia Bay

One Known Fatality

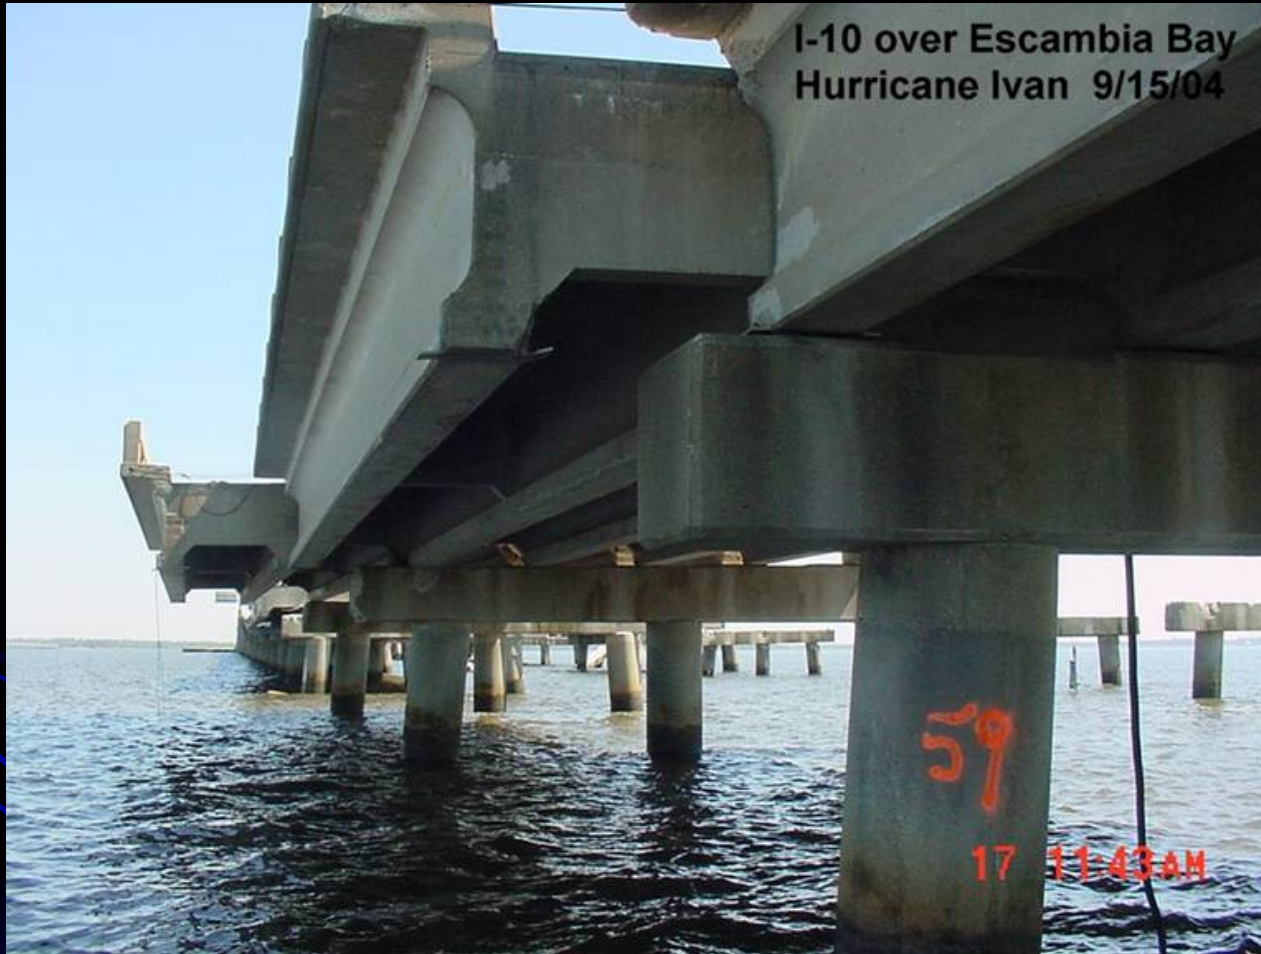
I-10 over Escambia Bay

Misaligned Spans: 50 EB & 16 WB

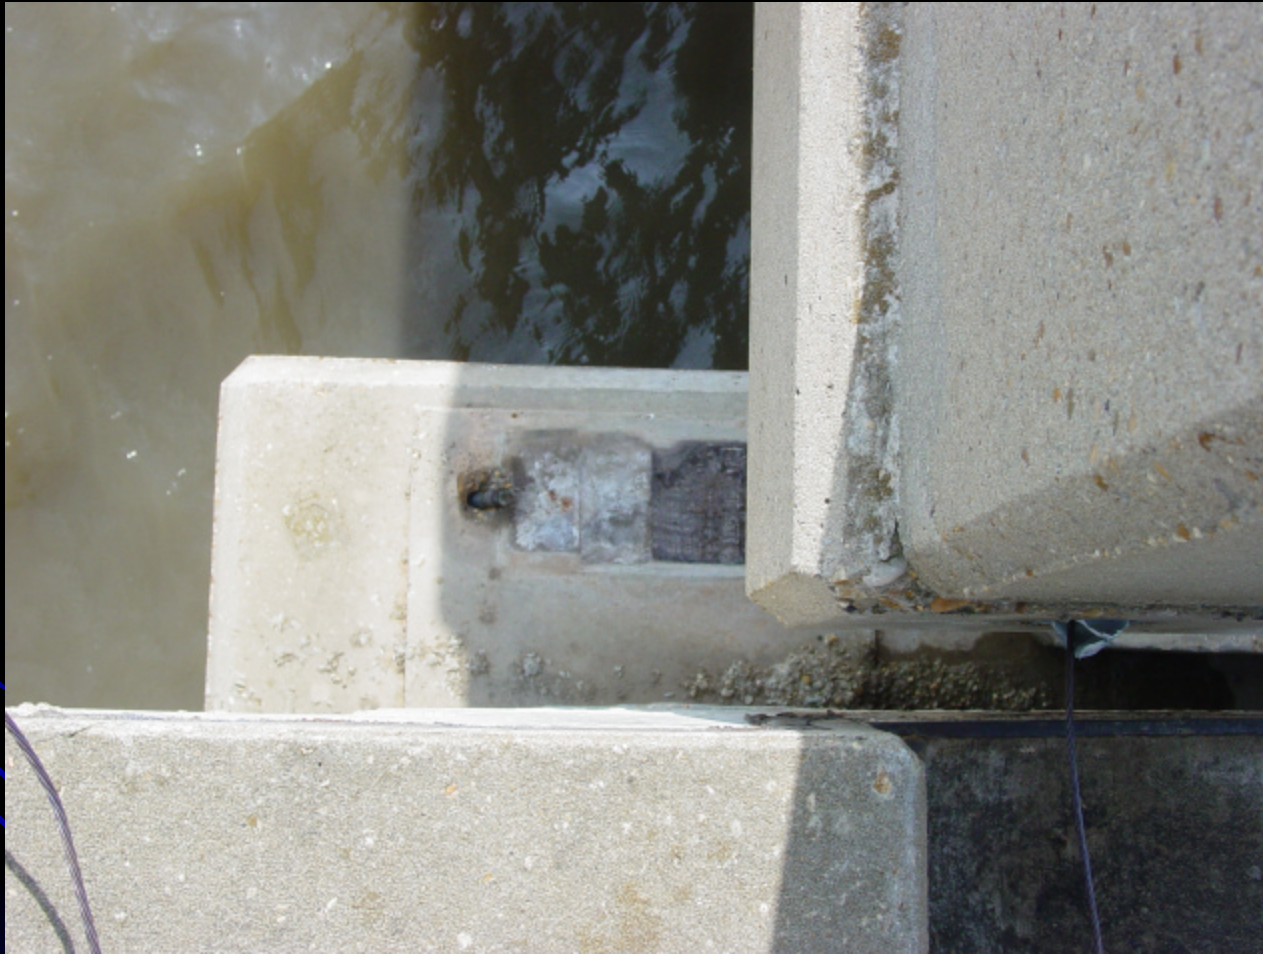
I-10 over Escambia Bay

Hold-Down Bolts Sheared

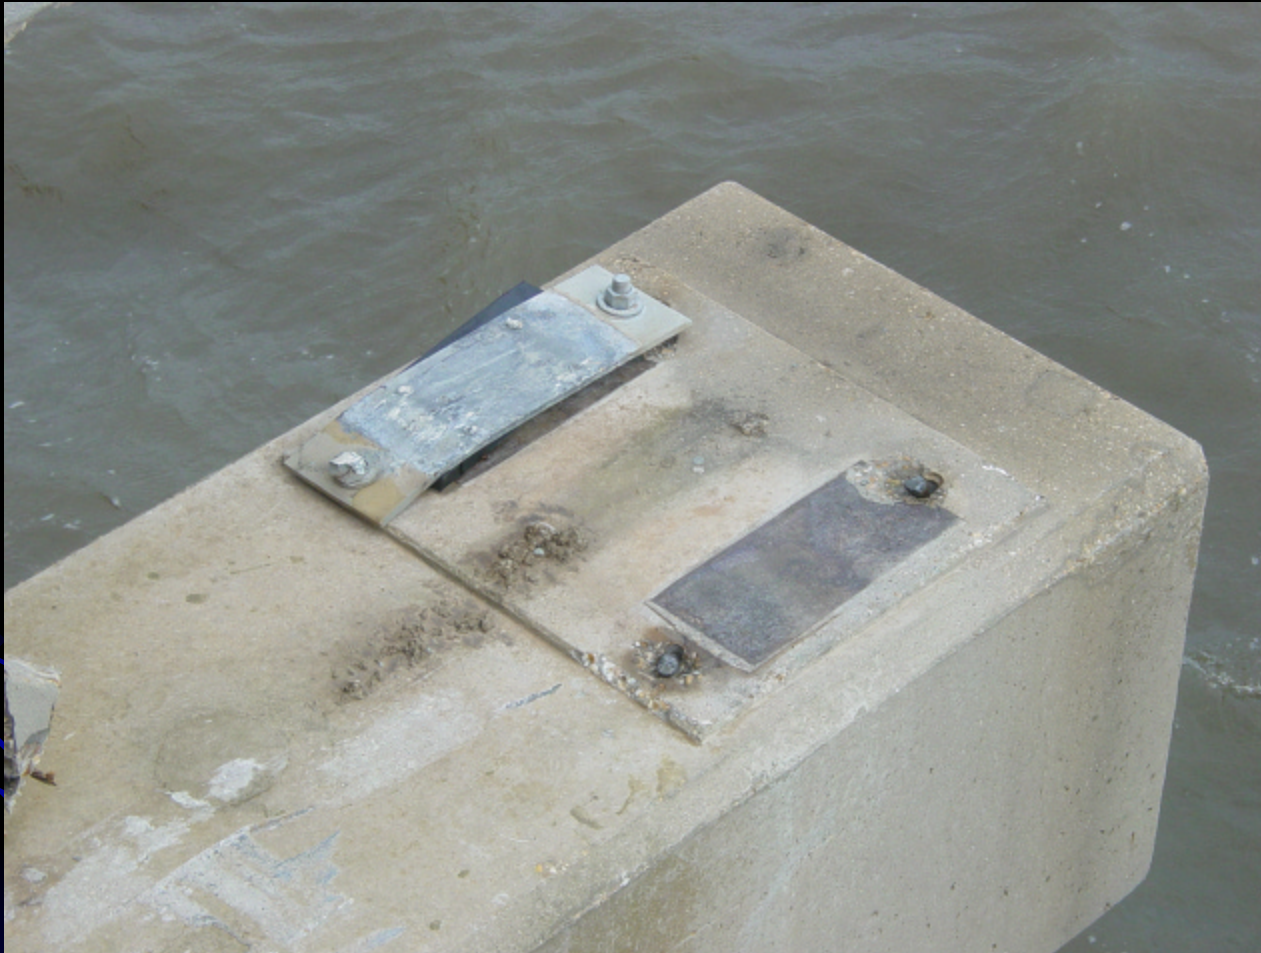
I-10 over Escambia Bay

Hold-Down Bolts & Embedded Studs Sheared

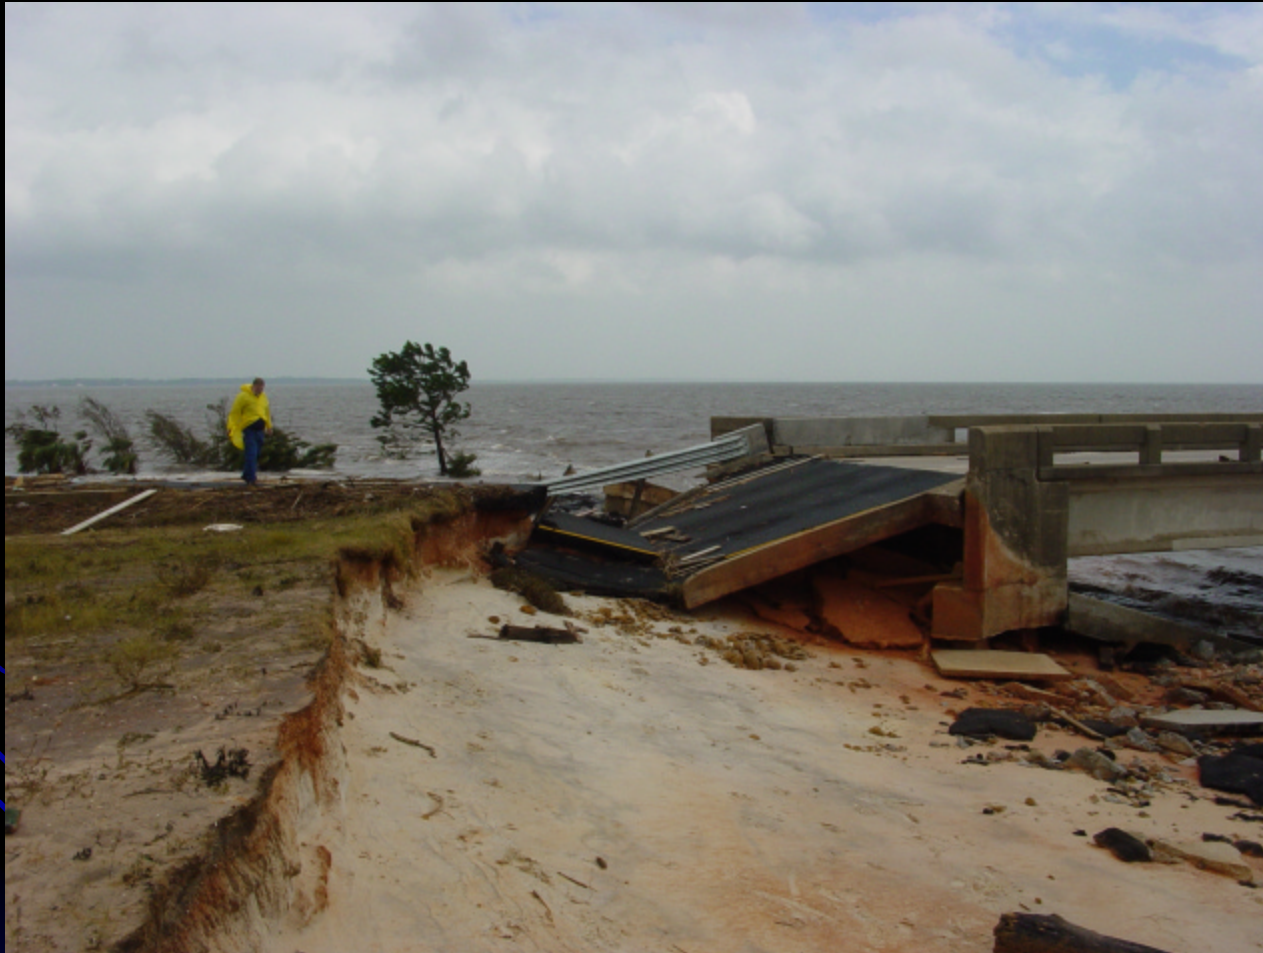
I-10 over Escambia Bay

East Abutment of EB Bridge

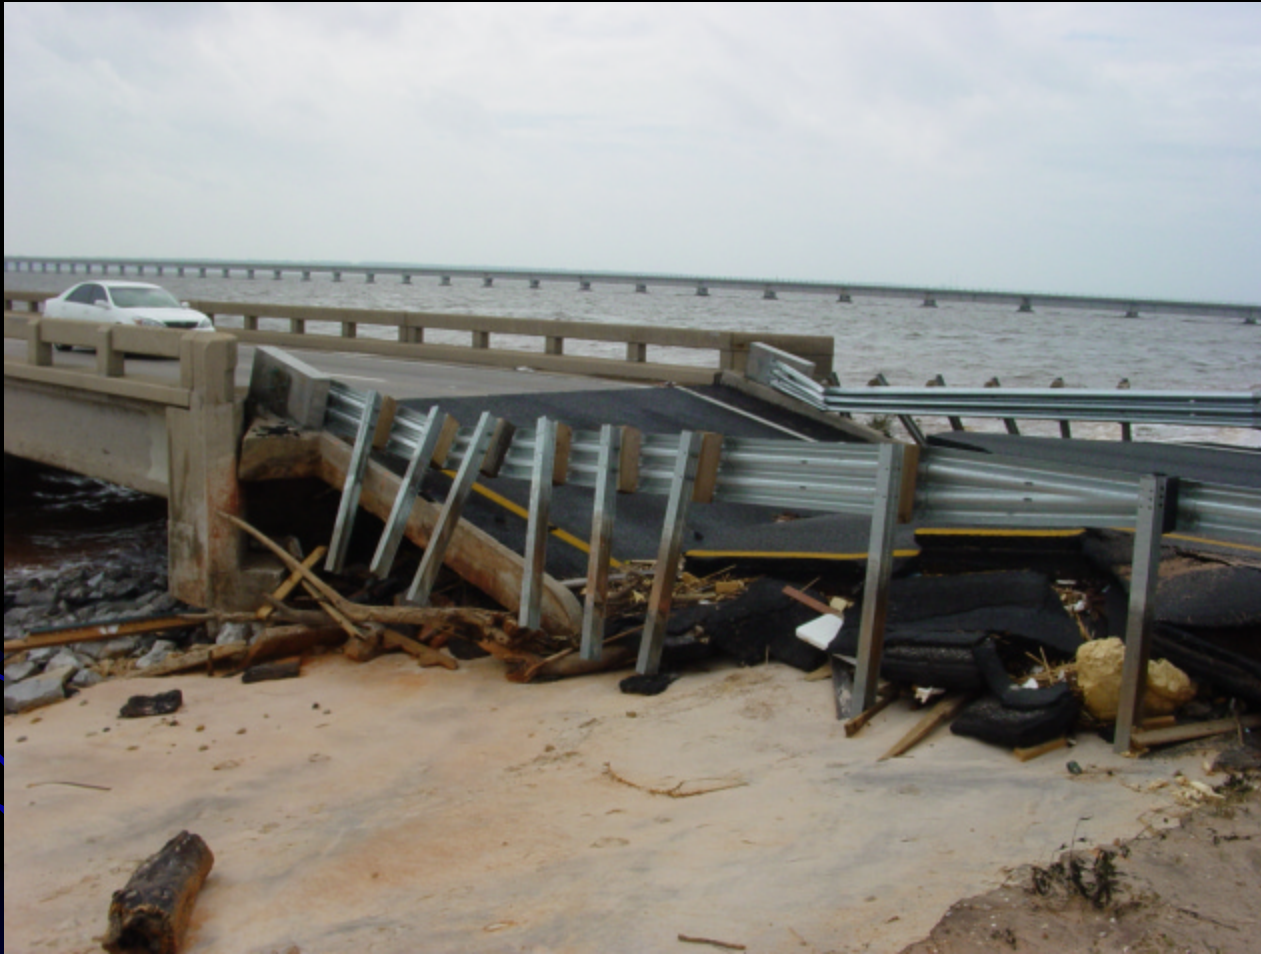
I-10 over Escambia Bay

East Abutment of WB Bridge

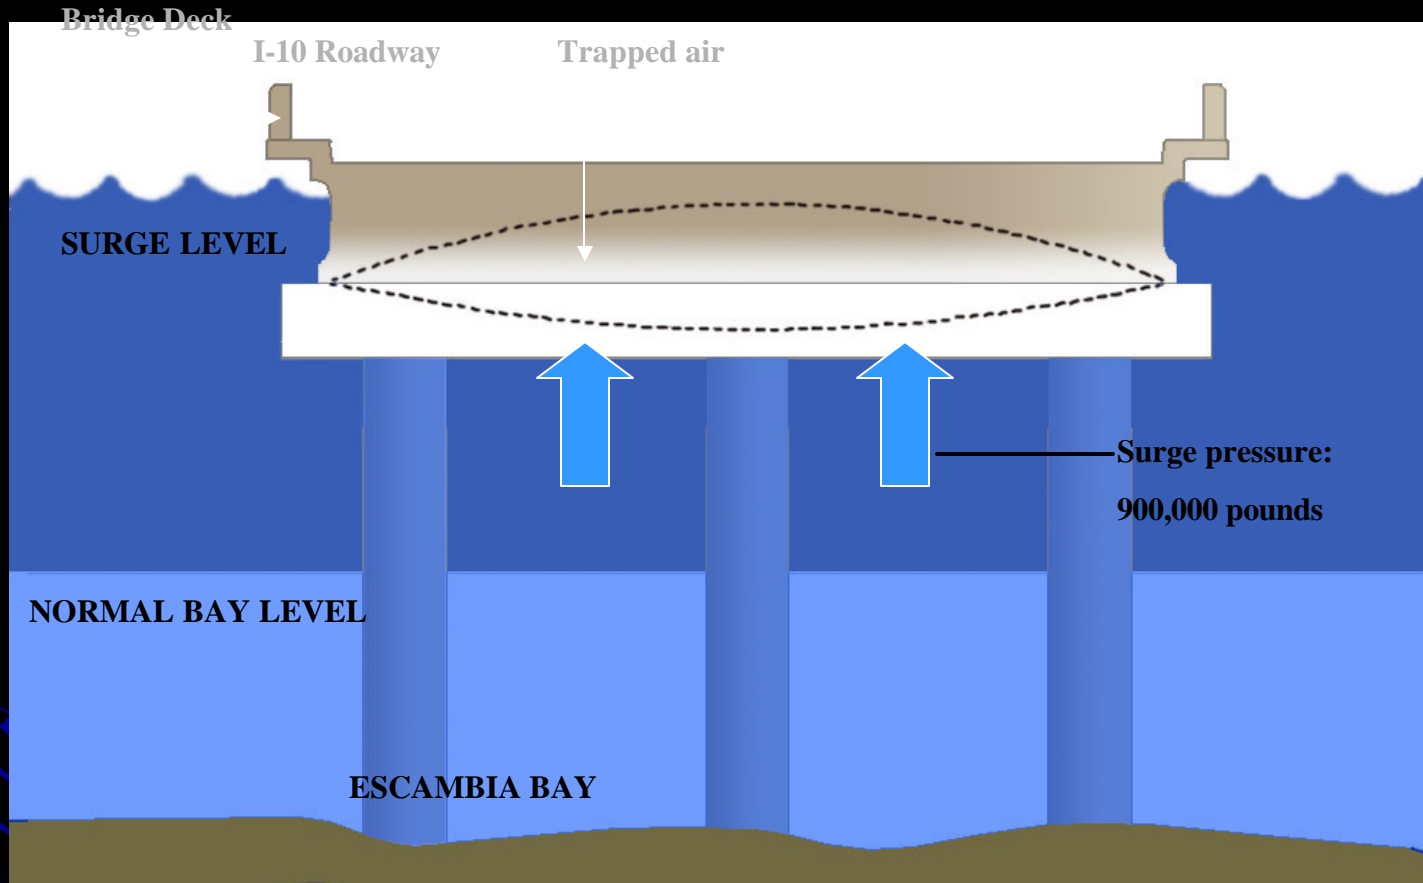
WATER HAMMER

1. The Lifting

Storm surge rose to 14 to 16 feet above sea level beneath the bridge decks, where beams captured air beneath them, increasing the upward force to 900,000 pounds.

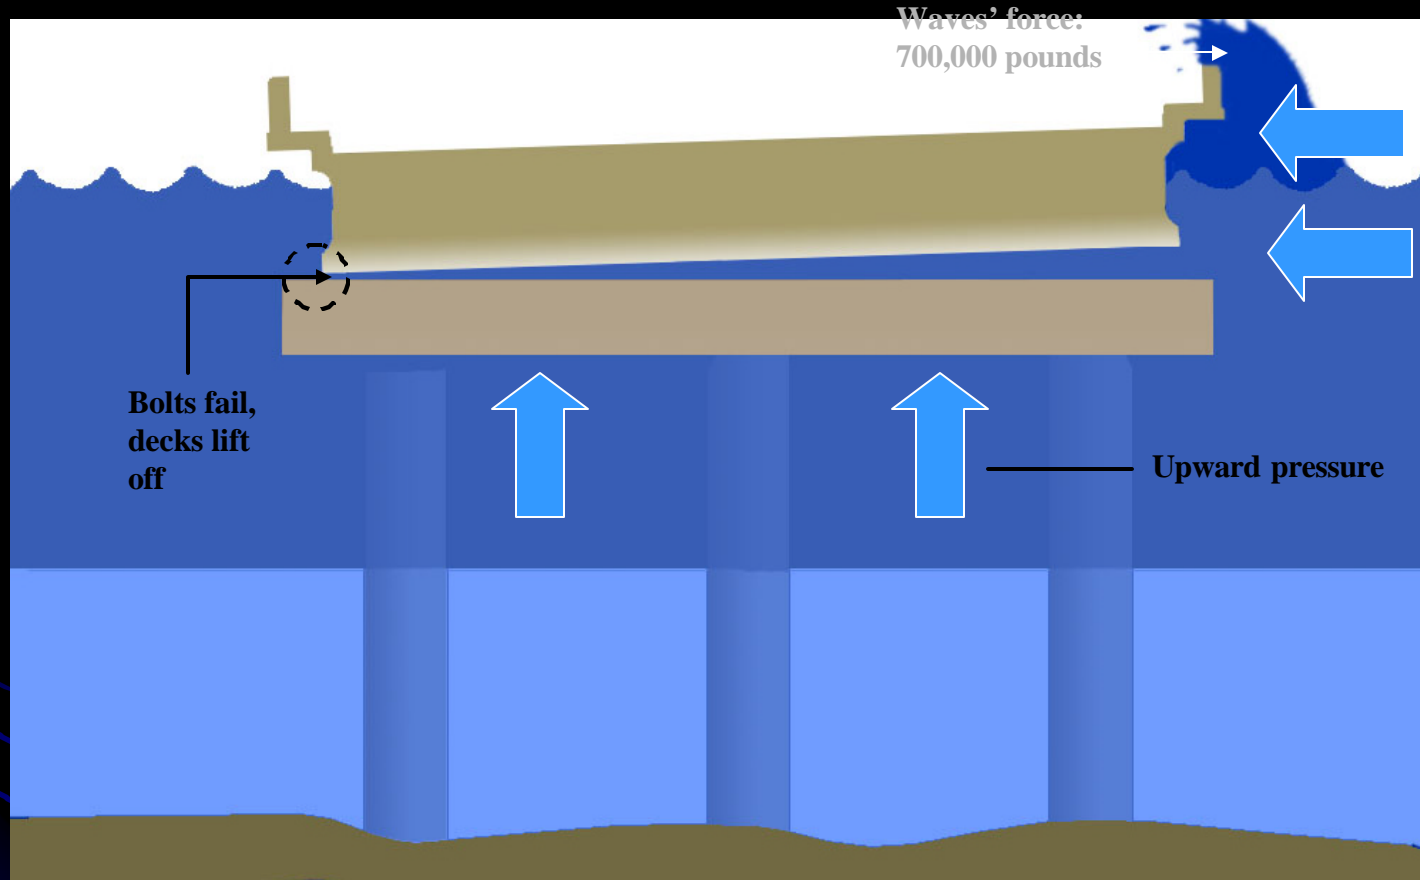
WATER HAMMER

2. The Pounding

At the same time, waves of 13 feet atop the surge hit the sides of the bridge decks with 700,000 pounds of force every 6.5 seconds at the height of the storm.

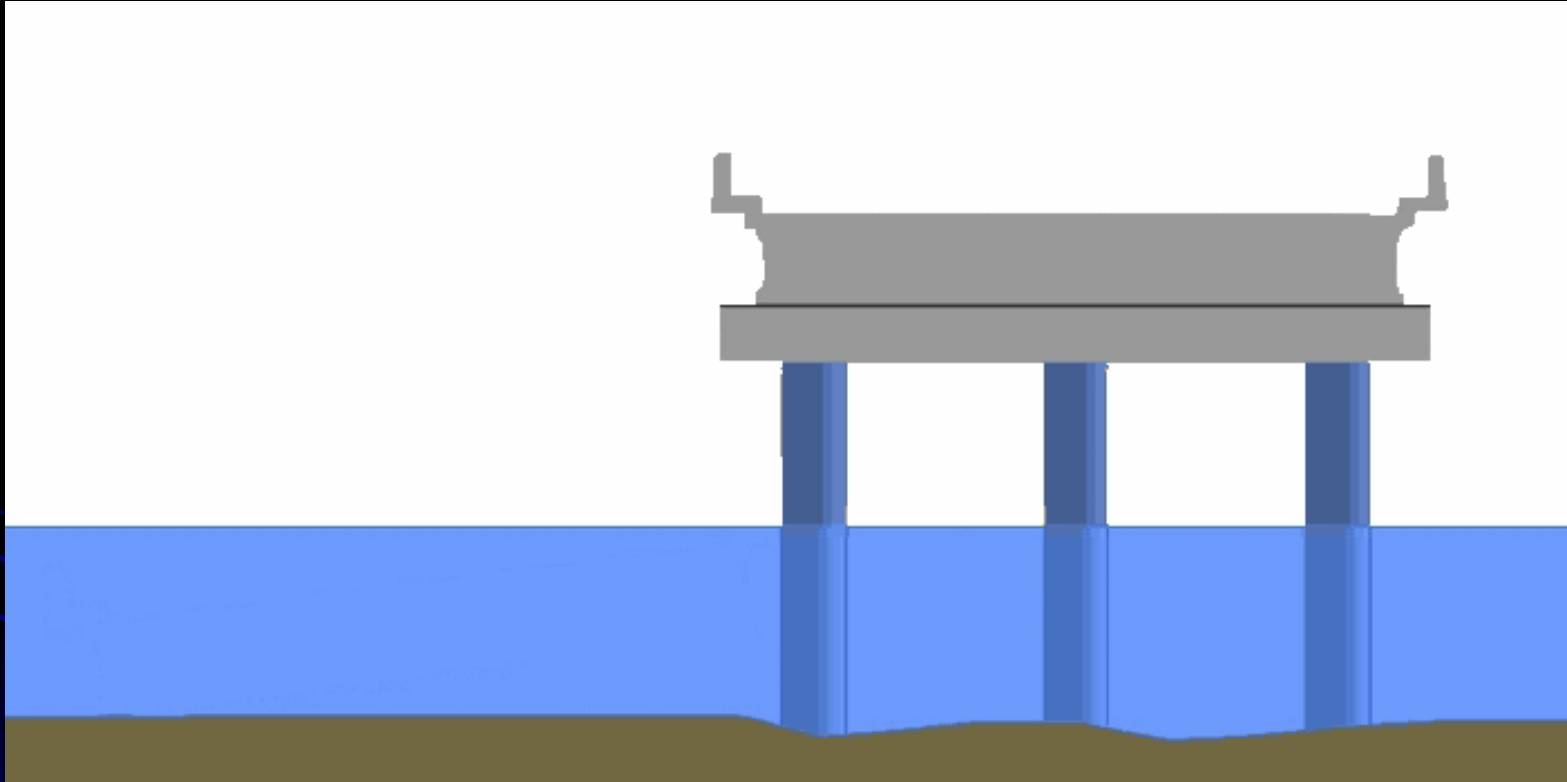
WATER HAMMER

Some sections of
roadway slide over

3. The Breaking

The water's lifting and pounding broke the connections between 150-foot-deep pilings and piers supporting the bridge decks, allowing the decks to slide sideways or fall into the water.

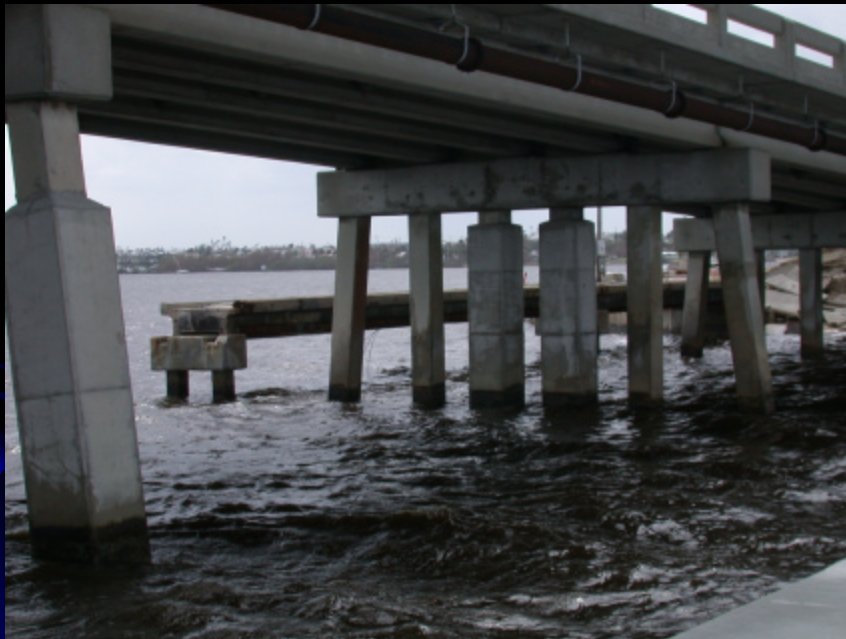
Hurricane Jeanne

Existing fishing pier – lost X spans

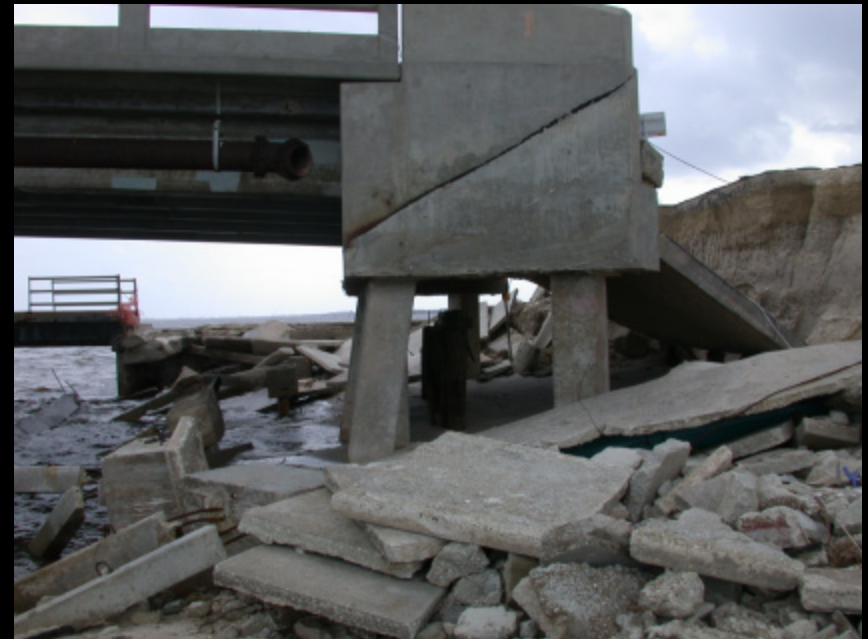
Hurricane Jeanne

Existing bridge closed for good –
New bridge to open in 3 weeks

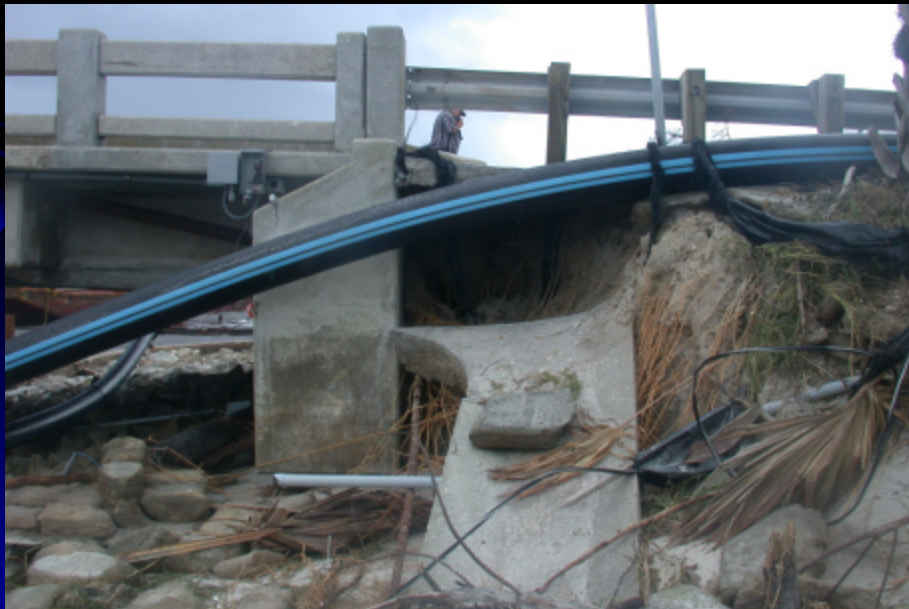
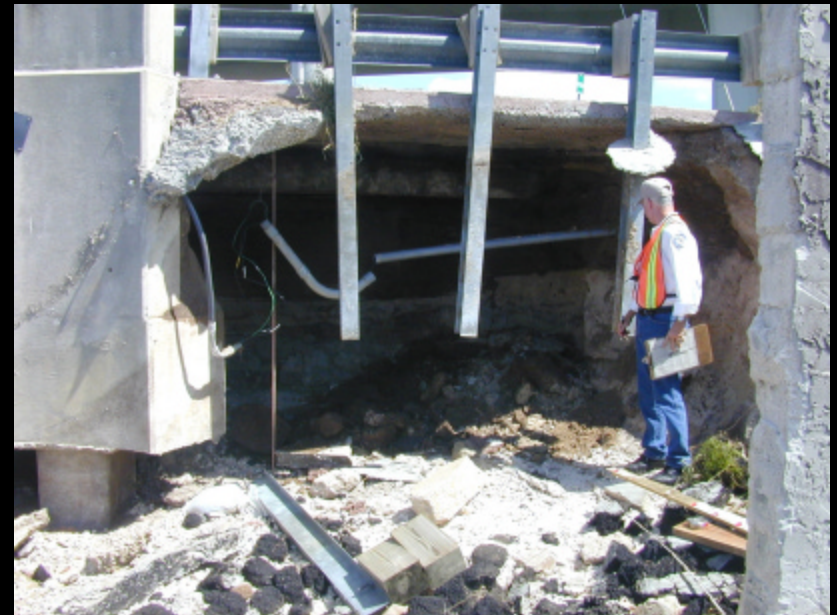
Other Bridges

Typical Slope failures around end bents at three bridges

E. Lyons Bridge
Lake Worth Bridge
Roosevelt Bascule Bridge

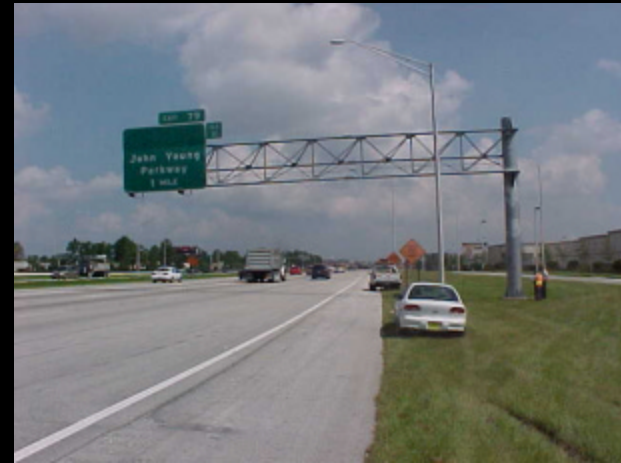
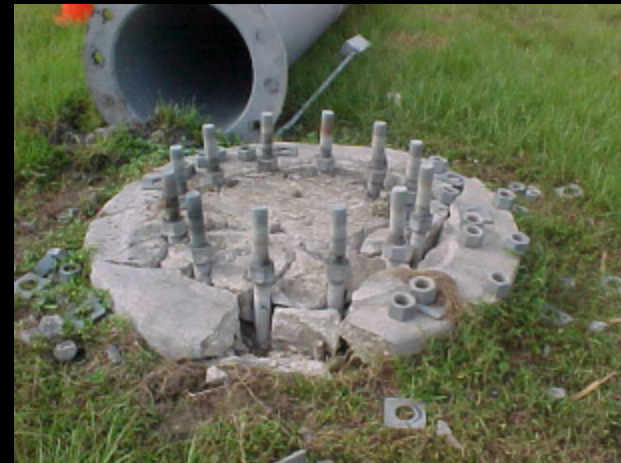
I-4 Cantilever Sign Structure

- Hurricane Jeanne
- Location I-4 near John Young Parkway
- Rush Hour 3:00 pm
- Damage to foundation identified by inspector and structure removed

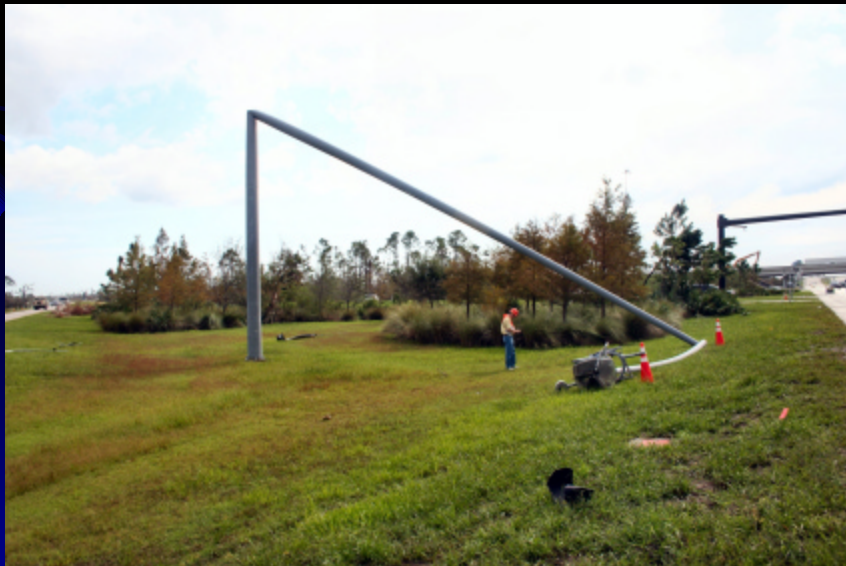
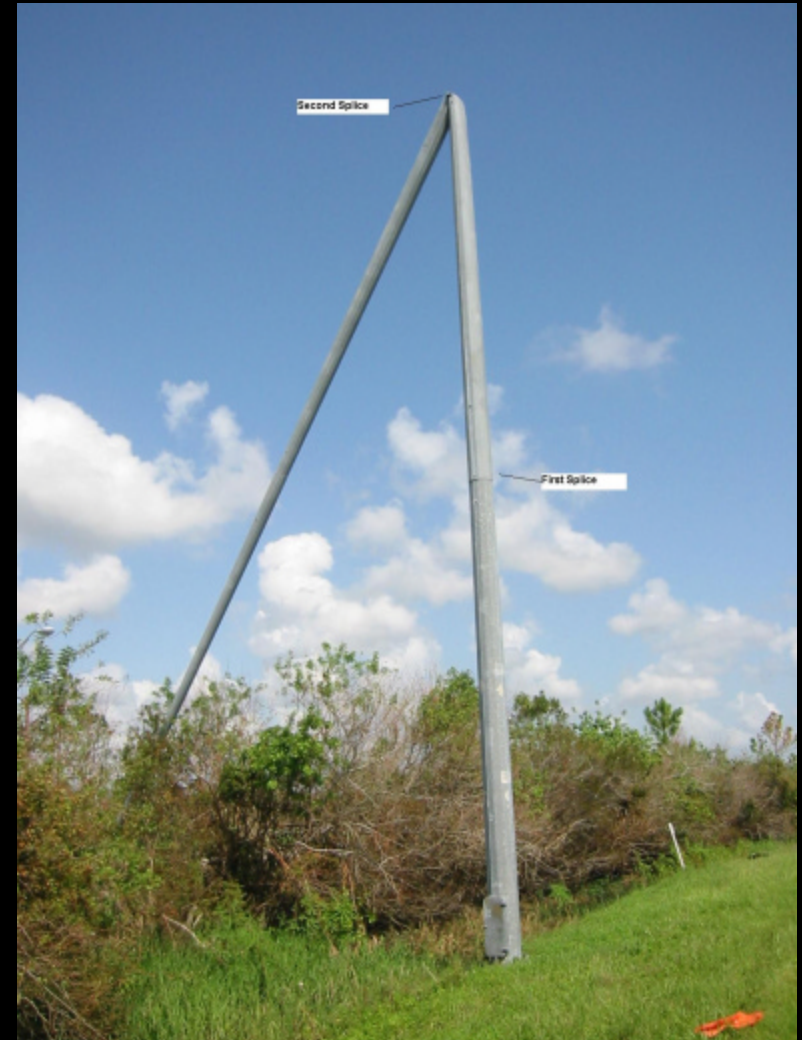
I-75 High Mast Lighting

19 High Mast Lights Failed in District 1

2 High Mast Lights Failed in District 4

Following Charley, Policy Issued to
Lower Lights when Category 2 or
Higher Threaten.

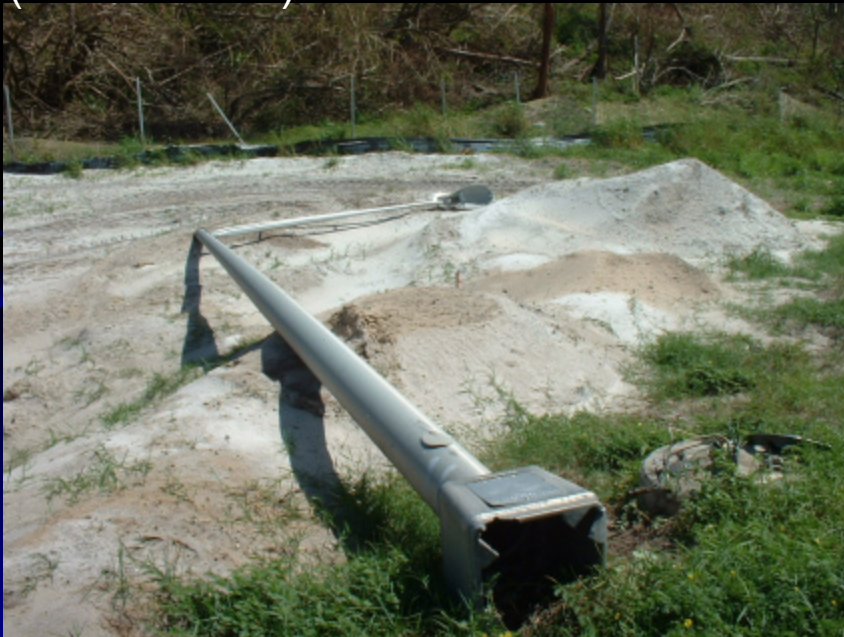
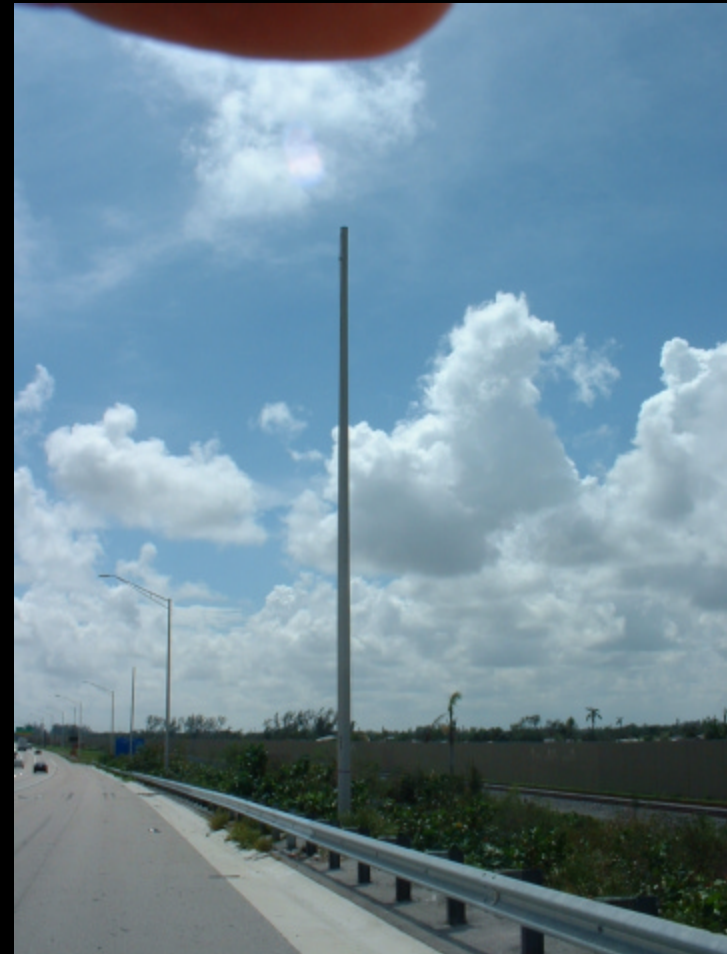
Lighting Structures

164 of 1,559 (10%) Poles Damaged
on 4 District 4 Projects.

Damage: Frangible aluminum bases,
support arms, light fixtures
(connections).

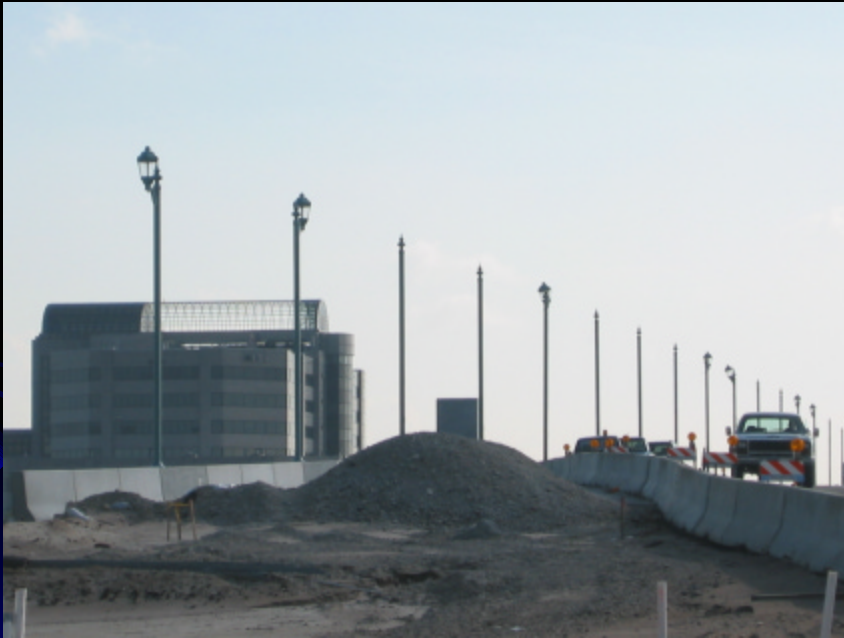
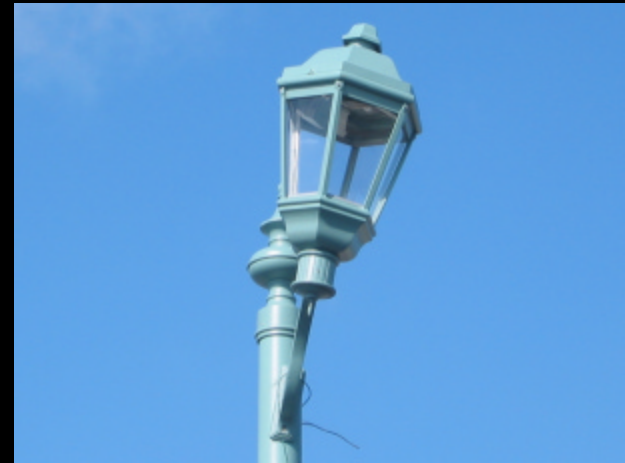
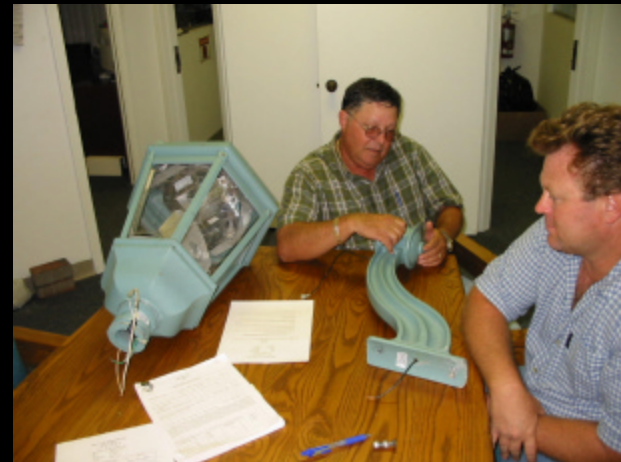
PGA – West Palm Beach

55 failures out of 186 lights
