# FLORIDA DEPARTMENT OF TRANSPORTATION ENGINEERING / CADD SYSTEMS OFFICE KNOWLEDGE BASE ARTICLE

## Topic: GEOPAK Multi-Line Report Utility “System fault: 5” Resolution

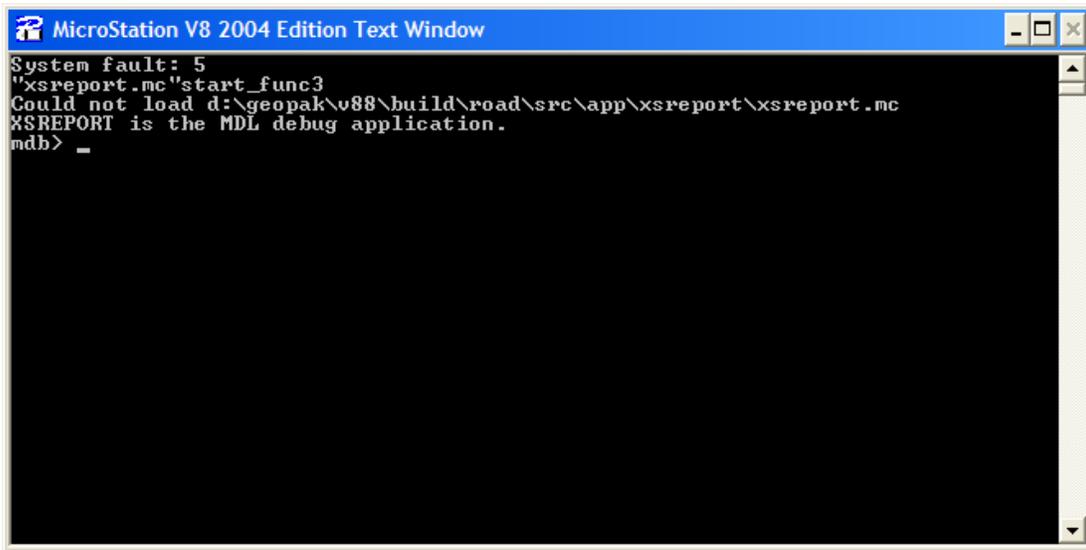
A *System fault: 5* error (shown below) has been encountered by multiple users in native V7 and upgraded V8 design files meeting the FDOT 2002 standards.

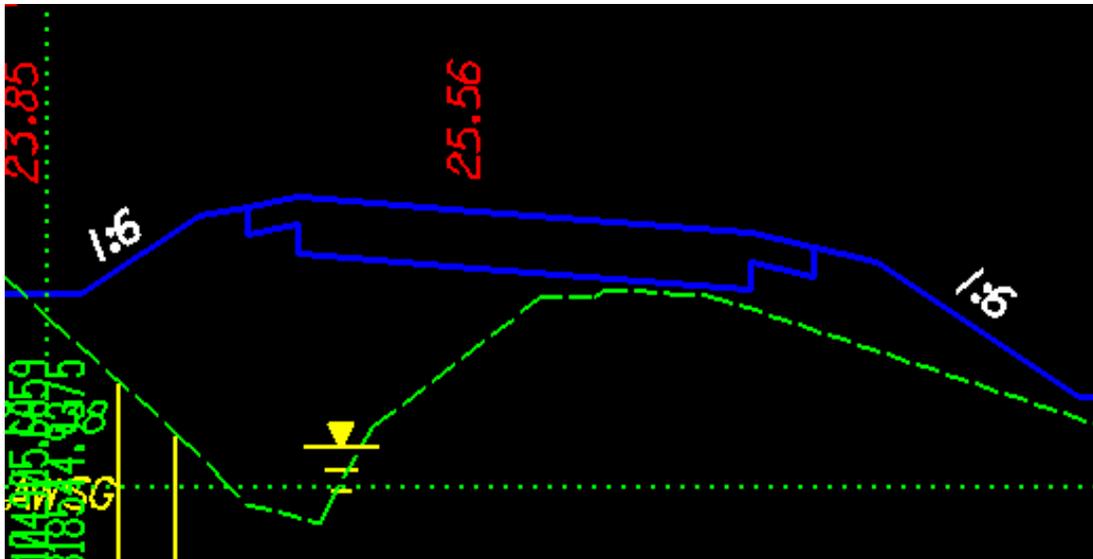
This error is caused when the top and bottom elements have the same symbology (Level 41, Color 2, Weight 2, Style 0) as shown in the following figure and the Multi-Line Report utility is not sure which one to use. The utility tries to use the top, but since the bottom is being specified, it gets stuck and produces the *System fault: 5* error.
