Durability of Epoxy Bond

January 1996

A Report on a Research Project Sponsored by  
the Florida Department of Transportation

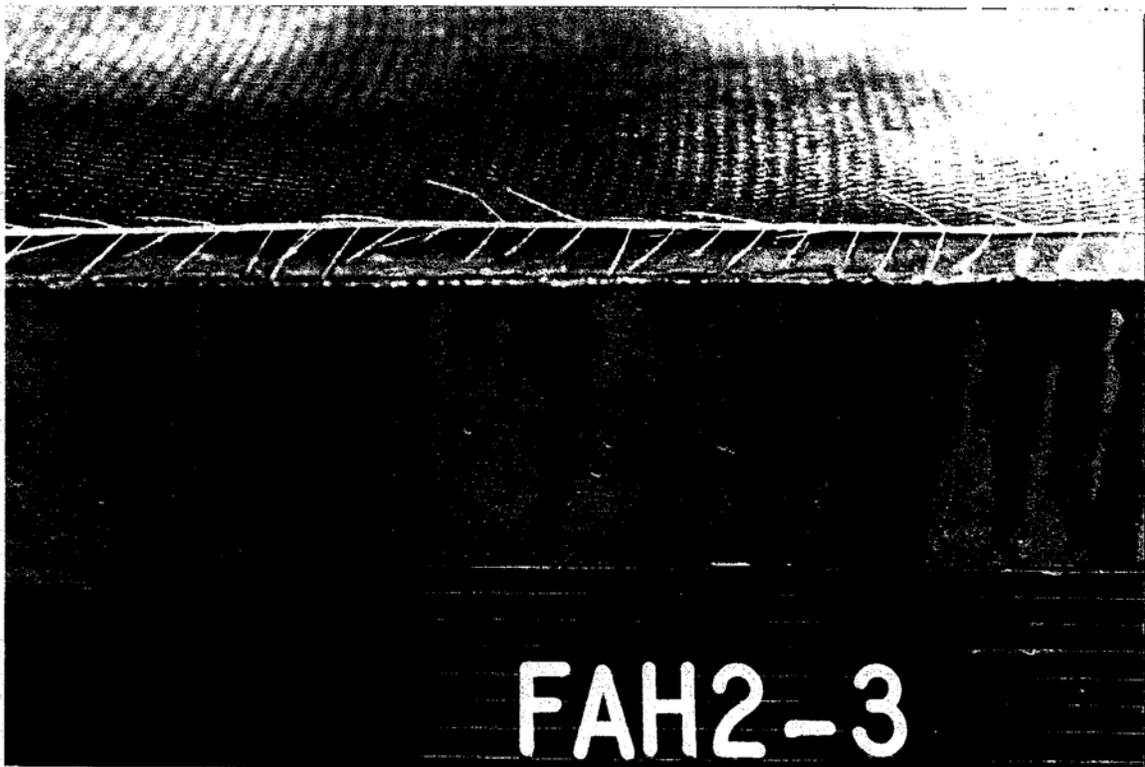
Only one specimen, FA2-3 exposed to thermal and tidal cycling showed some minor evidence of debonding. A blister formed in this specimen after approximately 6.5 weeks of exposure but subsequently stabilized to a size of about 2 in. x 0.4 in. Two other specimens, FAH2-3 and FAHP2-1 that were initially blemished, showed some increase in the de-bonded area. Plates 5-8 compare the state of the bond before and after exposure for specimens FA2-3 and FAH2-3. For the former, the debonded area is in the middle of the slab and cannot be seen. It can, however, be detected by tapping the region.

**Plate 5.** Defective Specimen in Bond Tank (as-received).

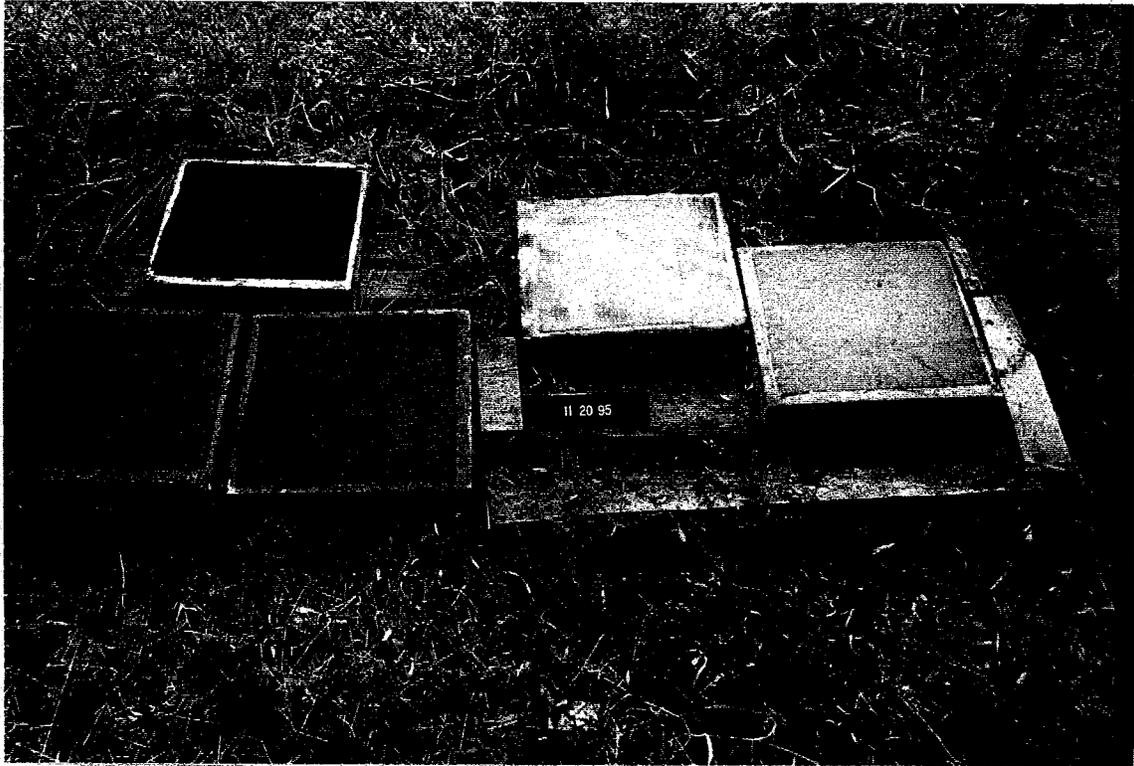
For specimens exposed outdoors, there was no deterioration of the bond between epoxy and concrete. However, there was discoloration of the carbon fiber material in two specimens - MP2-4 and T2-1 (see Plates 11 and 12).

**Plate 12. Discoloration of Outdoor Specimens.**
