# An Evaluation of the LightGuard™ Pedestrian Crosswalk Warning System

**Herman Huang, Ronald Hughes, and Charles Zegeer**  
**University of North Carolina at Chapel Hill**  
**Highway Safety Research Center**

*Florida Department of Transportation*  
*Safety Office*

June 1999

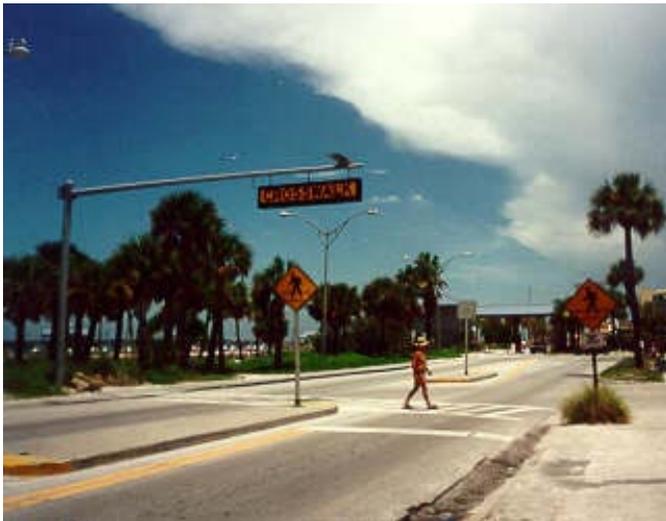
**Figure 1.** Internally illuminated overhead sign in Clearwater, Florida.

To enhance visibility at midblock crosswalks, cities may use high-visibility (continental) crosswalk markings, or they may install supplementary signs and devices. For example, Clearwater, Florida uses an internally-illuminated overhead sign (Figure 1). Portland, Oregon, and several cities in New York State are experimenting with a “YIELD TO PEDESTRIANS” sign that is mounted on a traffic cone placed at the crosswalk, on the centerline of the roadway (Figure 2).

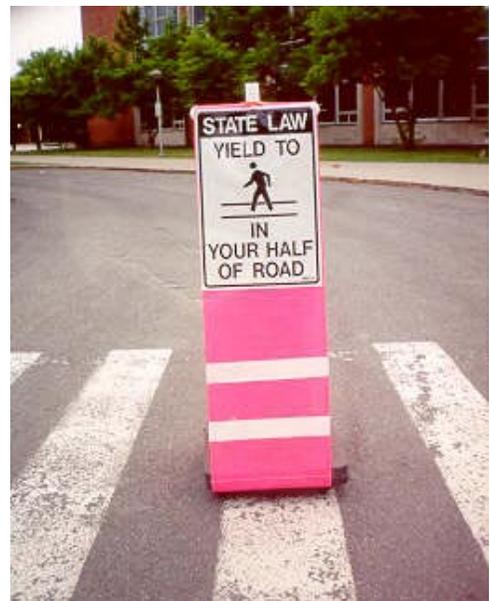
**Figure 2.** Sign used in New York State.

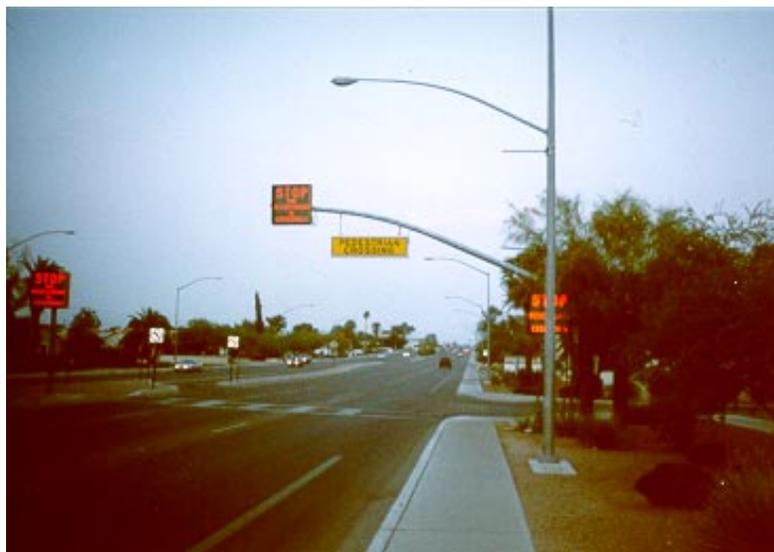
**Figure 3.** Pedestrian-activated overhead sign in Tucson, Arizona

Tucson, Arizona, has several pedestrian-activated overhead LED signs (STOP FOR PEDESTRIANS IN CROSSWALK) (Figure 3).

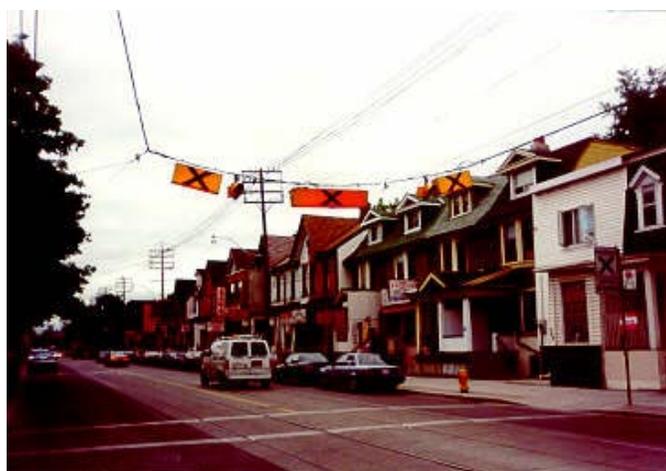
**Figure 4.** Toronto, Ontario, Canada has hundreds of internally-illuminated overhead signs and beacons that flash when activated.

Toronto, Ontario, Canada has hundreds of internally-illuminated overhead signs and beacons that flash when activated, as illustrated in Figure 4.

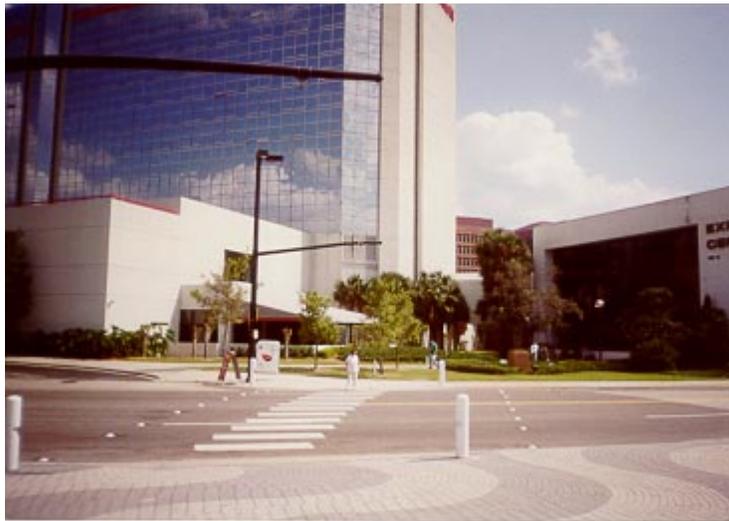
**Figure 6.** Photograph of flashing crosswalk, looking south toward the Marriott Hotel and the Expo Centre.

During the Spring of 1997, the City of Orlando installed a prototype LightGuard™ Pedestrian Crosswalk Warning System on Livingston Street, just west of downtown Orlando (Figure 5). The “flashing crosswalk,” as it is referred to throughout this report, connects a Marriott hotel to the south with the Bob Carr Performing Arts Centre (referred to as the Theater) and walkways leading to the Orlando Arena to the north. The flashing crosswalk is 30.5 ft (9.3 m) wide. Sporting events, concerts, and conventions all take place in the Arena. Prior to the installation of the flashing crosswalk, a crosswalk with continental-style markings, but no flashers, existed at this location. A photograph of the installation looking south from the Theater toward the Marriott is shown in Figure 6.

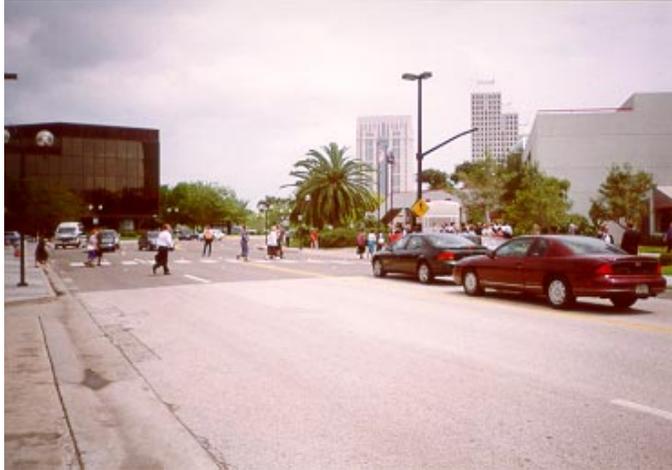
**Figure 9.** A view of the flashing crosswalk as it might appear to an oncoming motorist

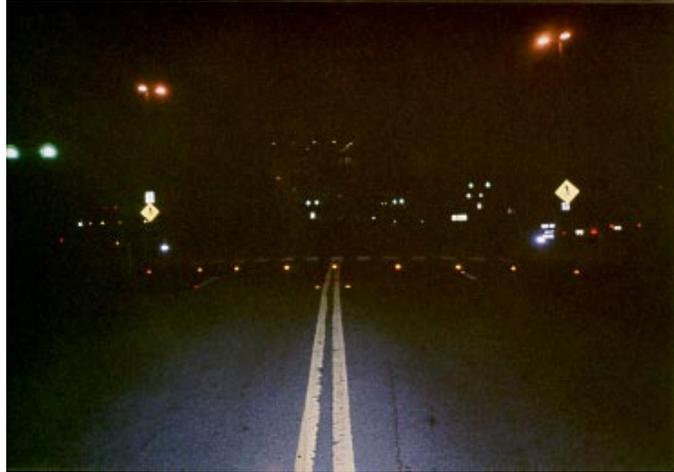
**Figure 16.** A view of the flashing crosswalk at night.

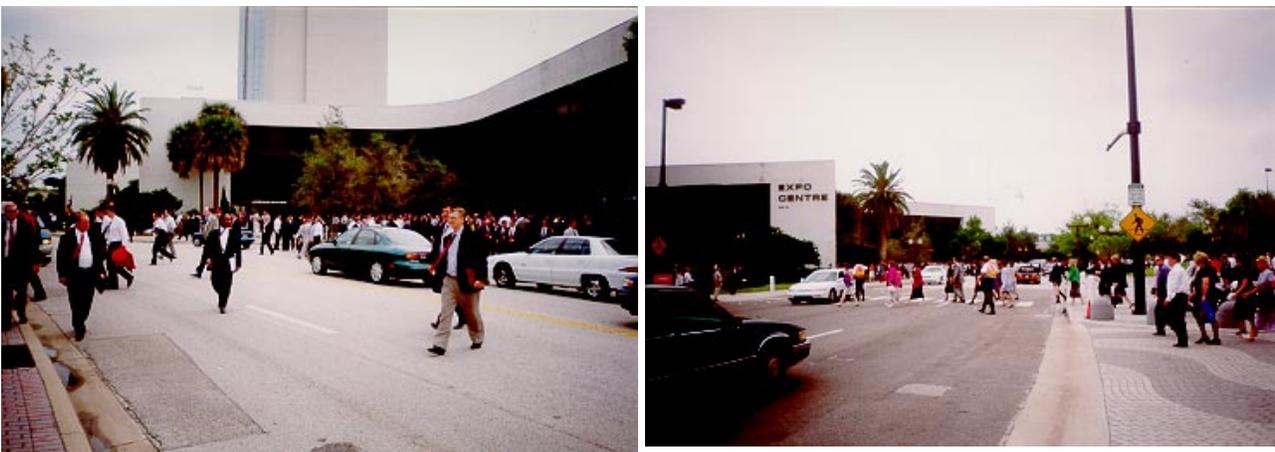
**Figure 17.** The specific place where pedestrians choose to cross reflects their origins and destinations.

It will not be easy to encourage more people to cross in the flashing crosswalk instead of somewhere else. The specific place where pedestrians choose to cross reflects their origins and destinations (Figure 17). Most people crossed in or near the flashing crosswalk when they were walking to and from the Marriott. On the other hand, most people crossed in or near Crosswalk B when they were walking between the Expo Centre and the Arena. It would not be reasonable to expect them to go out of their way so as to cross in the flashing crosswalk, when Crosswalk B is a more direct route. Thus, there is no single best alignment for the flashing crosswalk.
