Improved Durability of Post-Tensioned Bridges

Florida DOT efforts with AASHTO/ASBI toward improving Post Tension durability

POST-TENSIONING STANDARD DETAILS

More Specifically FDOT POST- TENSIONING STANDARDS FOR SEGMENTAL AND GIRDER POST-TENSIONED BRIDGES

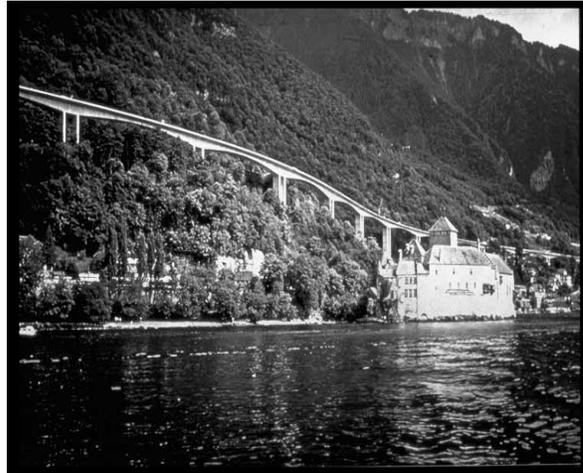
Chillon Viaduct, Switzerland, built 1967

- Continuous
- Midspan hinges
- Deflection
- External PT added
- Waterproof deck - no corrosion of tendons

- **Chillon Viaduct (Switzerland)**
 - **Added PT to cantilevers with mid-span hinges**
 - **No corrosion - good waterproofing / overlay**
- **Autobahn Bridges (various - Germany)**
 - **Cracks at 1/4 span joints with coupled tendons**
 - **Add external grease and sheath mono-strand**
- **Corbeil Bridge (France)**
 - **Added external longit PT to midspan - with**
 - **Transverse PT to bottom slab / internal frames**

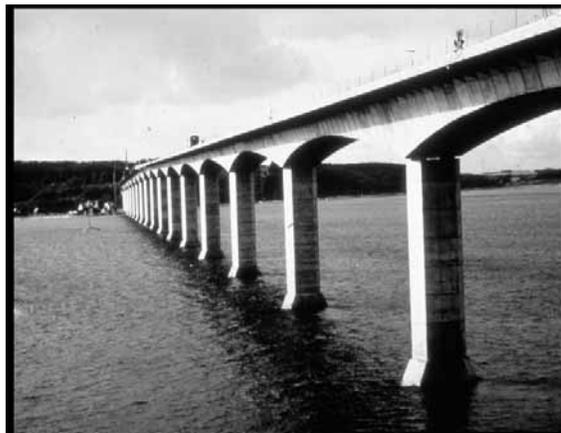
Sallingsund, Denmark (opened 1979)

- **Epoxy sealed joints**
- **Deck membrane and overlay**
- **No corrosion**

- **Good (20+yr) performance with no signs of corrosion of internal PT in major cantilever bridges at;**
 - **Sallingsund Fjord Bridge (Denmark - 1979)**
 - **M180 River Trent Bridge (England - 1979)**
- **Both of precast match cast segments with similarly sealed epoxy joints plus,**
- **Waterproof membranes and asphalt overlays**

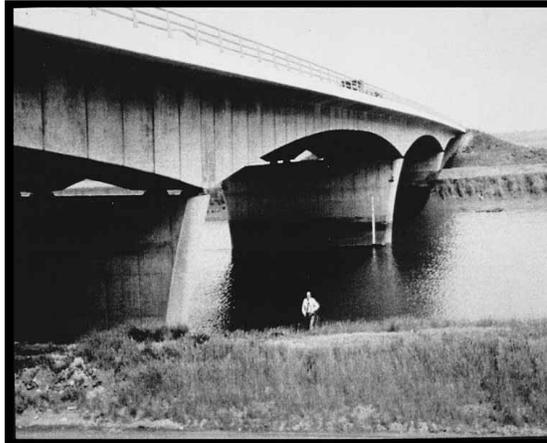
M180, Trent Bridge, UK, (opened 1979)

- **Epoxy Sealed Joints**
- **Deck membrane and overlay**
- **No corrosion**
