Session 25

Polymer Coated Stay-In-Place Metal Bridge Deck Forms

A corrosion resistant stay-in-place metal bridge deck form system has been developed to substitute for costly and laborious removable wooden forms. The galvanized metal forms are comprised of galvanized steel to which a 10-mil polyethylene sheet is thermally applied. Based on the results of several pilot projects using the coated forms, the Department is moving toward including these as a standard on future projects.

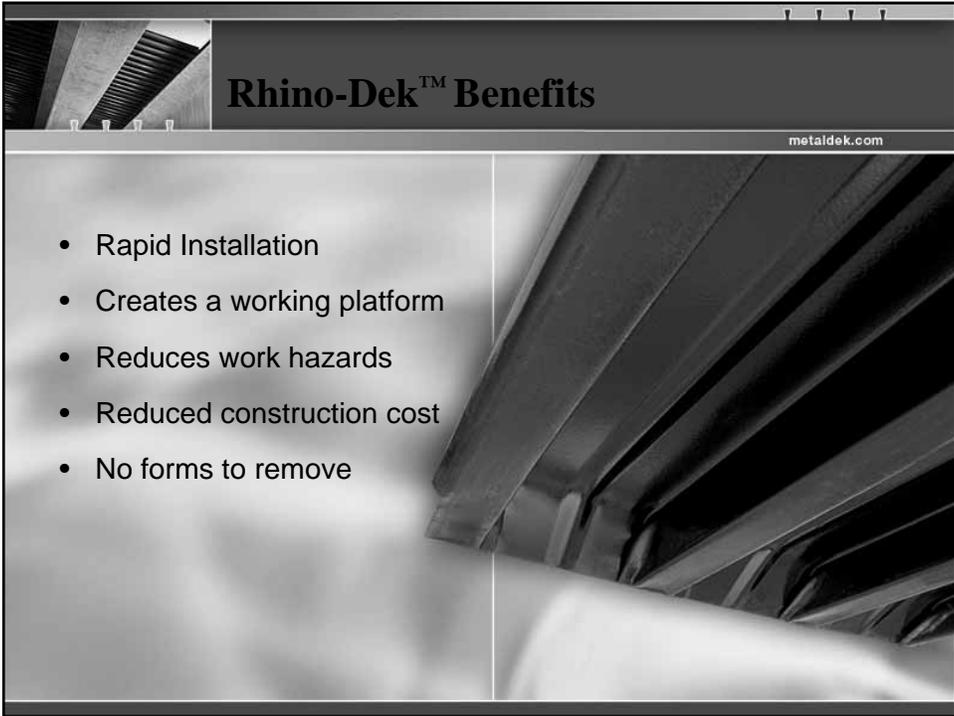
Rhino-Dek™ Benefits

This slide features a dark header with a small image of the product on the left. The title "Rhino-Dek™ Benefits" is centered in the header. Below the header, the slide is split into two vertical panels. The left panel contains a bulleted list of five benefits. The right panel shows a close-up, low-angle view of the Rhino-Dek product's corrugated surface and supporting structure.

- Rapid Installation
- Creates a working platform
- Reduces work hazards
- Reduced construction cost
- No forms to remove

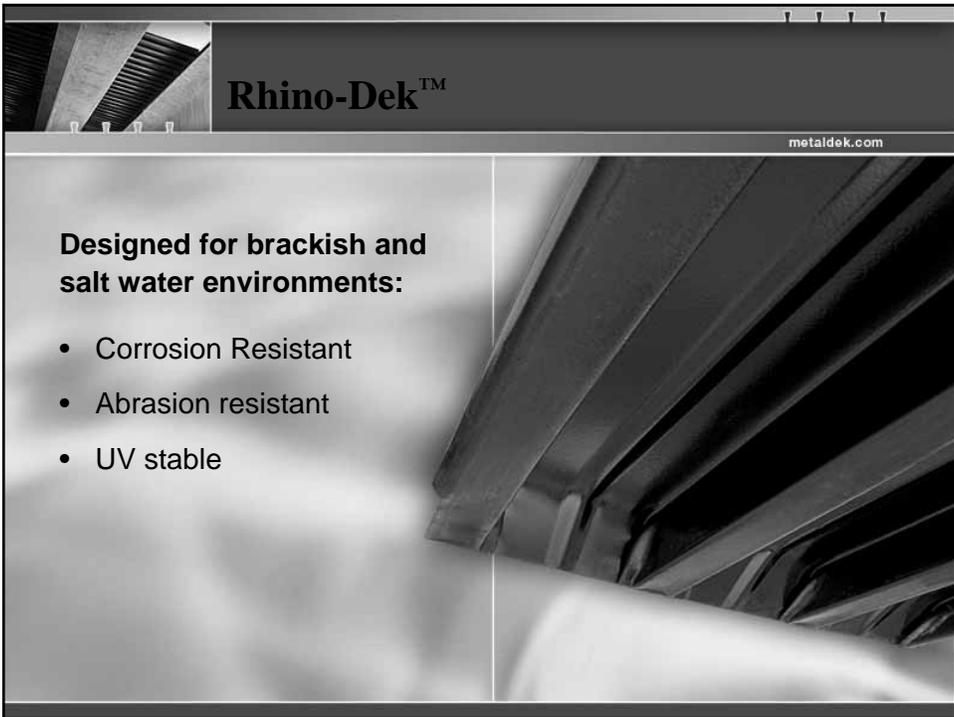
Rhino-Dek™

This slide features a dark header with a small image of the product on the left. The title "Rhino-Dek™" is centered in the header. Below the header, the slide is split into two vertical panels. The left panel contains a bolded heading followed by a bulleted list of three features. The right panel shows a close-up, low-angle view of the Rhino-Dek product's corrugated surface and supporting structure.

Designed for brackish and salt water environments:

- Corrosion Resistant
- Abrasion resistant
- UV stable

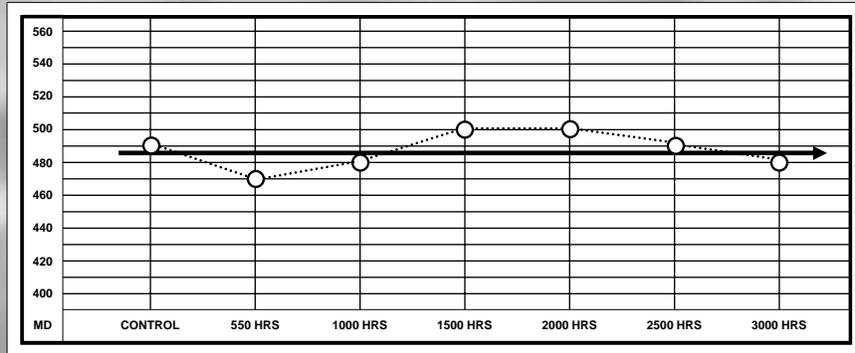
Polymer Laminate Percentage Elongation Study

Corrosion: UV Stability

- ASTM test method D-882
- UV testing at 8 hours of UV light and 4 hours of condensation at 37C

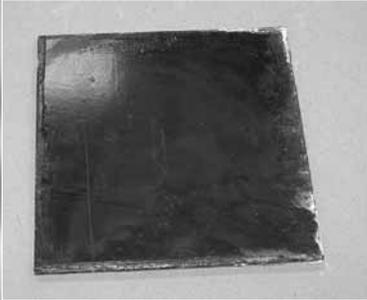
10 Weeks in Salt Fog Exposure

Rhino-Dek™ (sheared edge coating)
 No visible sign of coating damage, ASTM D610 rating of 10.

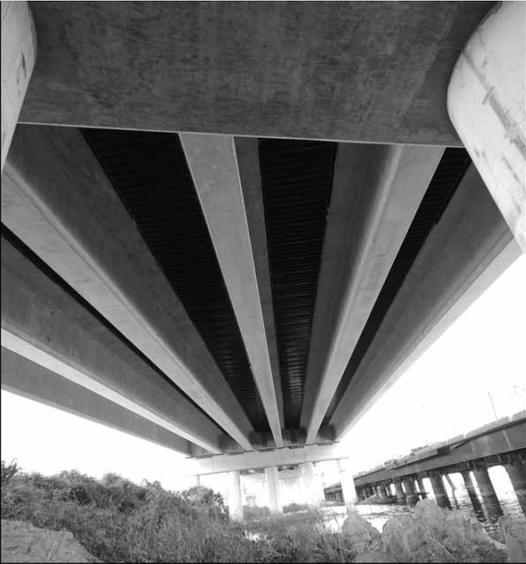
Project Components

- 2.5 x 8 forms
- 10 gauge support angle
- Sheet closure (skews)
- Closure angle
- Z-clip insert
- Void Filler
- Self-tapping screws

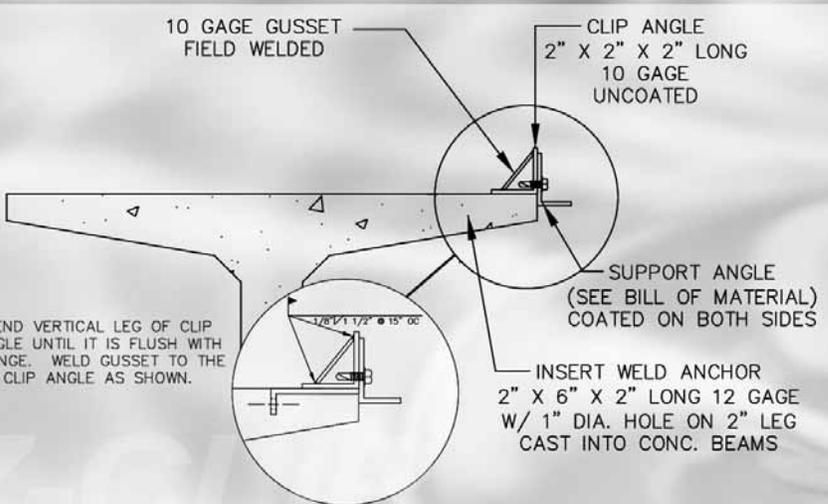
Trout River Bridge

10 GAGE GUSSET
FIELD WELDED

CLIP ANGLE
2" X 2" X 2" LONG
10 GAGE
UNCOATED

SUPPORT ANGLE
(SEE BILL OF MATERIAL)
COATED ON BOTH SIDES

INSERT WELD ANCHOR
2" X 6" X 2" LONG 12 GAGE
W/ 1" DIA. HOLE ON 2" LEG
CAST INTO CONC. BEAMS

BEND VERTICAL LEG OF CLIP
ANGLE UNTIL IT IS FLUSH WITH
FLANGE. WELD GUSSET TO THE
CLIP ANGLE AS SHOWN.
