Progress Report No. 1 (November 1, 2000 to June 30, 2001)

Lumps and Balls in High Slump Concrete: Reasons and Remedy

FDOT Contract No.: BC 837

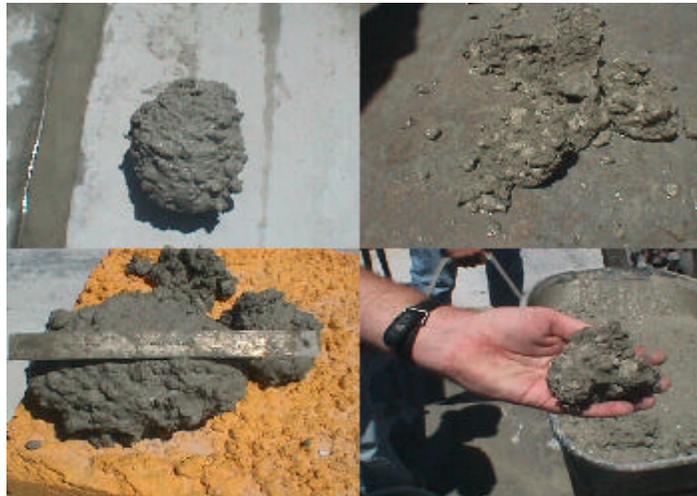
Picture 1: Composition of Concrete Balls

The ball sizes varied from 3 inches to 12 inches and no regular pattern was found. The balls were examined at the site for ingredients and found to be composed of wet mortar and aggregates with dry cement in the middle.

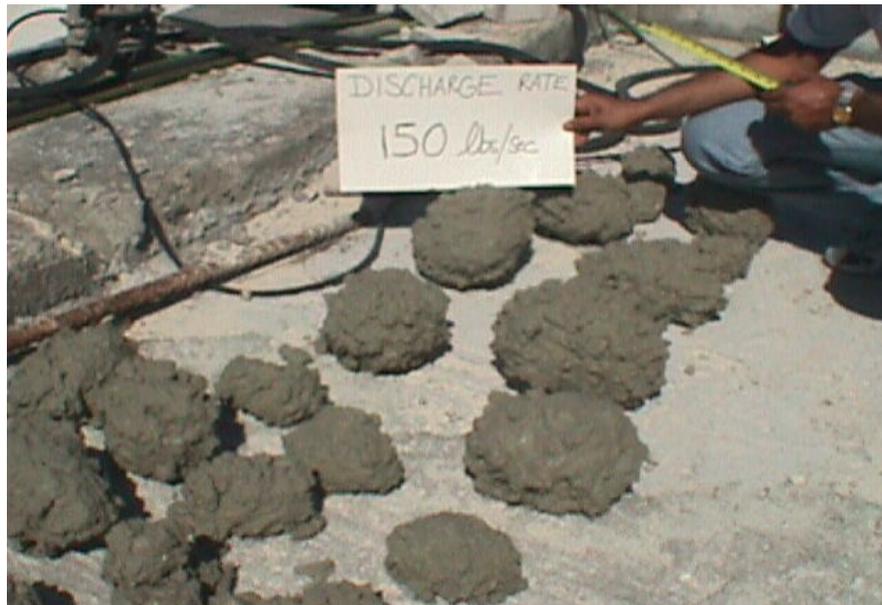
Picture 2: Concrete Lumps and Balls found from a Single Concrete Load
