Work Zone Awareness Session

2013 Design Expo
•By: Ezzeldin Benghuzzi and Chris Lewis

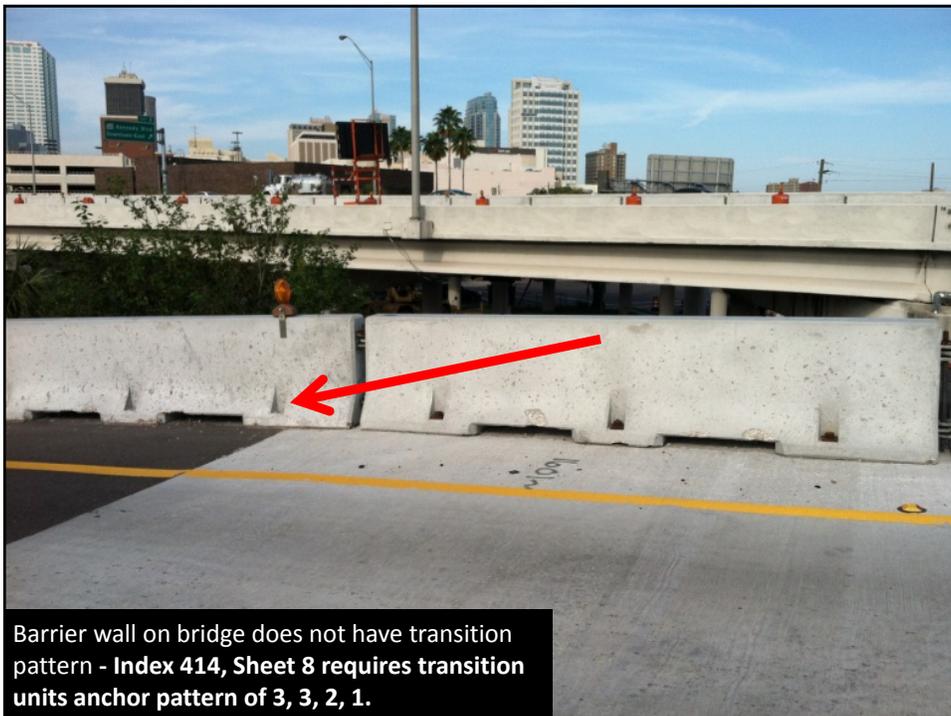
Barrier wall was not transitioned from freestanding to staked – Arrows below represent the transition pattern - **Index 414, Sheet 8** requires transition units anchoring pattern of **1, 2, 3, 3, staked/anchored**.

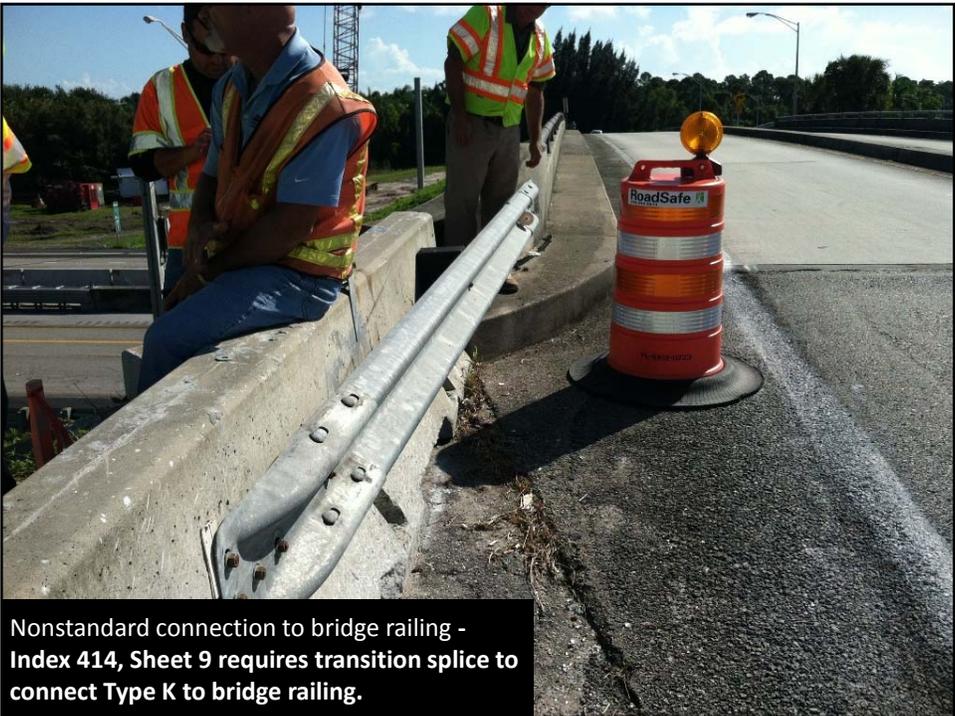
Nonstandard connection to bridge railing - **Index 414, Sheet 9** requires transition splice to connect Type K to bridge railing.

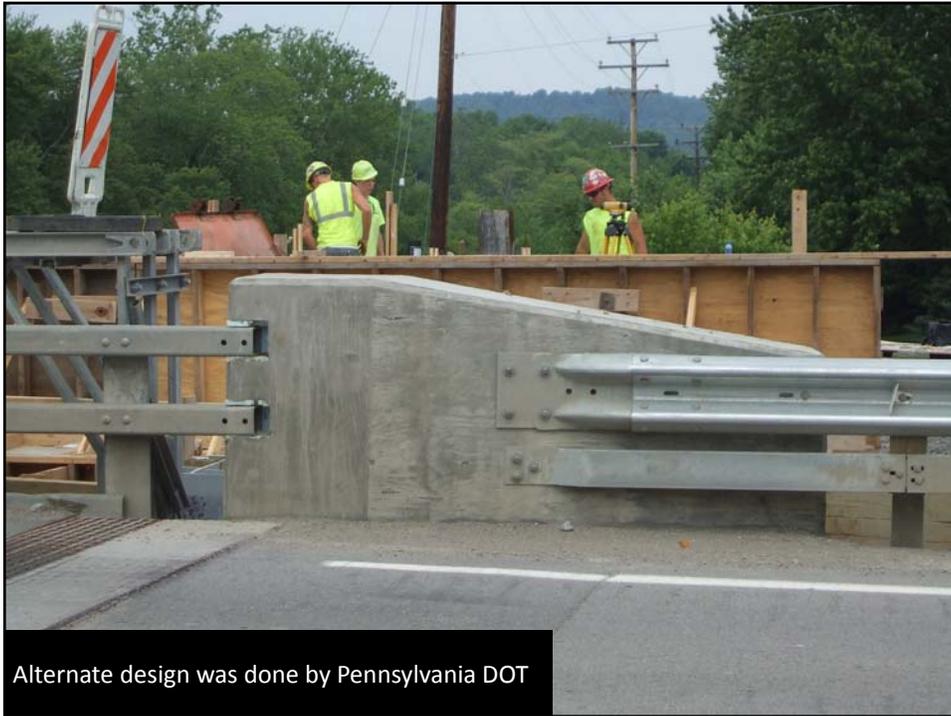
Alternate design was done by Pennsylvania DOT

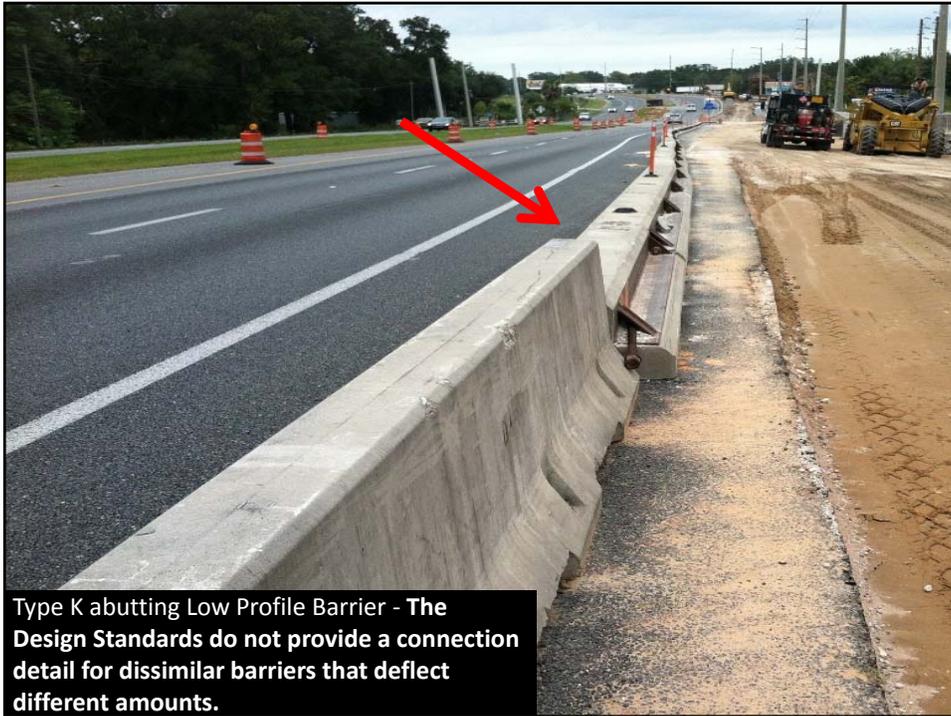
Deflection space behind low profile barrier is not free and clear of material [Index 412, Sheet 2 requires 9 inches deflection space]
