Post-Tensioning Best Practice Update and New Directions for Post-Tensioned Structures

Ben Goldsberry, P.E.
Florida Department of Transportation
Structures Design Office

June 13th, 2013

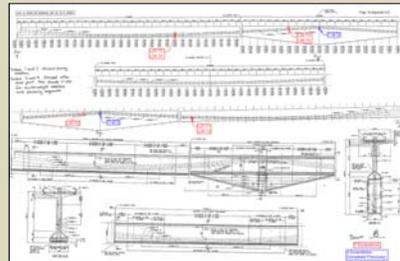
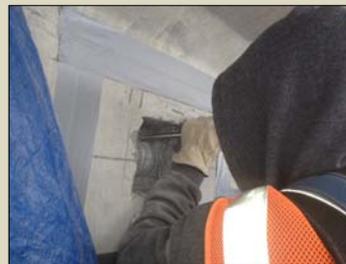
Inspection of Internal Grouted Tendons

- Internal tendons not easily inspectable
 - Full inspection not achievable
 - Spot inspection only
 - Limited view
 - Slow and expensive

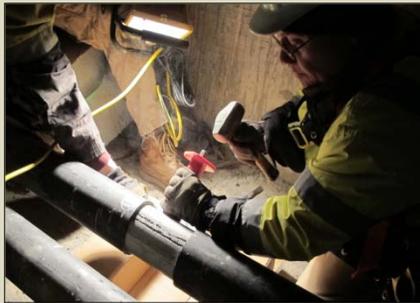
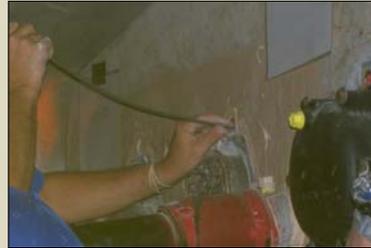
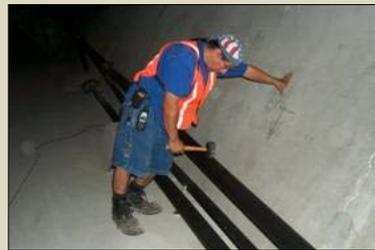
Inspection of External Grouted Tendons

- External tendons on segmental bridges
 - Spot inspection only
 - Boroscope inspection of trumpets
 - Manual soundings
 - Observable failure

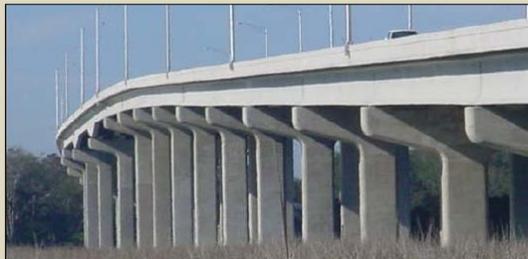
- Concrete Girders with Continuity PT
- 5 of 12 investigations completed
 - 4 bridges with minor issues
 - One 9-year old bridge with significant problems found
 - Extensive soft grout
 - Corrosion in haunched areas of sloped tendons

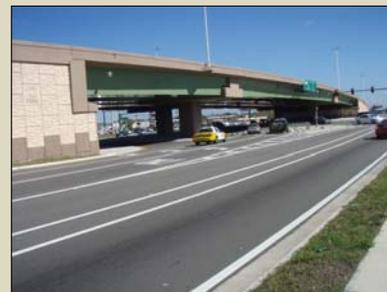
- Bridges with Substructure PT
- 15 of 16 investigations completed
 - 14 bridges with no problems found
 - One bridge
 - High chloride content in PT straddle bent
 - 19 bridges with substructure PT
 - 3 with PT below ground line will not be investigated

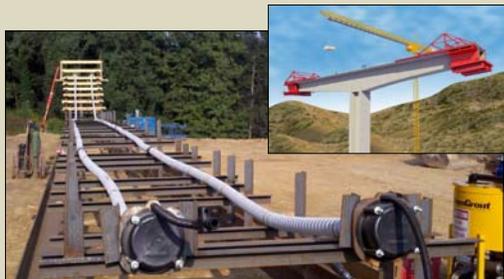
← Mock up test on VDOT cast-in-place segmental project

- Full scale mock up test
- 462-7.4(e)

(e) Demonstrate, to the Engineer's satisfaction, grouting of a longitudinal tendon by constructing a full-scale mockup with all associated PT system components of a typical longitudinal tendon profile on the project. Utilize 'clear' duct for the mockup to facilitate visual inspection and verification that no voids or bleed are present in the tendon mockup after grouting. Place a non-stressed PT strand equivalent to the typical longitudinal tendon size inside the duct to simulate in-place PT strand.

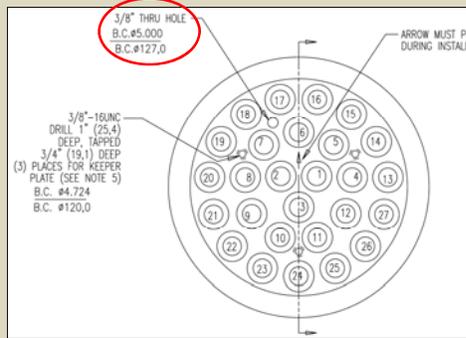
- Vent hole in wedge plate
- 960-2(f) Component Standards

(f) Geometry of grout outlets must facilitate access for endoscope inspection directly behind wedge plate using a straight 3/8 inch diameter drill bit. *For all PT systems other than 4 strand flat configurations, place vent hole(s) of 3/8 inch minimum diameter through wedge plate to allow for passage of grout and inspection.*

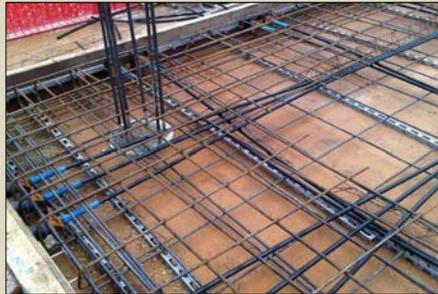
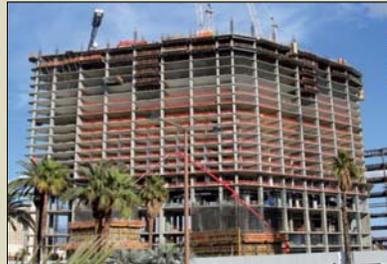
Greased and Sheathed Monostrand

Used in buildings and parking structures since the 1950s

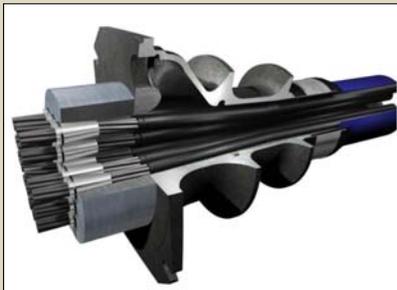
Anchorage for Greased and Sheathed

- Bridge tendon
 - Larger duct
 - Larger anchorage
 - Larger members

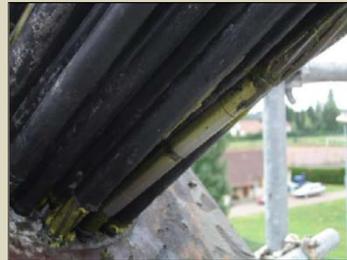
- Strands can be replaced one-by-one
- Installing new strand into existing sheath could be challenging

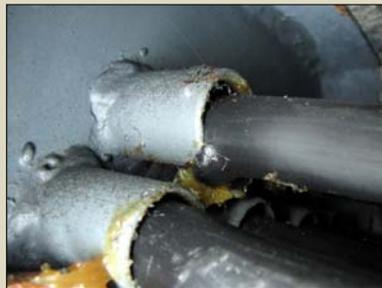
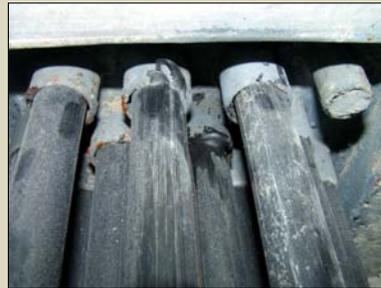
- Challenges at deviators for external tendons
- Problem on recent European bridge

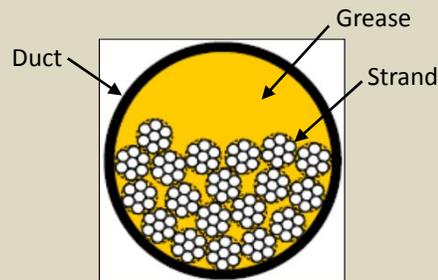
- Advantages
 - High level of corrosion protection
 - Replaceable
 - Inspectable
 - External tendons can be mechanically detensioned and removed for inspection
 - Grease injection can be restarted later

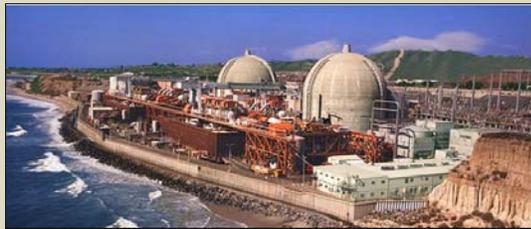
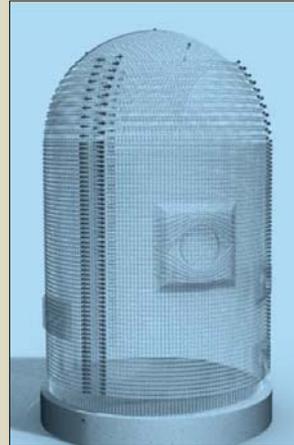
Nuclear containment structures

- Grease as PT corrosion protection has a 40+ year history of successful use around the world
- USA, Canada, England, Sweden, Spain, Japan, South Korea, China, Taiwan

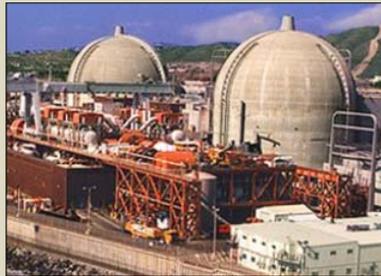
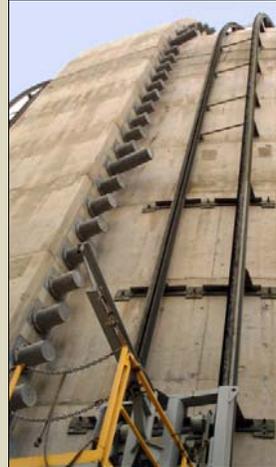
Tendon Replacement Project (2009)

- California nuclear generating station
- Four steam generators replaced
- Removal of horizontal and vertical tendons
- Grease filled ducts

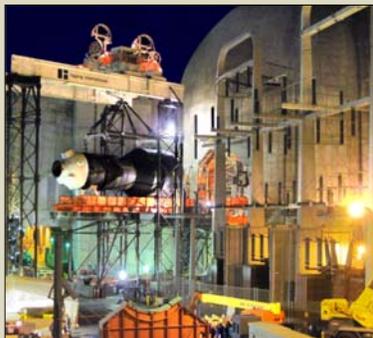
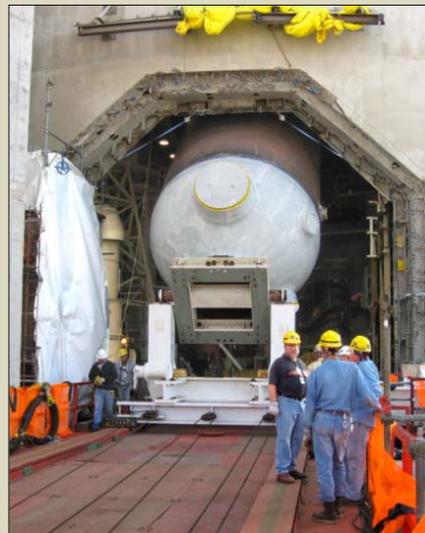
- Total of 164 tendons de-tensioned and removed
- 82 tendons in each structure
 - 46 horizontal
 - 36 vertical
- Remove and replace steam generators
- Temporary 28-ft opening cut in 4-ft thick concrete containment structure

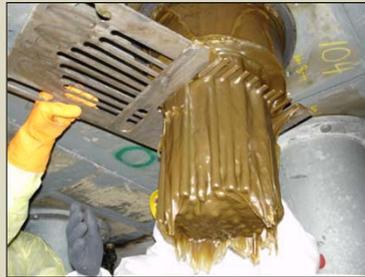
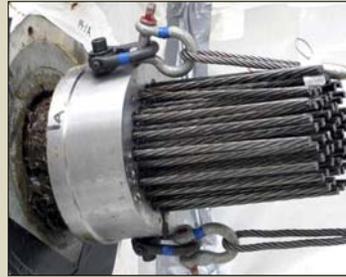
- Containment structures built in 1979/80
- 65-70°F ambient temperature at the time of cap removal
- Existing tendon condition after 30 years

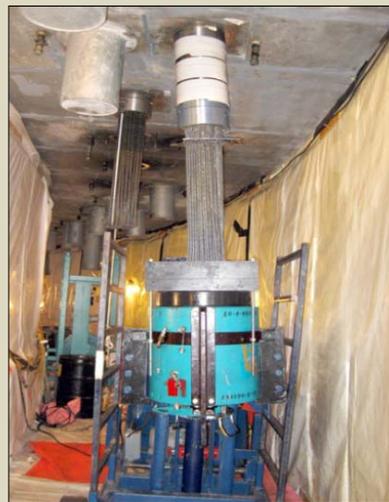
- Complex tendon geometries
- Limited access conditions
- QA program in compliance with Nuclear Regulatory Commission (NRC) regulations
- On-site tendon demonstration program

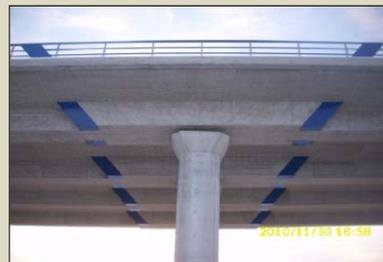
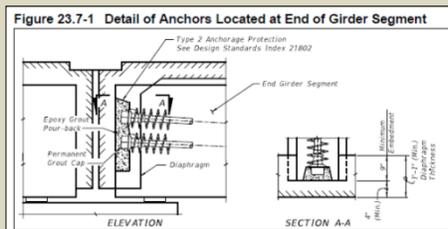
- Future anchorage access
 - Offset beam ends?
 - Consider new potential blister locations?

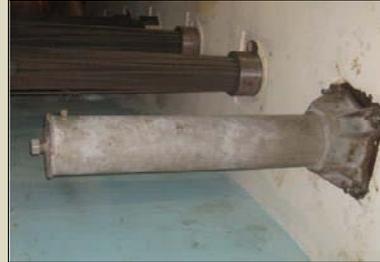
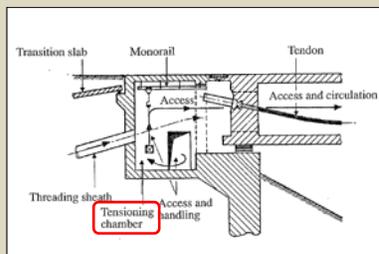
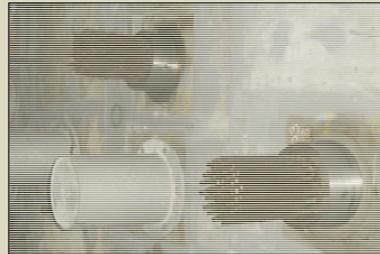
- De-tensioning
 - Strand tails
 - Mechanical de-tensioning
 - Tensioning chamber at end of bridge?
