**A 30-Year Performance Evaluation of a  
Two-Layer Concrete Pavement System**

**FDOT Office**  
State Materials Office

**Research Report Number**  
FL/DOT/SMO/10-540

**Date of Publication**  
December 2010

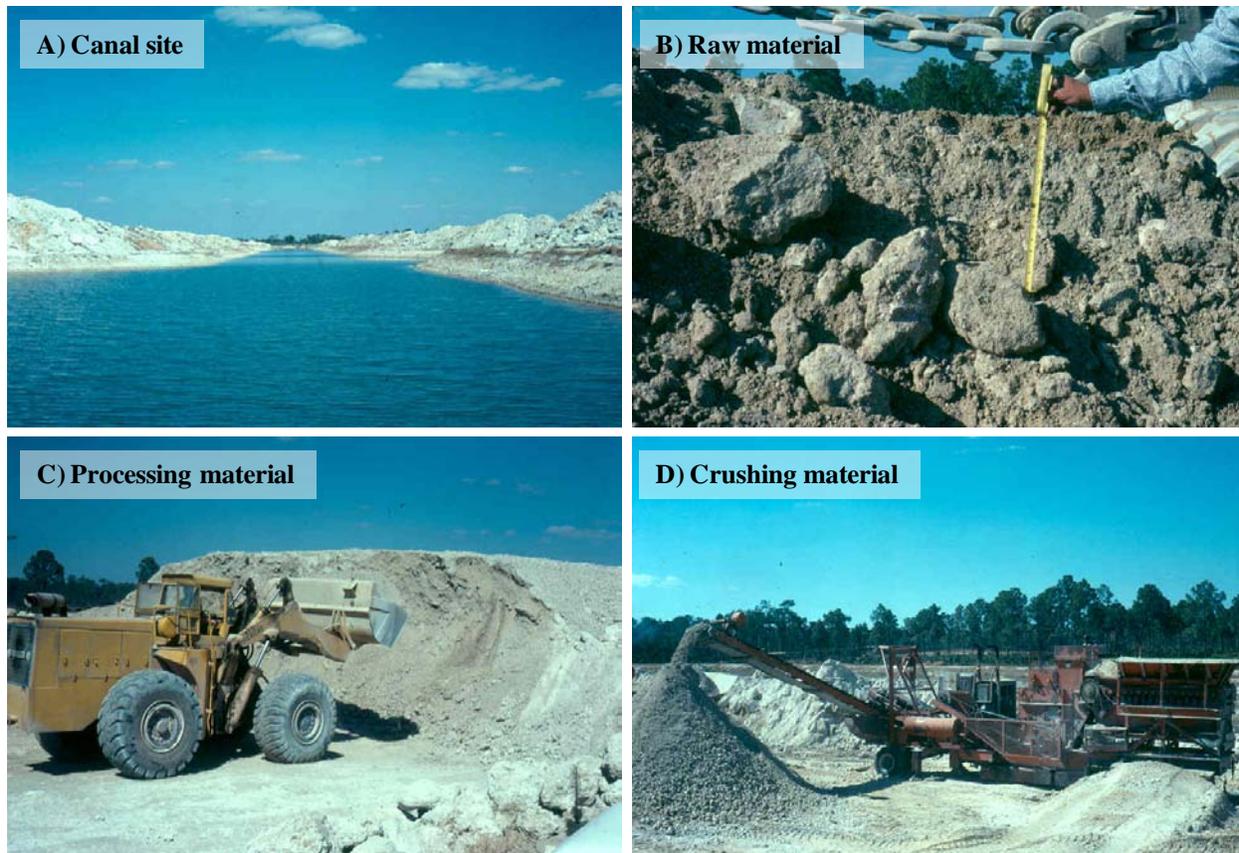
**FIGURE 1 Econocrete aggregate source.**

In March of 1978, an experimental two-layer concrete pavement was opened to traffic on State Road (SR) 45 in Charlotte County, Florida. The experimental sections consisted of a 3 inch (7.5 cm) Portland cement concrete (PCC) surface with a 9 inch (23 cm) lean concrete (commonly referred to as econcrete) layer. Sections were constructed over either 6 inch (15.0 cm) cement-treated or 6 inch (15 cm) granular subbases. The control section was a standard 9 inch PCC on top of a 6 inch (15 cm) cement-treated subbase. The econcrete layer aggregate source was located four miles from the project and consisted of a mixture of rock, sand, and shell produced from the dredging of canals. In the past, this aggregate source had been used as fill material since it did not meet FDOT's concrete or base aggregate specifications. The aggregate was crushed on-site at the dredging location to produce a uniform aggregate supply and then transported to the batch plant site and stockpiled. FIGURE 1 shows photographs of the dredged canal, raw material, processing, and crushing of the econcrete aggregate source.

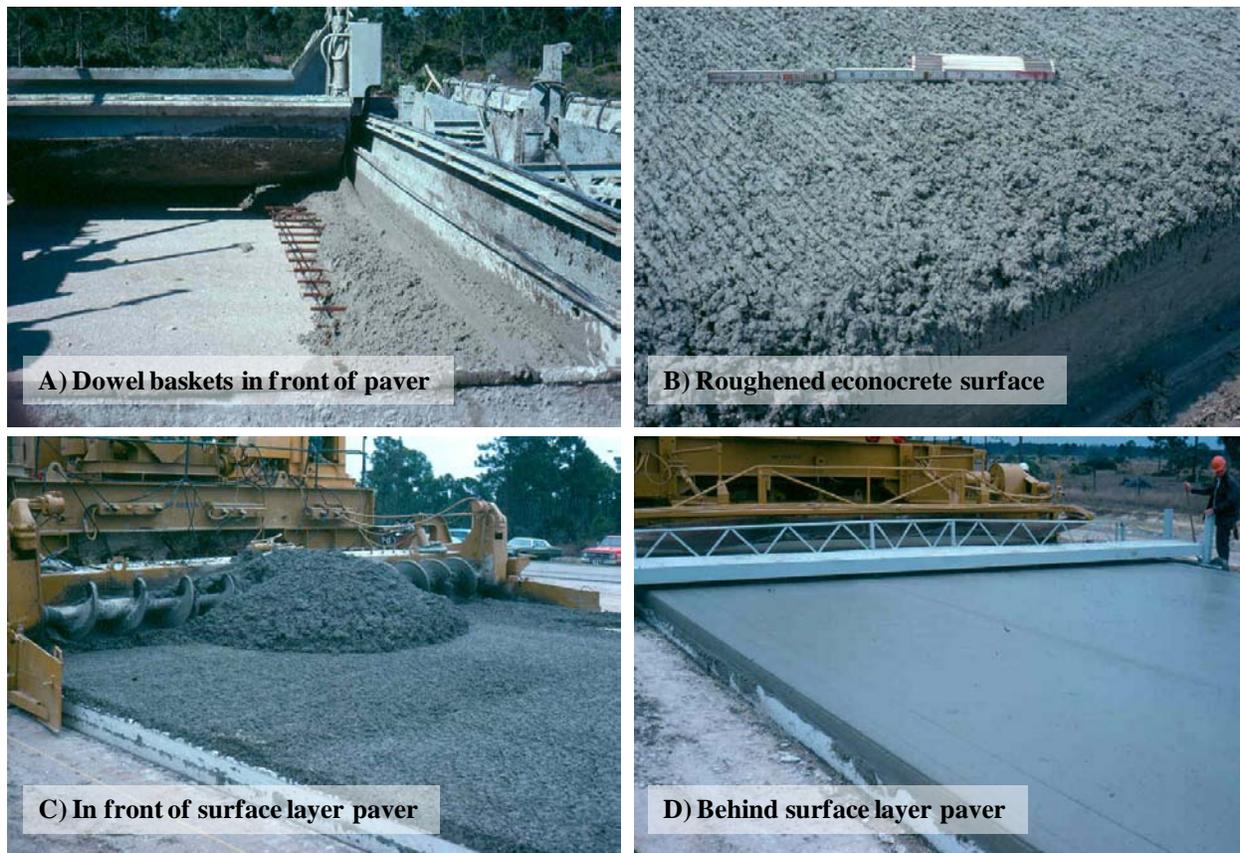
**FIGURE 3 Paving operation.**

The PCC surface consisted of a 3 inch (7.5 cm) jointed plane concrete pavement (JPCP) of the same mix design and properties as the control section. The surface layer was constructed using a slipform paver approximately ½ to 1 hour after placing the econcrete. The result was a monolithic structure with the econcrete layer bonded to the surface layer. FIGURE 3 shows the paving process and TABLE 3 summarizes the properties of the econcrete mixture. Cement content was varied to achieve three different strength levels. FIGURE 4 shows the gradation and properties of the aggregates used for the econcrete.

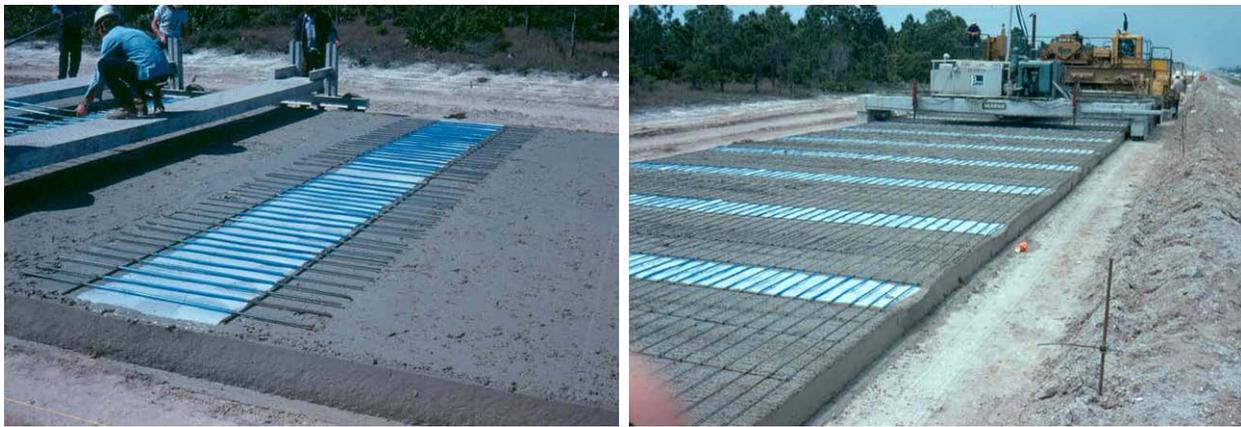
**FIGURE 6** Debonding material used for experimental joint concept (steel reinforcement shown).

Some subsections of sections 4 and 5 included an experimental crack inducing concept. This concept required placement of a plastic crack inducing joint insert in the fresh surface of the concrete. A debonding agent was applied at various distances before and after the insert as shown in FIGURE 6. The concept hypothesized that a hairline crack would reflect in the concrete surface layer at the locations corresponding to the joint insert and debonded interface. Over time, transverse cracks did appear at the approximate location of the joint insert. However, longitudinal cracks formed perpendicular to the transverse cracks in most of the sections. Heavy spalling occurred at some of the transverse joints. Crack sealant was not applied to all of the transverse cracks since they occurred after construction and at various time periods. Many of these sections failed and were removed within 1 year due to extensive cracking and the unsightly appearance that resulted from the construction problems noted above. Furthermore, it was concluded that a bond must be established for thin concrete overlays of rigid pavements. Current guidelines for traditional concrete overlays call for an unbonded overlay thickness of 4 to 11 (10 to 28 cm) inches and bonded overlay thickness of 2 to 5 inches (5 to 7 cm) depending on traffic and desired life (11). Some sections with the experimental joint concept were still in service after 10 years of service but their condition ranged from poor to fair.

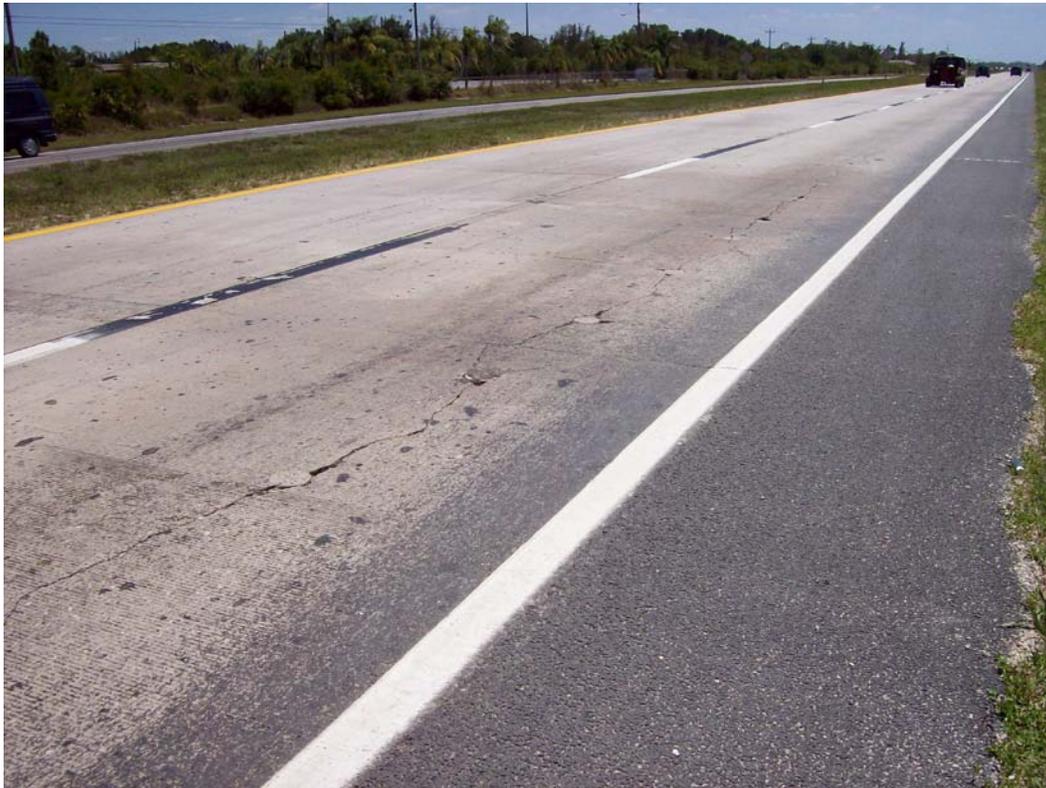
**FIGURE 12 Longitudinal cracking in section 2.**

A crack evaluation was performed in 2007 to determine the type and number of cracks. TABLE 5 shows the result of this survey for the traffic lane. Longitudinal cracking was the most predominant crack type and was observed primarily in the control section and section 2. Longitudinal cracks were observed in the wheel paths, along the center of the slab, and near the longitudinal joint. A photograph of longitudinal cracking observed in section 2 is shown in FIGURE 12. Literature indicates that cement-treated subbases may promote uncontrolled cracking due to high friction, rigidity, and in some cases, bonding between the concrete slab and subbase (17, 18). In addition, the compressive strength of the cement-treated subbase was 880 psi (6 MPa) at the time of construction. The ACPA recommends a compressive strength of 300 psi (2 MPa) to 800 psi (5.5 MPa) to limit the stiffness and minimize curling and warping stresses (19). Florida no longer recommends the use of cement stabilized courses below concrete pavements due to their rigidity, lack of permeability, and the difficulty in achieving non-erodible properties (13).

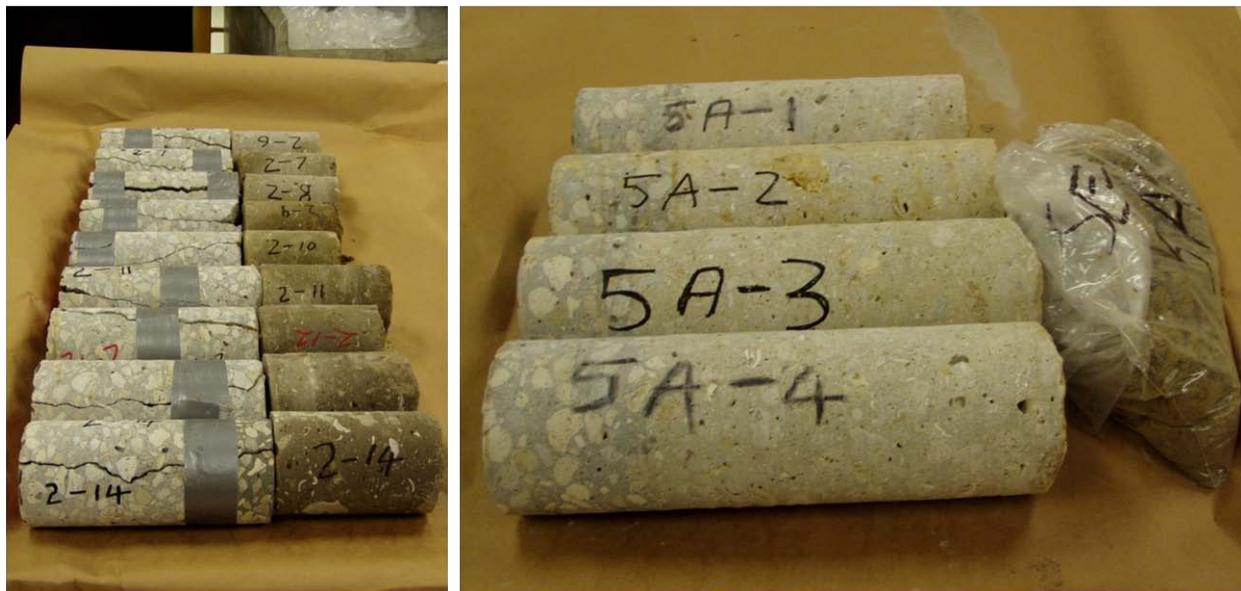
**FIGURE 13 Photographs of control and section 3 cores.**

More than 40 cores were collected in 2007 to verify the long-term structural properties of the PCC and econcrete. TABLE 6 summarizes the laboratory properties. In general, the properties of the PCC and econcrete A mixture have experienced little long term change while the econcrete B and C mixes have increased in strength and now approach those of the A mixture. It should be noted that, in general, there were less samples tested and more variability in the 2007 test data than the samples measured during construction. The modulus and strength values for the PCC remain more than double the econcrete. The considerable bond strength is evidence that the two-layer system is still acting as a monolithic structure. The slight difference in the PCC and econcrete coefficient of thermal expansion (COTE) (less than 5 percent) minimized the thermal stress on the bond. Thermal curling and loading stresses would have been greater and may potentially lead to more cracking had the bond degraded. FIGURE 13 shows photographs of cores taken from the control sections and section 3. The photographed core numbers represent a previous numbering system.
