National Center for Asphalt Technology
1600 Lee Road 151
Opelika, AL 36804
(334) 844-6855

PROJECT OVERVIEW

2000 PAVEMENT TEST TRACK

2000 INSTRUMENTATION PLAN

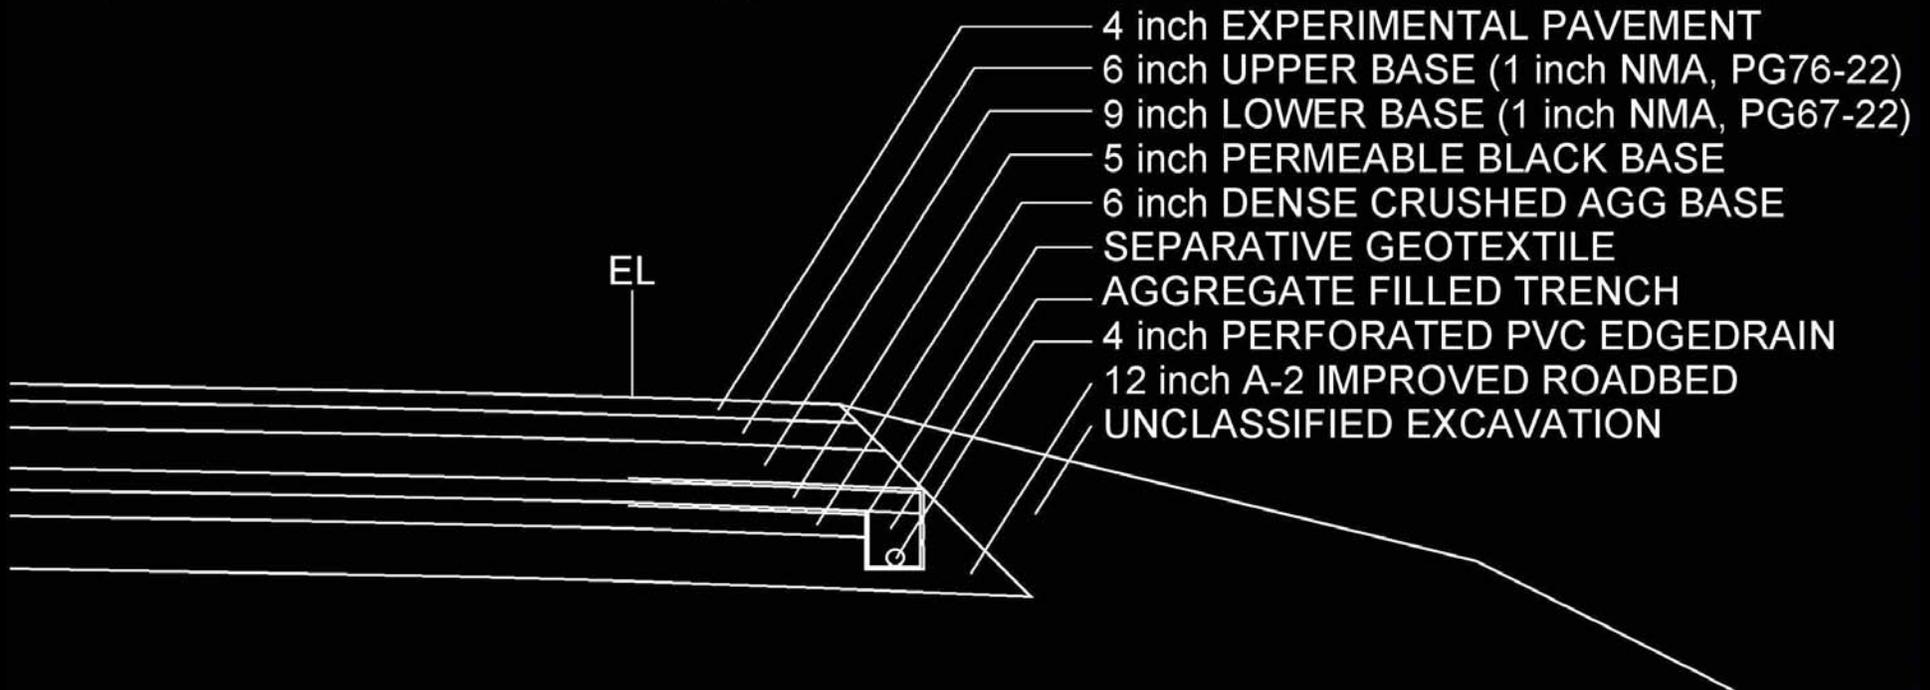
TRACK BUILDUP

OUTSIDE RESEARCH LANE
(inside lane has same buildup)

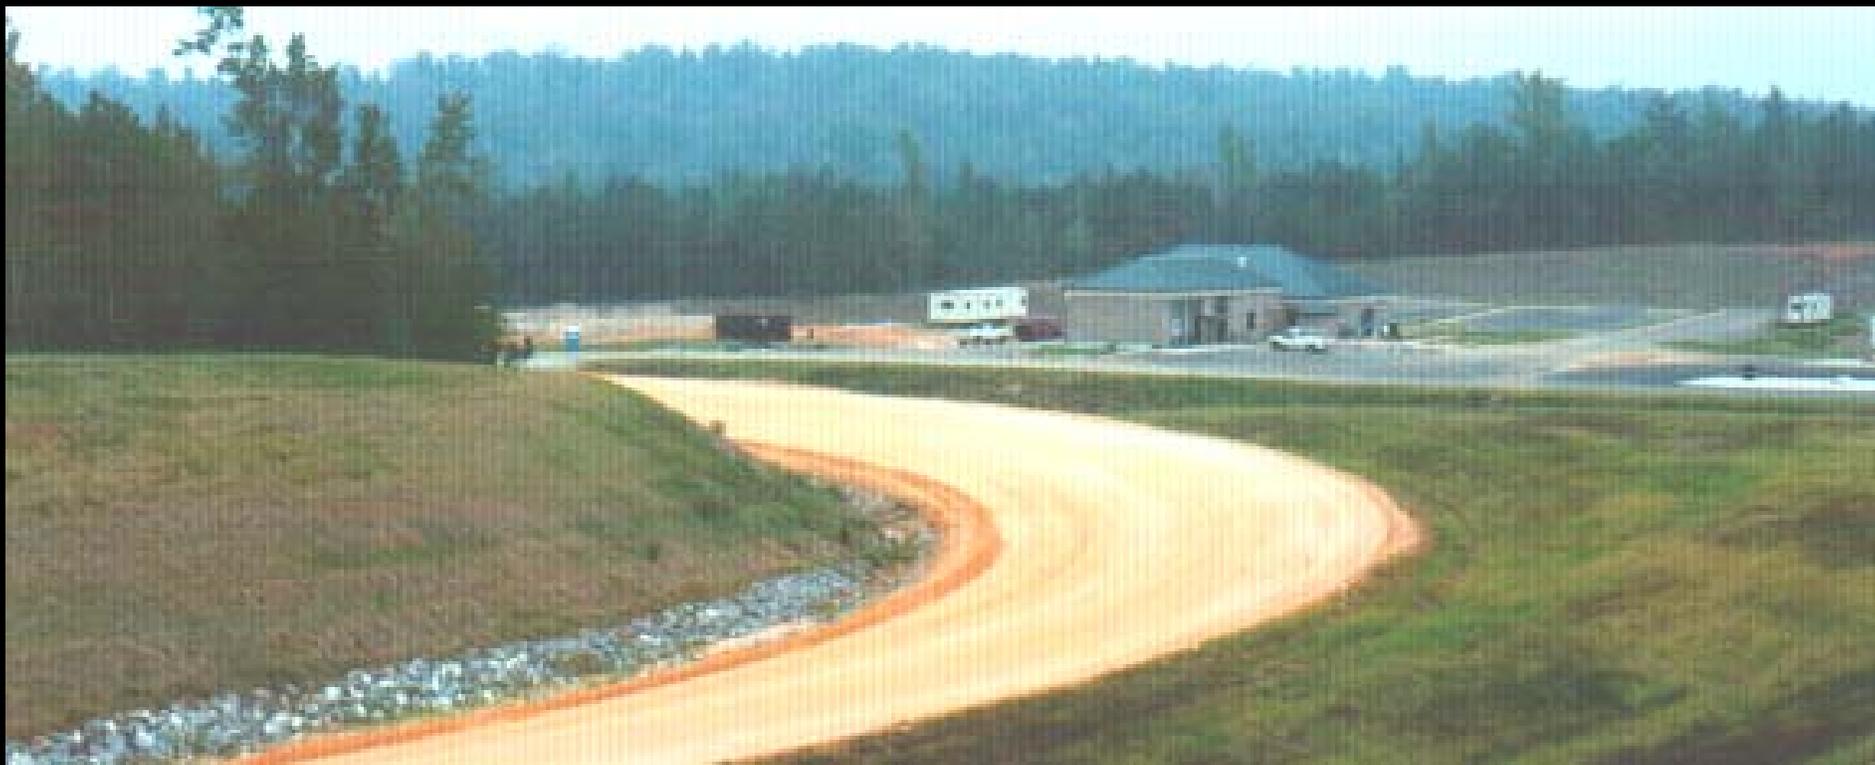
UNIFORM SUBGRADE @ $\approx 30''$

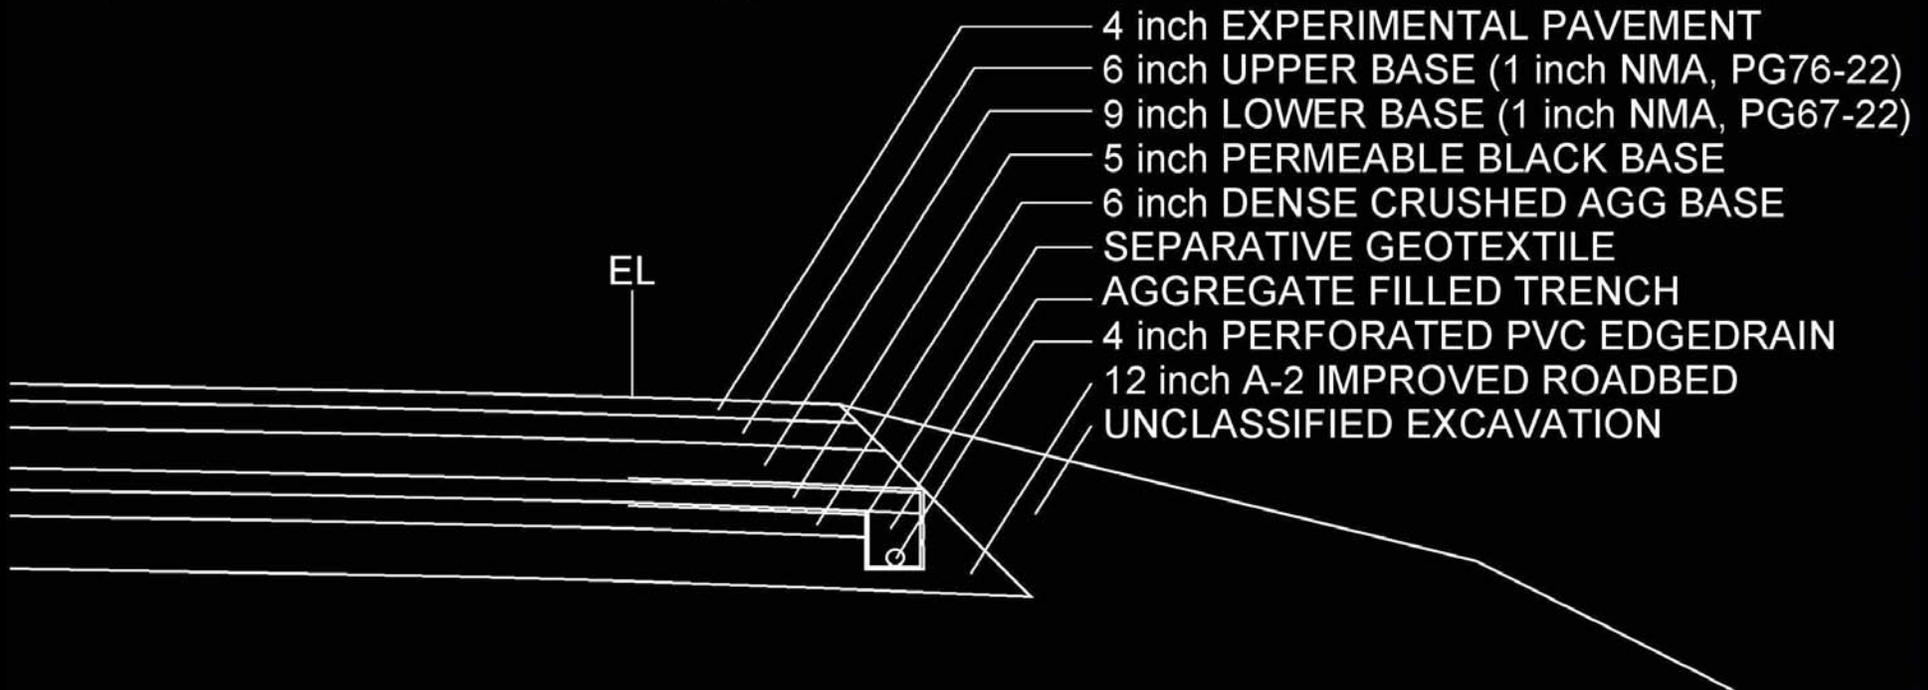
TRACK BUILDUP

OUTSIDE RESEARCH LANE
(inside lane has same buildup)

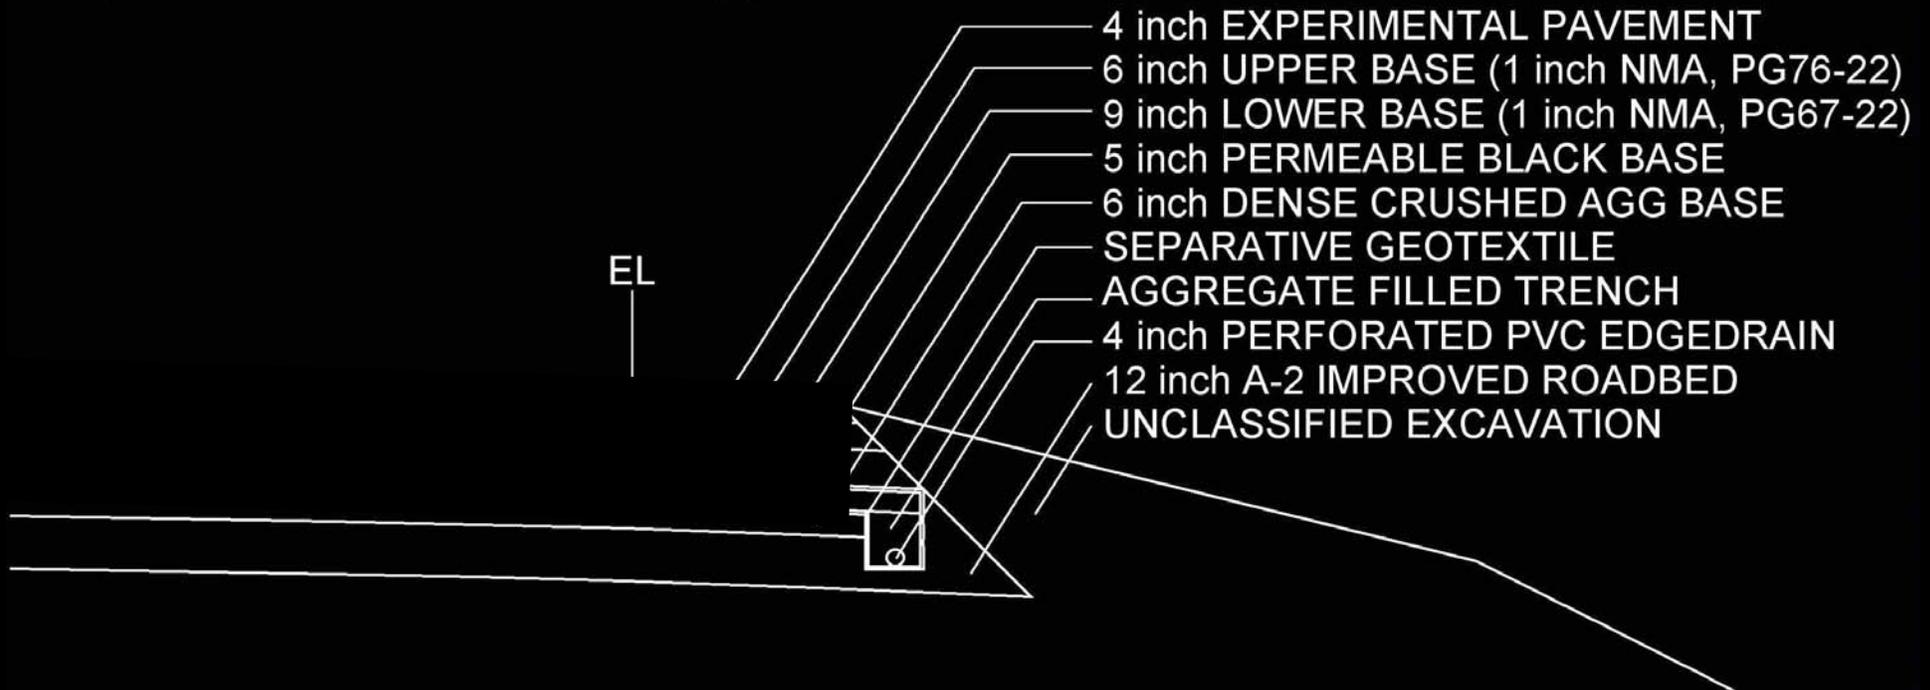
TRACK BUILDUP

OUTSIDE RESEARCH LANE
(inside lane has same buildup)

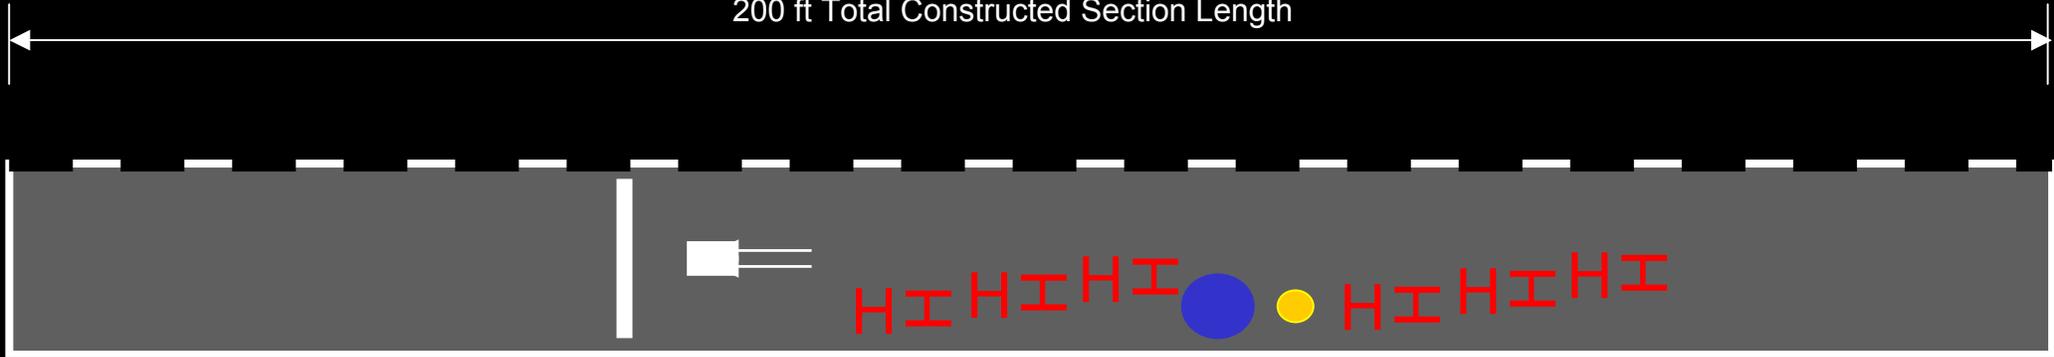
STRUCTURAL INSTRUMENTATION LAYOUT

200 ft Total Constructed Section Length

- Stack of Two 9”D Pressure Cells (Top of Subgrade & Base)
-

- Bridge Type Strain Gage in the Longitudinal Direction Under HMA
-

- Bridge Type Strain Gage in the Transverse Direction Under HMA
-

- Stack of Two Inductive Coils (Small Diameter) for Vertical Strain
-

Time Domain Reflectometry Moisture Gage in Subgrade
-

Piezoelectric Pressure Sensitive Trigger Switch (& “Z”)
