FINAL REPORT

U.F. Project No: 49104504972-12

Contract No: BC-354

Evaluation of Early Strength Requirement of Concrete for Slab Replacement Using APT

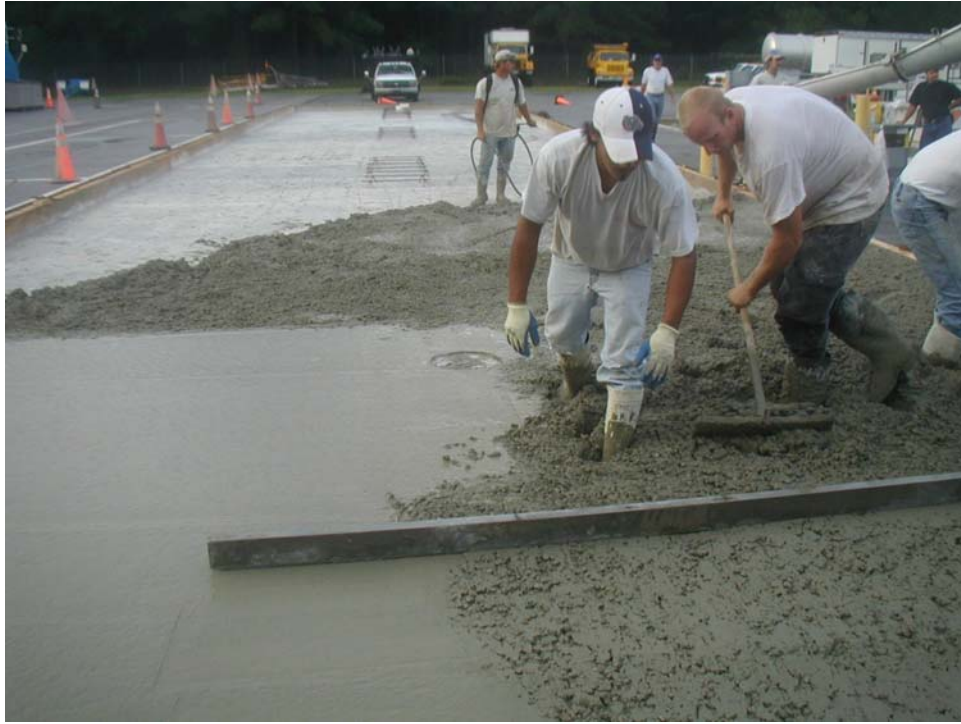
Figure 2. Placement of concrete on test track

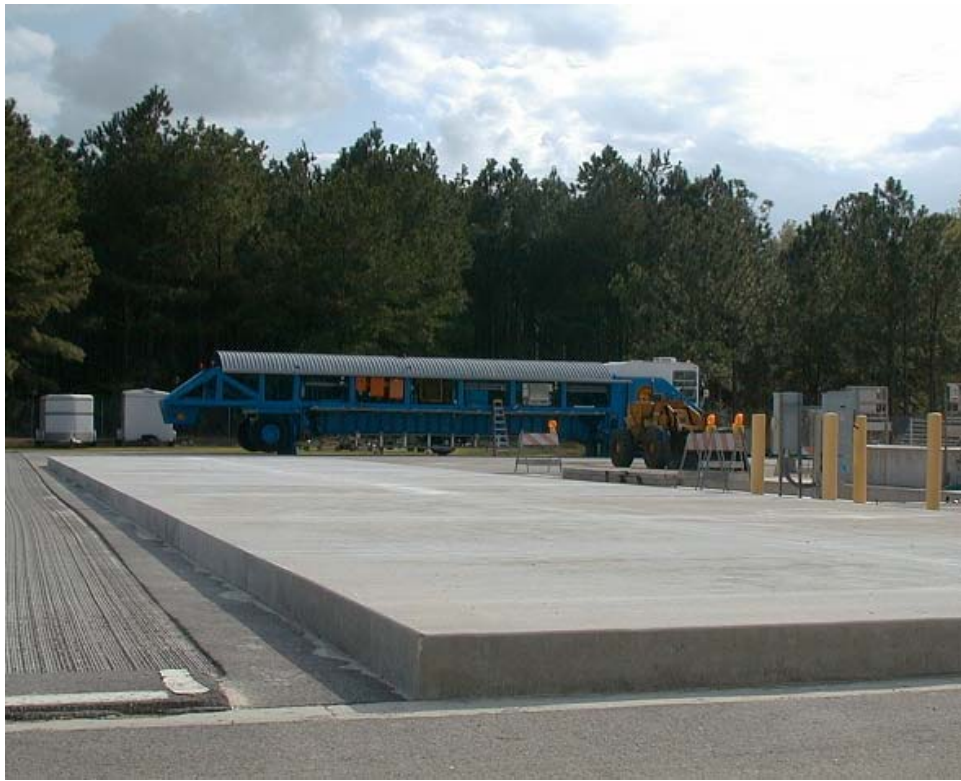
Figure 3. Finished concrete test track

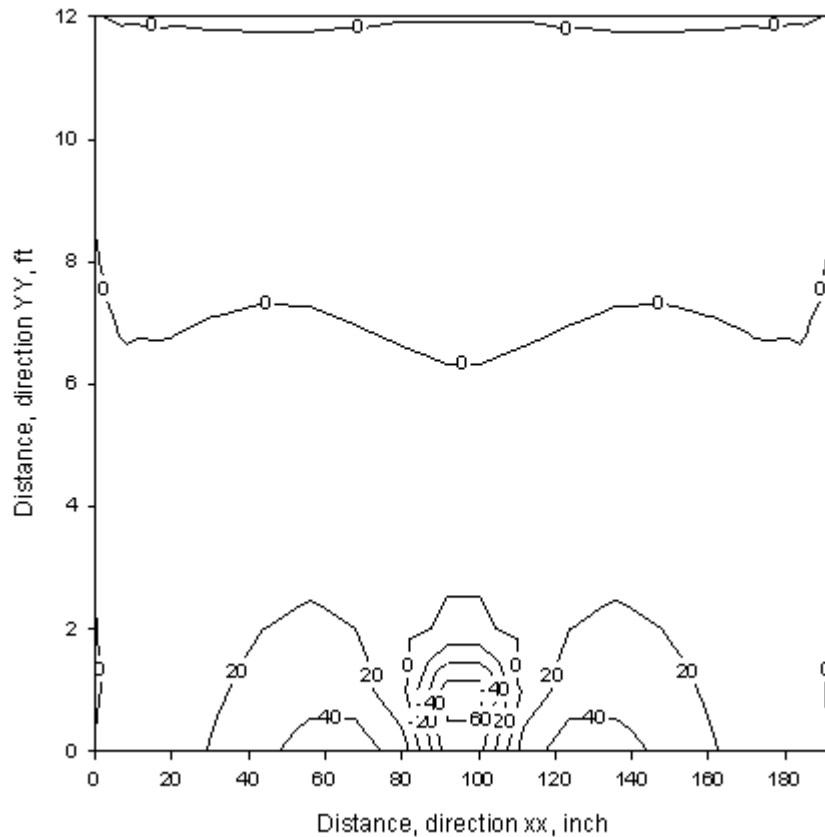
Figure 15. Distribution of maximum principal stresses due to a 12-kip load at the mid-edge for the condition of no load transfer at the joints

Figure 15 shows the distribution of the maximum principal stresses on the test slab caused by a 12-kip (53-kN) load at mid edge, for the condition of no load transfer across the joints and edges.

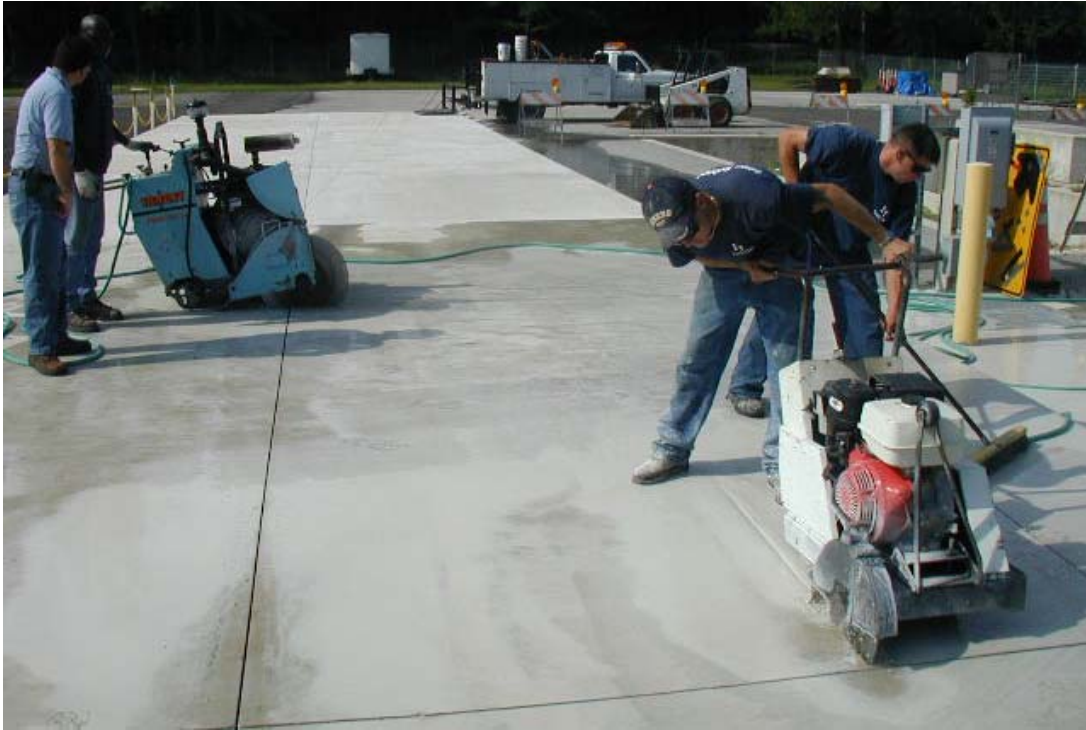
Figure 20. Cutting of a concrete slab (12 ft × 16 ft) into small pieces (3 ft × 4 ft)

Slab removal for the first slab replacement test was conducted on July 17, 2003 under the supervision of FDOT personal. A 12 ft × 16 ft slab was separated into 3 ft × 4 ft pieces using a diamond bladed saw as shown in Figures 20 and 21. Each separated piece was removed using the weight lifter as shown in Figure 22. Special attention was given to protect the surrounding slabs. Steel plates were placed along the joint to protect the adjacent slab from damage as the broken pieces were removed, as shown in Figure 23. The damaged places of the asphalt base were patched using a cold asphalt mix and compacted using a vibrator as shown in Figure 24.

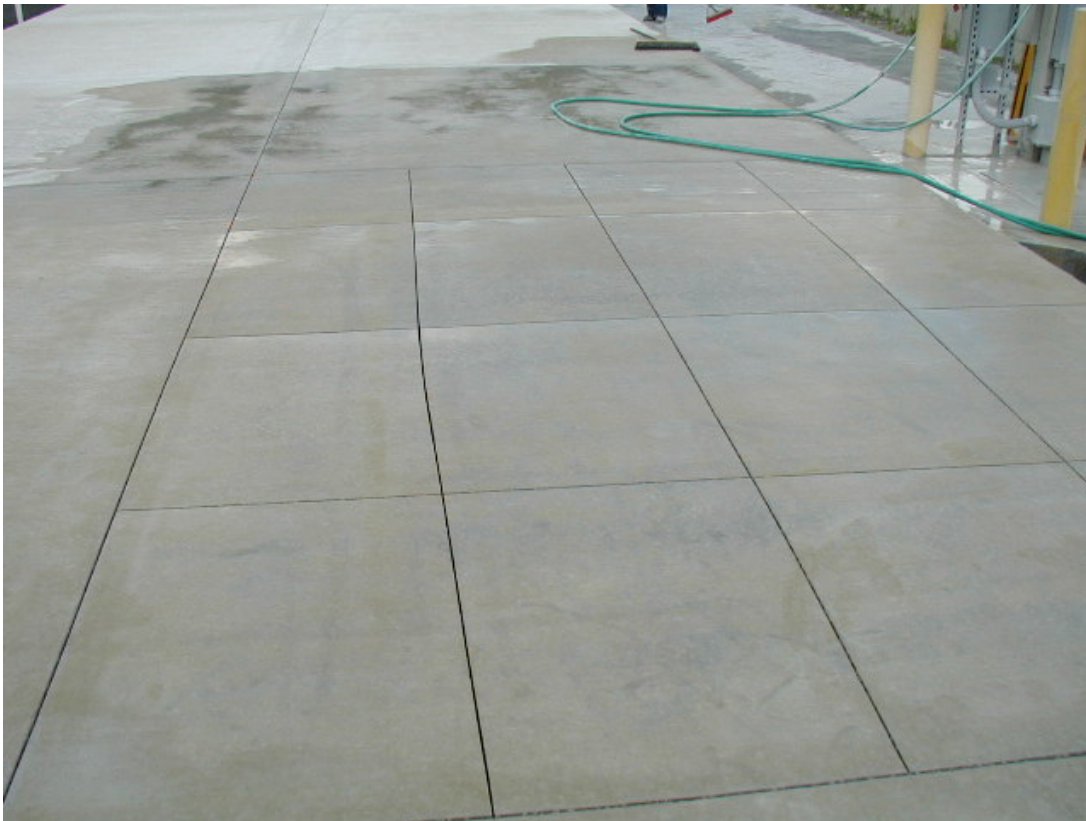
Figure 21. Separated concrete pieces after cutting with diamond bladed saw

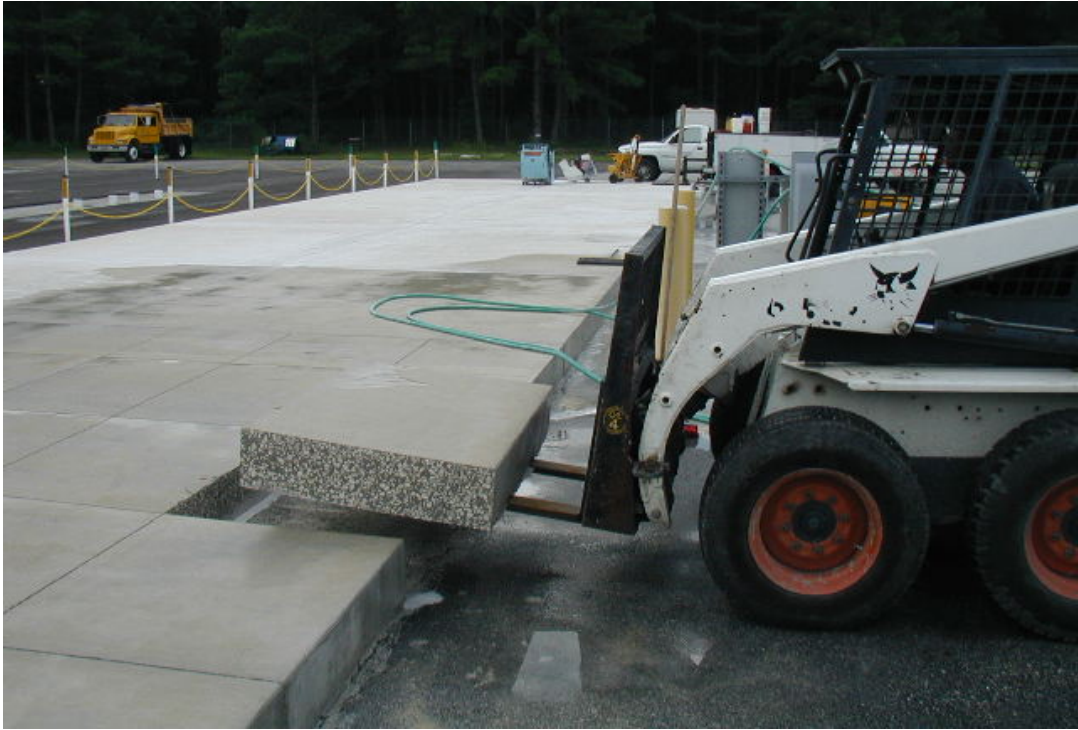
Figure 22. Removal of separated pieces using a lifter

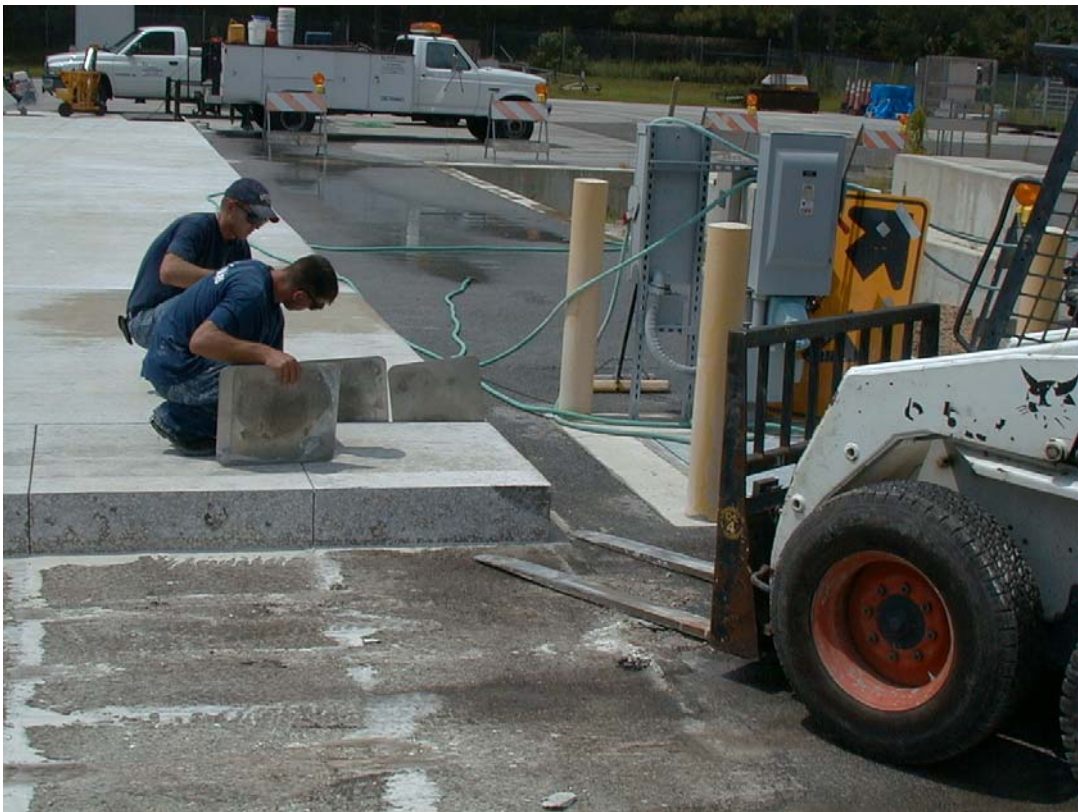
Figure 23. Removal of concrete pieces adjacent to the surrounding slabs

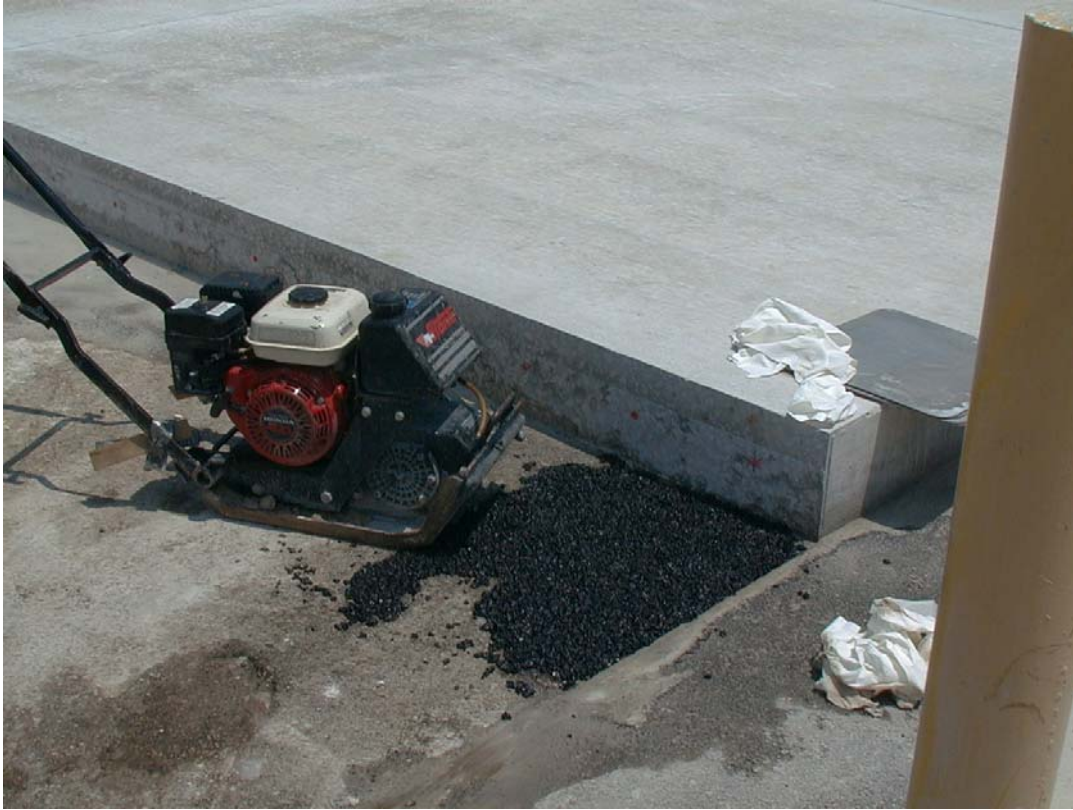
Figure 24. Correcting the damaged portion of the asphalt base

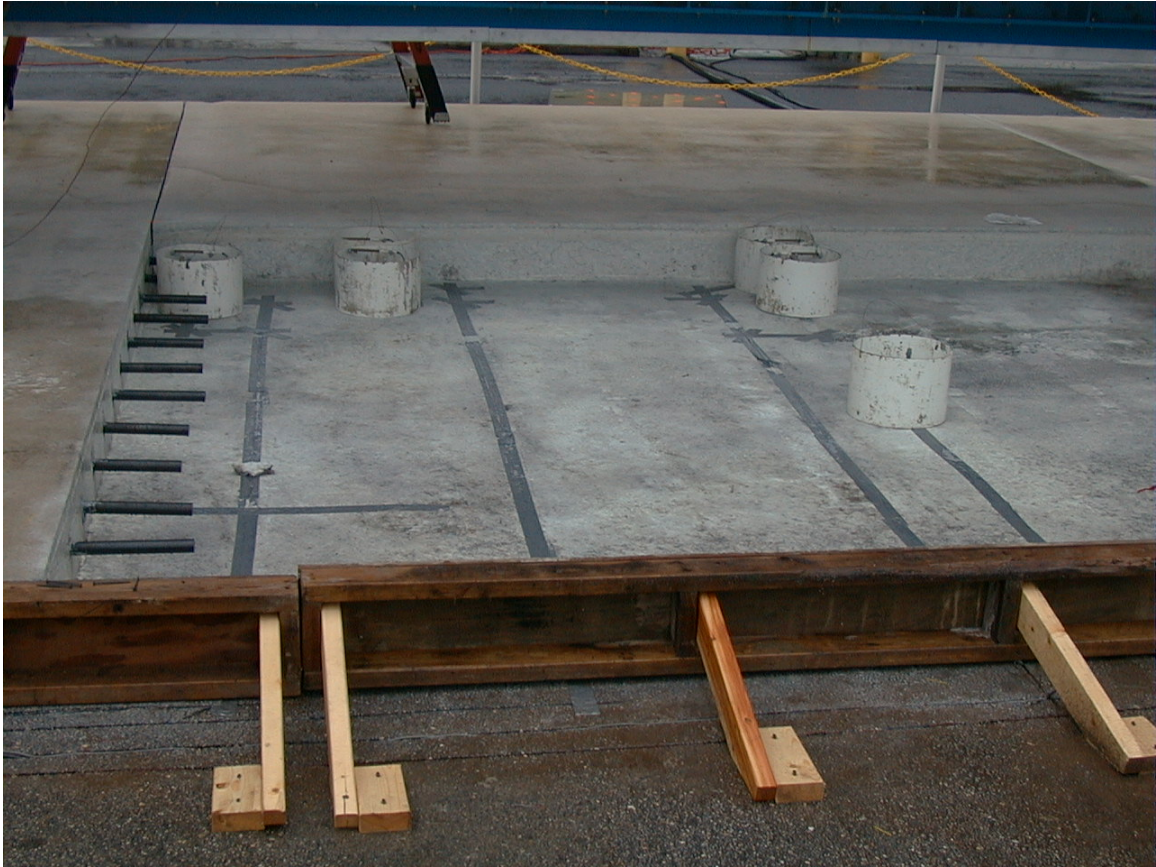
Figure 25. Dowel bars epoxied to an adjacent slab before placement of the test slab

Dowel bars were placed in drilled holes made on the adjacent slabs in one-foot intervals starting six inch from the edge. The dowel bars were fixed to the adjacent slabs using an epoxy and the open ends of the bars to be embedded in the concrete of the test slab were sprayed with a lubricant to allow movement in the longitudinal direction. Figure 25 shows the dowel bars epoxied to an adjacent slab before placement of the concrete test slab.

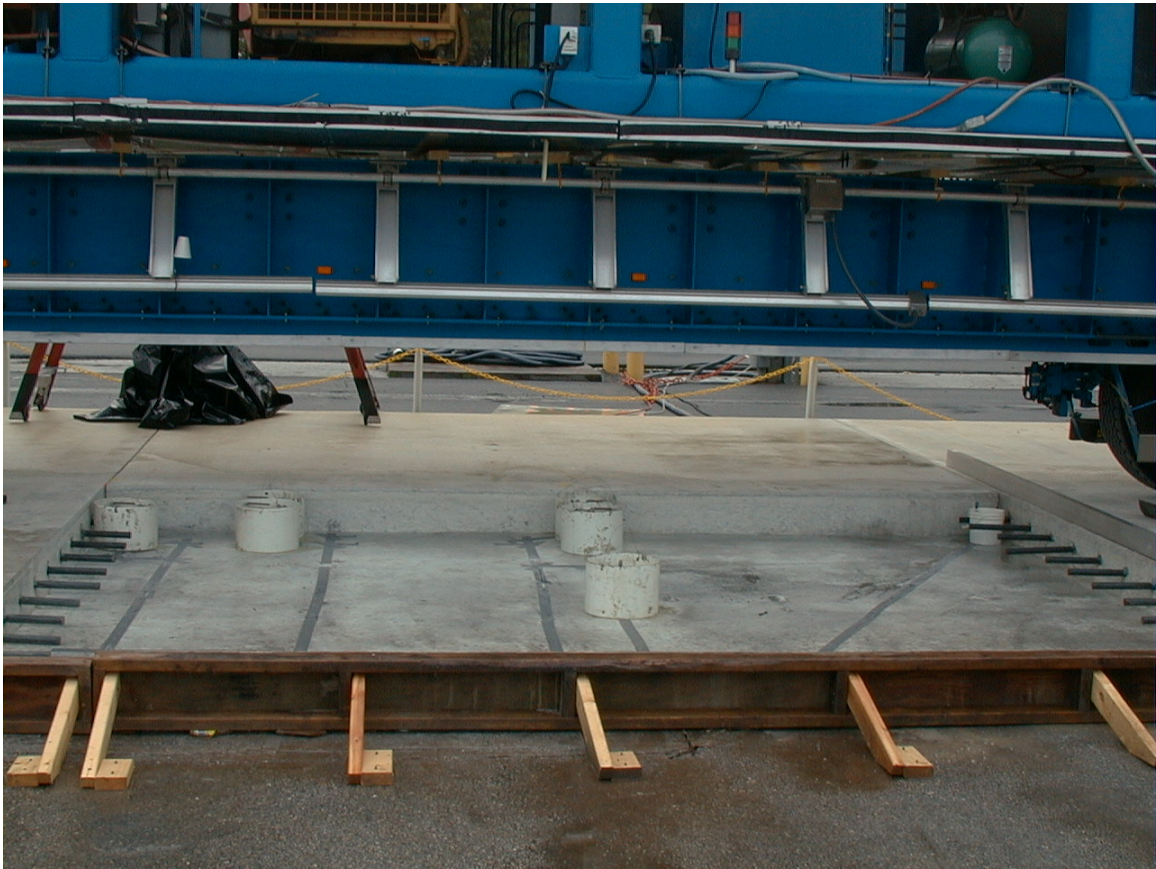
Figure 27. Formwork for the free edge of Test Slab 1C

The first test slab (1C) to be replaced was confined by three adjacent slabs and had one free edge. Figure 27 shows the formwork for the free edge of Slab 1C. The other four test slabs (1G, 2C, 2E & 2G) to be placed were free at both longitudinal edges. So formwork was used for on both edges of these test slabs.

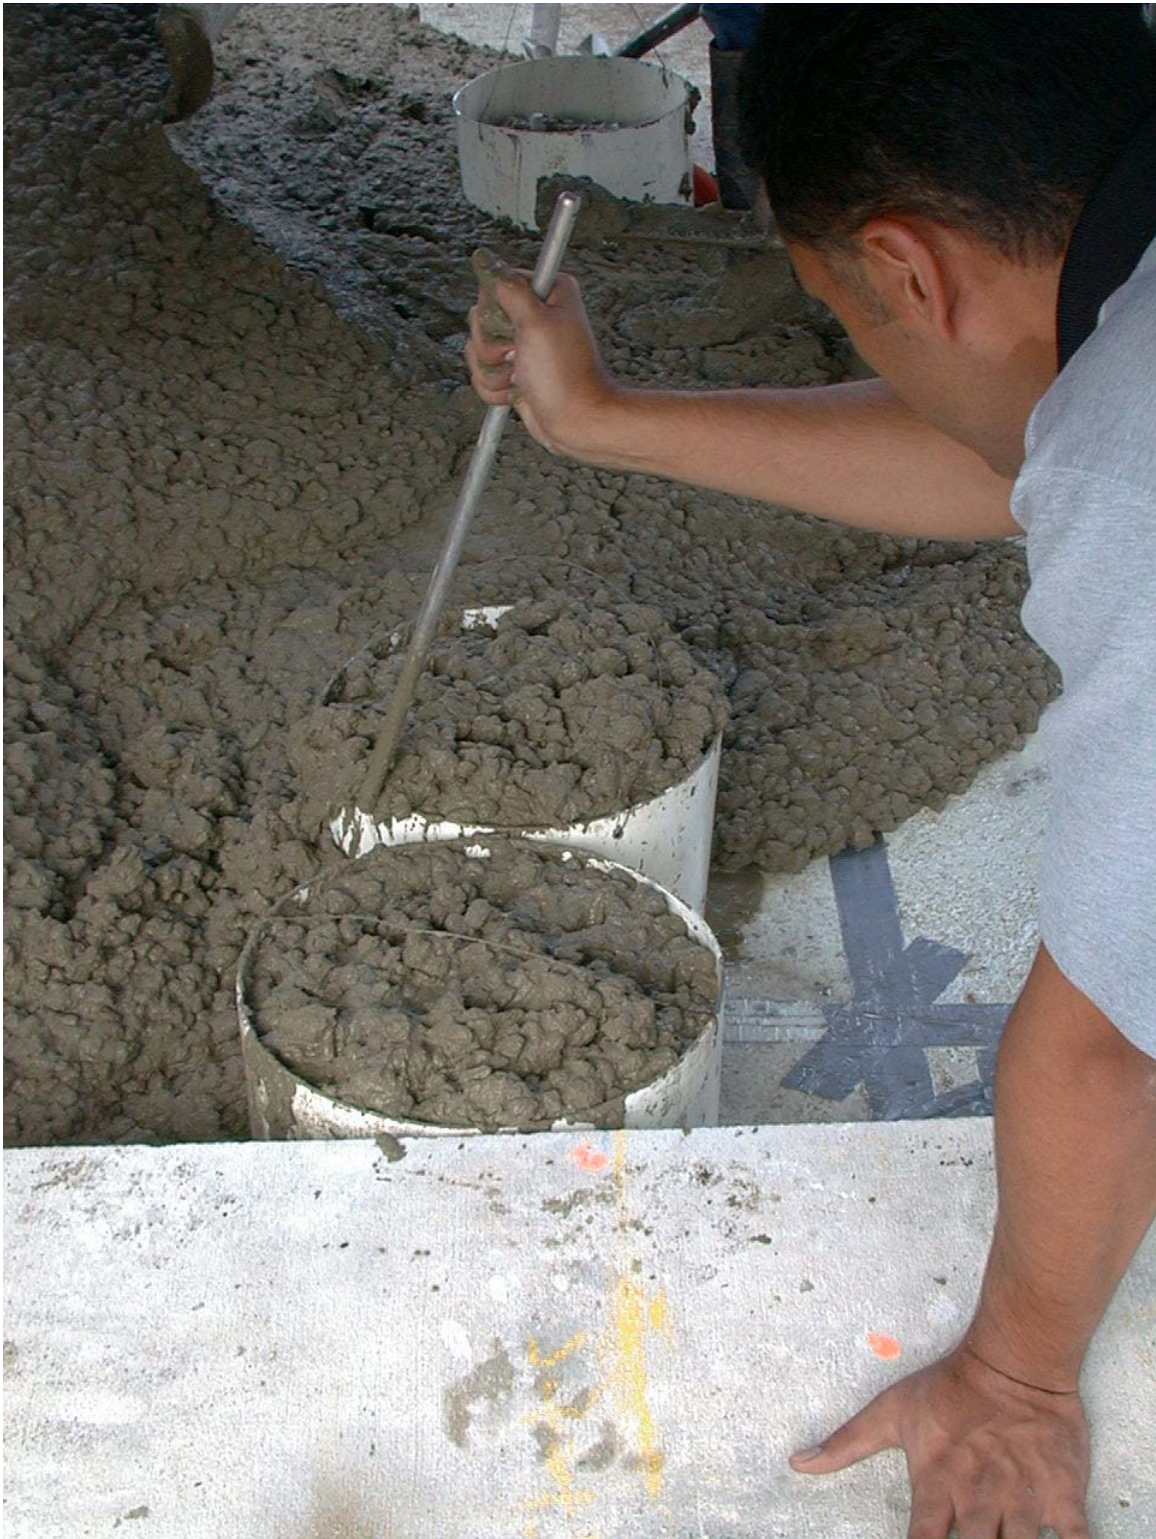
Figure 28. Placing concrete around strain gauges

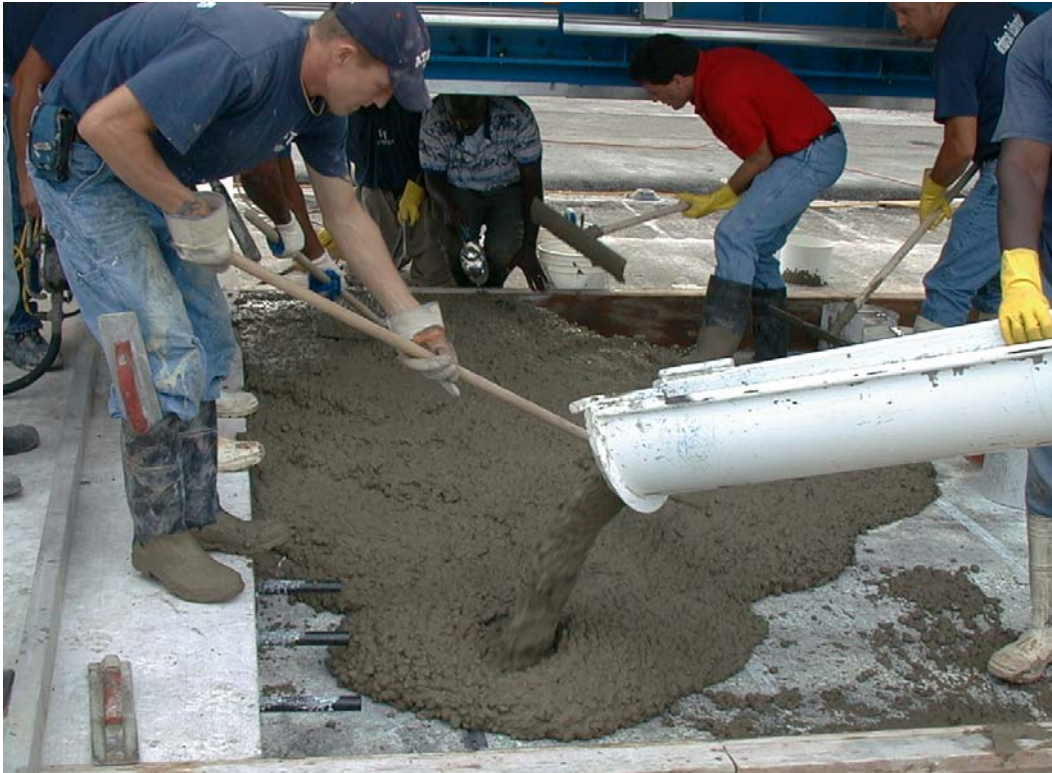
Figure 29. Placement of concrete for a test slab

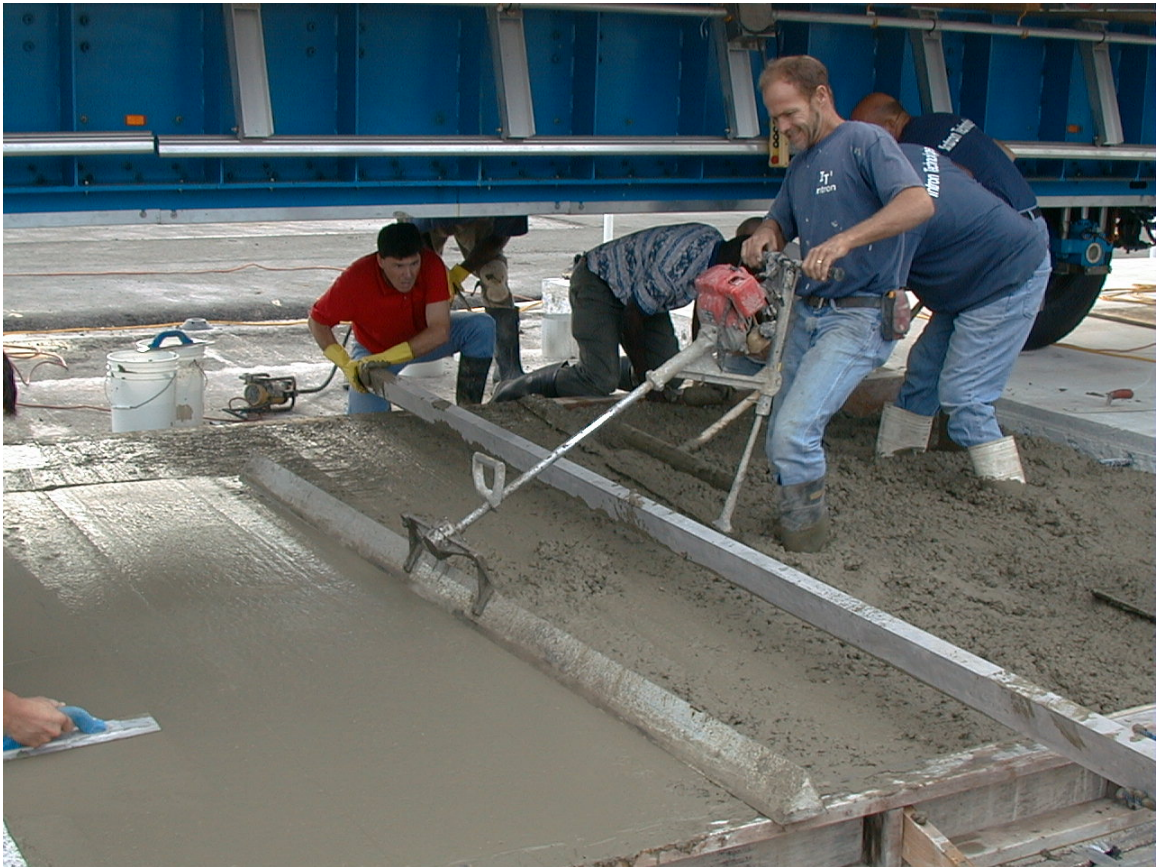
Figure 31. Leveling of concrete surface

A vibrating leveling bar was used to level off the concrete. Figure 31 shows the leveling of the concrete surface of the test slab. The concrete surface was finished with additional hand troweling. A broom was passed over the concrete surface to produce a rough surface texture before it hardened. After placement and finishing of the concrete, 3-in. (7.6 cm) deep saw cuts were made to form the joints for the slabs. Figure 32 shows a picture of this sawing operation.

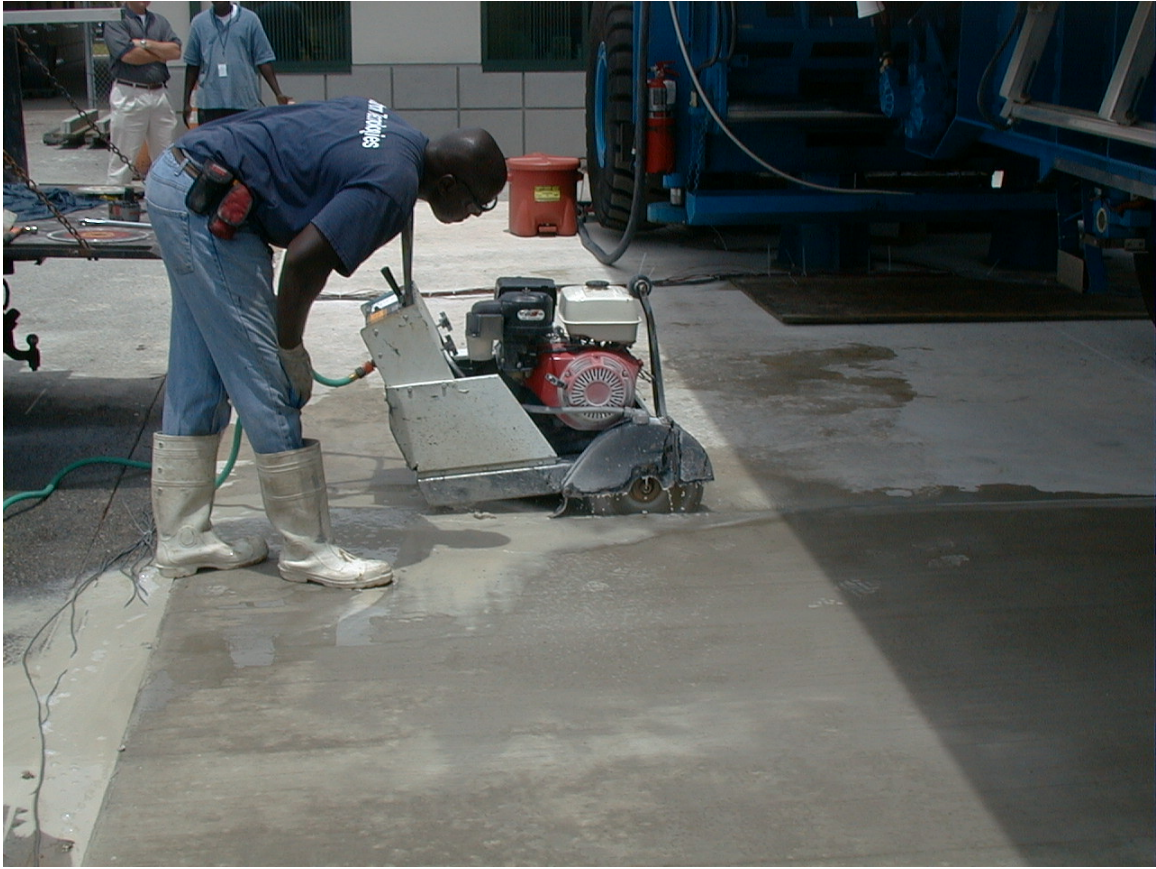
Figure 32. Making a 3-inch deep saw cut at the joint

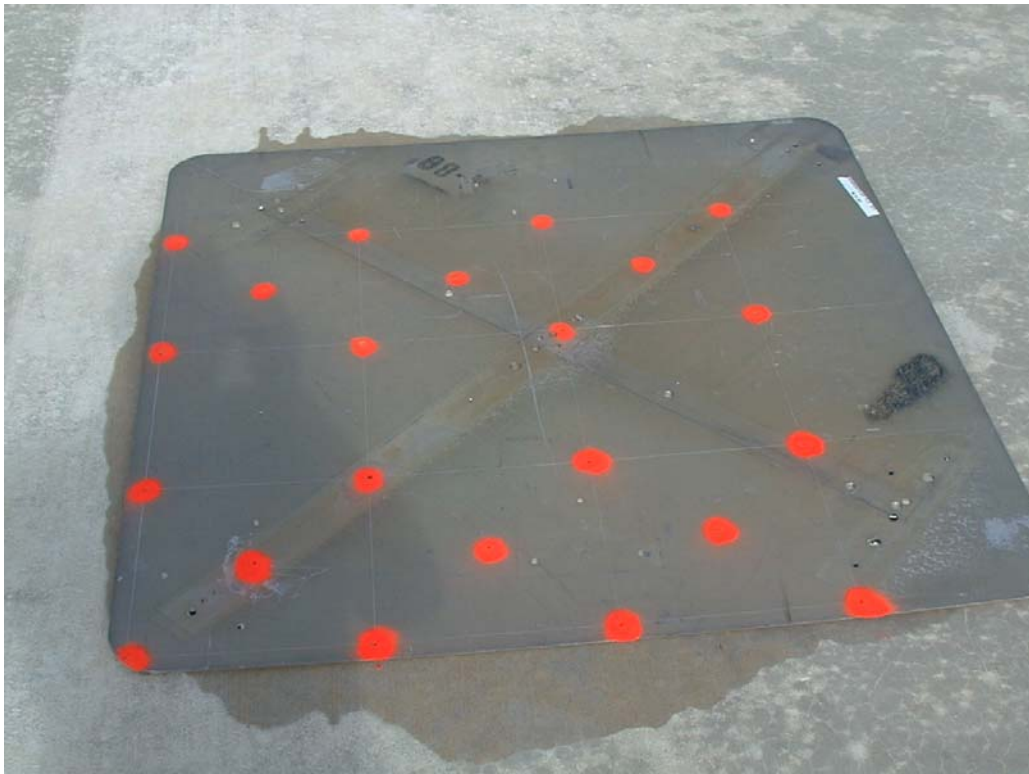
Figure 40. Steel template for marking impact and receiver locations

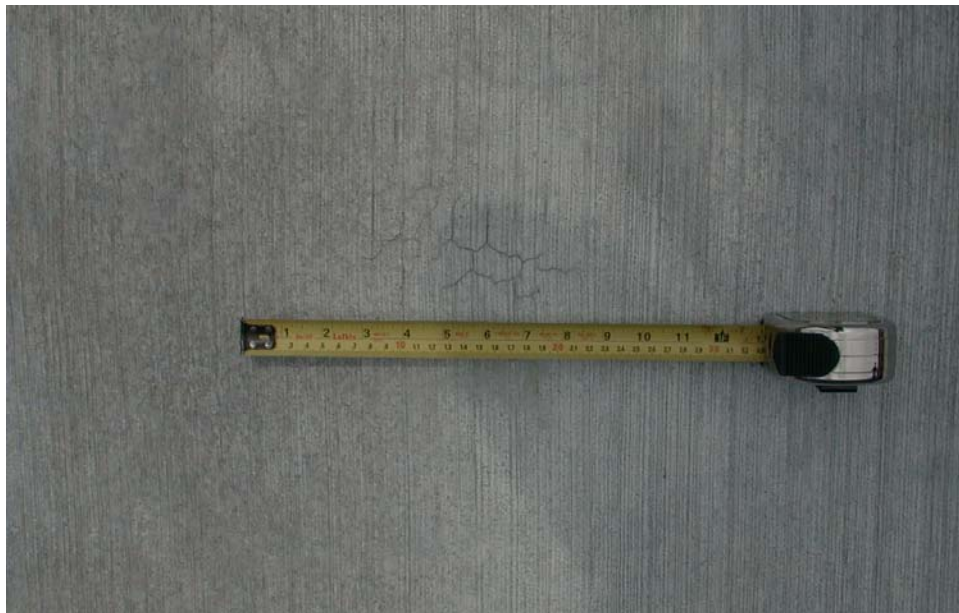
Figure 42. Shrinkage cracks on Test Slab 1C

Shrinkage cracks were observed at a few places on the finished surface of Slab 1C within a few hours after the placement of the concrete. Figure 42 shows the shrinkage cracks induced on the slab. The first load related crack was detected on the 15th day of loading, which was one day after the load had been increased to 18 kips. The first detected crack was a corner crack, which occurred on the wheel path at the north end of the slab. Figure 43 shows a picture of this corner crack. This corner crack extended from the joint at 25 inches from the edge to the edge at 35 inches from the joint. HVS loading was continued for another day, at which point another corner crack, which extended from the joint at 47 inches from the edge, was observed. Figure 44 shows a picture of the cracked Slab 1C at the end of HVS testing. Figure 45 shows the initial and final crack map for Slab 1C.

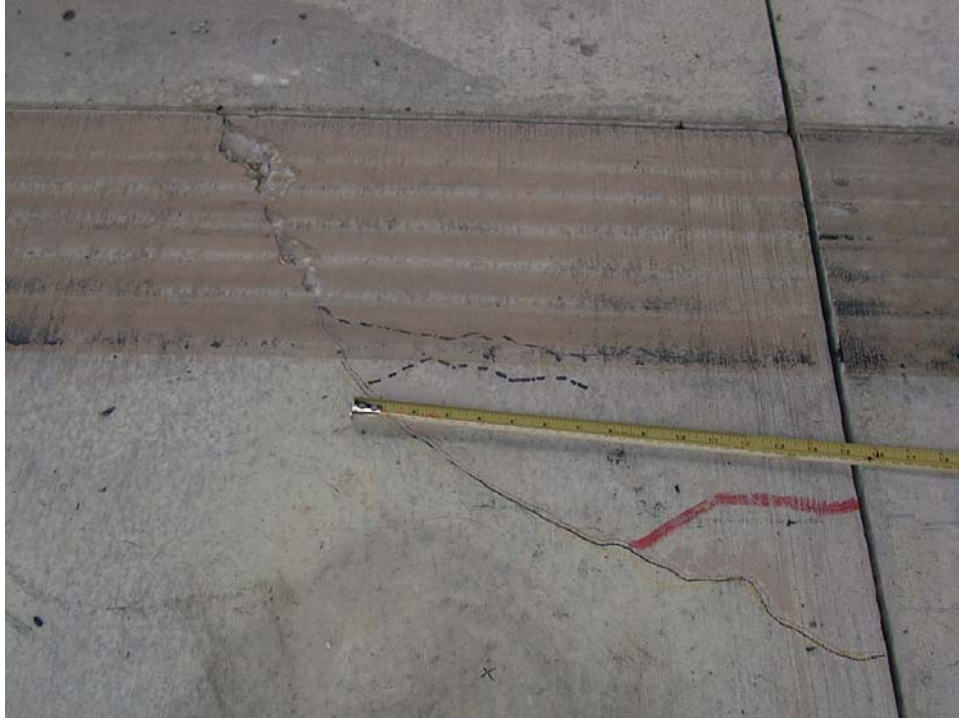
Figure 43. Corner crack on Slab 1C

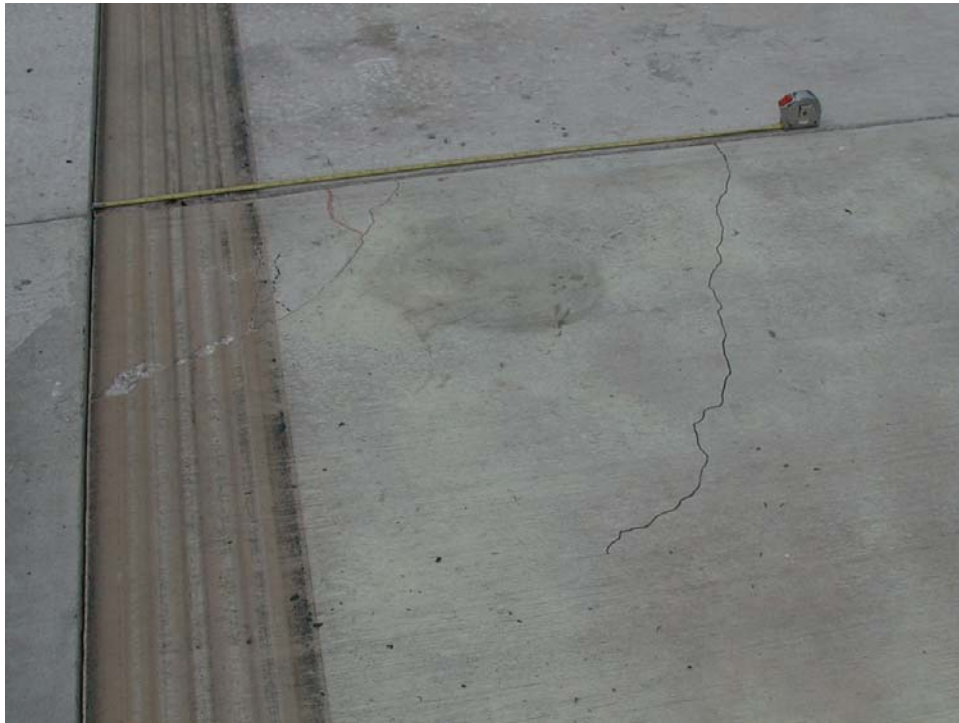
Figure 44. Cracked Slab 1C at the end of HVS testing

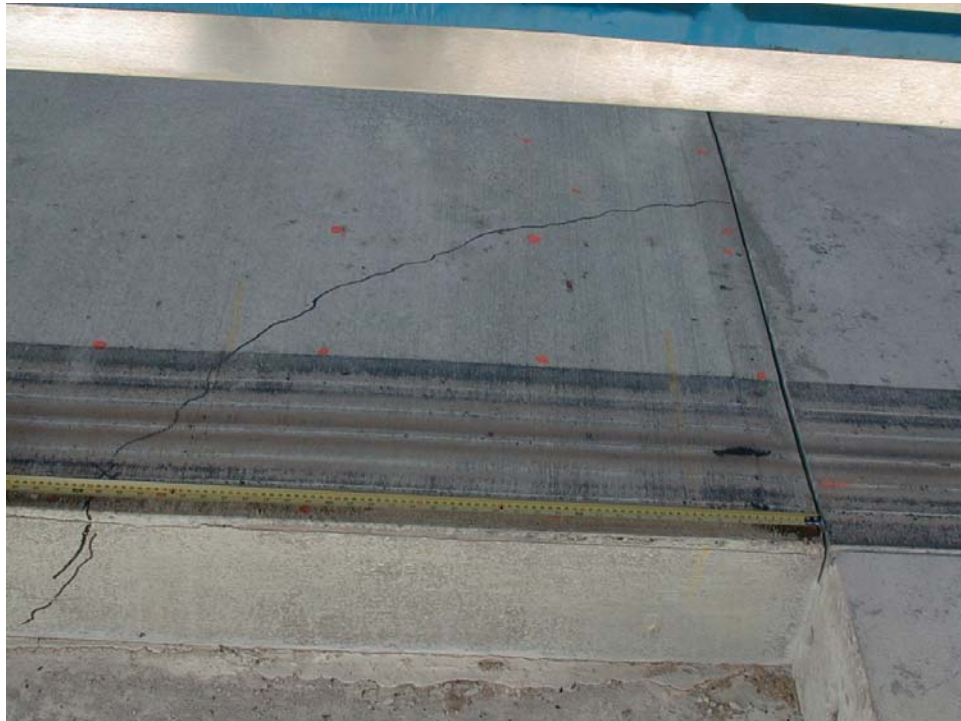
Figure 46. Corner crack at the southern end of Slab 1G

For Slab 1G, cracking was detected after 11 days of HVS loading and 2 days after the HVS load was raised to 15 kips, with a total of 107,152 load repetitions at 12 kips and 20,464 load repetitions at 15 kips. At the southern end of the slab, there was a corner crack, which extended from the joint at 30 inches from the edge to the edge at 33 inches from the joint. This crack happened to run over the location of strain gauge no. 3. Figure 46 shows a picture of this corner crack. There was also a similar crack on the northern end of the slab, which extended from the edge at 34 inches from the joint. However, this crack did not propagate all the way to the joint. In addition to the corner cracks, there were two transverse cracks at the mid-edge of the slab (89 and 100 inches from the southern joint of the slab). Figure 47 shows the transverse cracks at the mid-edge of the slab. These cracks propagated towards the center of the slab with additional HVS loading. Figure 48 shows the propagation of the mid-edge cracks with additional

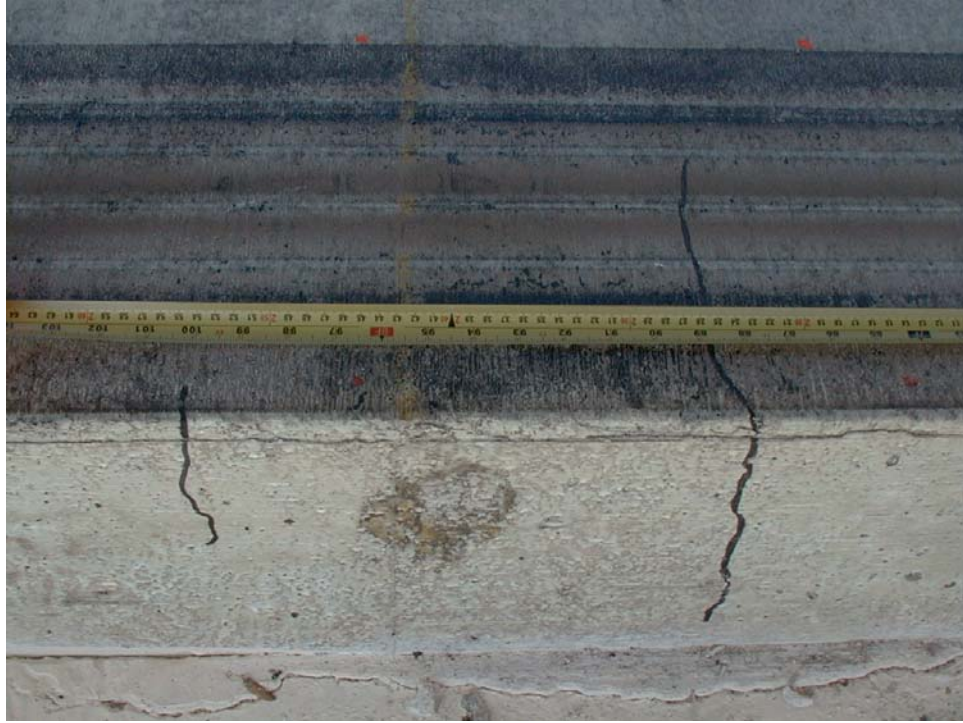
Figure 47. Transverse cracks at the mid-edge of Slab 1G

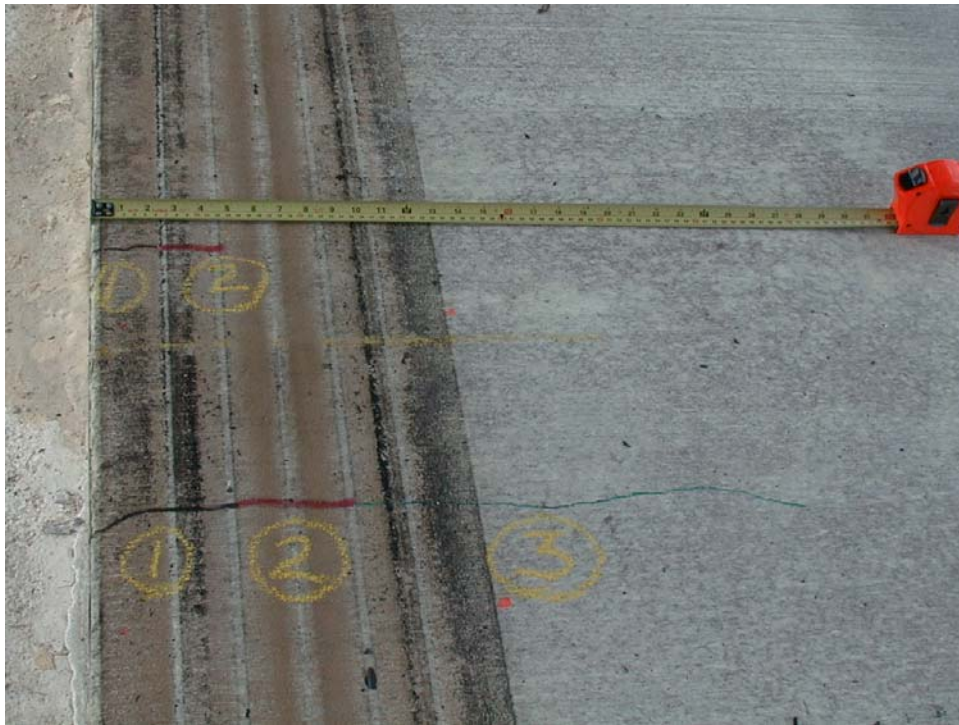
Figure 48. Crack propagation at the mid-edge of Slab 1G with additional loading

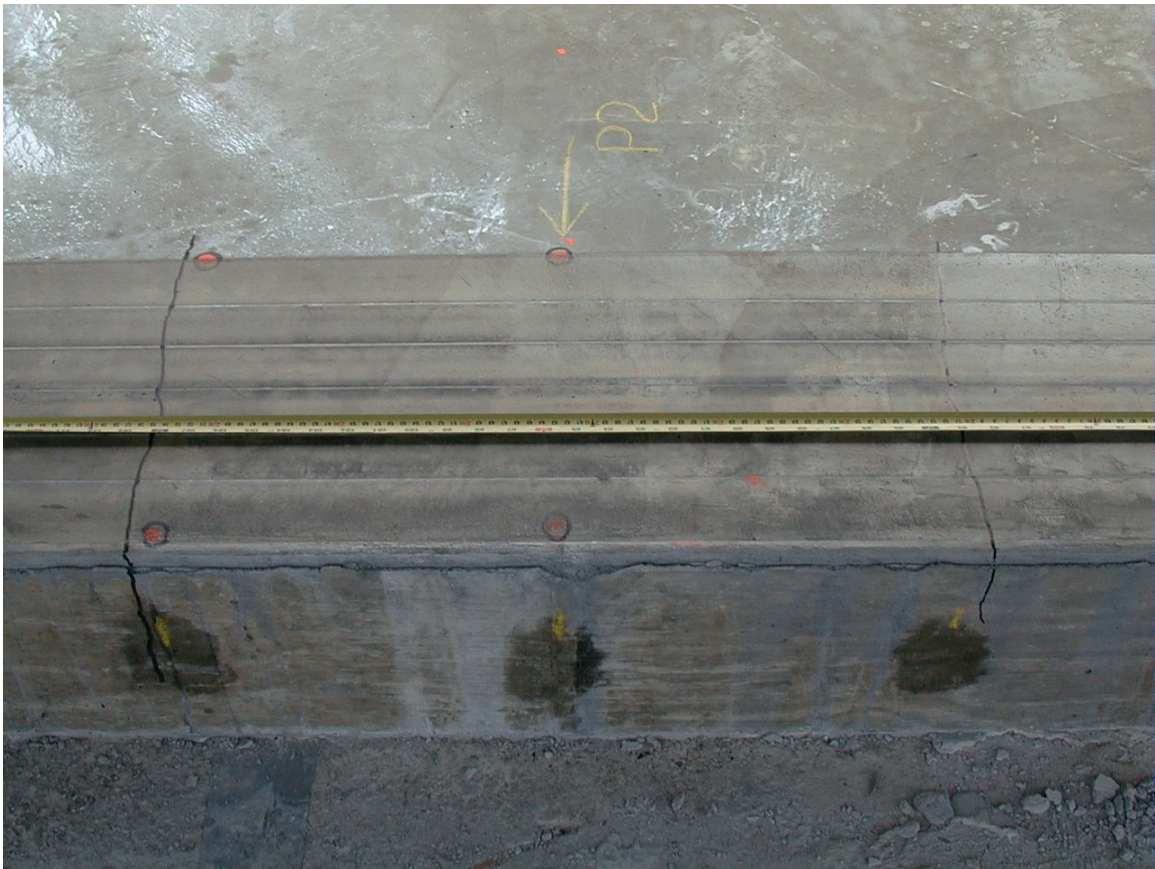
Figure 50. Transverse cracks at mid-edge of Slab 2C

For Slab 2C, cracks were first detected after 3 days of HVS loading, with a total of 33,176 load repetitions at 12 kips. There were two transverse cracks at about 1 foot off from the center of the slab on the wheel path. Figure 50 shows a picture of these two transverse cracks. Additional hairline cracks were detected after 7 days of loading, with a total of 82,243 load repetitions at 12 kips. Figure 51 shows a picture of the cracks on Slab 1C after 7 days of HVS loading. Figure 52 shows the initial and final crack map of Slab 2C.

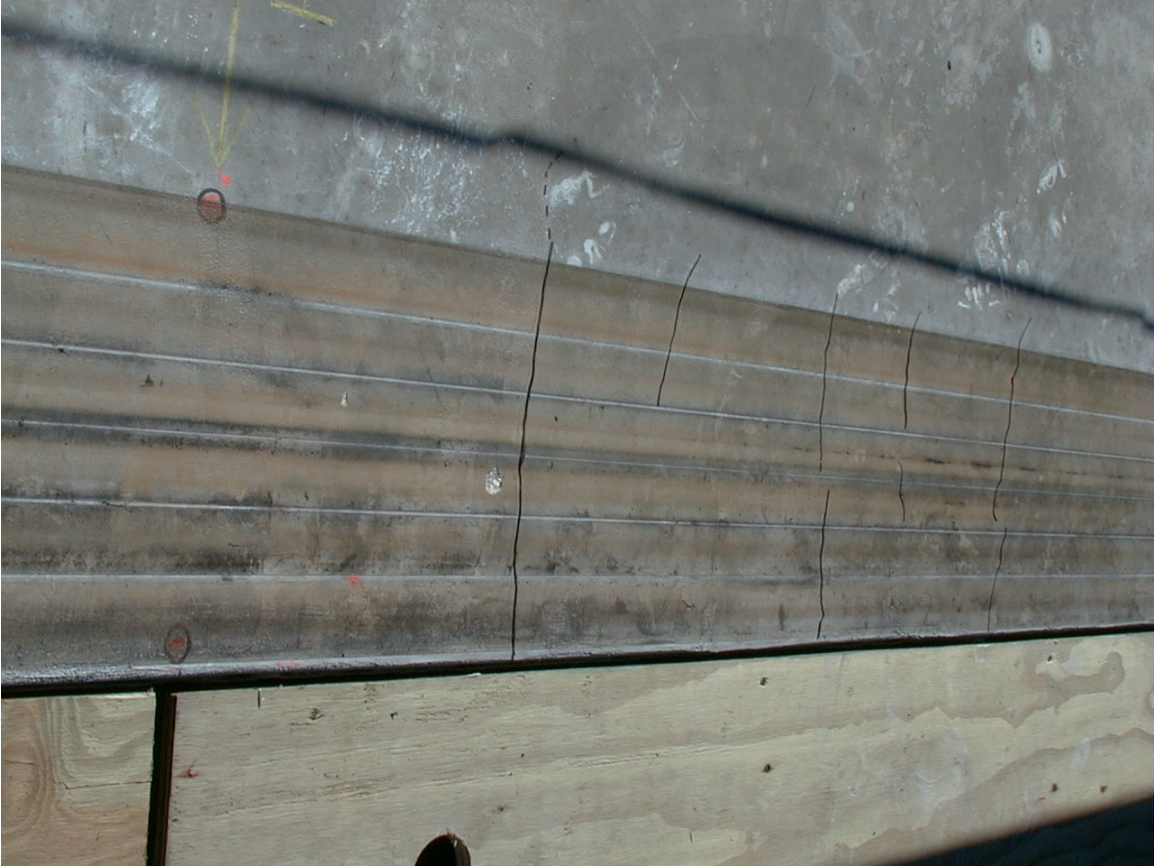
Figure 51. Cracks on Slab 2C at the end of HVS testing

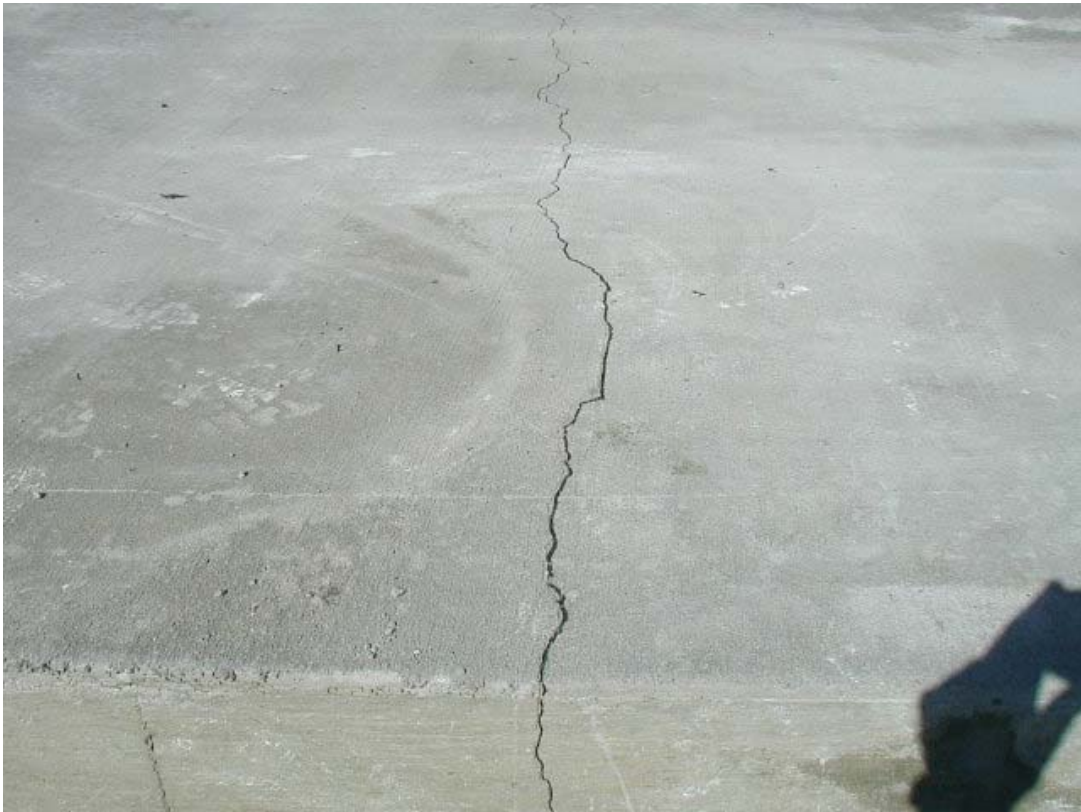
Figure 53. Transverse crack on Slab 2E at the middle of the slab

The premature cracking of Slab 2E could not be explained by the computed temperature-load induced stresses. From the appearance of the deep transverse crack across the middle of the slab, it was postulated that the cracking might be caused by the locking-up of the dowel bars at both joints.

For Slab 2E, cracks were first detected at the 7th day after the start of HVS loading, with a total of 40,809 load repetitions at 12 kips. The HVS loading was halted for 3 days due to a mechanical problem with the HVS after 3 days of loading. A transverse crack was first detected one day after HVS loading at 12 kips was resumed (or at the 7th day of test). This crack extended from the loading edge to the opposing edge at the middle of the slab. Figure 53 shows the transverse crack that developed on Slab 2E. Figure 54 shows the crack map of Slab 2E.
