FINAL REPORT

U.F. Project No: 49104504972-12

Contract No: BC-354

Evaluation of Early Strength Requirement of Concrete for Slab Replacement Using APT

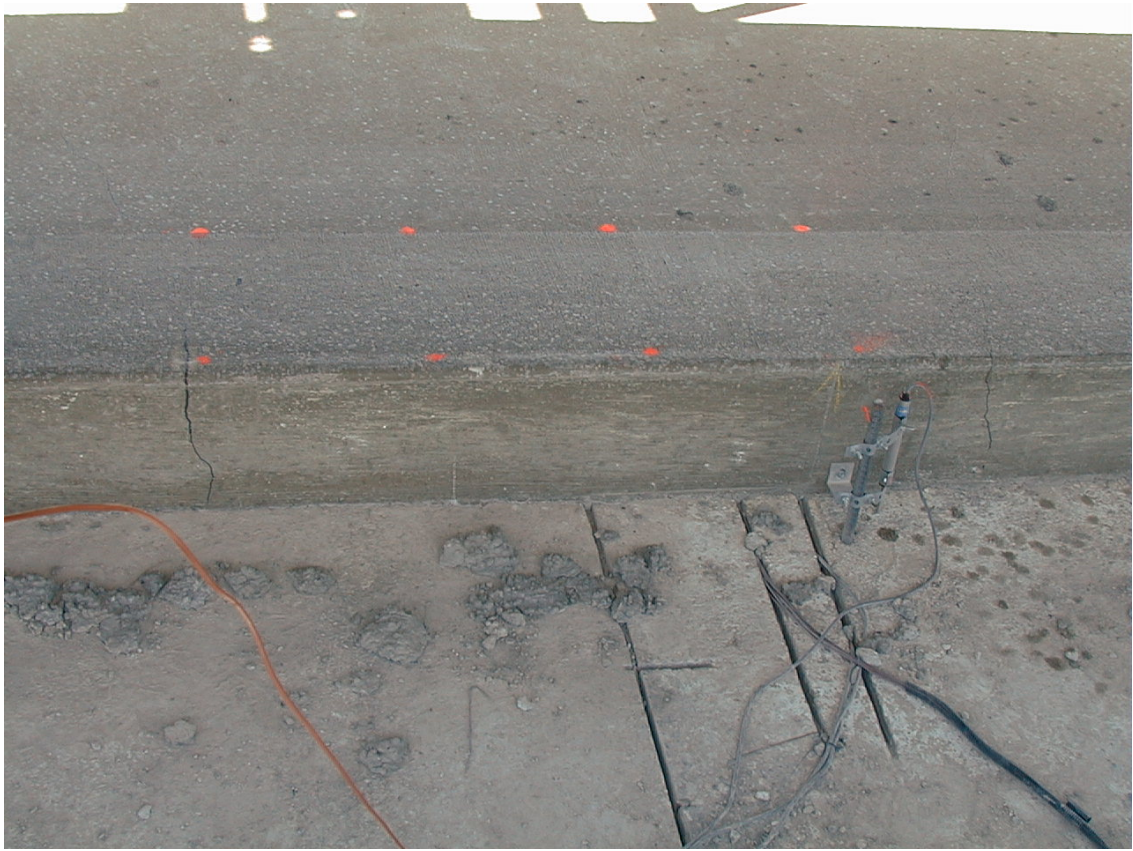
Figure 55. Transverse cracks on Slab 2G at the middle of the slab

For Slab 2G, the first crack was detected at the 6th day of loading with 50,933 passes of HVS wheel load at 12 kips. Two transverse cracks were noted to start from the edge. One transverse crack started at 9 inches south of the mid-point, while the other started at 36 inches north of the mid-point. Figure 55 shows a picture of the transverse cracks that developed on Slab 2G. Figure 56 shows the initial and final crack map of Slab 2G.

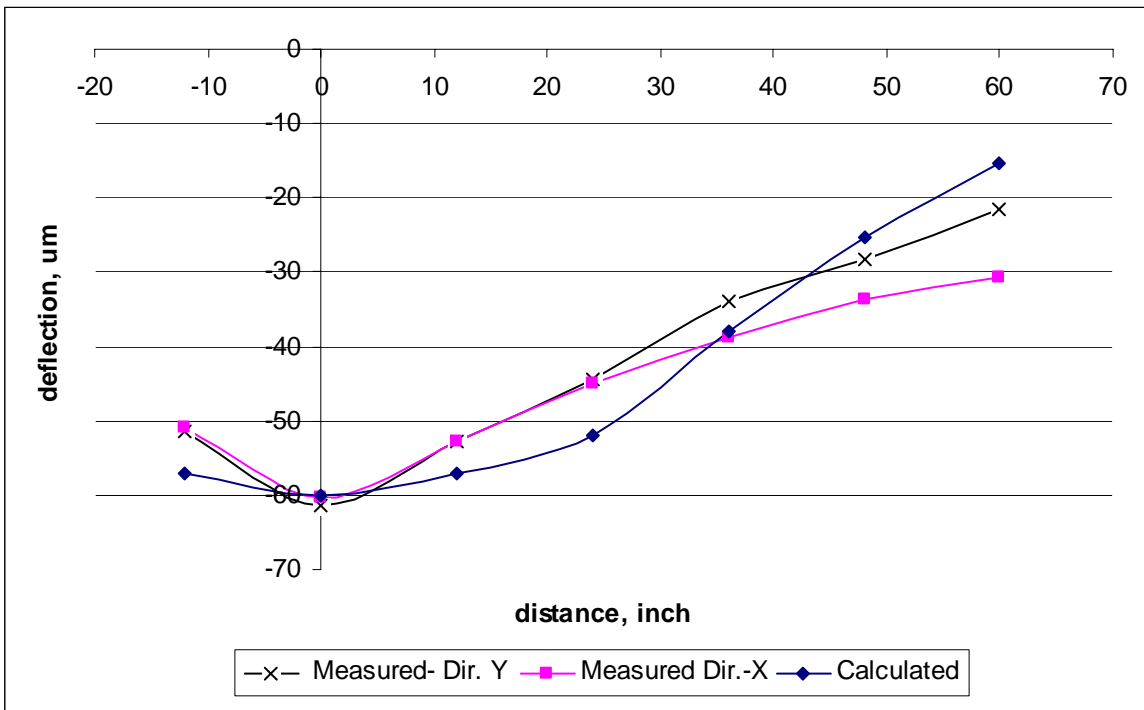
Figure 57. Measured and computed deflection basins caused by a 9-kip FWD load at slab center for Slab 1G

The computed and measured deflections at the locations of the geophones for Slab 1G are shown in Figure 57. The measured deflections in the X direction were noted to be different from those in the Y direction. The differences in deflections in the two directions may be due to cracks on the slab. The computed deflection basin was obtained by using a modulus of subgrade reaction of 0.9 kci. The computed deflection for Slab 2C is shown in the Figure 58. For Slab 2C, the modulus of subgrade reaction was estimated to be 1.1 kci. The lower modulus of subgrade reaction for the Slab 1G could be due to deterioration of the asphalt layer prior to the placement of the concrete slab at Slab 1G. FDOT personal had noticed the deterioration of the asphalt layer at Slab 1G and had used a cold asphalt patch to repair the damaged area before placement of the replacement concrete slab.

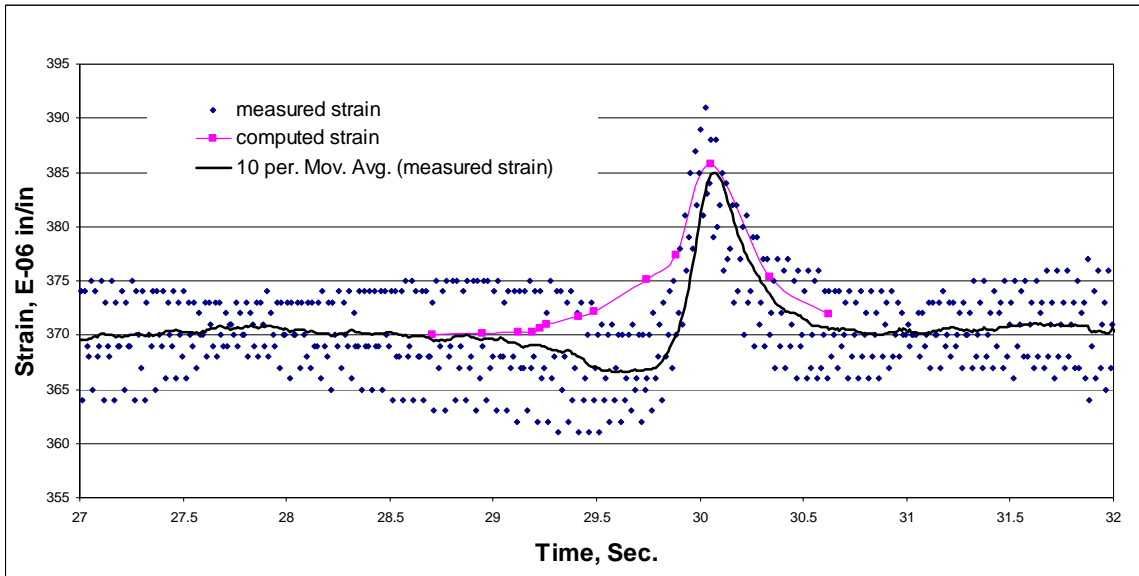
Figure 69. Measured and computed strains for gauge 7 on Slab 1C

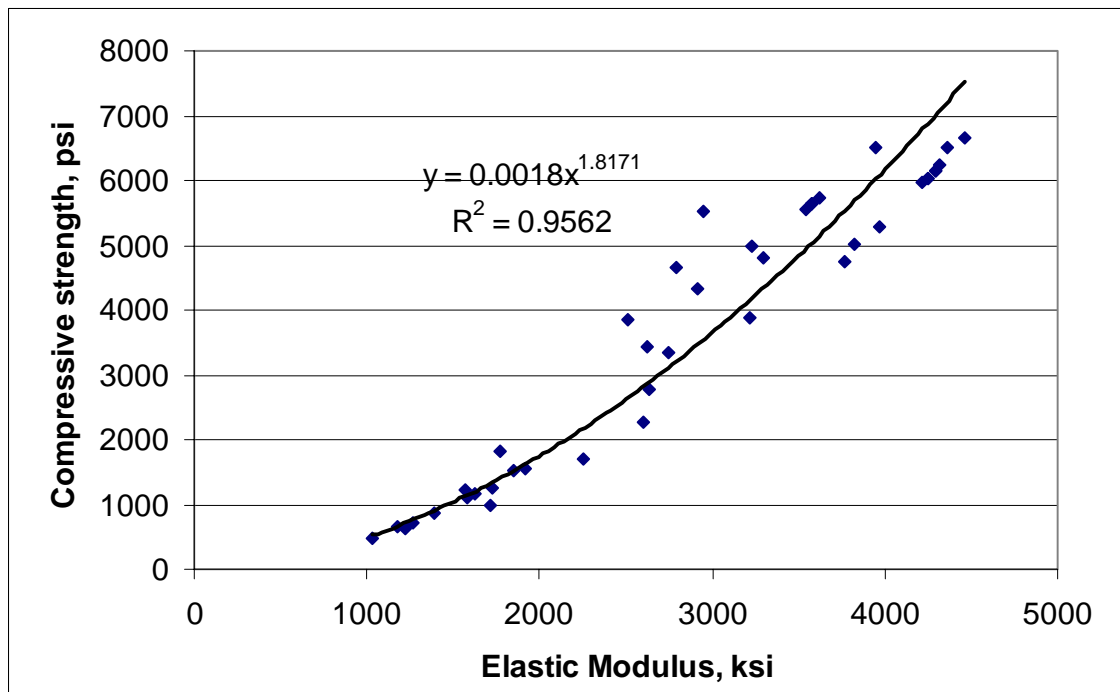
Figure 82. Relationship between compressive strength and elastic modulus
