Florida Department of
TRANSPORTATION

Precast Pre-stressed Concrete Pavement Web Interim Report

State Road
600

Last Update
August 2014

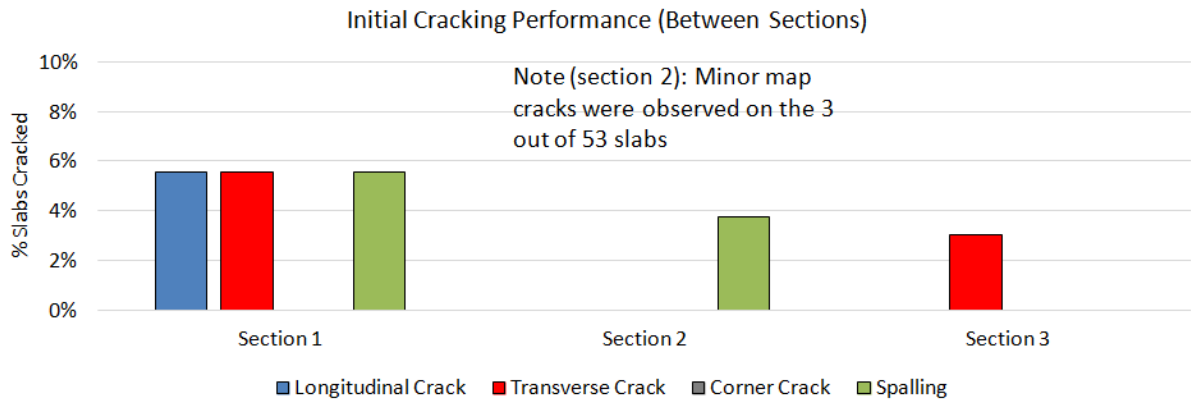
Pavement Distress

- Percent of Deteriorated Slabs (All Test Sections, Newly Placed Slabs)
 - Longitudinal Crack
 - Transverse Crack
 - Corner Crack
 - Spalling

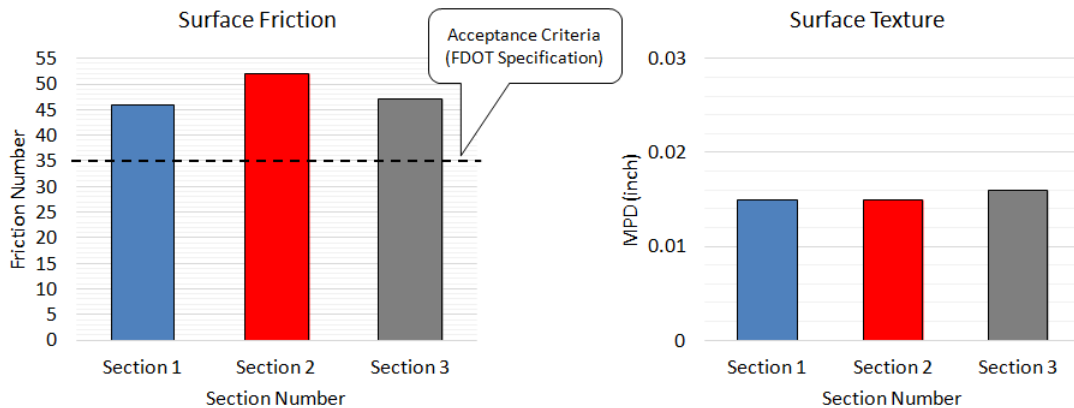
- Surface Texture and Friction
 - Surface texture: Mean Profile Depth (MPD), ASTM E 2157
 - Surface Friction: FN-40R, ASTM E 274 (FDOT Spec: ≥ 35)

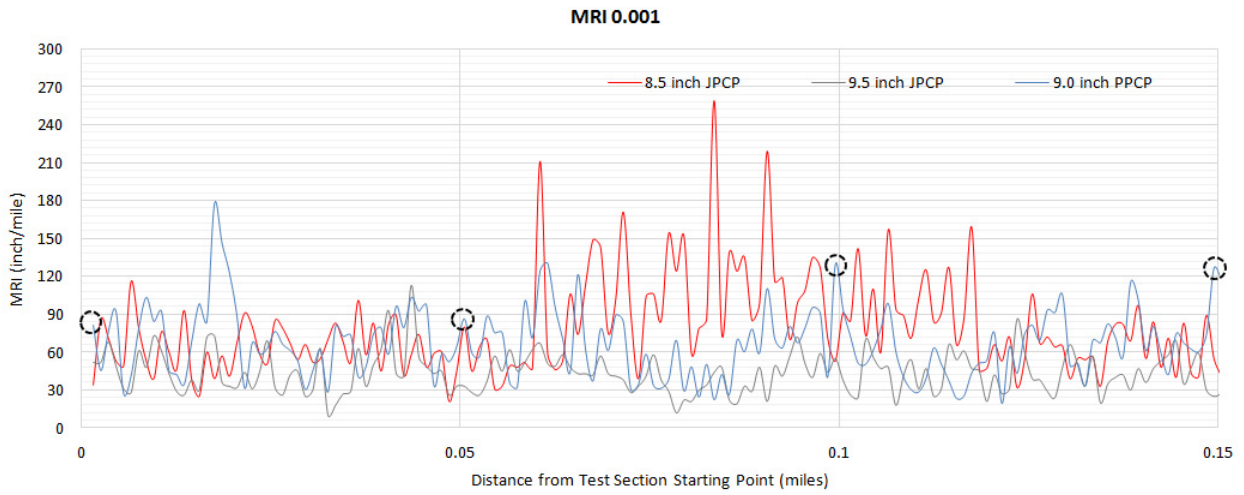
Initial Smoothness

- ○ Expansion Joint Location

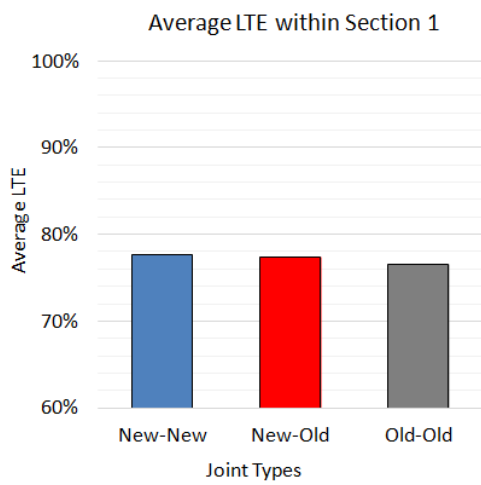
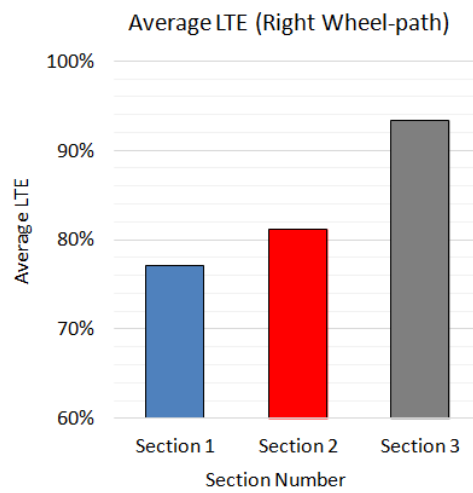
FWD Test (LTE)

The performance is evaluated in terms of Deflection, Faulting, Friction, Cracking and Ride Quality (an average of both wheel paths).
