Corrosion Resistant Alloys for Steel Reinforcement in Concrete

2012 Update

Mario Paredes, PE*
State Corrosion Engineer

* Florida Department of Transportation

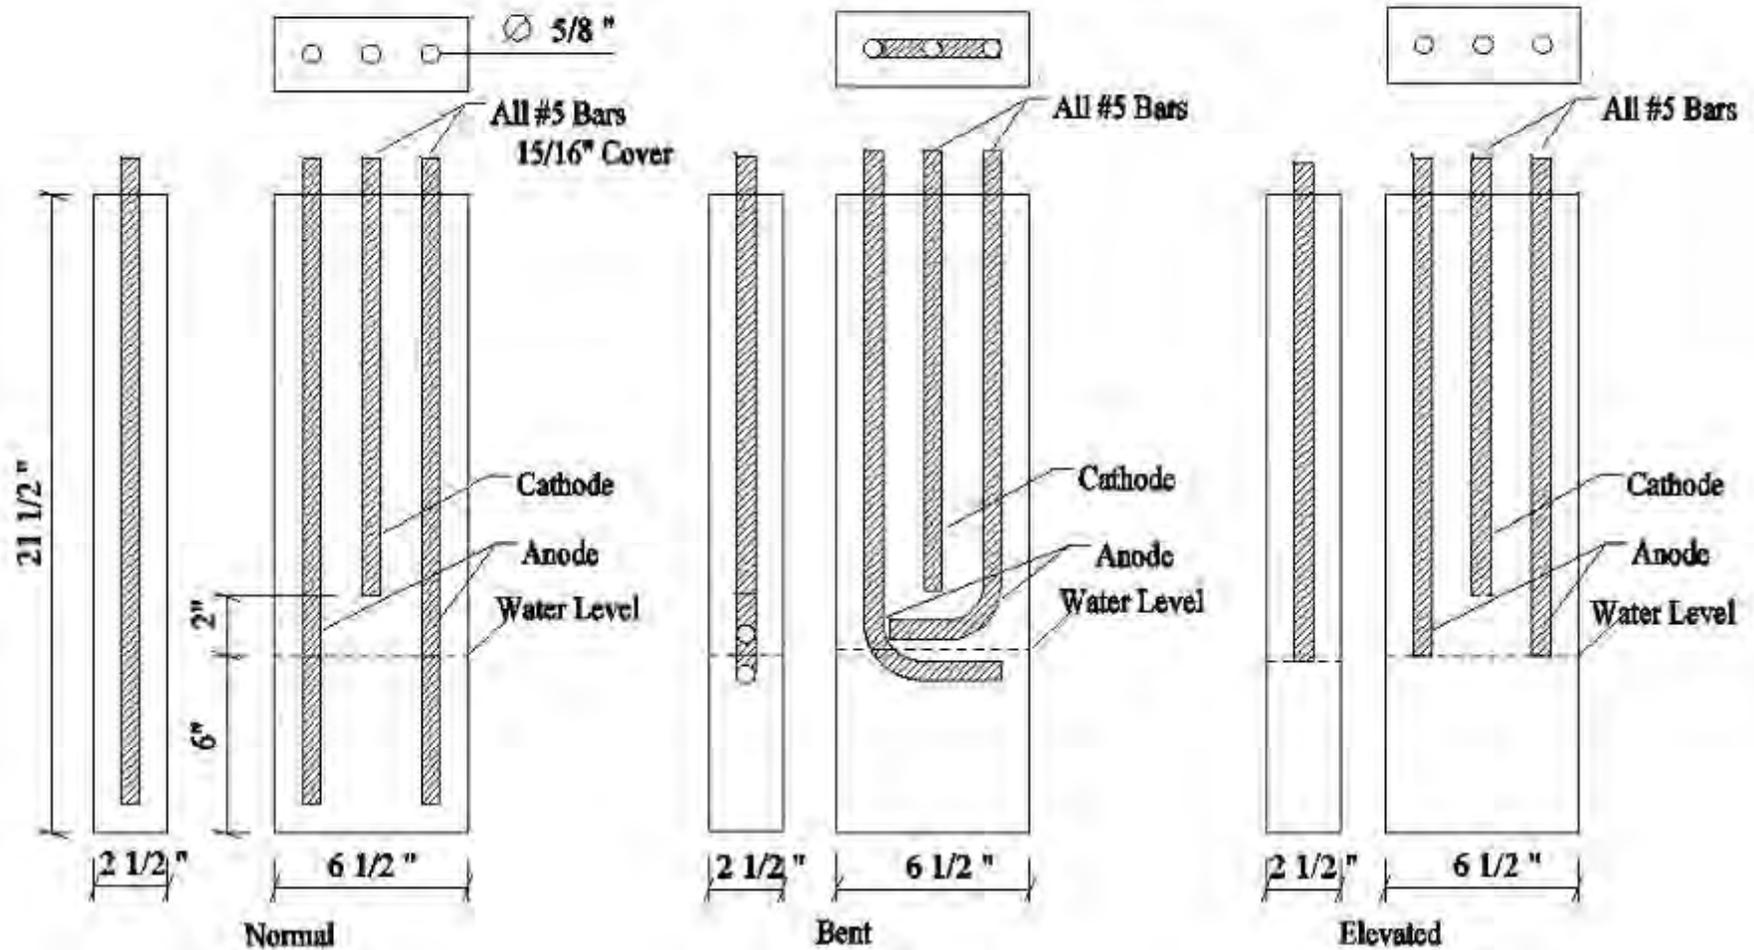
3 Bar Tombstone Specimen Geometries

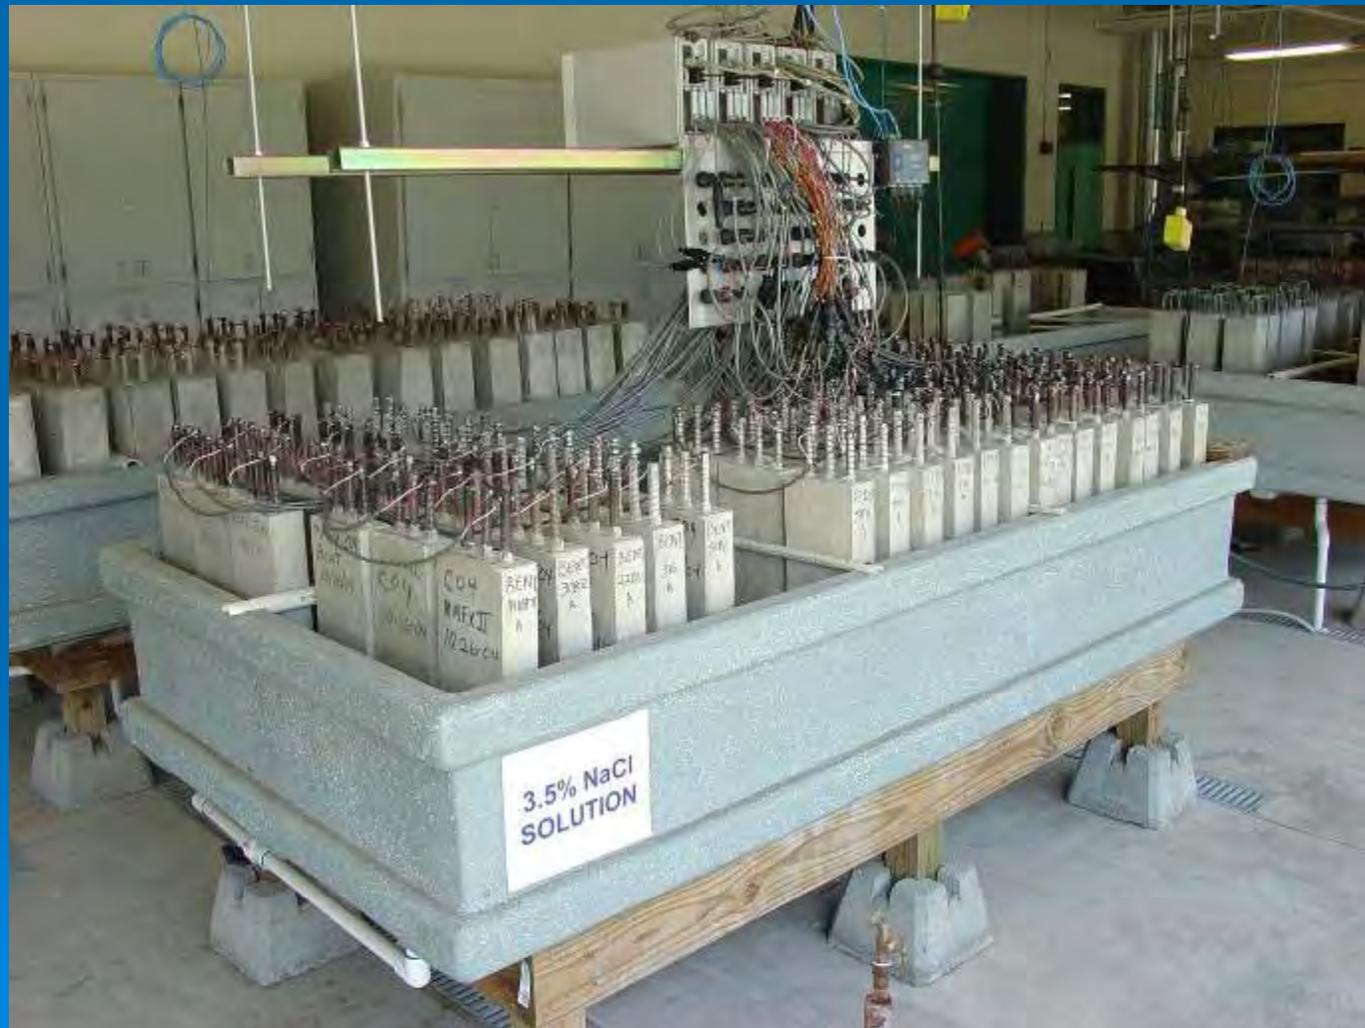
Laboratory 3-Bar Tombstone Specimens

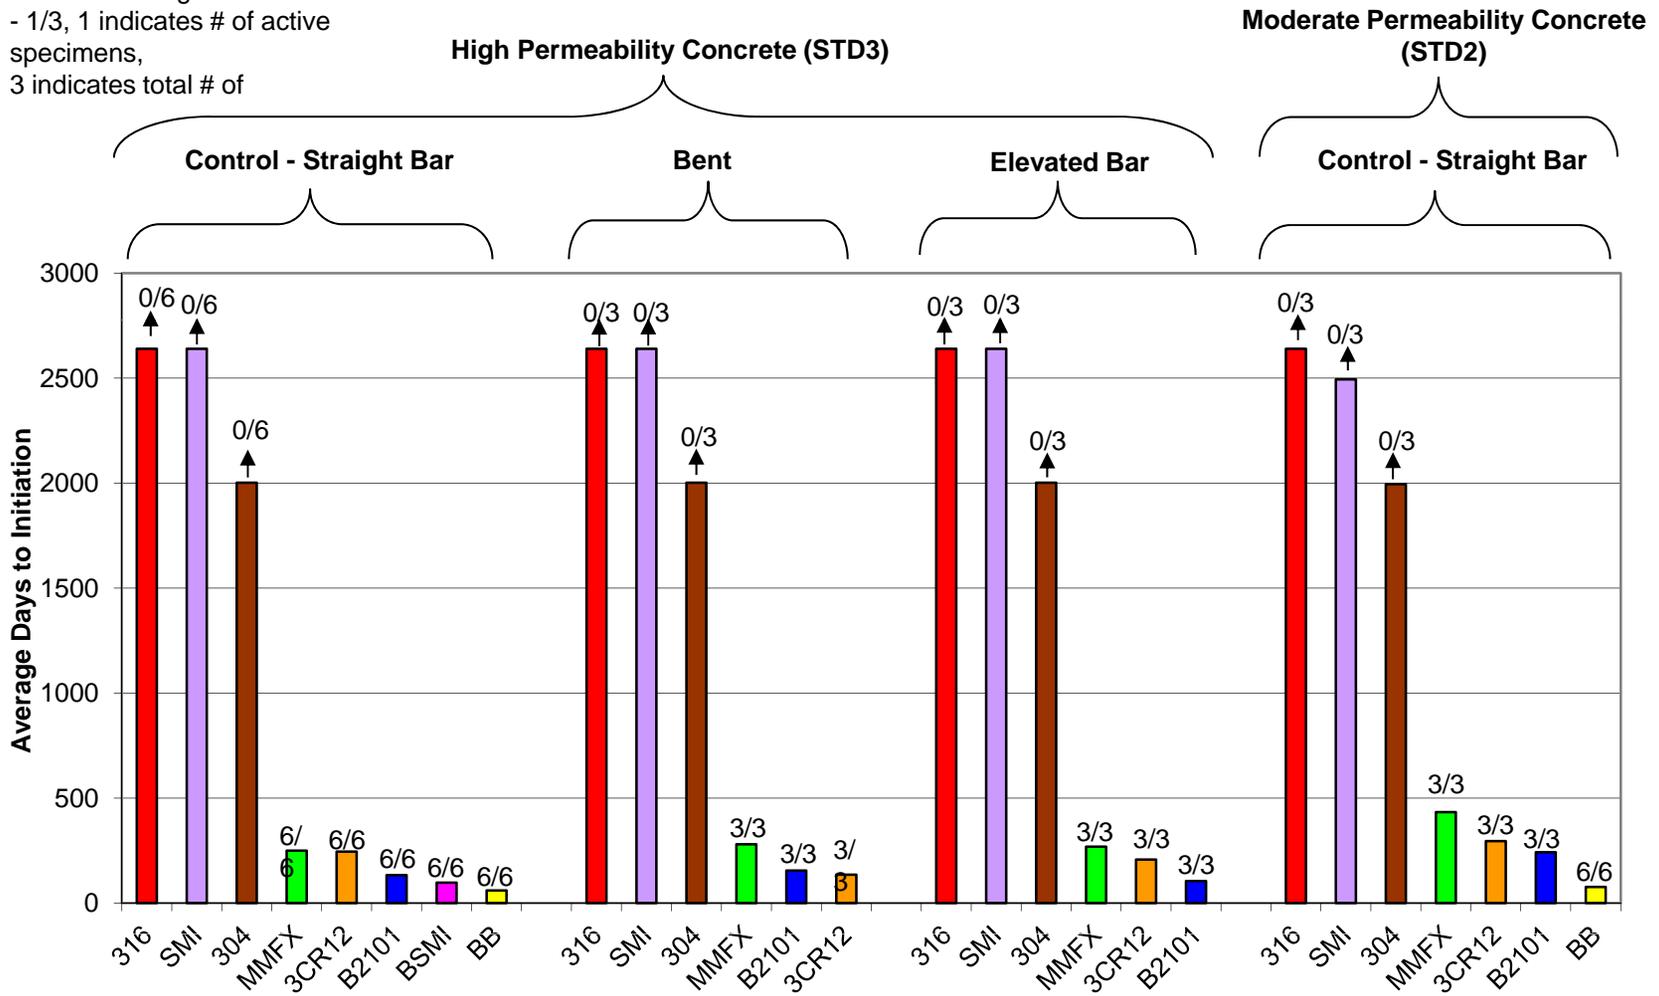
3-BAR TOMBSTONE PERFORMANCE

- All bars as received.
- ↑ Indicates not all samples in the set have shown signs of corrosion
- 1/3, 1 indicates # of active specimens, 3 indicates total # of

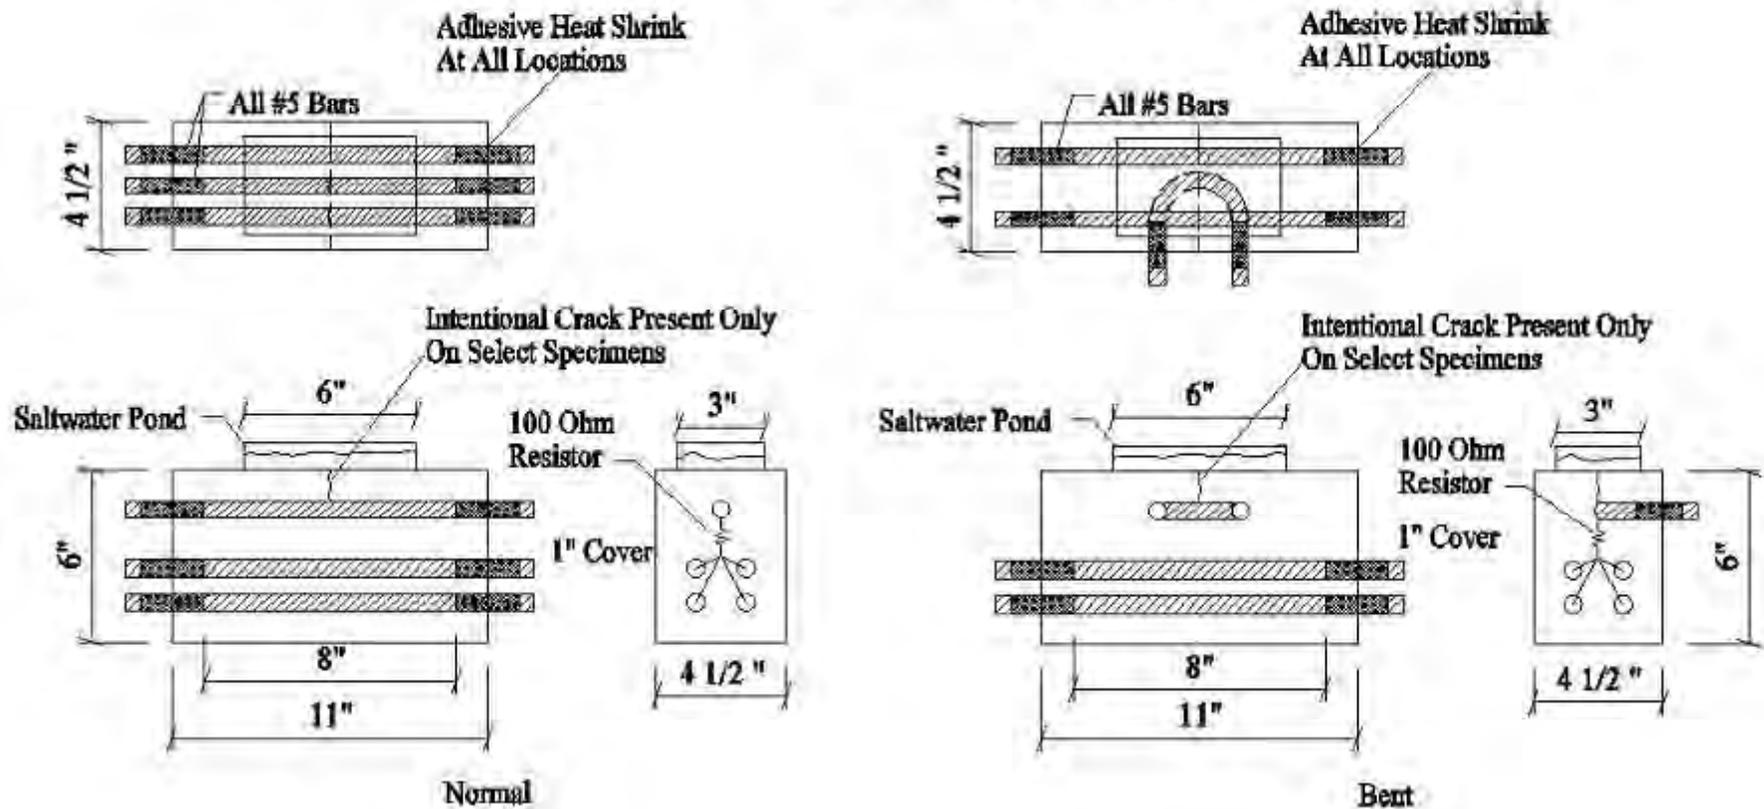
Macrocell Slab Specimen Geometries

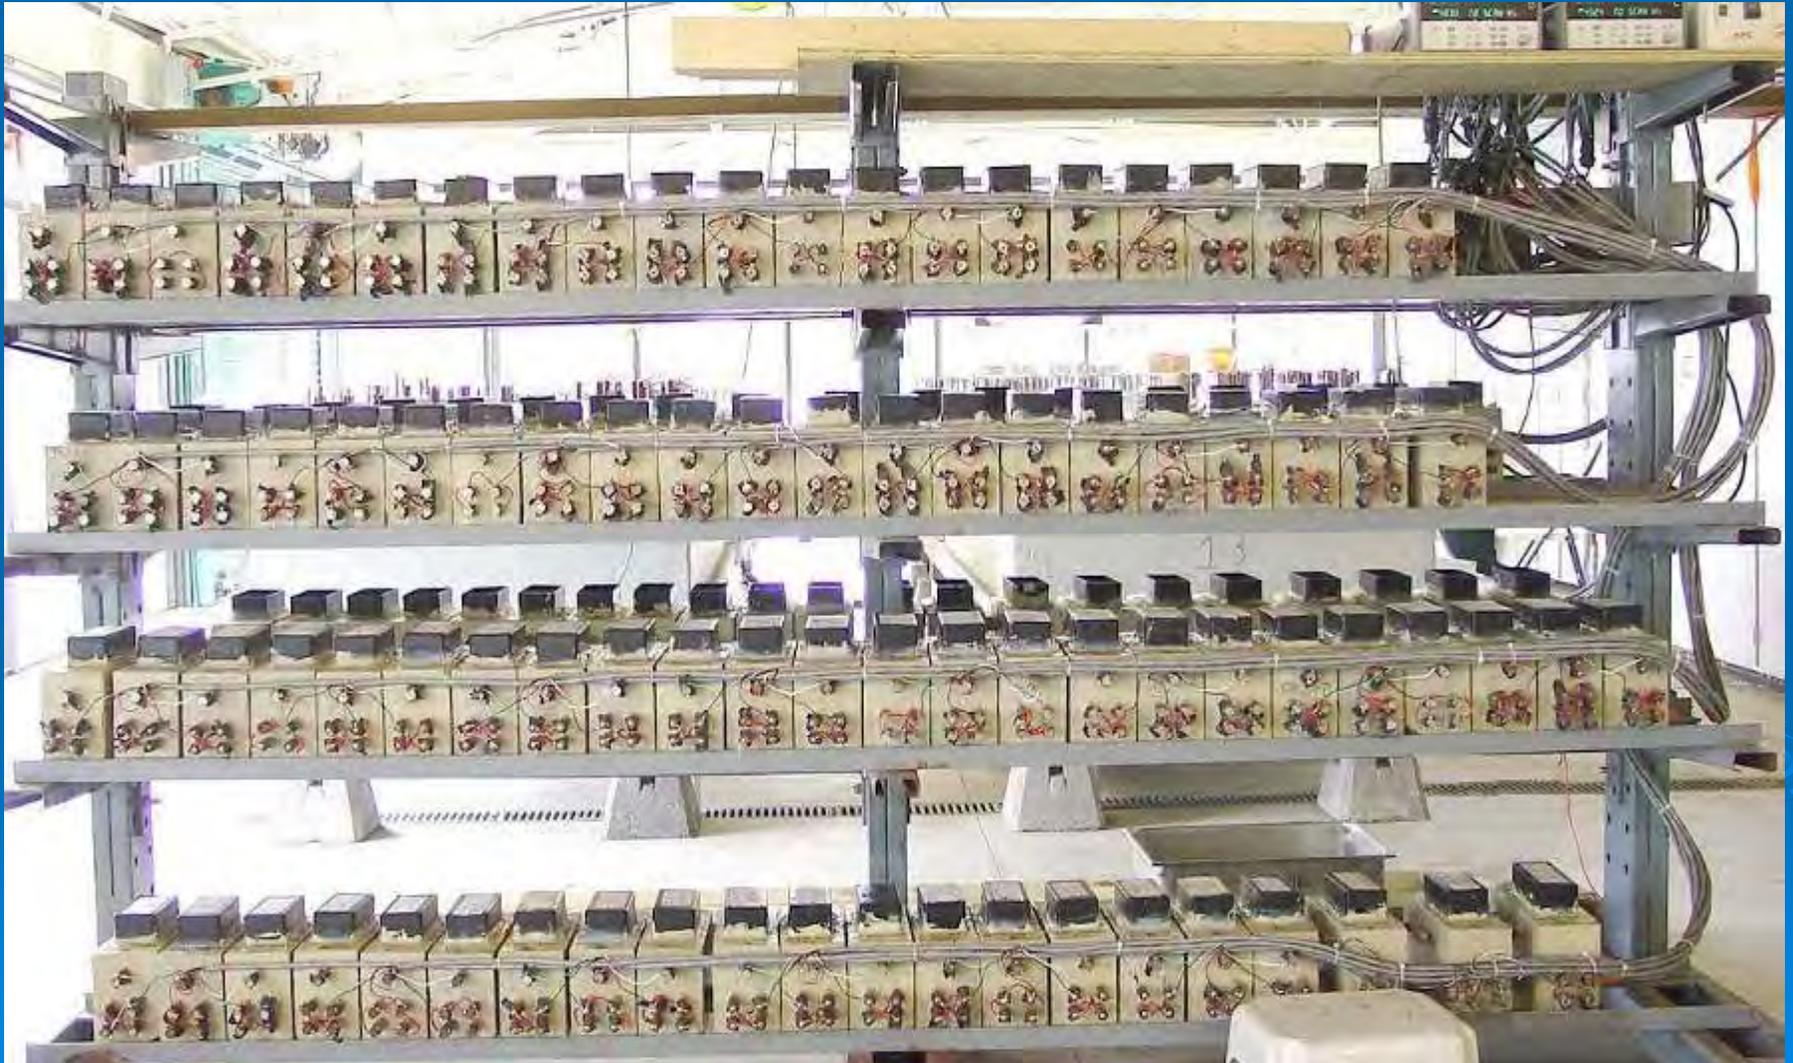
Macrocell Slab Specimens

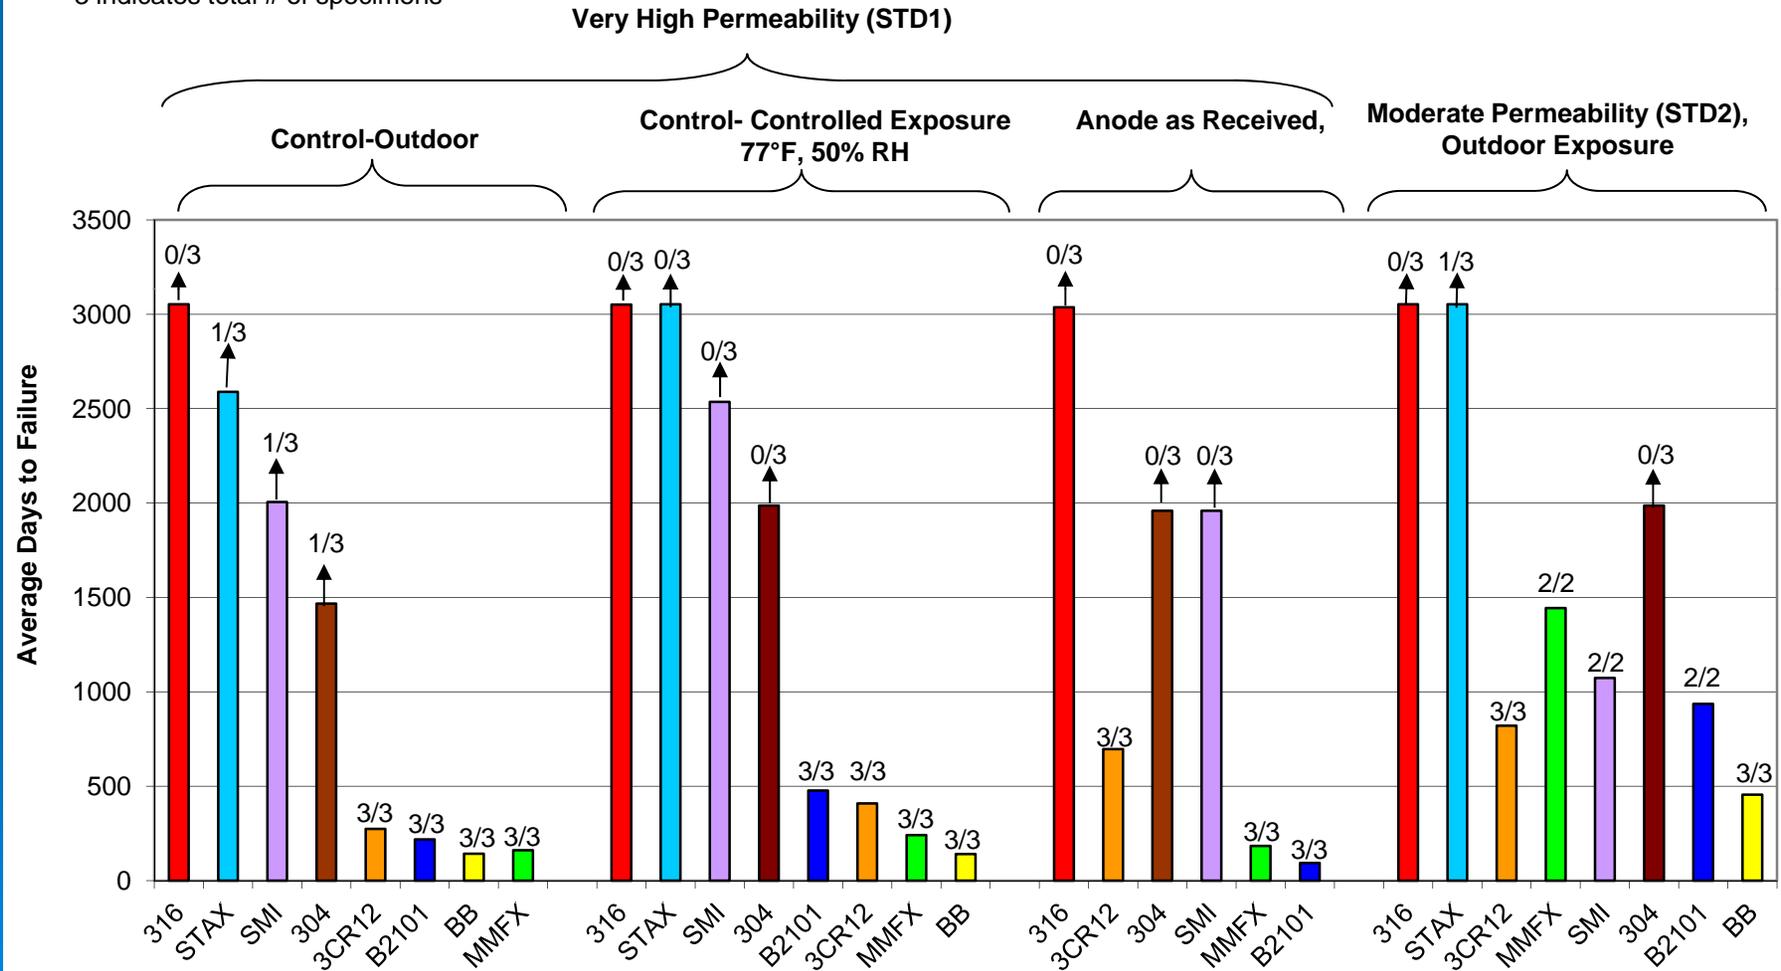
- All bars wire brushed
- ↑ Indicates not all samples in the set have shown signs of corrosion
- 1/3, 1 indicates # of active specimens, 3 indicates total # of specimens

Macrocell Slab Specimens Performance Effects of Environment, Concrete, & Preparation on Time to Corrosion

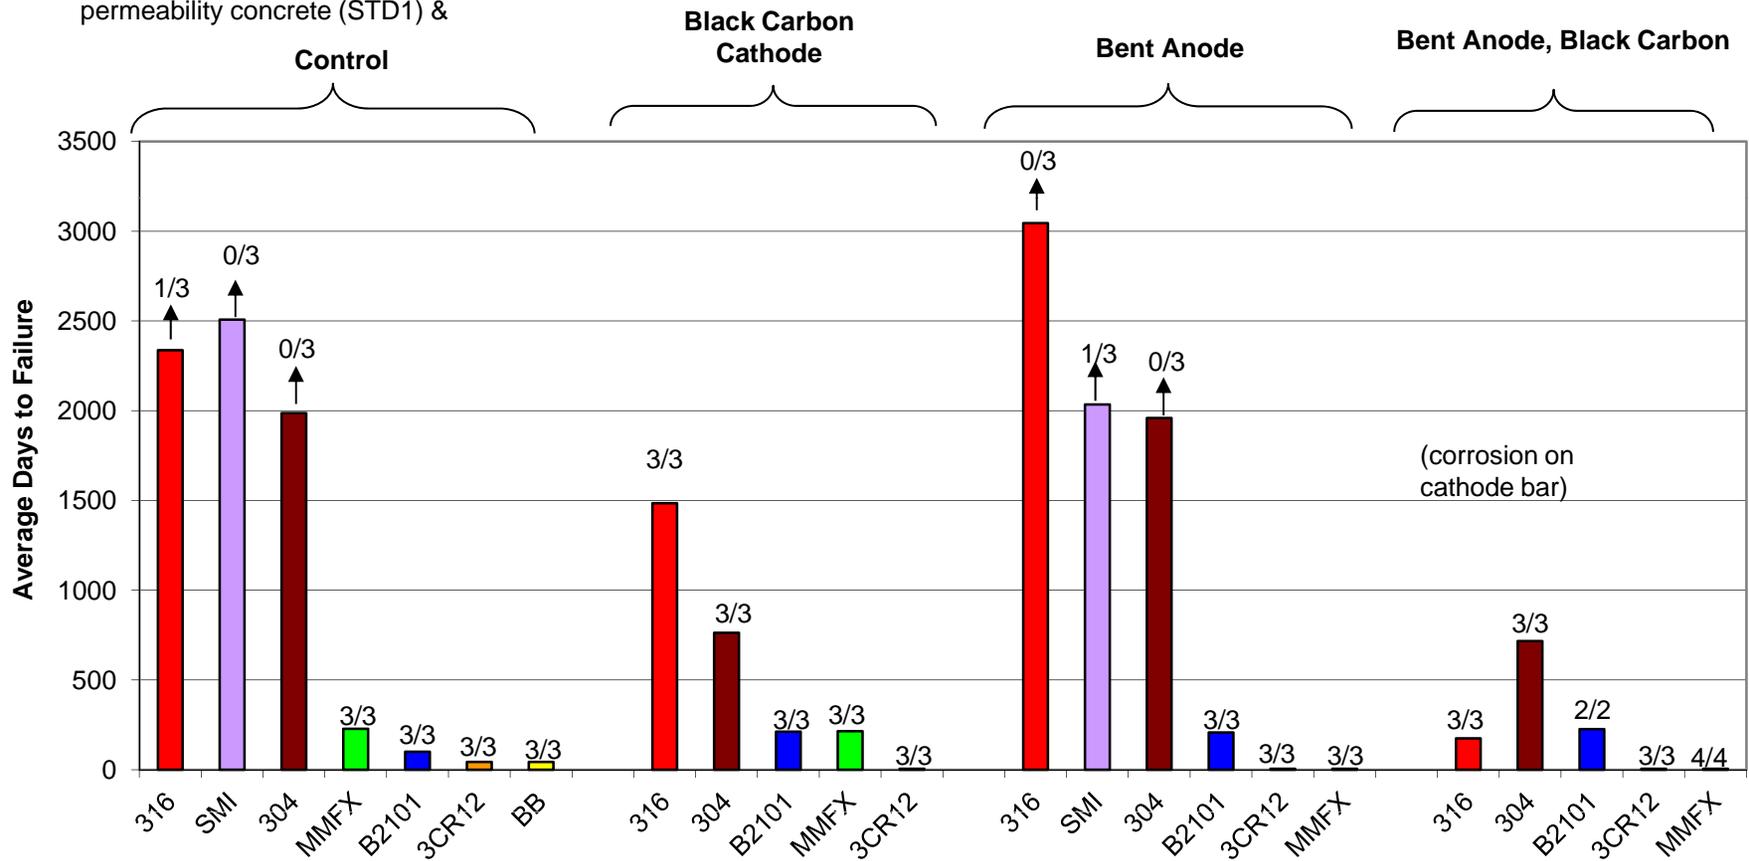
Macrocell Slab Specimens Performance Effects of Cracked Concrete on Time to Corrosion

- All bars wire brushed
- ↑ Indicates not all samples in the set have shown signs of corrosion
- 1/3, 1 indicates # of active specimens, 3 indicates total # of specimens
- All specimens cast using very high permeability concrete (STD1) &

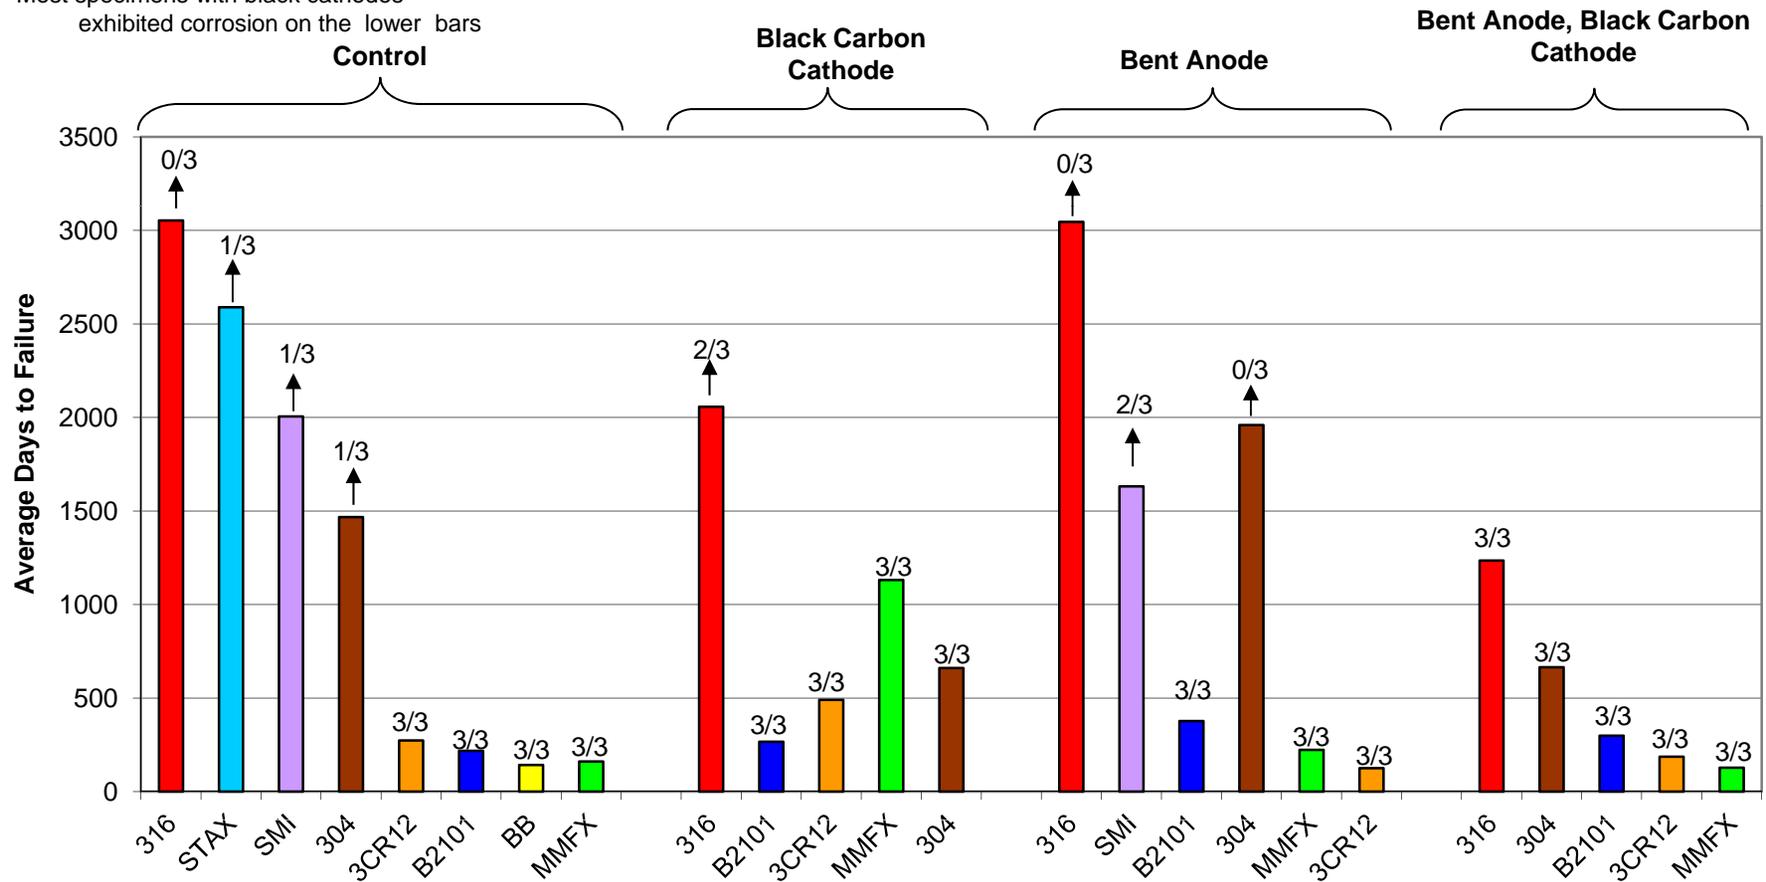
- All bars wire brushed
- ↑ Indicates not all samples in the set have shown signs of corrosion
- 1/3 1 indicates # of active specimens, 3 indicates total # of specimens
- All specimens cast using very high permeability concrete (STD1) & exposed outdoors
- Most specimens with black cathodes exhibited corrosion on the lower bars

Macrocell Slab Specimens Performance Effects of Anode Configuration & Cathode Material on Time to Corrosion

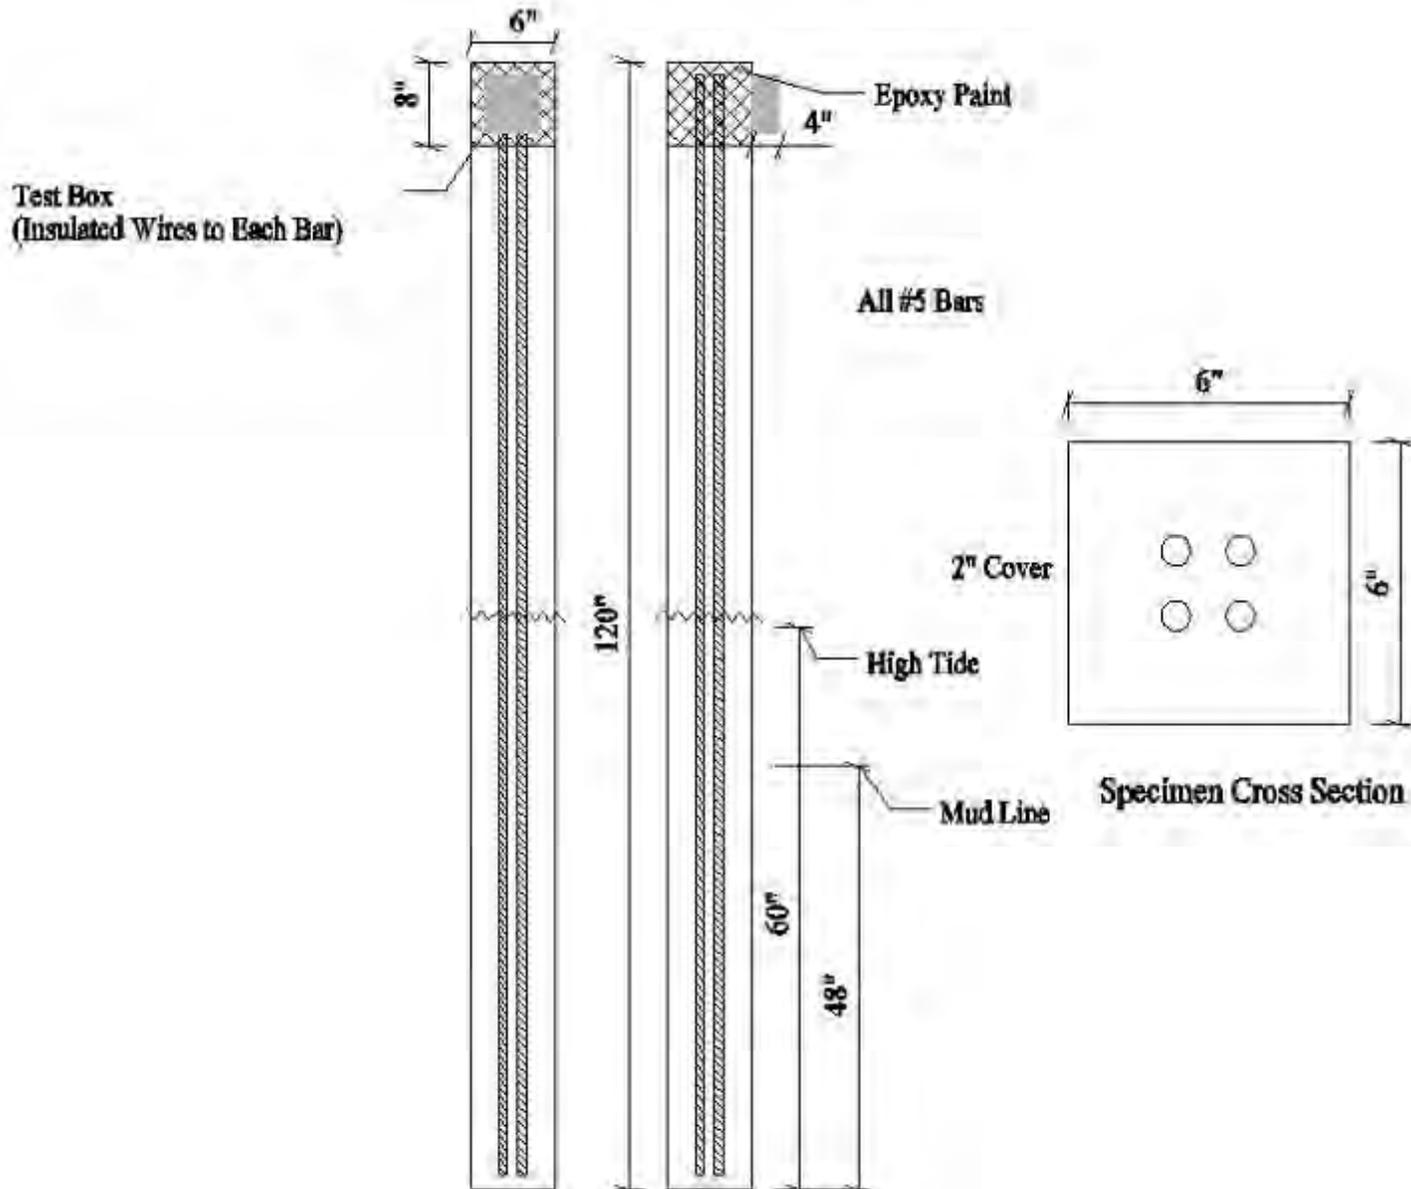
Field Specimen Geometry

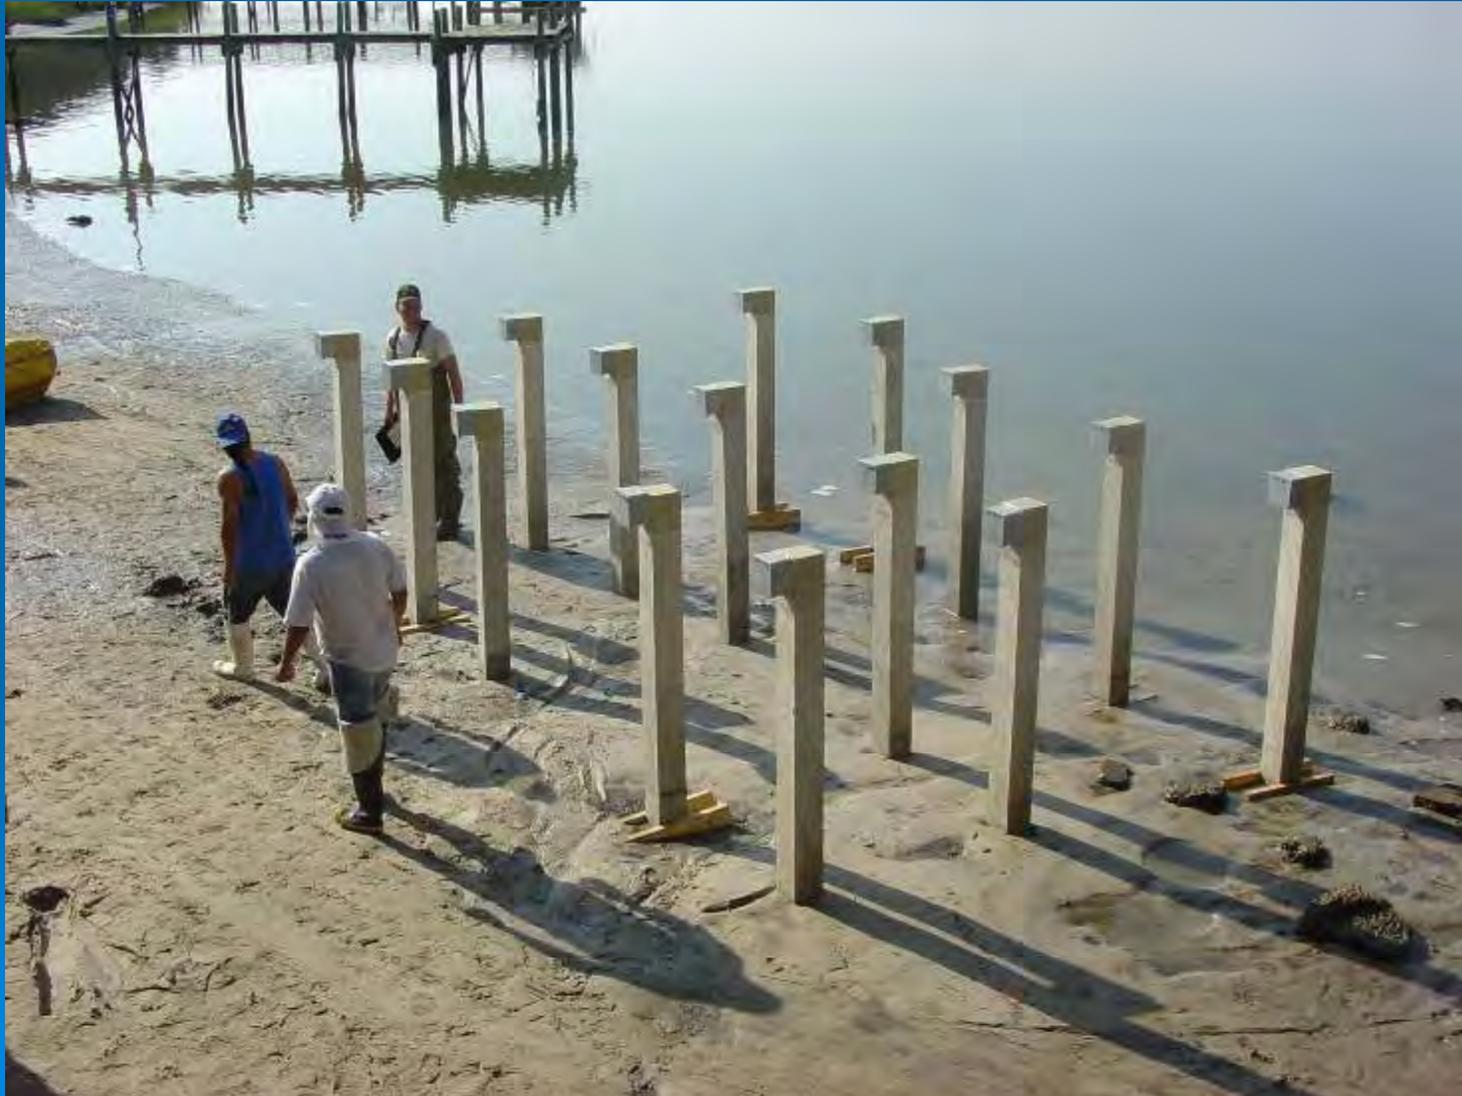
Field Specimens

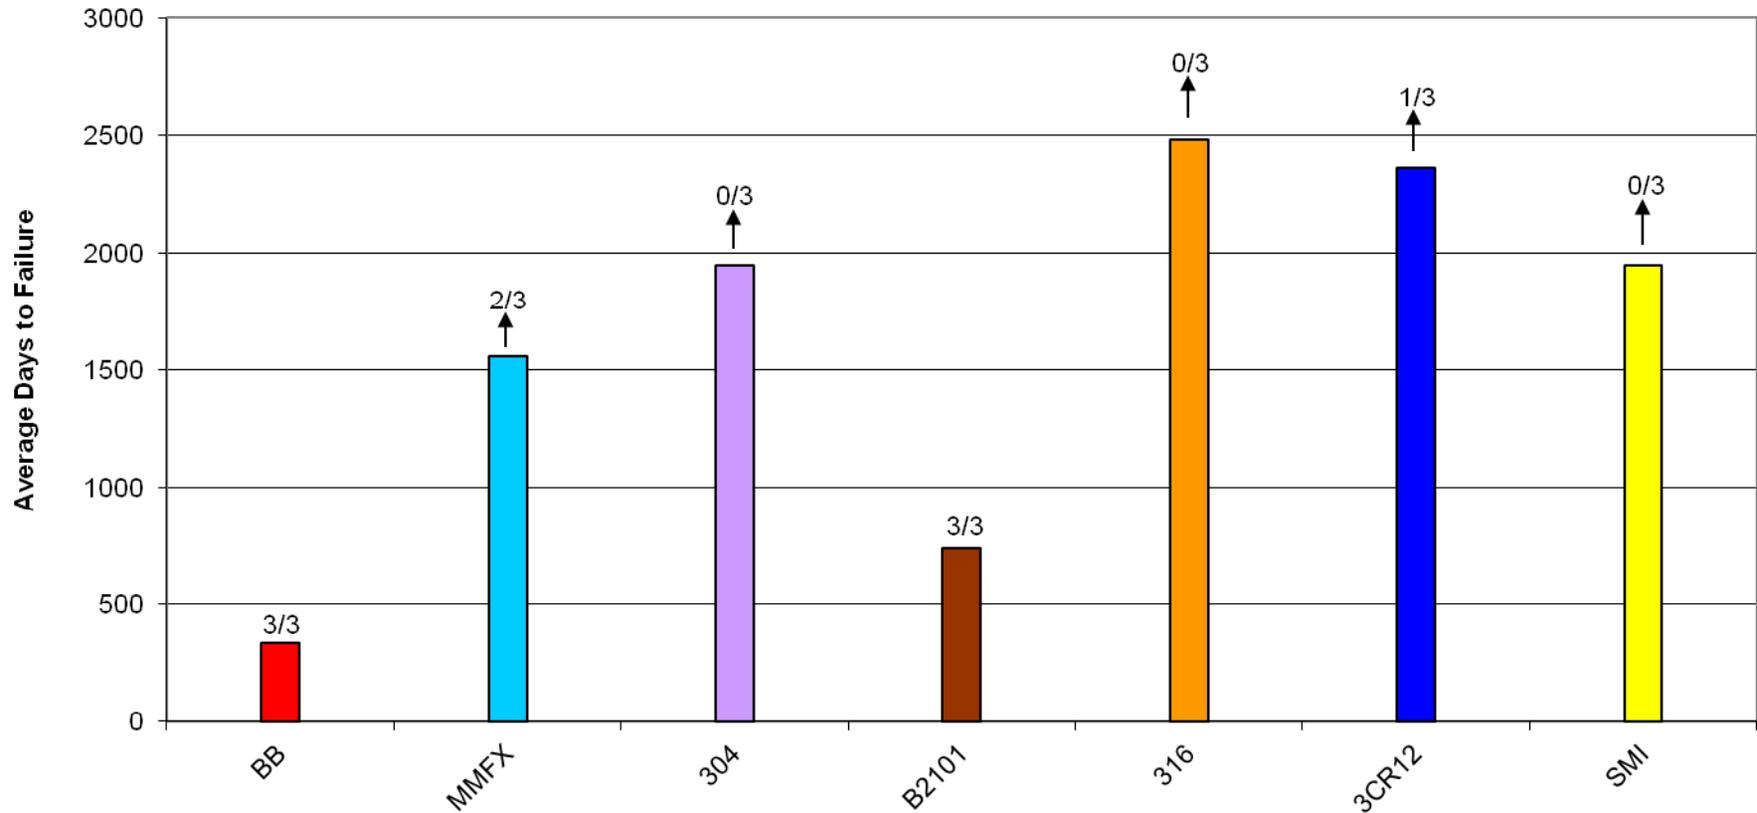
CRESCENT BEACH FIELD SITE SPECIMENS AVERAGE DAYS TO FAILURE

- ↑ Indicates not all samples in the set have shown signs of corrosion
- 1/3 1 indicates # of failed specimens, 3 indicates total # of specimens
- Failure determined by visual sign of corrosion induced cracking and/or corrosion bleed out
