RAIL CROSSING GUARD PILOT PROJECT ALONG SOUTH FLORIDA RAIL CORRIDOR

FINAL PROJECT REPORT

FLORIDA DEPARTMENT OF TRANSPORTATION
CONTRACT # BC498

Prepared by: Nestor Traffic Systems, Inc.

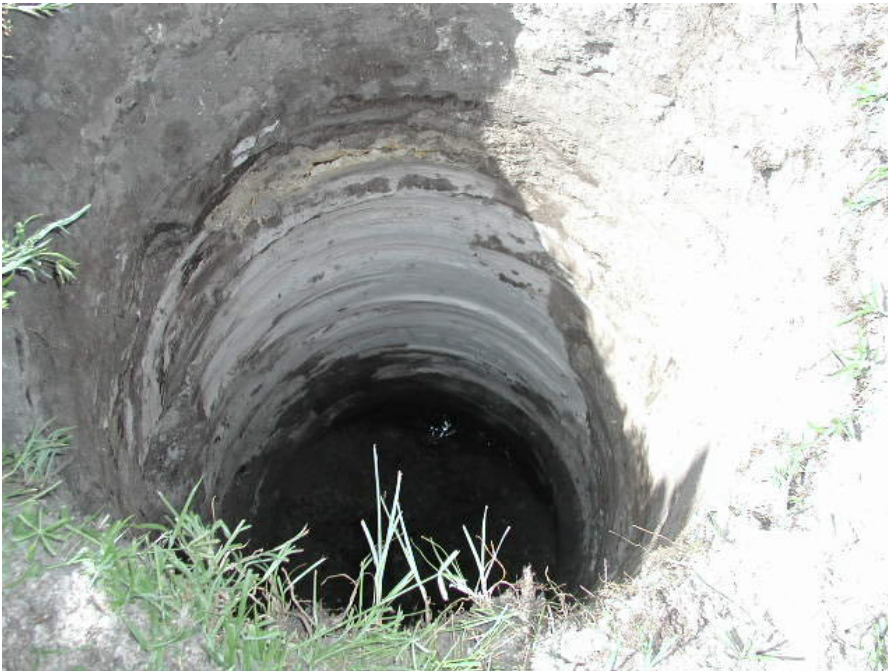
Figure 4 Close Up Looking Down Drilled Shaft for Camera Pole Foundation at Commercial Boulevard

New underground conduits and hand holes were then installed followed by the installation of drilled shaft pole foundations and cabinet foundations. Following successful testing of the foundation concrete from each pole location at the FDOT District 4 test lab, the new camera and antenna poles were set in place by the subcontractor. The trackside equipment cabinets were also set onto their respective foundations.

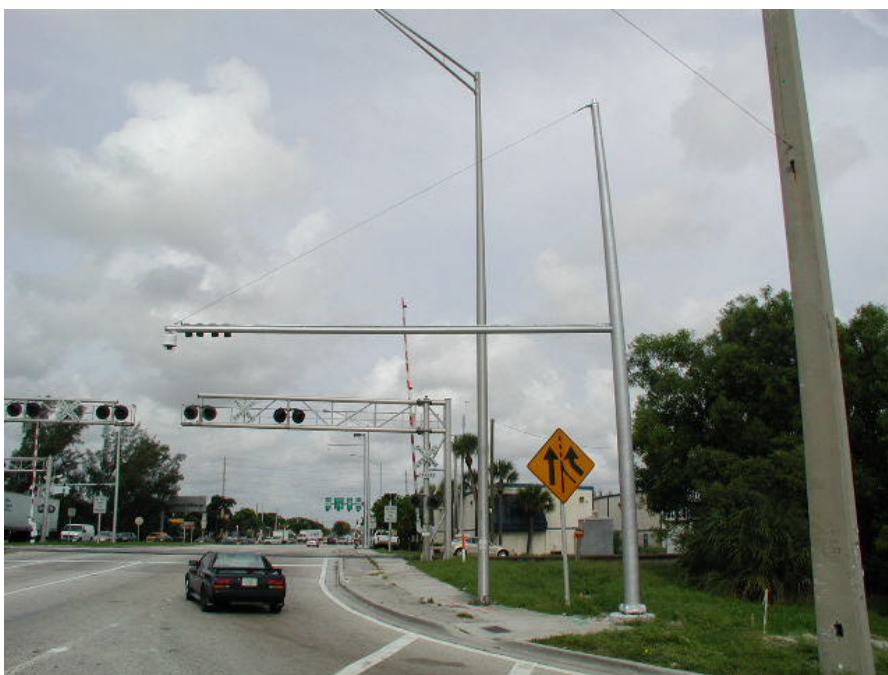
Figure 6 Fiberglass Pole Bending Under Load of Mastarm and Camera
Copyright © 2002 Nestor Traffic Systems, Inc.

Although the composite poles were easily and successfully installed, a problem was discovered immediately following the installation of the cameras on the pole mastarms. The poles were observed to bend above the point of mastarm attachment, deflecting by as much as 6 inches from the vertical. The

manufacturer of the poles was contacted to provide an assessment of the situation. They have confirmed that the deflection of the pole is a result of the compaction of the composite material under the load of the camera. This is a static load and will not cause the poles to bend further beyond the point at which the compaction is in equilibrium with the camera load. Figure 6 shows an example of the bent pole at Commercial Boulevard.

The solution to this problem is to use either steel or concrete poles for all future camera installations.

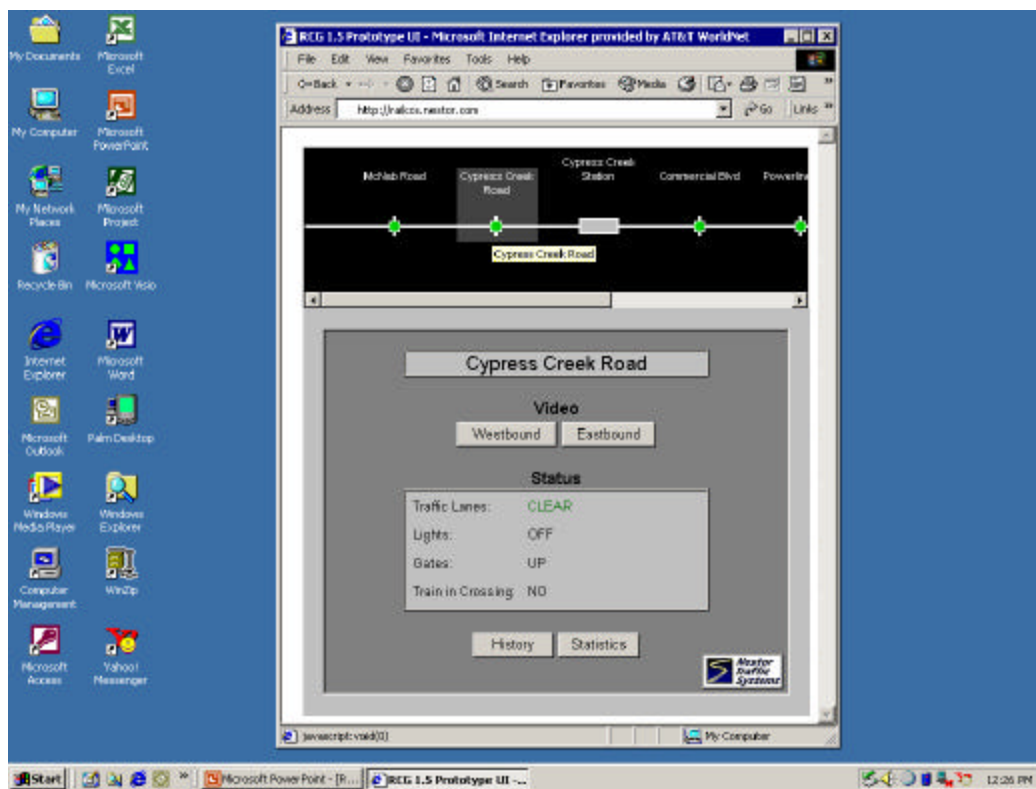
Figure 7 Rail CrossingGuard Information Display

The following images show screen shots of the Rail CrossingGuard web browser-based user interface. Figure 7 shows the topmost view of the RCG information display. The screen is divided into corridor information and information on a specific crossing selected by clicking on the crossing icon in the corridor display.

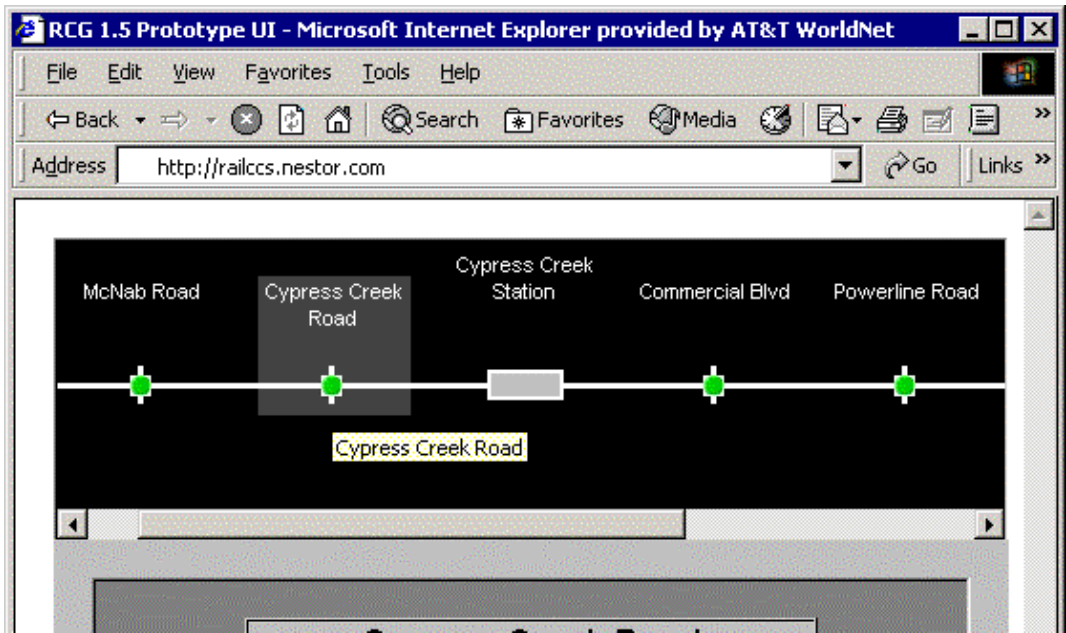
Figure 8 Corridor View

Figure 8 shows an expanded view of the corridor portion of the screen display. The display shows the RCG-monitored crossings, as well as the location of the Cypress Creek Road Station.

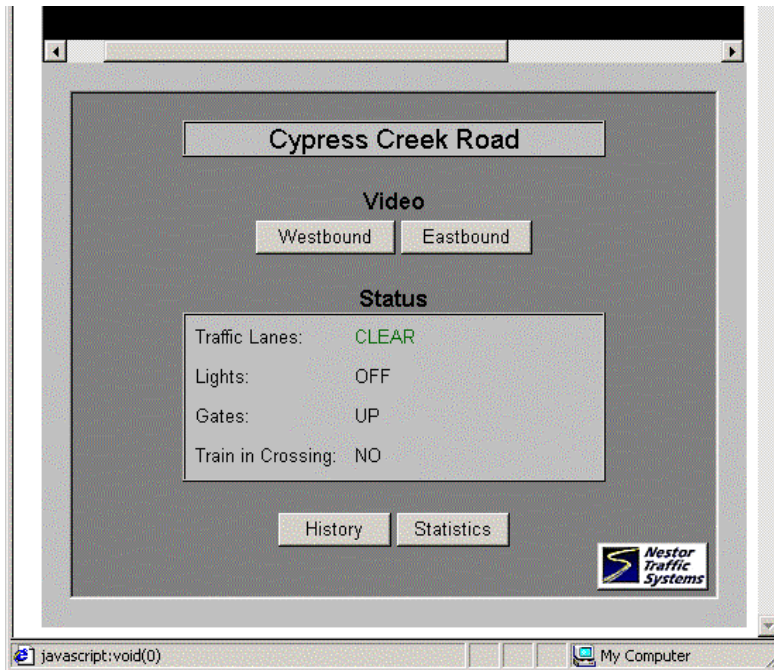
Figure 9 Crossing Status Details

Figure 9 shows the crossing detail portion of the RCG top view display. Crossing status information is provided, along with buttons allowing the user to access live video of the crossing in either of the two traffic directions (Eastbound or Westbound). Additional buttons allow the user to access statistics as well as a recent history of crossing activity.

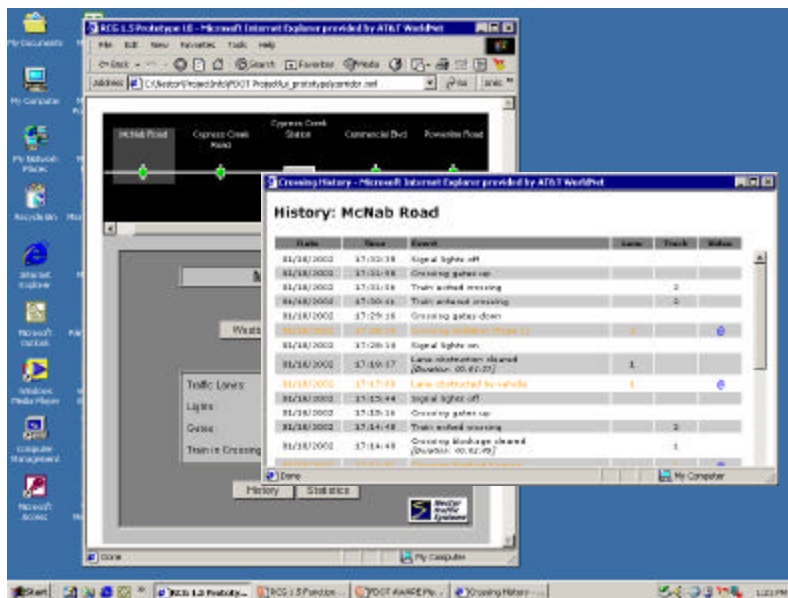
Figure 12 Crossing Status with History Display

The next screen shot (Figure 12) shows a picture of the crossing status screen after the user has clicked on the button to display crossing history. Figure 13 shows the history panel, enlarged.

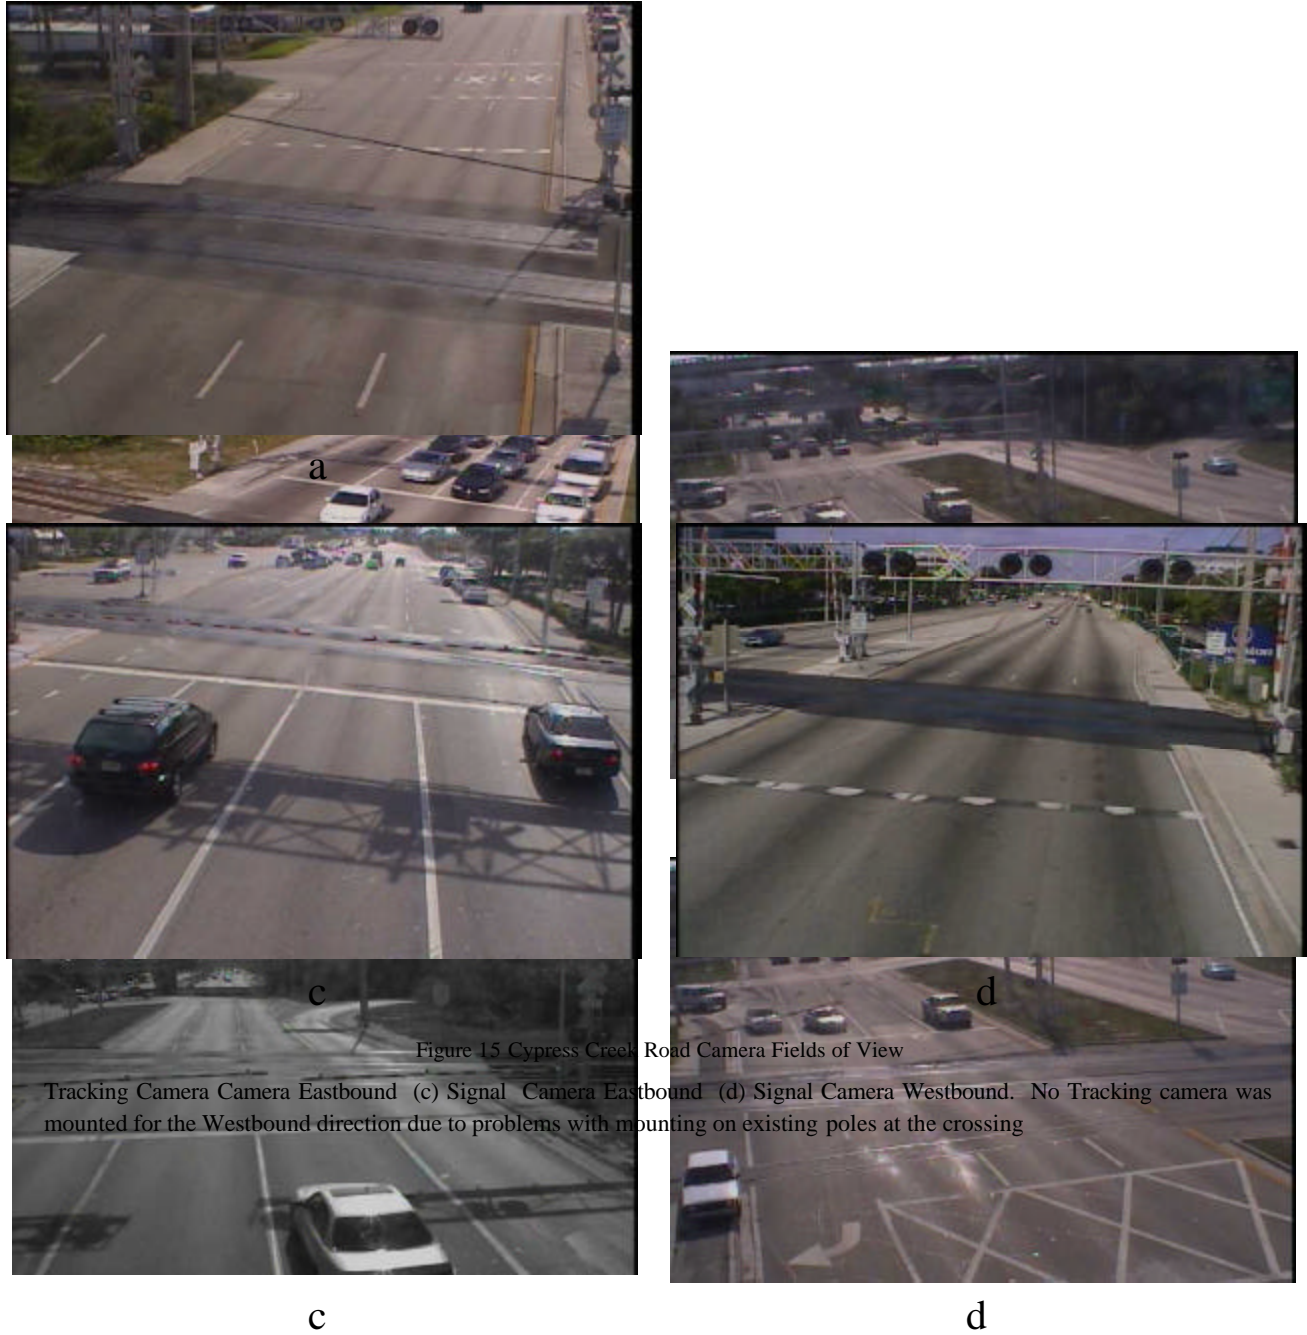
Figure 15 Cypress Creek Road Camera Fields of View

The following figures contain the fields of view from the Tracking Cameras (“High Mount Cameras”) and the Signal Cameras (“Low Mount Cameras”) at each of the crossings. Note that, in the case of the crossings at Commercial Blvd., Cypress Creek Road and McNab Road, a Tracking Camera and a Signal Camera were mounted for each of 2 vehicle directions of travel at the crossing. (At Cypress Creek Road, no Tracking Camera was mounted for the eastbound direction.) However, in the case of the Powerline and Prospect Road crossings, the project plan called for only one Tracking and Signal Camera to be installed at each of those crossings. Due to difficulty in obtaining permissions to mount a camera on an existing structure at the Prospect Road crossing, no Tracking Camera was installed there.

Tracking Camera Camera Eastbound (c) Signal Camera Eastbound (d) Signal Camera Westbound. No Tracking camera was mounted for the Westbound direction due to problems with mounting on existing poles at the crossing

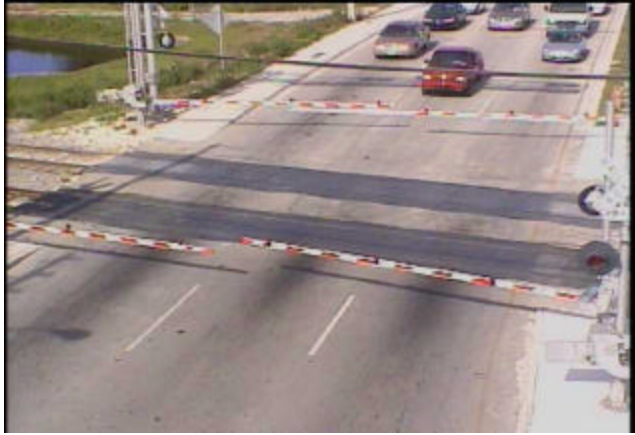
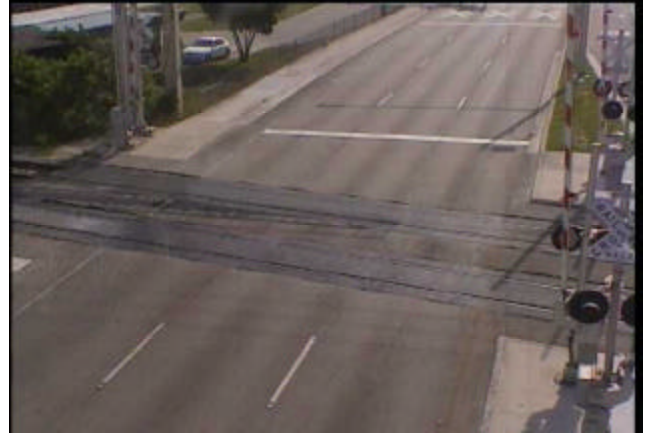
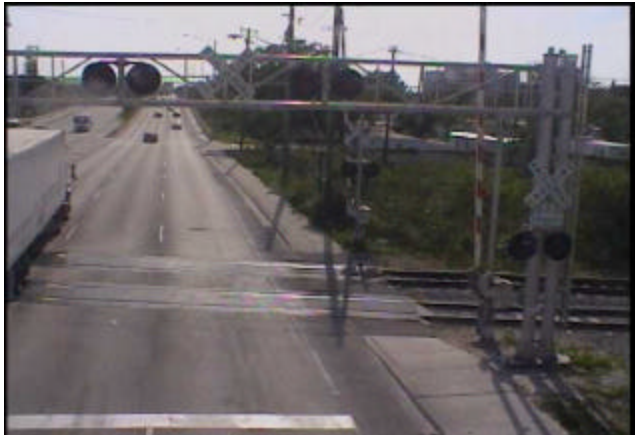
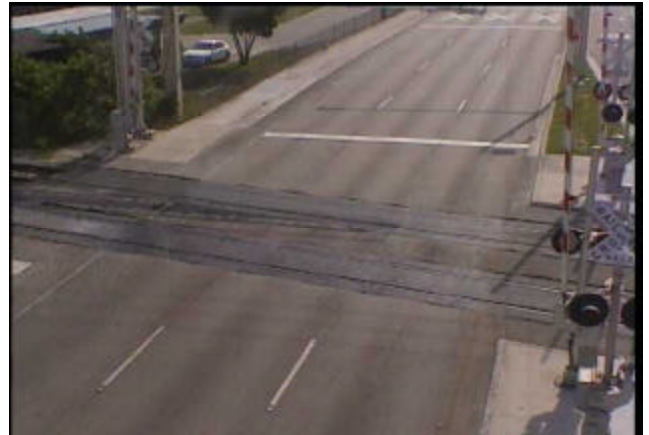
Figure 16 McNab Road Camera Views

(a) Tracking Camera Eastbound (b) Tracking Camera Westbound (c) Signal Camera Eastbound (d) Signal Camera Westbound

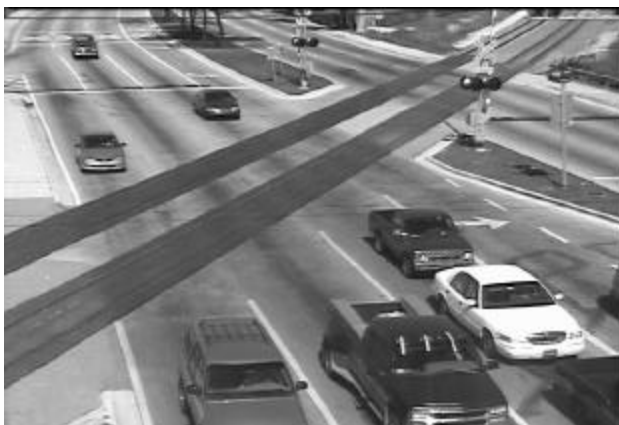
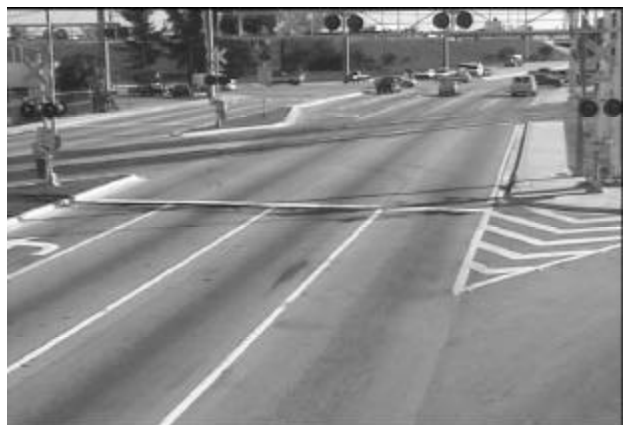
Figure 17 Camera Views for Powerline/Prospect

(a) Powerline Powerline Southbound Tracking Camera (b) Powerline Southbound Signal Camera/prospect Road Crossings

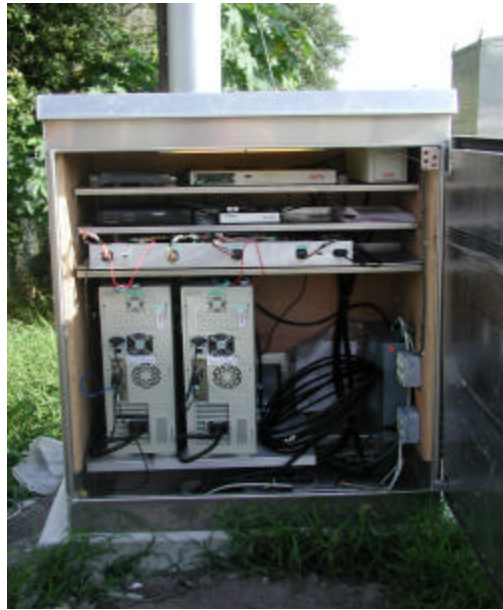
Figure 18 Rail CrossingGuard TrackSide Station
(Image shows two TrackSide Stations in a controller cabinet.)

the use of standard computers in air-conditioned traffic cabinets, Nestor is able to deliver the most currently available hardware and software capabilities on the Microsoft/Intel computing platform. The air-conditioned cabinets that were provided as part of the project were standard, NEMA controller cabinets provided by McCain Traffic Supply.

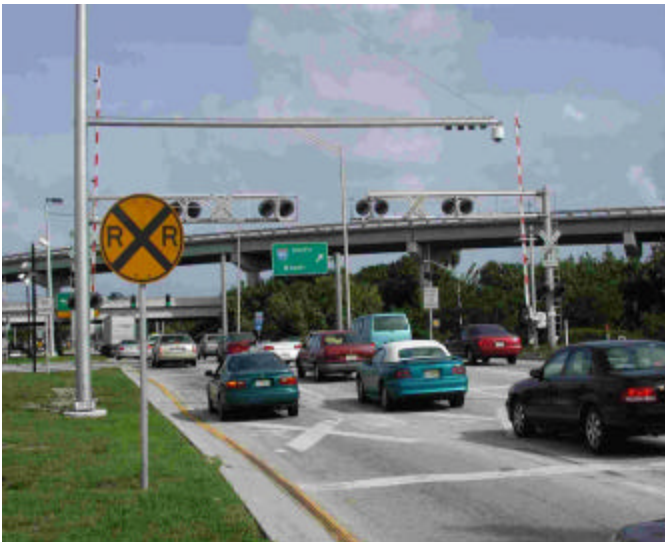
Figure 19 Signal Cameras Installed at Commercial Boulevard

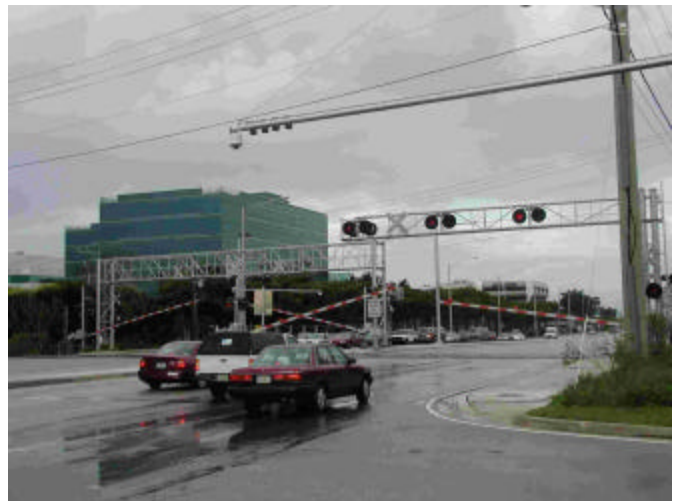
Figure 20 Signal Cameras Installed at Cypress Creek Road

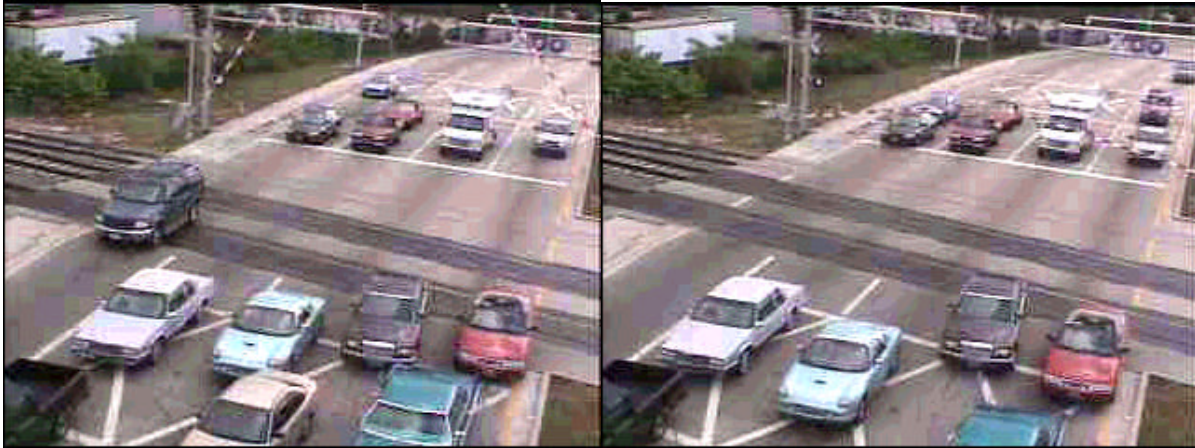
The following are still images that have been extracted from the video captured at the Commercial Boulevard crossing. These segments have been chosen to illustrate various conditions and driving behavior observed at the crossing that have triggered Rail CrossingGuard to issue alerts to the Operations Center.

Figure 23 Traffic Backed Up on the Crossing as the Gates are Coming Down

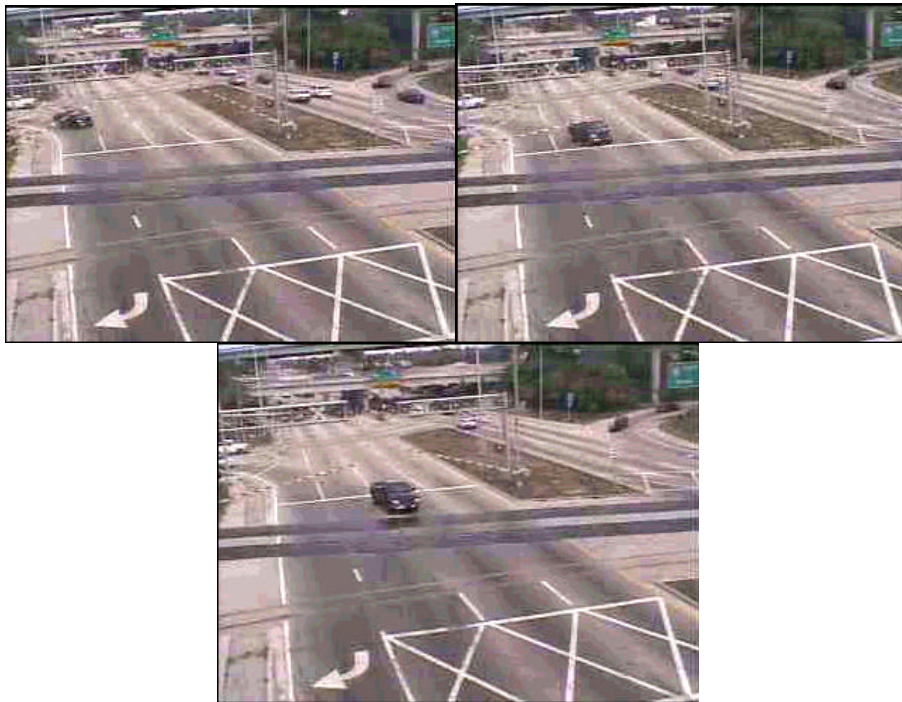
Figure 24 Vehicle Violating the Crossing Signals and Gates

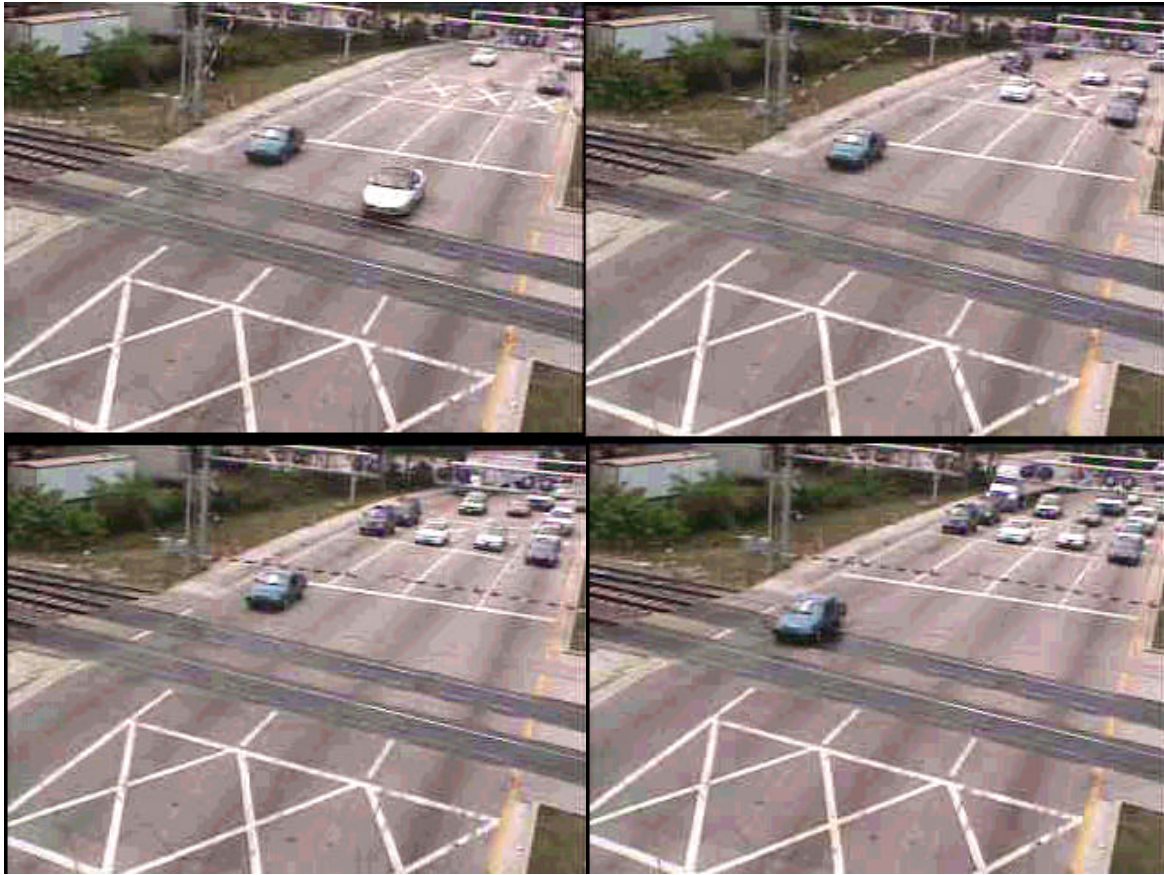
Figure 25 Vehicle Stopped in the Crossing with the Gates Down

The video showed the blue vehicle hesitating as the gates began to lower. The driver stopped, but ended up inside the crossing as the gates came down. The vehicle stayed there as the gates lowered completely and then drove through the crossing. The train arrived shortly thereafter.
