Video Based Studies of Flexible Traffic Separators at Highway- Railroad Grade Crossings

**Prepared for the Florida Department of Transportation
Rail Office
By The University Of Florida
Transportation Research Center**

April 2003

**Volume II: Video Based Studies of Flexible Traffic Separators at
Highway-Railroad Grade Crossings**

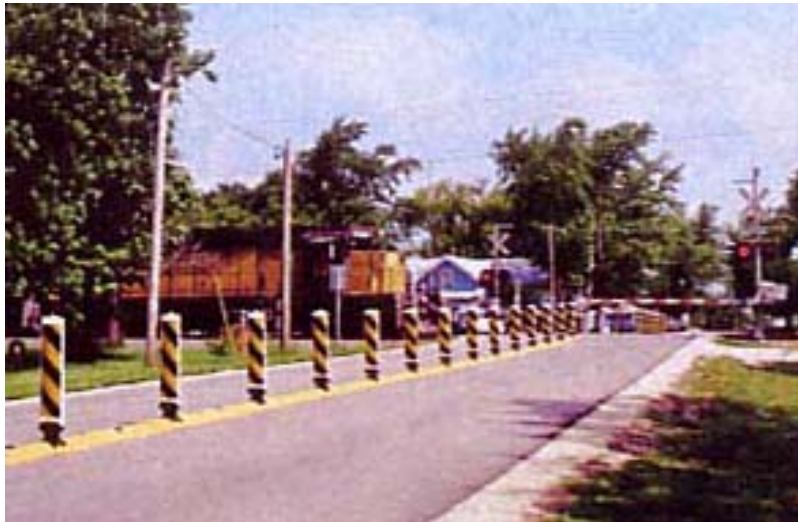
Figure 2-1: QWICK KURB® Crossing

According to the product literature, QWICK KURB® is “*the least expensive safety measure to significantly improve grade crossing safety and the only traffic separator system that has been involved in a FRA sponsored system.*” The manufacturer reports that, in one test, the drive-around violations decreased by 75% after the installation of QWICK KURB®.

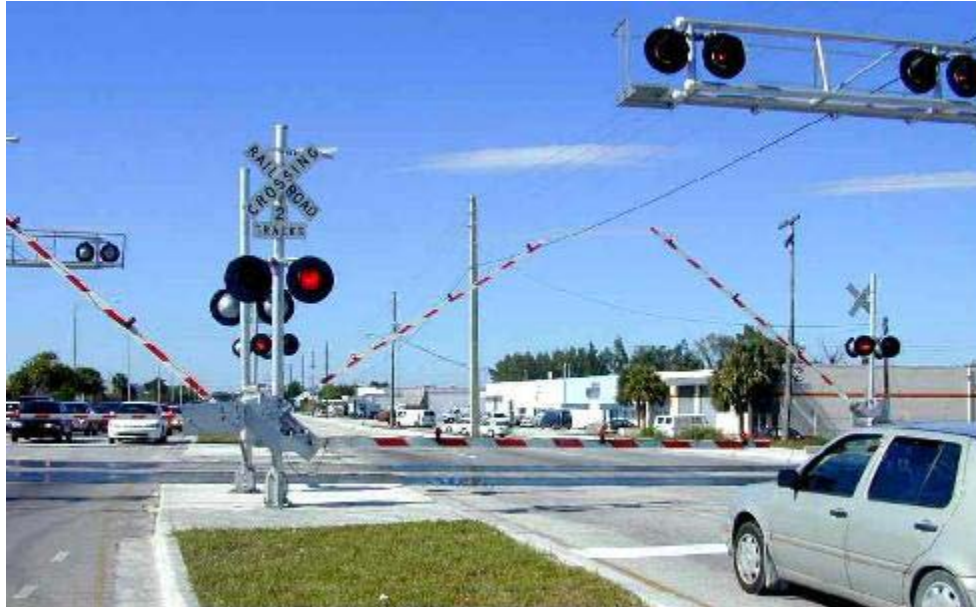
Figure 2-2: Four-Quadrant Gate Railroad Crossing

(exit gates) to ensure that vehicles do not become trapped. The addition of the obstruction detection system provides the two-fold capability of alerting approaching trains equipped with in-cab signaling devices to the possibility of trapped vehicles, and releasing the exit gates so the trapped vehicles can escape the crossing.

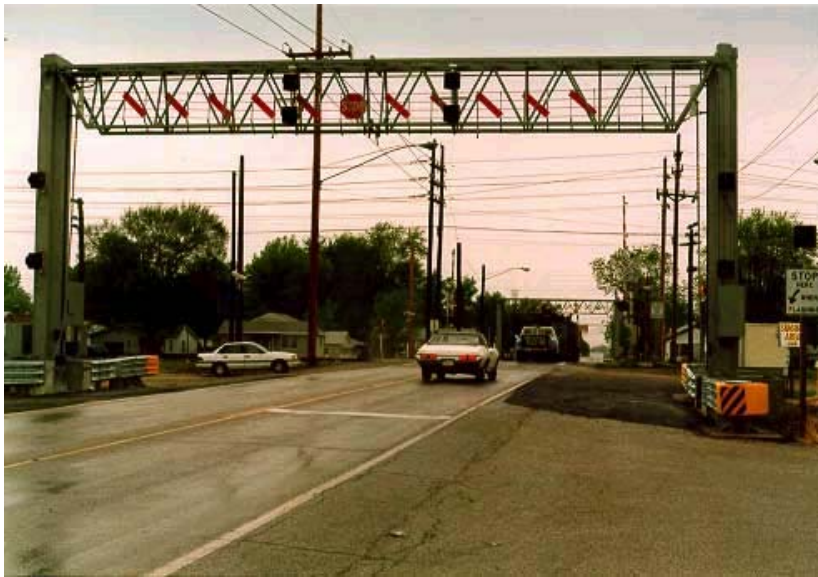
Figure 2-3: Vehicle Arresting Barrier at Railroad Crossing

The steel tape is wound through a series of offset pins contained in the energy absorber. When a vehicle hits the net assembly, the steel tape is pulled through the pins and out of the energy absorber. The energy required to pull the tape through the pins offsets the energy required to decelerate a vehicle to a controlled stop.

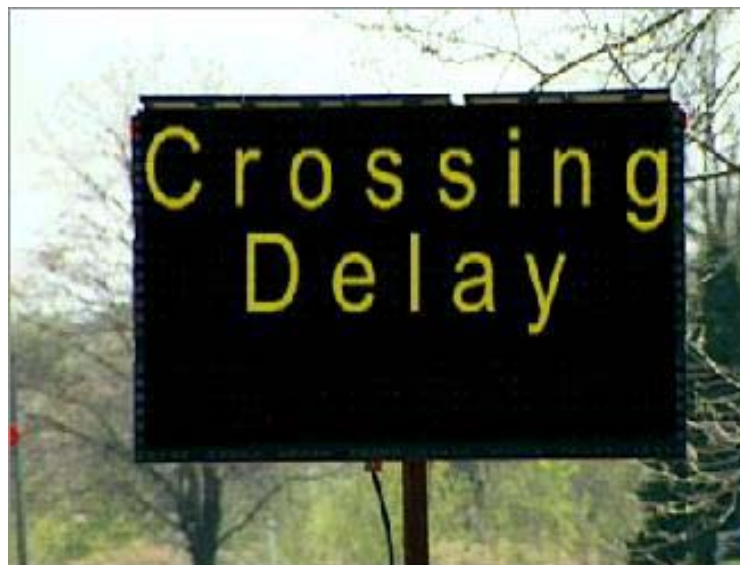
Figure 2-4: Variable Message Sign Board

The intelligent grade crossing allows nearby variable message signs to display messages that inform drivers of current conditions at the crossing. Messages displayed include “Train Approaching”, “Crossing Delay”, “Exit Lane Blocked” and “Train in Station”.

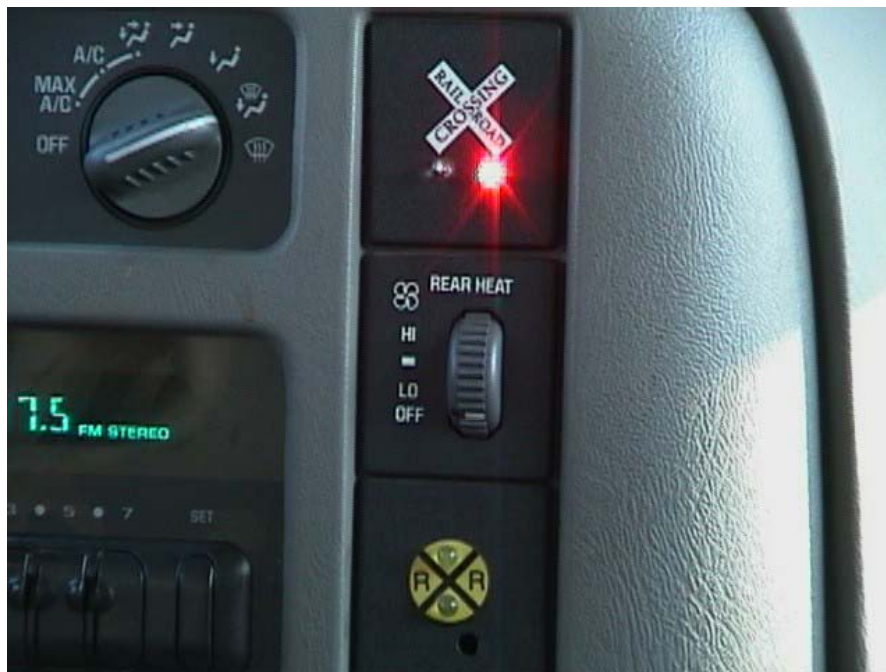
Figure 2-5: In-Vehicle Warning Display

The system uses wireless vehicle and roadside communication antennas built into the familiar crossbuck sign and front vehicle license plate. The trackside unit picks up a signal from the railroad’s train detection electronics and transmits that signal to the antenna-signs. The in-vehicle display alerts drivers using both visual and audible signals.

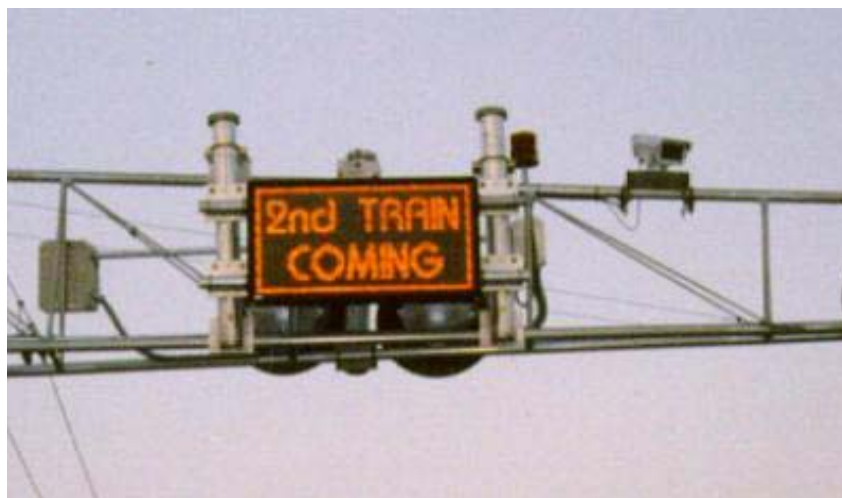
Figure 2-6: Second Train Warning System

The same track circuitry used to detect trains to activate the crossing's gates, lights and bells identifies when a second train is approaching the crossing shortly after an initial train. A signal is then sent to activate the second train coming sign, which stays illuminated until the second train has passed through the crossing, the gates are raised, and the lights and bells deactivate.

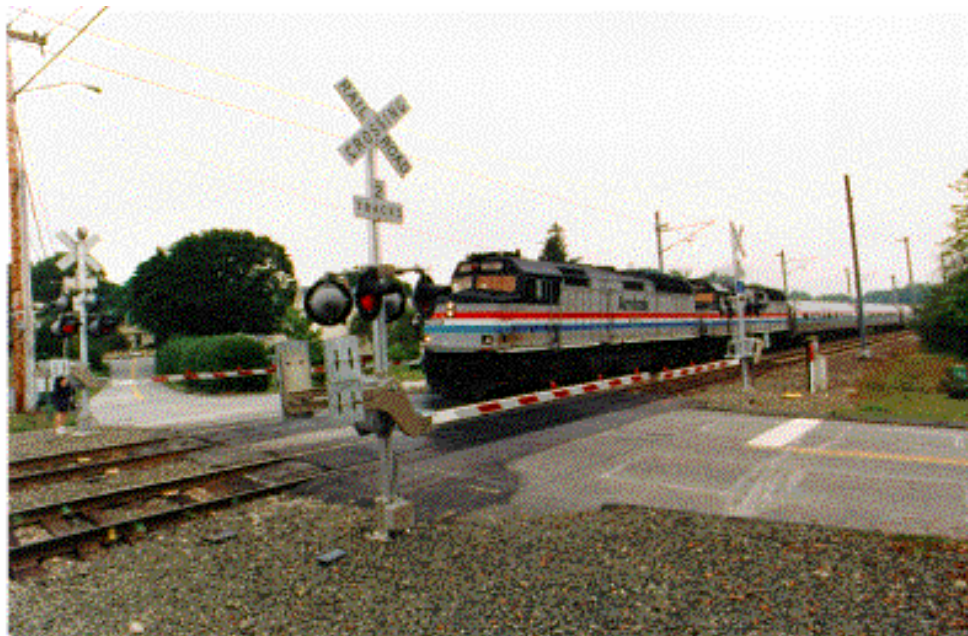
Figure 2-7: Four-Quadrant Gate with Automatic Train Stop

A system of four gates is used rather than the usual two, to prevent waiting vehicles from starting to cross the tracks and thus running the gate. Six inductive loop sensors, embedded within the crossing, are used to detect the presence of a vehicle or other obstacle that is blocking the crossing. The interface with the Amtrak in-cab signaling system provides the locomotive engineer with a notice to stop the train safely before it reaches the crossing. If the engineer fails to reduce the train's speed, the in-cab signaling system will stop the train automatically.

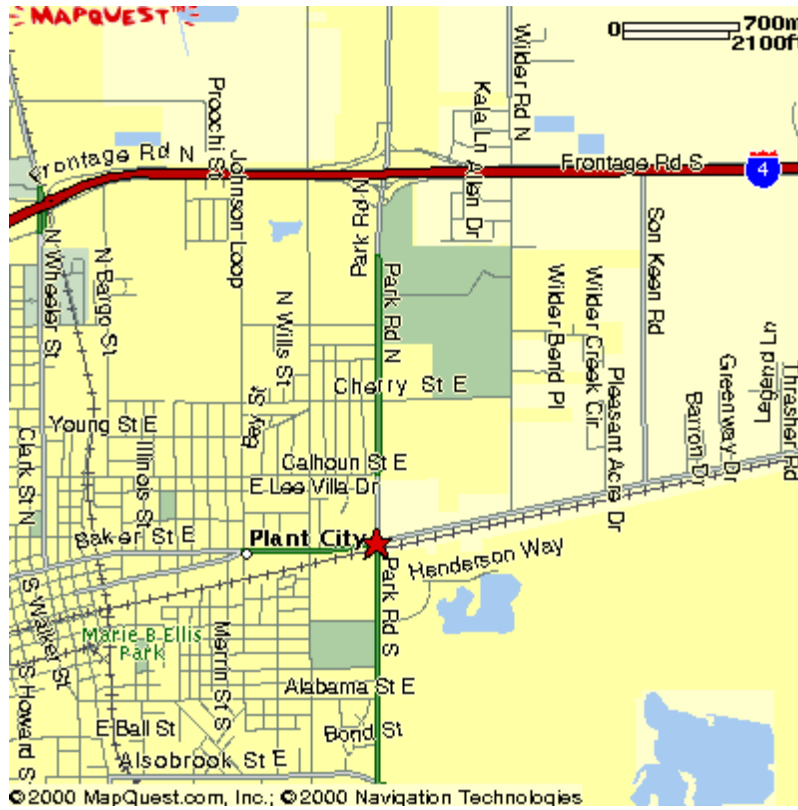
Figure 3-1: Map of the Park Road Site

The railroad crossing is located near the intersection of US 92 and Park Road in Central Florida's Hillsborough County (see Figure 3-1). The railroad tracks run east and west intersecting Park Road, which runs north and south. US Highway 92 runs parallel to the tracks on the north side and intersects Park Road at an approximate right angle. The Park Road site includes a double-track crossing with dual gates and flashing lights. Park Road itself is a rural highway with two lanes to the south and three lanes to the north. Figure 3-2 depicts the site-specific characteristics of the Park Road study site. Figure 3-3, Figure 3-4, and Figure 3-5 are pictures taken before and after the addition of the traffic separator to the site.

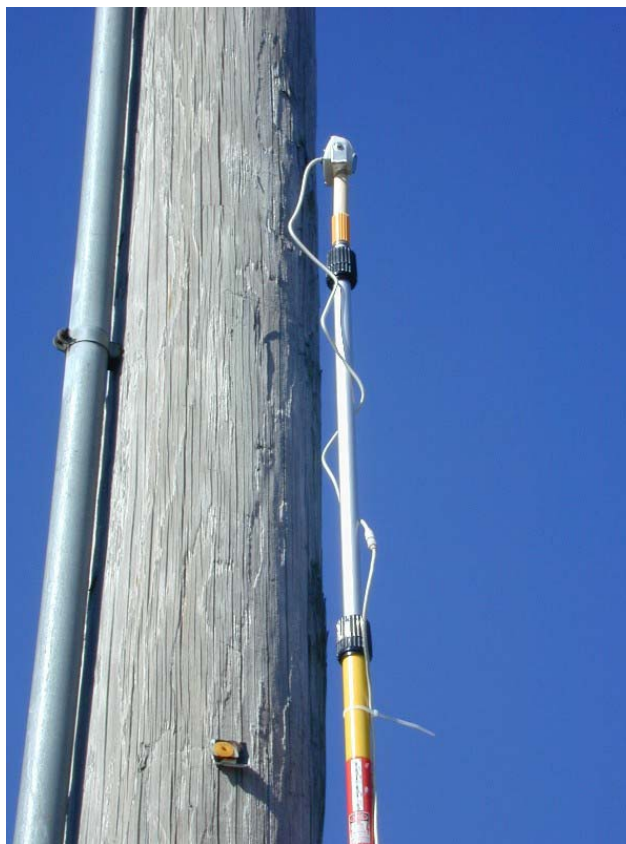
Figure 3-17: Camera Mount

The camera was mounted on a telescoping 1” diameter mast attached to the wooden utility pole by means of standard TV antenna-mast mounting brackets. The maximum camera height placement is 18 feet above ground level. The bottom of the mast is a 3/4” PVC conduit set to a minimum of 8 feet above ground level and secured to the outside of the telescoping mast. See Figure 3-17.

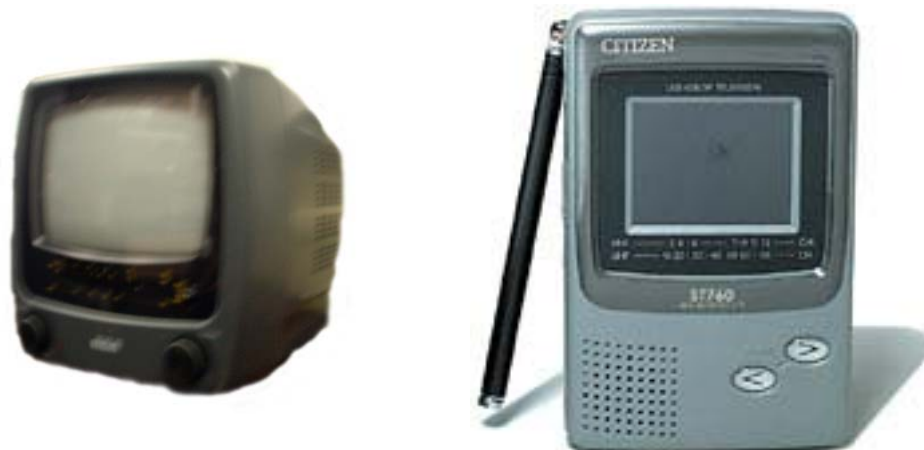
Figure 3-18: Monitors

A 5" portable TV monitor or 2.2" LCD hand-held TV was included in the cabinet. This allowed the local authorized personnel to check out the images captured by the camera at the study site. See Figure 3-18.

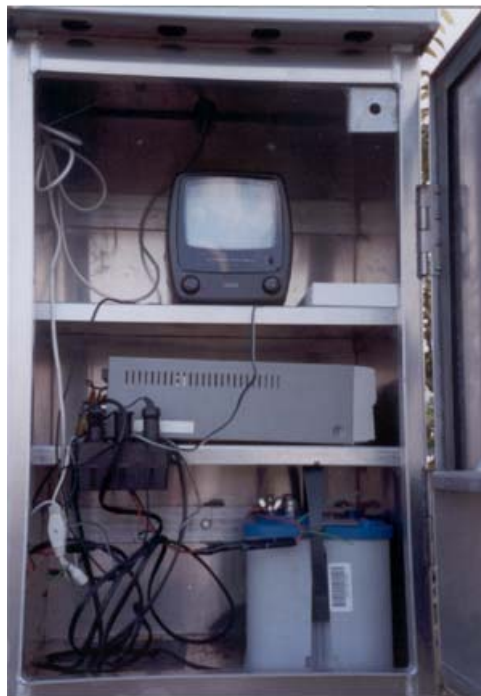
Figure 3-19: Mounted Cabinet

The VCR, battery and monitor are housed inside a 27H x 17W x 14D aluminum cabinet that is capable of being transported in the trunk of most vehicles. This cabinet is attached to a utility pole by ¼” lag screws. A single 3-wire cable carries the 12 Volt DC power and video signal between the camera, battery and VCR. See Figure 3-19.

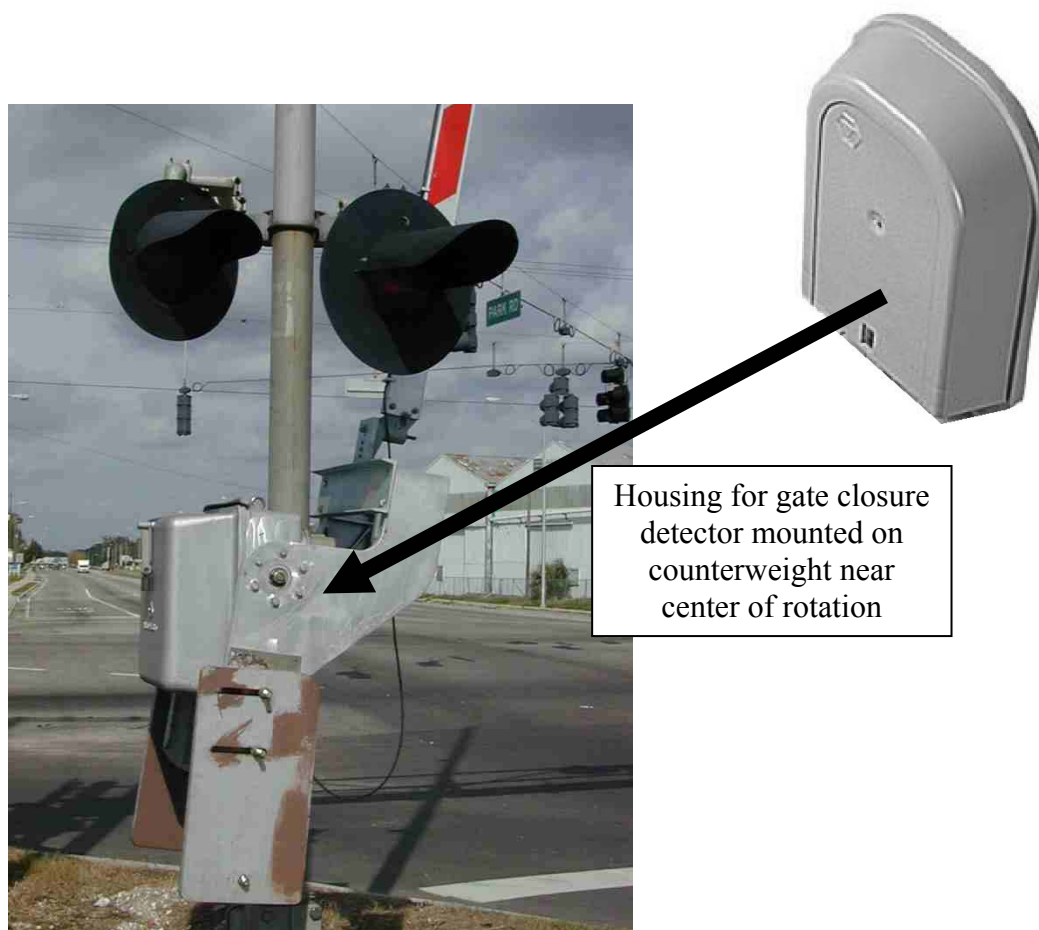
Figure 3-20: Proposed Enclosure for the Sensor Device

The receiver was proposed to be mounted in a similar enclosure on a pole near the crossing with a cabinet containing the camera and VCR. It can operate continuously with the power supplied by a heavy-duty marine battery located in the cabinet. The receiver output will be connected to the VCR controller in the cabinet. The controller would consist of a DTMF decoder set to recognize the tone from the sensor/transmitter, a timer that will activate the VCR for a specified time period. The controller would also activate an event recorder that will record the date and time of the gate closure in non-volatile memory.

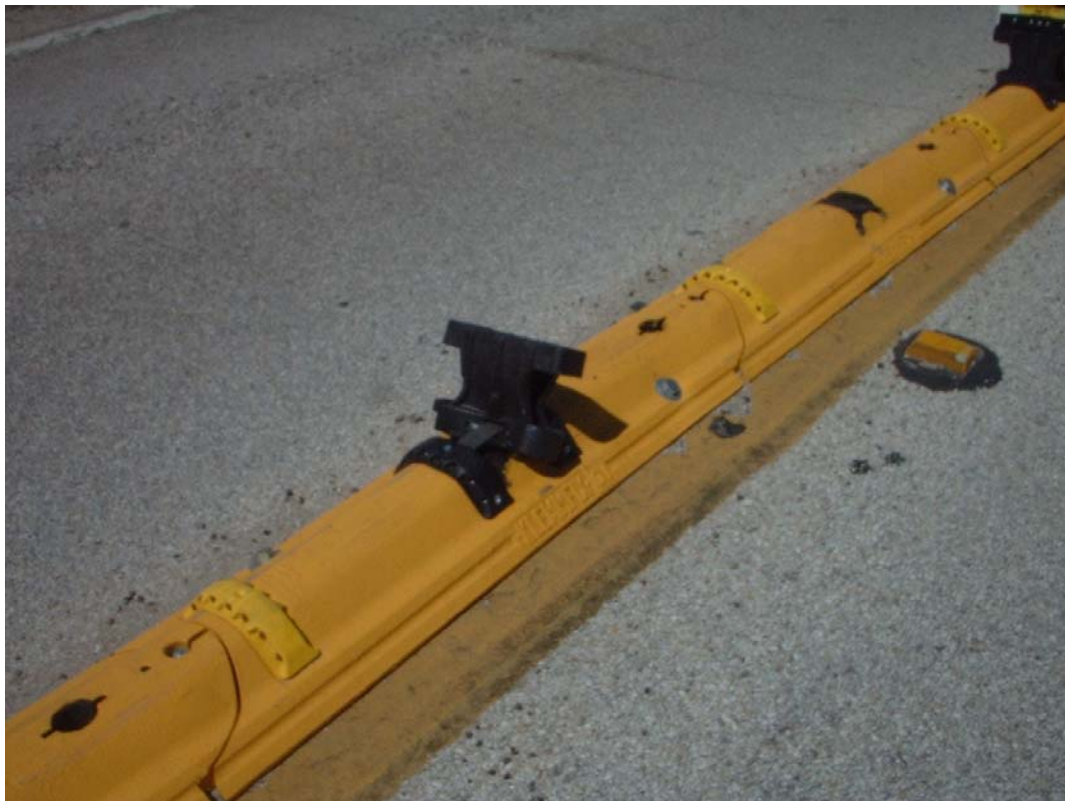
Figure 4-1: QWICK KURB® Damage

Significant damage was recorded to a Quick KURB® installation at the US 98 site. Nine consecutive markers were completely removed from the traffic separator, apparently from the impact of a large motor vehicle such as a semi-trailer. Factors that may have contributed to the collision include narrow lane width (9.2 feet) and the number of lanes (2). With additional lanes, motorists have the ability to compensate for the presence of the traffic separator and may be able to avoid collision with the markers. The manufacturer made repairs to the damaged markers in a timely manner.

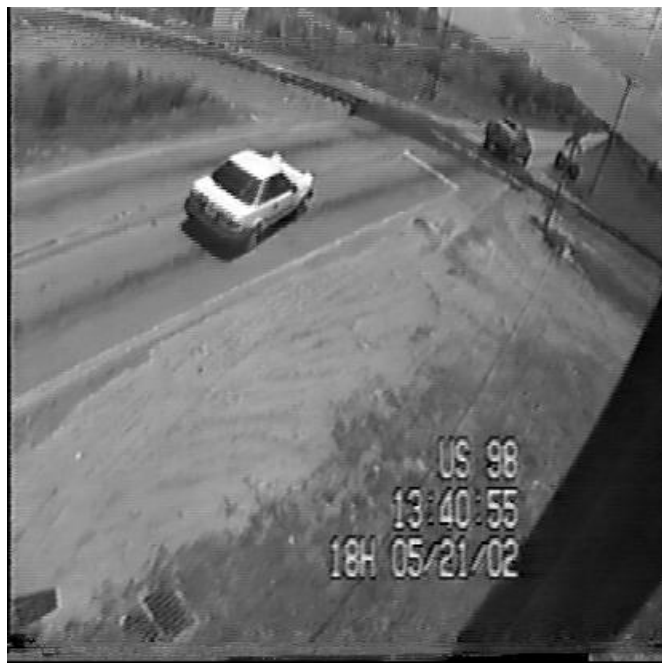
Figure 4-2: Platoon Violation

Platoon violations were common and occurred when one motorist chose to violate, and subsequent motorists followed suit. One extreme example involved seven vehicles. After the initial violation, drive-around violations were committed by motorists traveling in both the northbound and southbound directions.

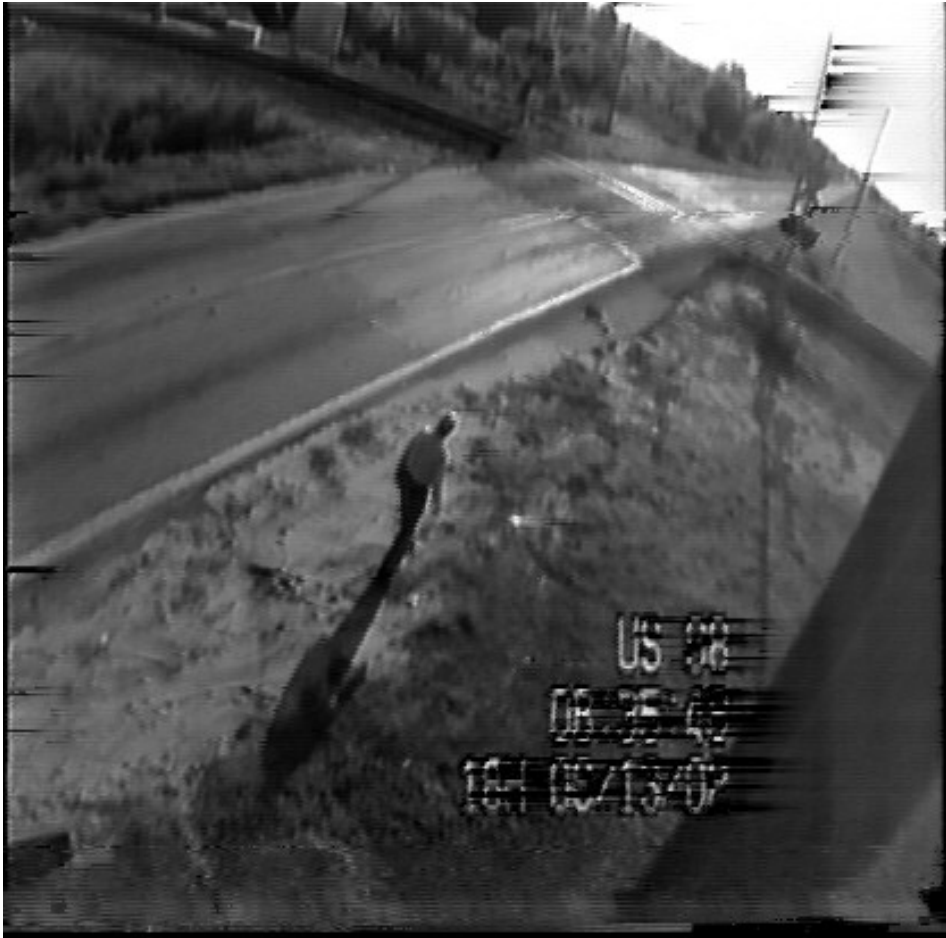
Figure 4-3: Pedestrian Approaching Tracks

A pedestrian fatality occurred at the US 98 site. The fatality was the result of an apparent trespass, and occurred before the separators were installed. It was not connected in any way with the study. The subject was seen walking off the edge of the viewable range, and later it was reported that the subject had been involved in a collision with a train.

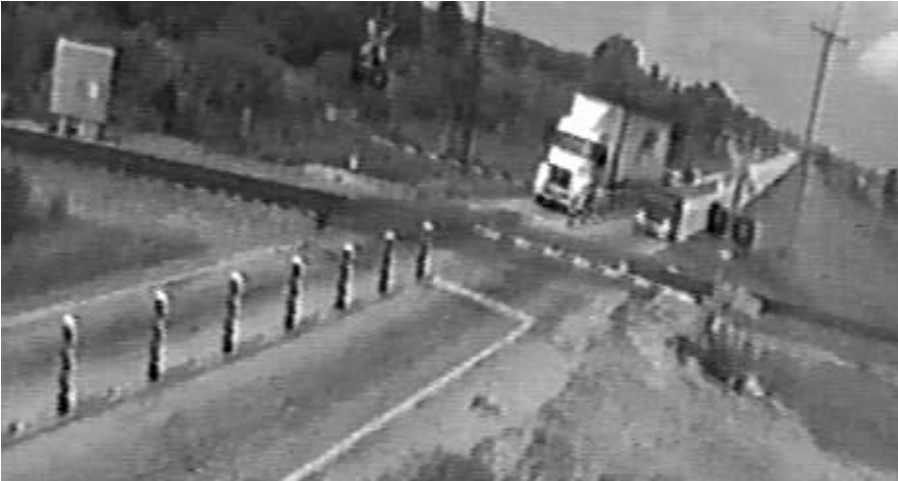
For reasons that were not observable on the videotape, the gates were down for nearly seven minutes before the train arrived. The offending vehicle joined the back of the waiting queue and waited for 35 seconds before pulling into the oncoming traffic lane, bypassing the other vehicles in the queue and entering the crossing on the wrong side of the road. A photograph of the offending vehicle as it is about to enter the crossing is shown below.

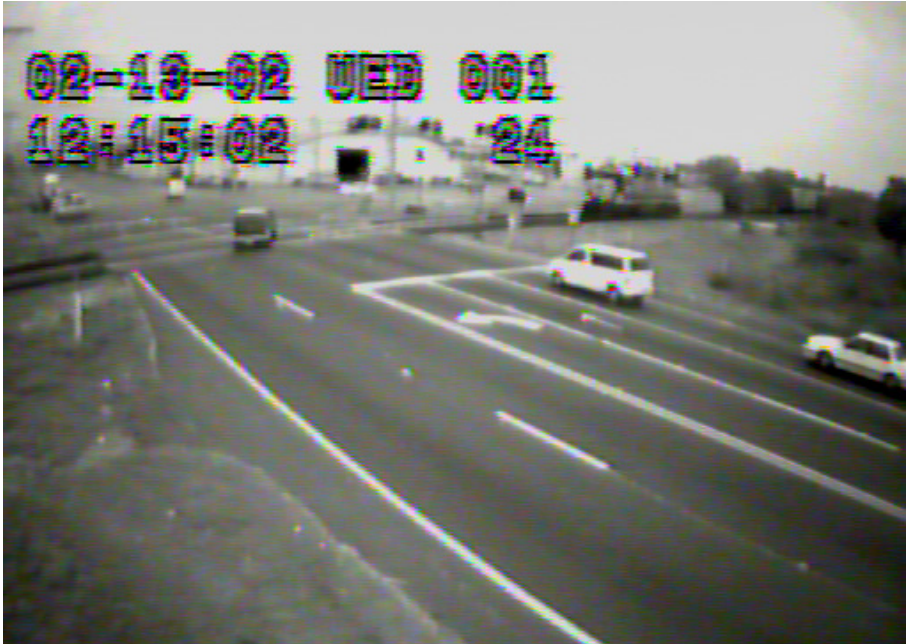
Figure 4-5: Northbound Drive-Around Violation Prior to Train Arrival

Only one northbound vehicle out of 127 vehicles drove around the gates before the train’s arrival (see Figure 4-5). The vehicle did not stop and had to execute a big curve at a high acceleration rate during this violation. The driver driving in the northbound middle lane made a right turn at the near intersection through the northbound left-turn lane with only 5 seconds of clearance time. This perilous violation could have been avoided with the installation of a traffic separator.

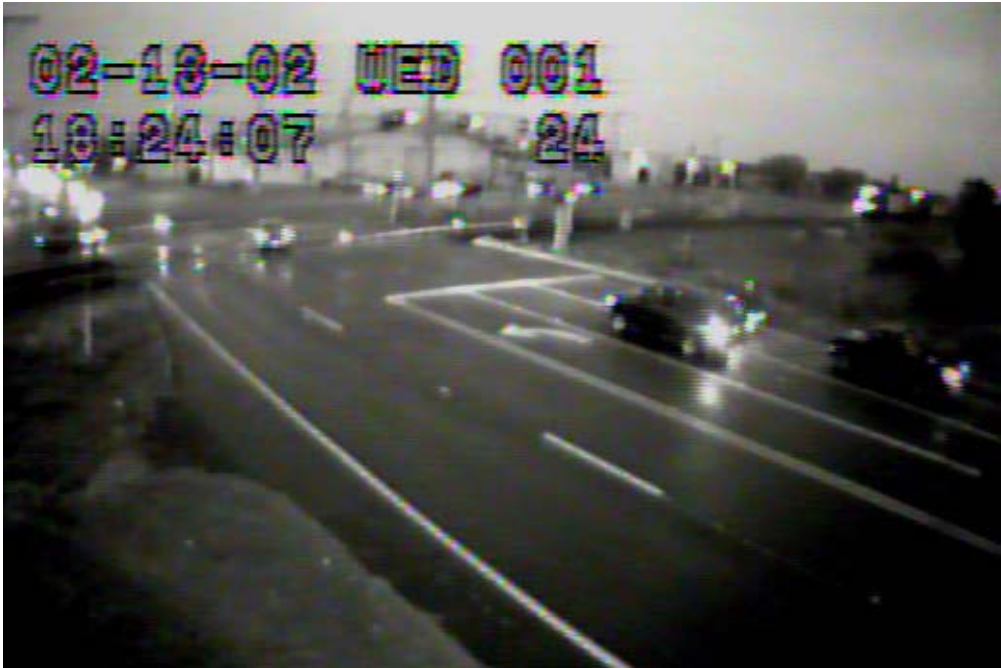
Figure 4-6: Northbound Drive-Around Violation During Train Switching Operations

Only one northbound vehicle out of 227 vehicles drove around the gates after the train’s arrival (see Figure 4-6). The vehicle arrived at the northbound middle lane when the gates were down with a stopped train near the crossing. The driver drove around the gates to the intersection stop line as soon as the train started moving away from the crossing. The switching operations of trains may induce drivers to drive around the gates because the drivers can see the slow movement of the train and decide they can make the movement safely. This behavior could be disastrous especially if there is more than one track at the crossing, as with the Park Road site. The vehicles that drive around these gates might conflict with an approaching train on other tracks.

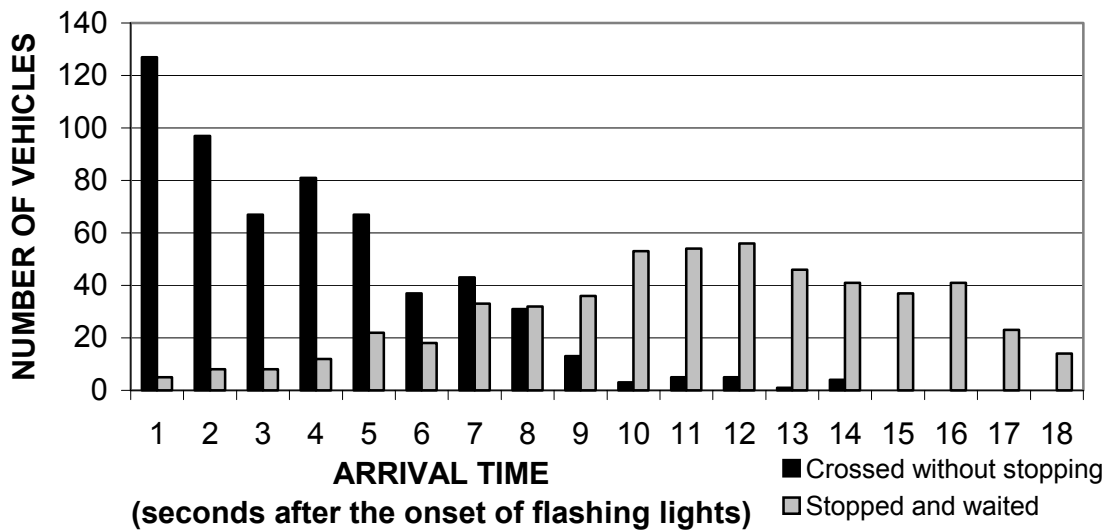
Figure 4-8: Crossing and Stopping Driver Behavior Before the Gates are Down (Northbound Before Separator Installation)

A more detailed study was carried out to determine the crossing behaviors from the signal onset until the gates are completely down. Figure 4-8, Figure 4-9 and Figure 4-10 show crossing or stopping behavior of drivers who approach the crossing at each time point before the gates are completely down. In the table, flashing lights began at “0” second, gates began to descend at “5” second, and gates were complete down at “19” seconds at the Park Road Site.

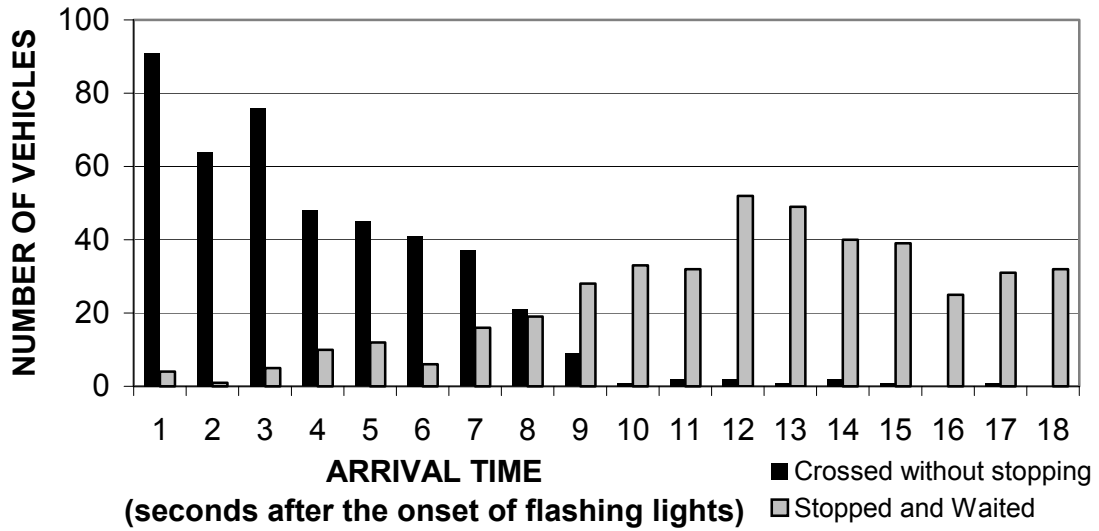
Figure 4-9: Crossing and Stopping Driver Behavior Before the Gates are Down (Northbound After Separator Installation)

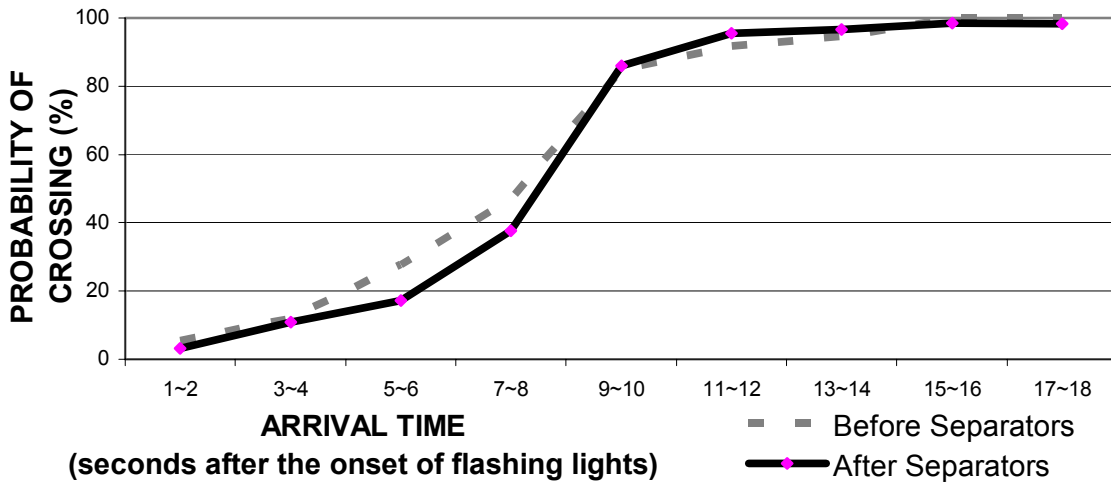
Figure 4-10: Probability of Stopping Before the Gates are Down (Northbound Before and After Separator Installation)

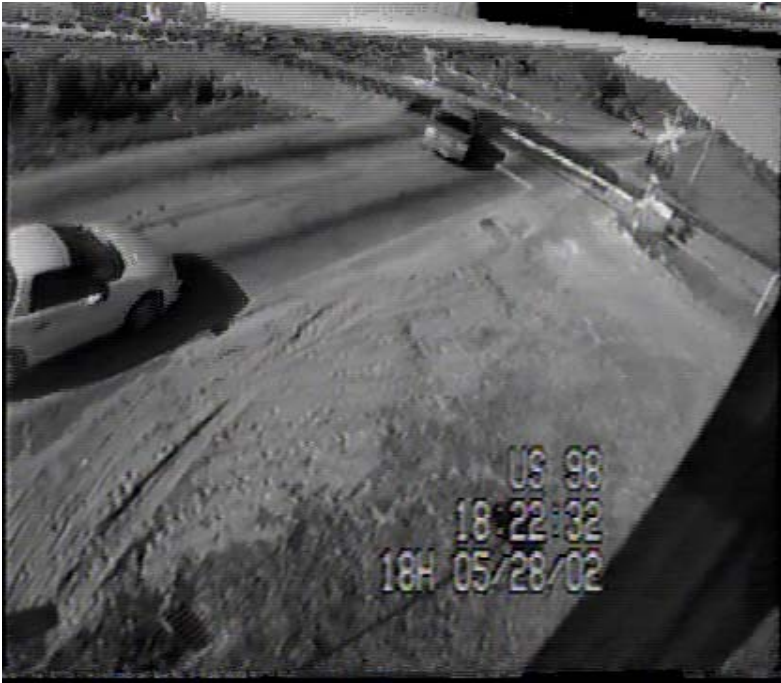
Figure 4-11: Drive-Around Violation at US 98 Site

US 98	BEFORE TRAIN ARRIVAL	AFTER TRAIN ARRIVAL	OVERALL
BEFORE BARRIER INSTALLATION	6 / 444 (1.6%)	0 / 611 (0.0%)	6 / 615 (1.1%)
AFTER BARRIER INSTALLATION	1 / 236 (.42%)	0 / 293 (0.0%)	1 / 293 (.34%)

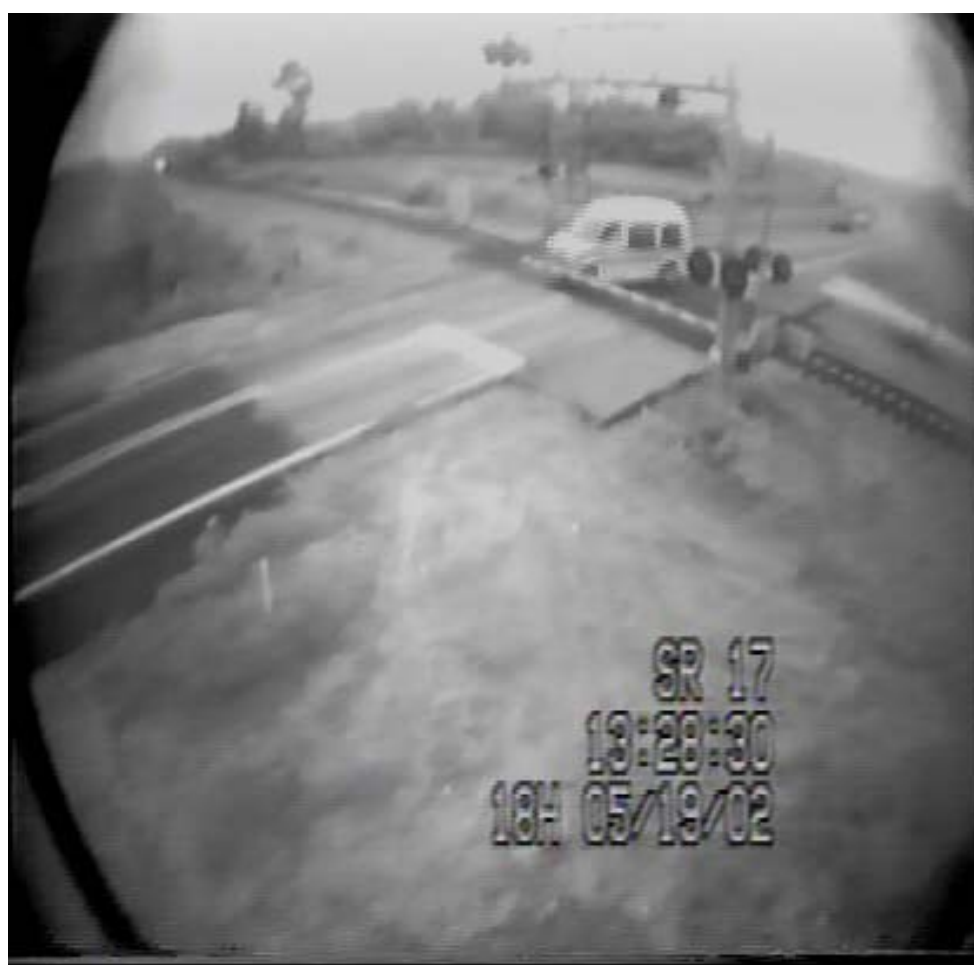
Figure 4-12: Drive-Around Violation at SR 17 Site

A total of 17 drive-around vehicles have been observed violating the warning gates in the before train arrival category. Seven of them drove around the gates in platoon style, and one pedestrian violation took place. All of the detailed information and picture clips of drive-around violations are included in Appendix C.

SR 17	BEFORE TRAIN ARRIVAL	AFTER TRAIN ARRIVAL	OVERALL
BEFORE BARRIER INSTALLATION	17 / 267 (6.7%)	0 / 453 (0.0%)	17 / 457 (3.9%)
AFTER BARRIER INSTALLATION	0 / 160 (0.0%)	0 / 293 (0.0%)	0 / 293 (0.0%)

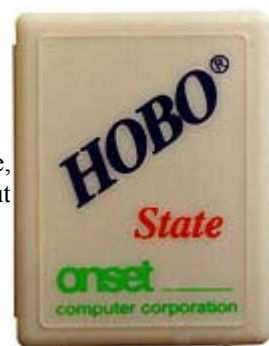
The HOBO H6 State logger records when devices change between open and closed, storing the time, date, and state for each change. Black arrows in diagram show when data is recorded. Use your PC to readout and analyze the data.
