# **Evaluation of X-Box Pavement Markings at Railroad-Highway Crossings**

**University of Florida  
Department of Civil and Coastal Engineering  
P.O. Box 116580  
Gainesville, FL 32611-6580**

**Final Report**

**January 2002**

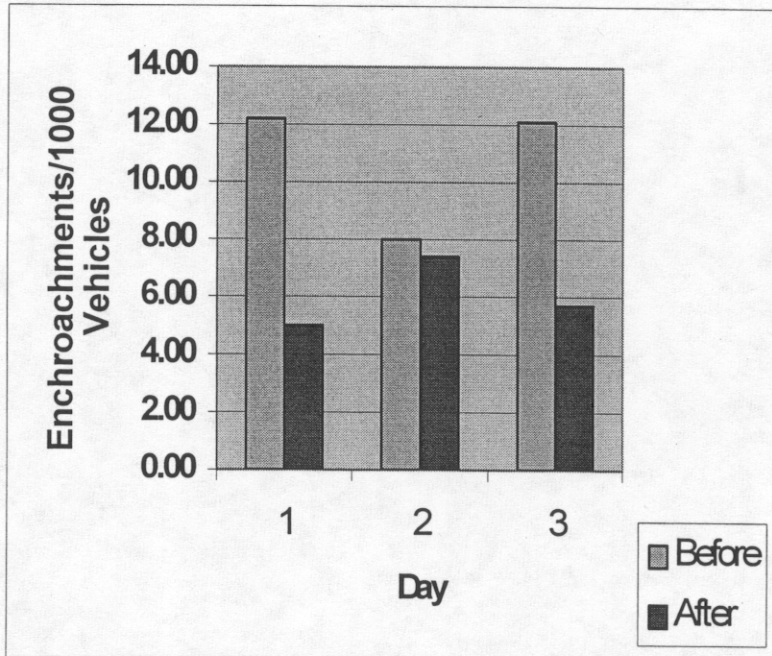
Figure 1-3. Comparison of Encroachments at Box Hill Grade Crossing

markings on the near side of the crossing, as shown in figure 1-2, and yielded few encroachments onto the tracks. Although the study was very short in duration, it did show a significant reduction in the number of encroachments on or adjacent to the tracks, as can be seen in figure 1-3<sup>3</sup>.

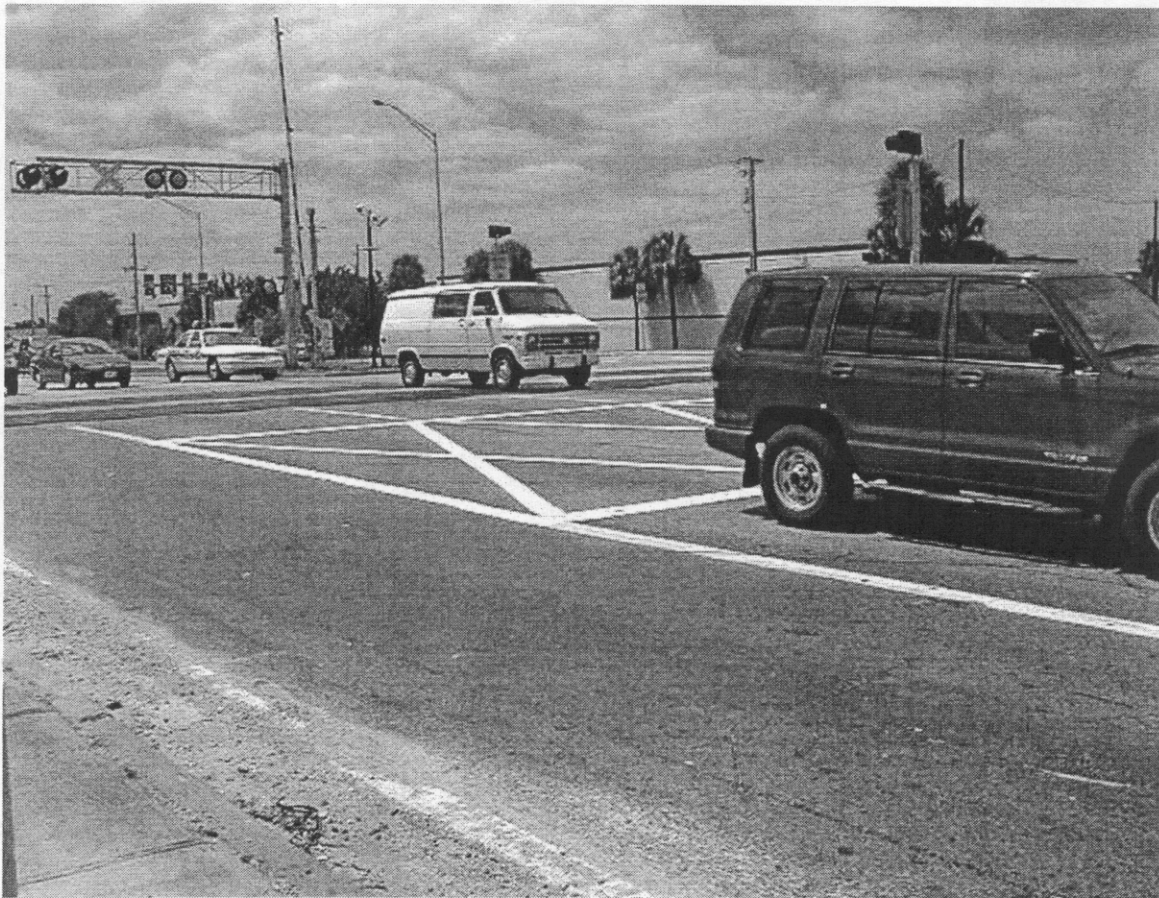
**Figure 2-2. Commercial Blvd. Crossing with European X Markings Installed**

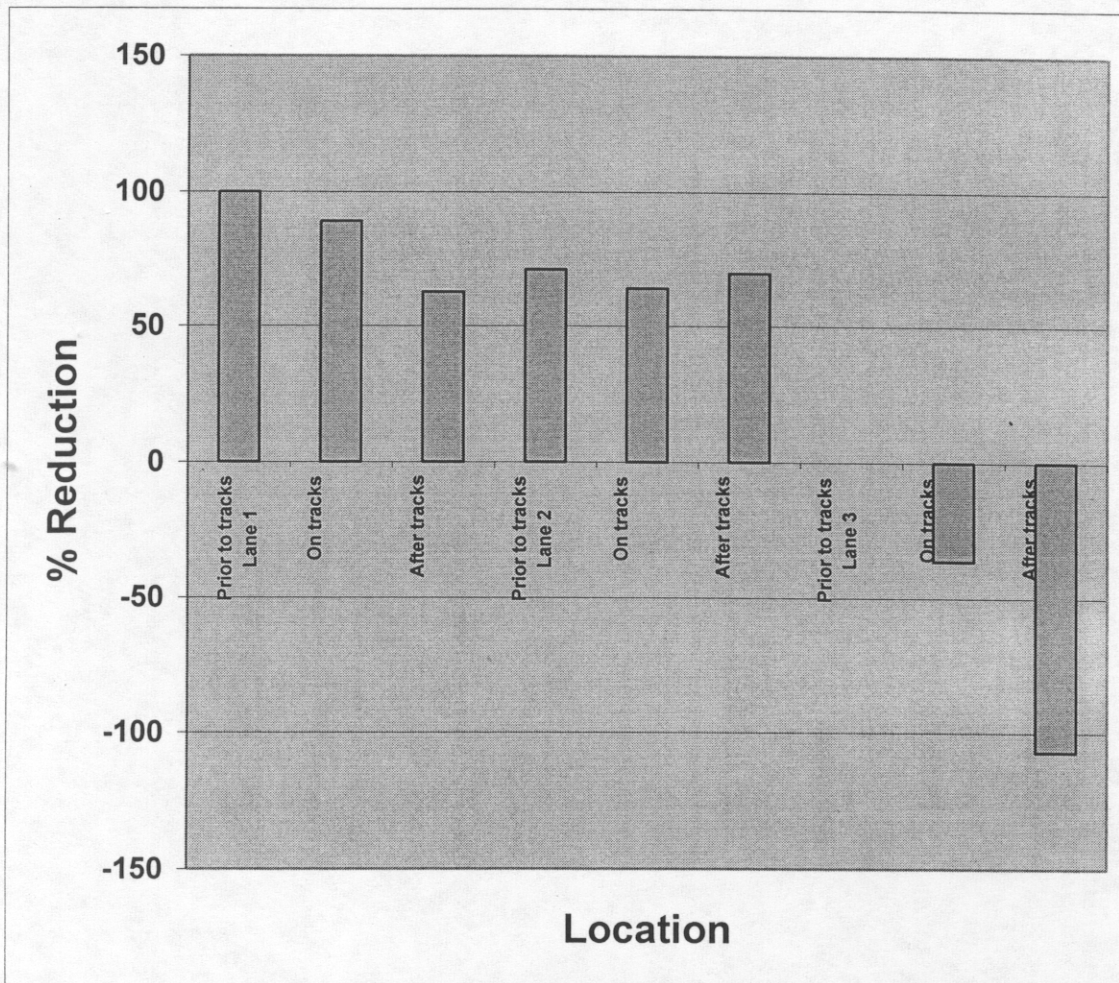
Figure 3-7. Percentage Reduction in Stops/1,000 Cars for Barberville Spring Study

As with the Labor Day study, the percentage changes between the stoppage rates for each of the Barberville lanes and the critical zones within the lanes were plotted as shown in figure 3-7. The picture that emerges is not as clean-cut as in the earlier analysis, in that there were increases in the stoppage rates in all zones for lane 3. Notwithstanding this situation, the overall rate still decreases dramatically because the relative stoppage rates are low for lane 3.

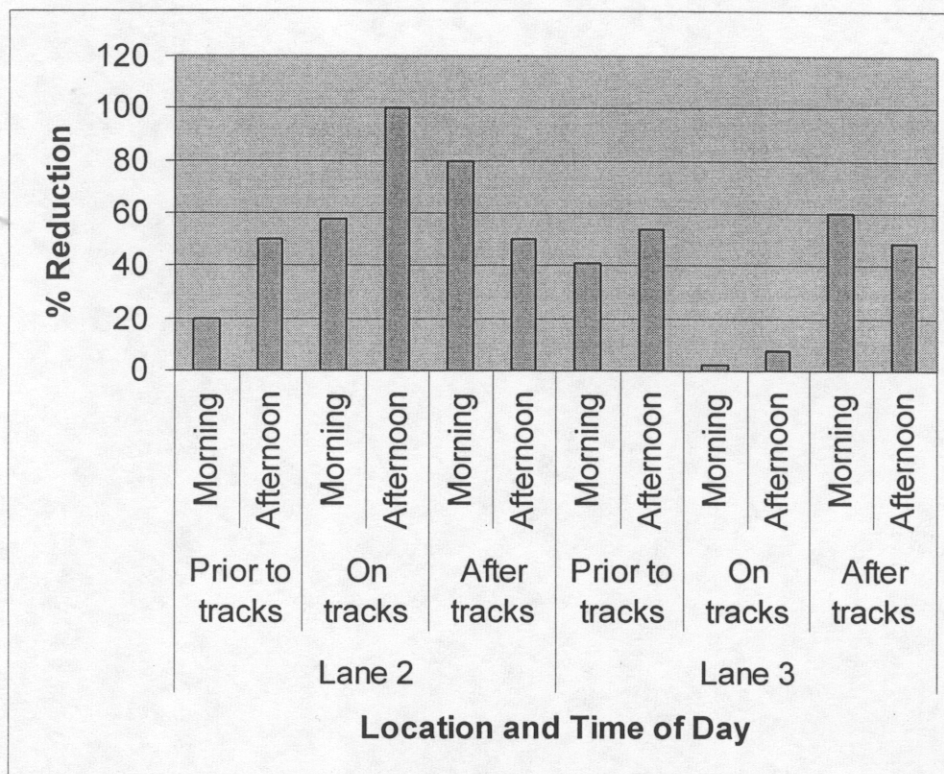
Figure 3-12. Percentage Reductions in Stops/1,000 Cars for Inside Lanes on Commercial Blvd

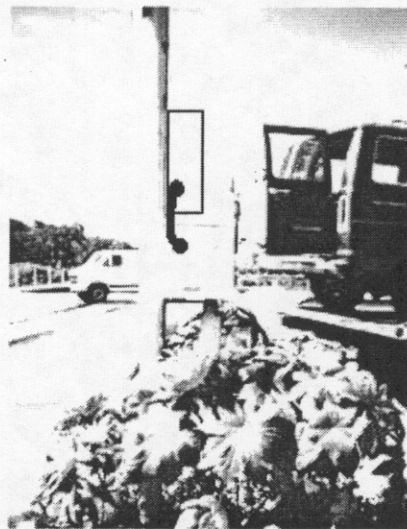
Figure A-2. Installation of Recorder Box at Oakland Park Blvd

The other location was more difficult because of differences in the flasher pole installation. The telescoping pole was subsequently accommodated at the Oakland Park Blvd site using extended mounting clamps for greater clearance as shown in figure A-2.

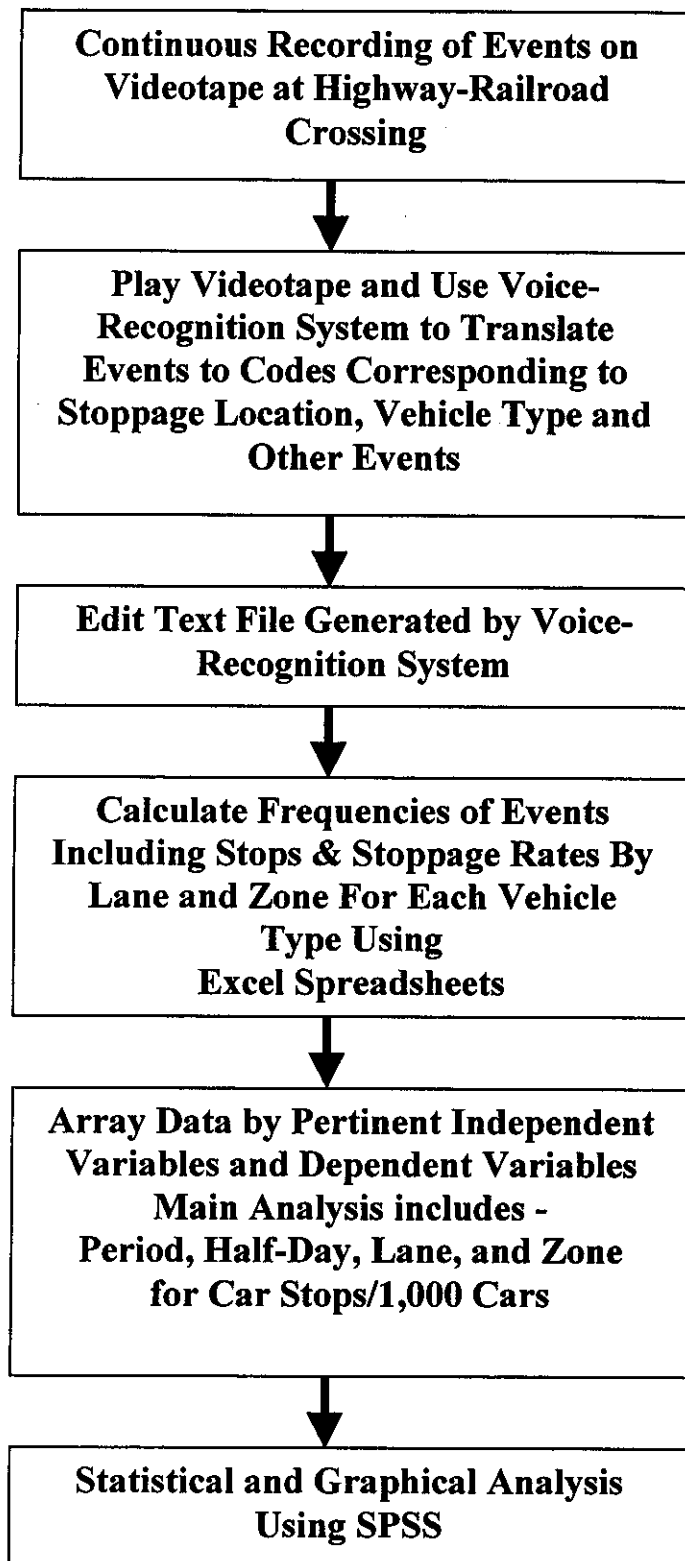
**Figure B-1. Data Acquisition and Analysis Process**

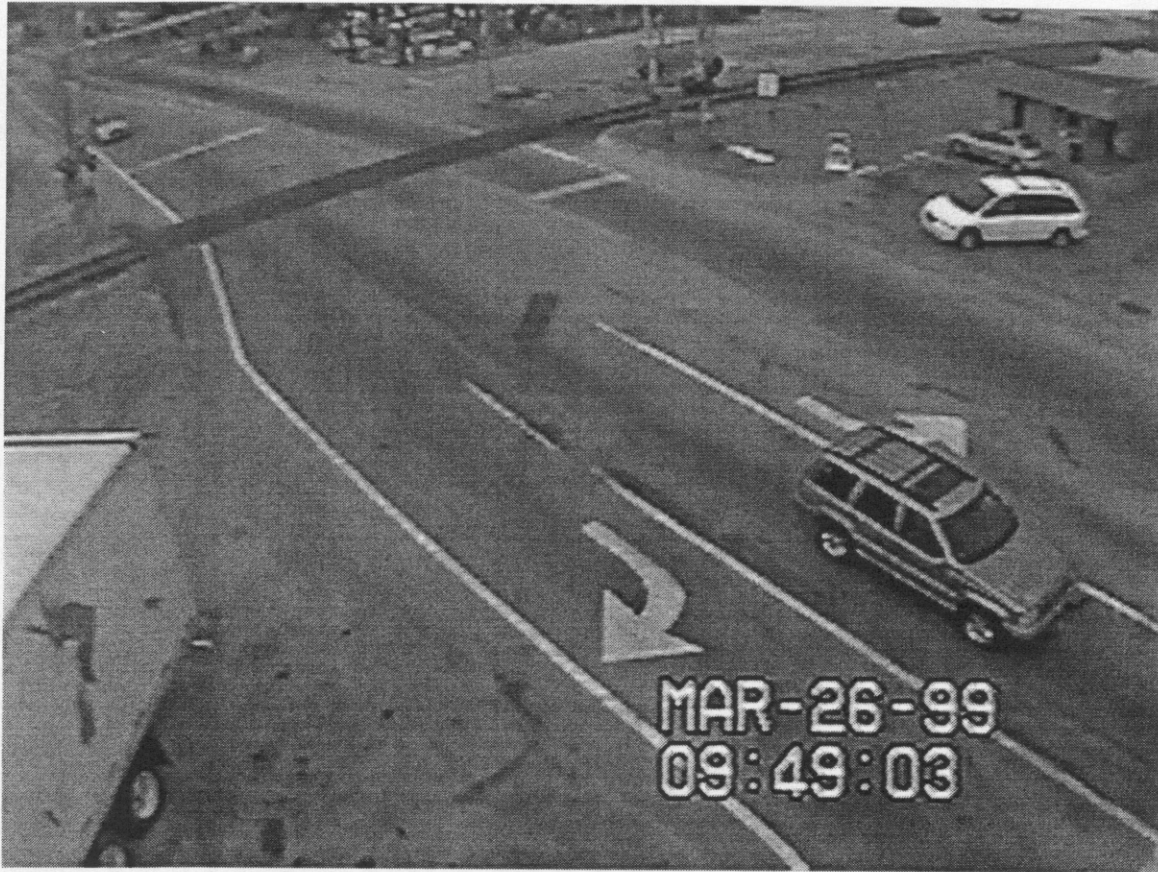
**Figure B-2. Camera View of Barberville Highway-Railroad Crossing**

left-turn lane to right-turn lane), and the second digit indicated the stopping zone (numbered in travel sequence) as shown in table B-1.

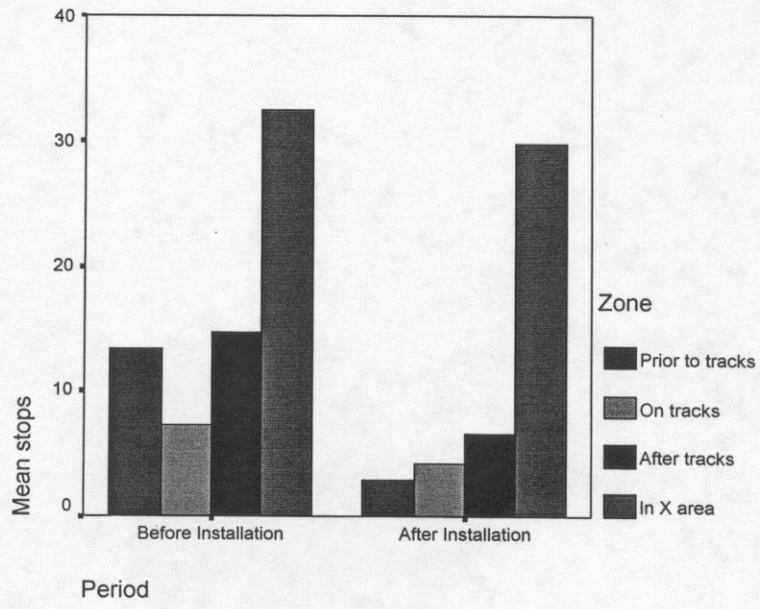
**Figure B-10. Example of Graphical Analysis**

The SPSS package also provides nested means and graphic capabilities that allow probing more deeply into the data. This facility was used to attempt to understand why the European X markings were successful at Barberville, but not at Commercial Blvd. This feature is illustrated in figure B-10.
