## Florida Department of Transportation Research

### Improved Inspection Techniques for Steel Prestressing/Post Tensioning Strand

BDK80 977-13

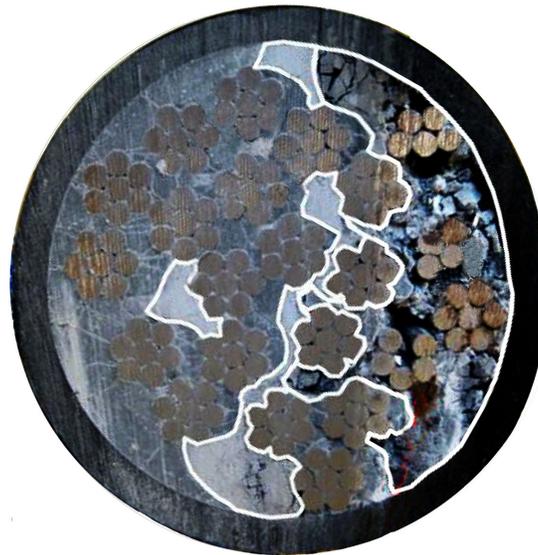
*In this cross-section of a post-tensioning duct, clusters of tensioning strands can be seen scattered throughout, surrounded by grout. Grout condition varies from intact (left), to decaying (outlined gray areas; middle), to decayed (right), where voids and corroded tendons are visible.*
