In-Service Performance Evaluation (ISPE) for G4 (1S) Type of Strong-Post W-Beam Guardrail System and Cable Median Barrier: Volume II

Final Report
Contract No. BDK80 977-19
December 2012
(Revised March 2013)

Prepared by:
Lehman Center for Transportation Research
Florida International University

Prepared for:
Research Center
Florida Department of Transportation

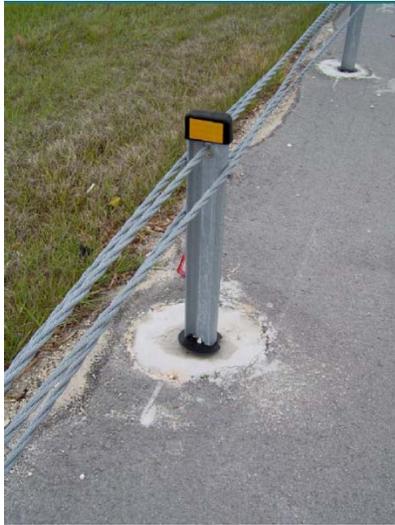
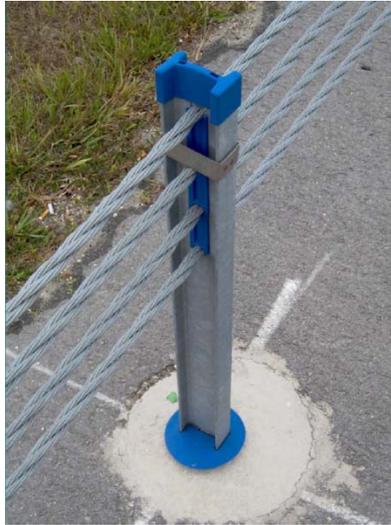
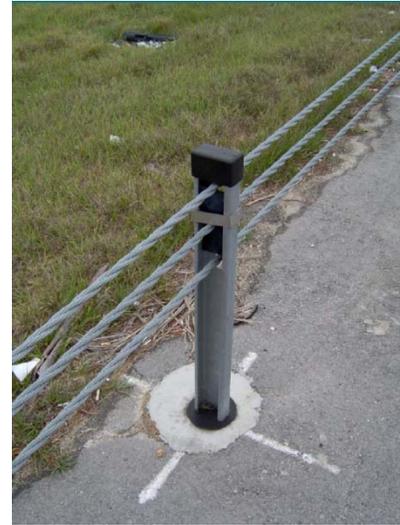
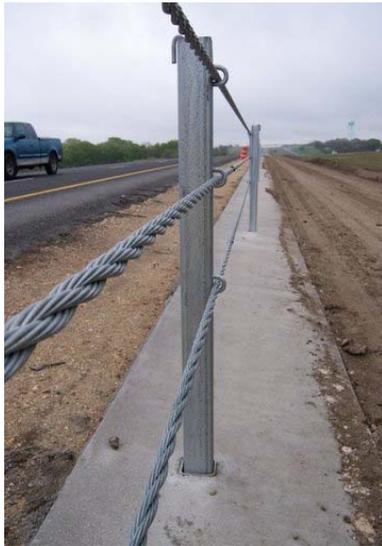
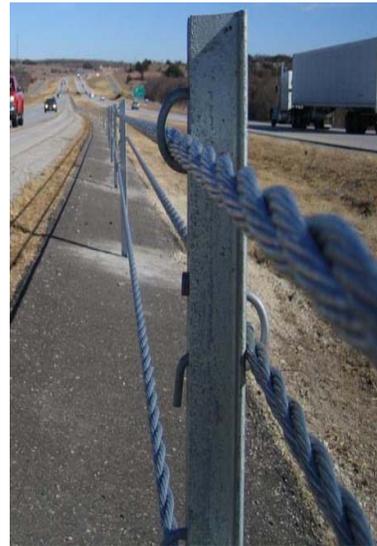
Figure 1-1: Types of High-Tension Cable Barrier Systems Used in Florida
Sources: ¹ Cook and Johnson (2006); ²Alberson et al. (2007)

a) Brifen¹

b) Safence¹

c) CASS¹

d) Gibraltar²

e) Nucor Marion²

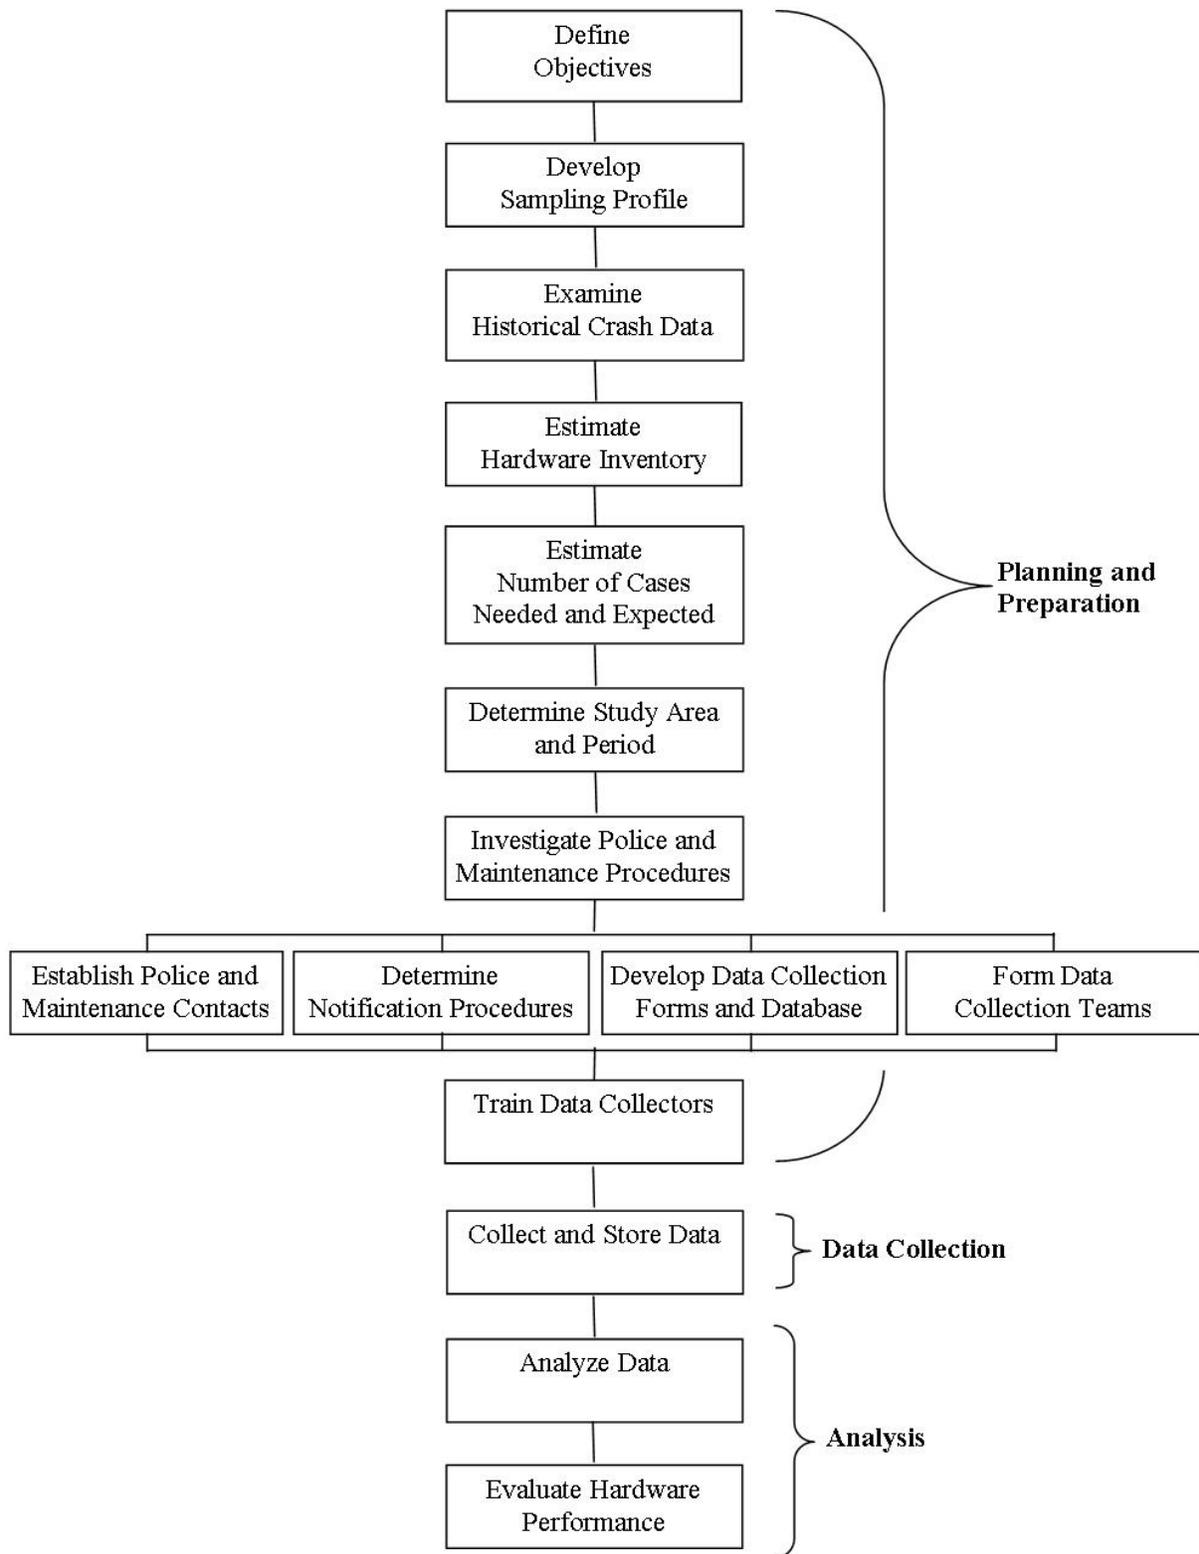
Figure 2-1: Flow Chart of the ISPE Process (Ray et al. 2003)

There is no formal process set in place for conducting an in-service performance evaluation (Ray et al. 2003; Schalkwyk et al. 2006). Appendix D of NCHRP Report 490 aimed at addressing this issue. Figure 2-1 shows the flowchart of the entire ISPE process broken down into three sub phases: planning and preparation, data collection, and analysis. The following sections discuss each of the three sub-phases in detail:

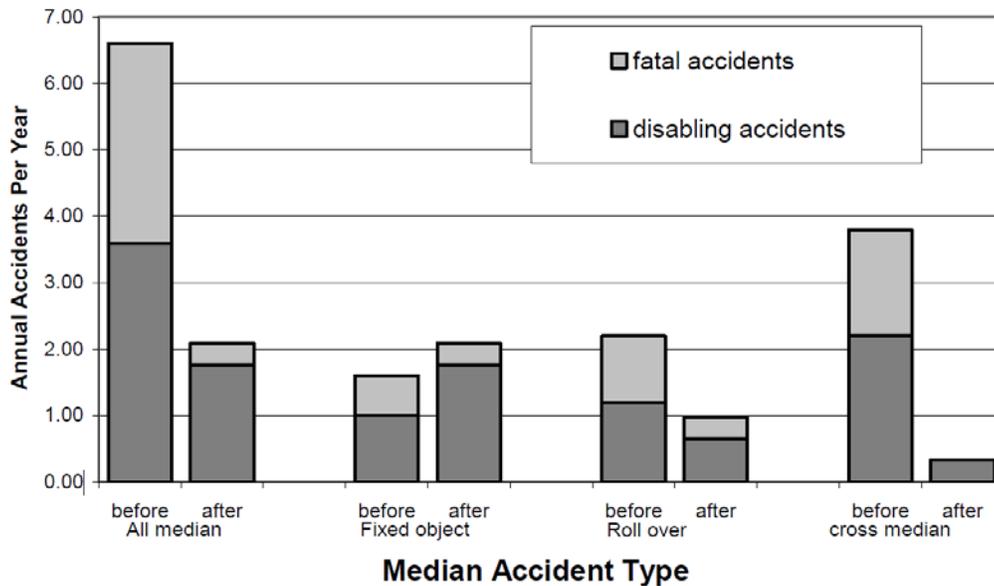
Figure 2-2: Comparison of Annual Crashes Before-and-After Cable Median Barrier Installation (McClanahan et al. 2004)

McClanahan et al. (2004) documented Washington State’s experience with cable median barrier system by analyzing installation and maintenance costs, and by performing before-and-after evaluation of the system. The research team analyzed 24.4 miles of cable median barriers along I-5. The installation cost was estimated to be \$44,000 per mile. The average cost per repair was found to be \$733. The average annual maintenance cost was approximately \$2,570 per mile. The time required to repair the cable median barrier was approximately 30% less than that for W-beam guardrail. Figure 2-2 compares the before-and-after crash experience by crash type. Post installation, there was a significant reduction in the number of severe crashes. Also, the cable median barrier was successful in preventing cross-median crashes. This research concluded that the annual societal benefits of cable barriers were approximately \$420,000 per mile.

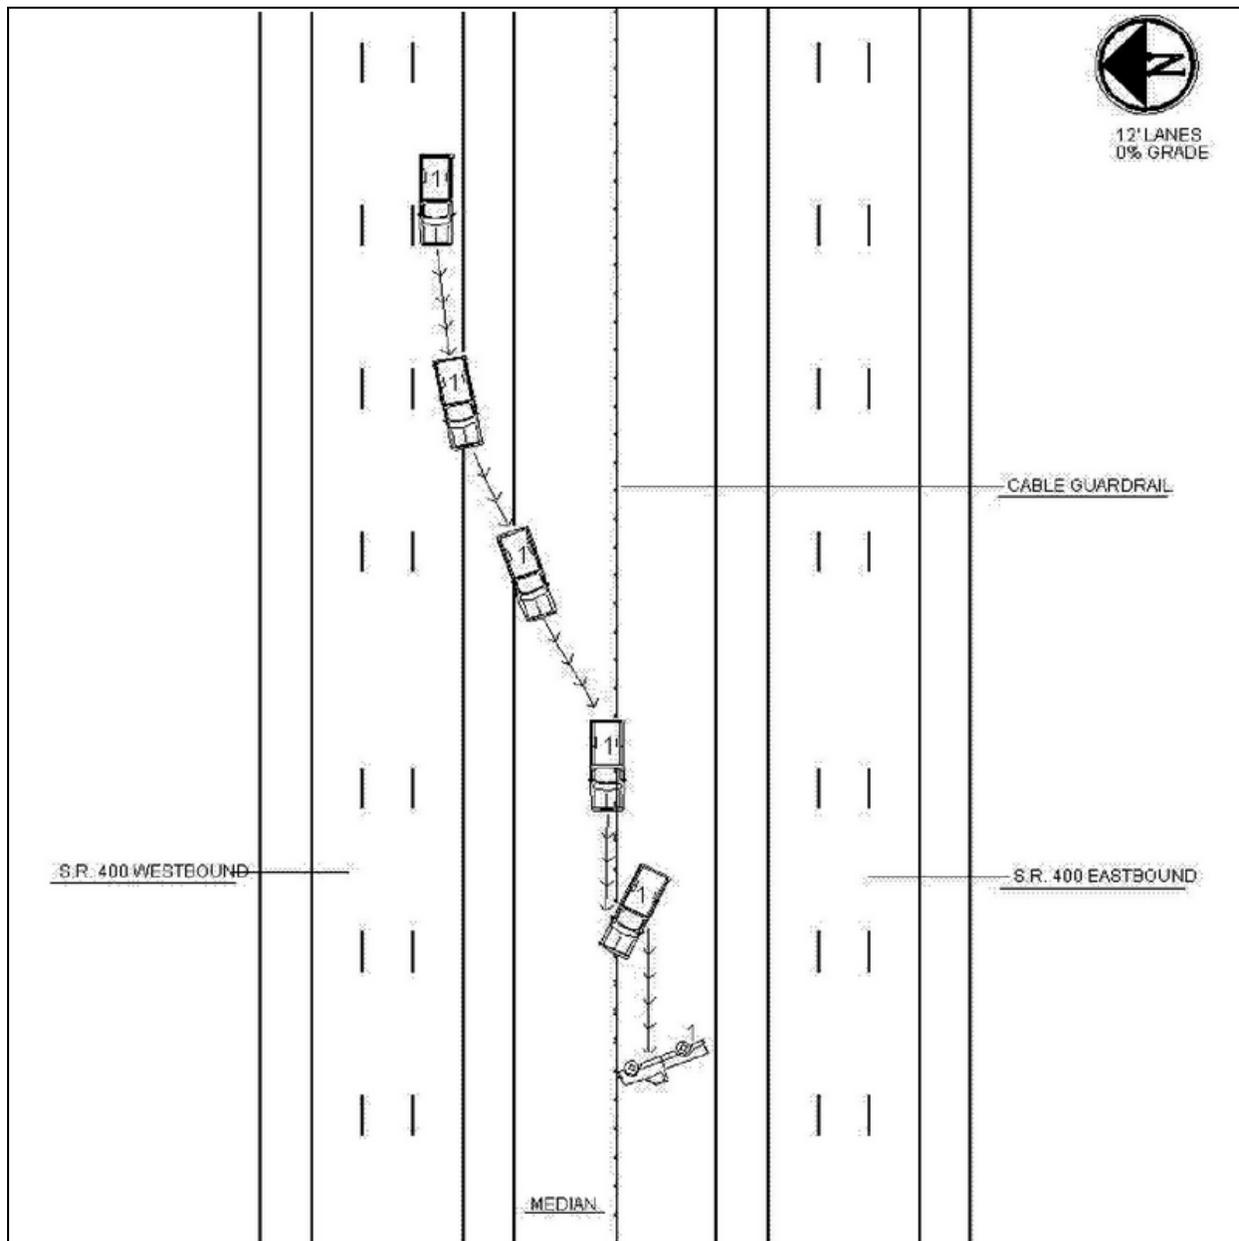
V1 was traveling west on S.R. 400. The driver of V1 stated that he fell asleep at the wheel. V1 left the road and entered the median. V1 struck the cable guardrail and overturned onto its left side. V1 came to final rest on its left side facing in a westerly direction in the median of S.R. 400.

Figure 3-1: Example of a Barrier Crossover Over-ride Crash (Crash # 776721690)

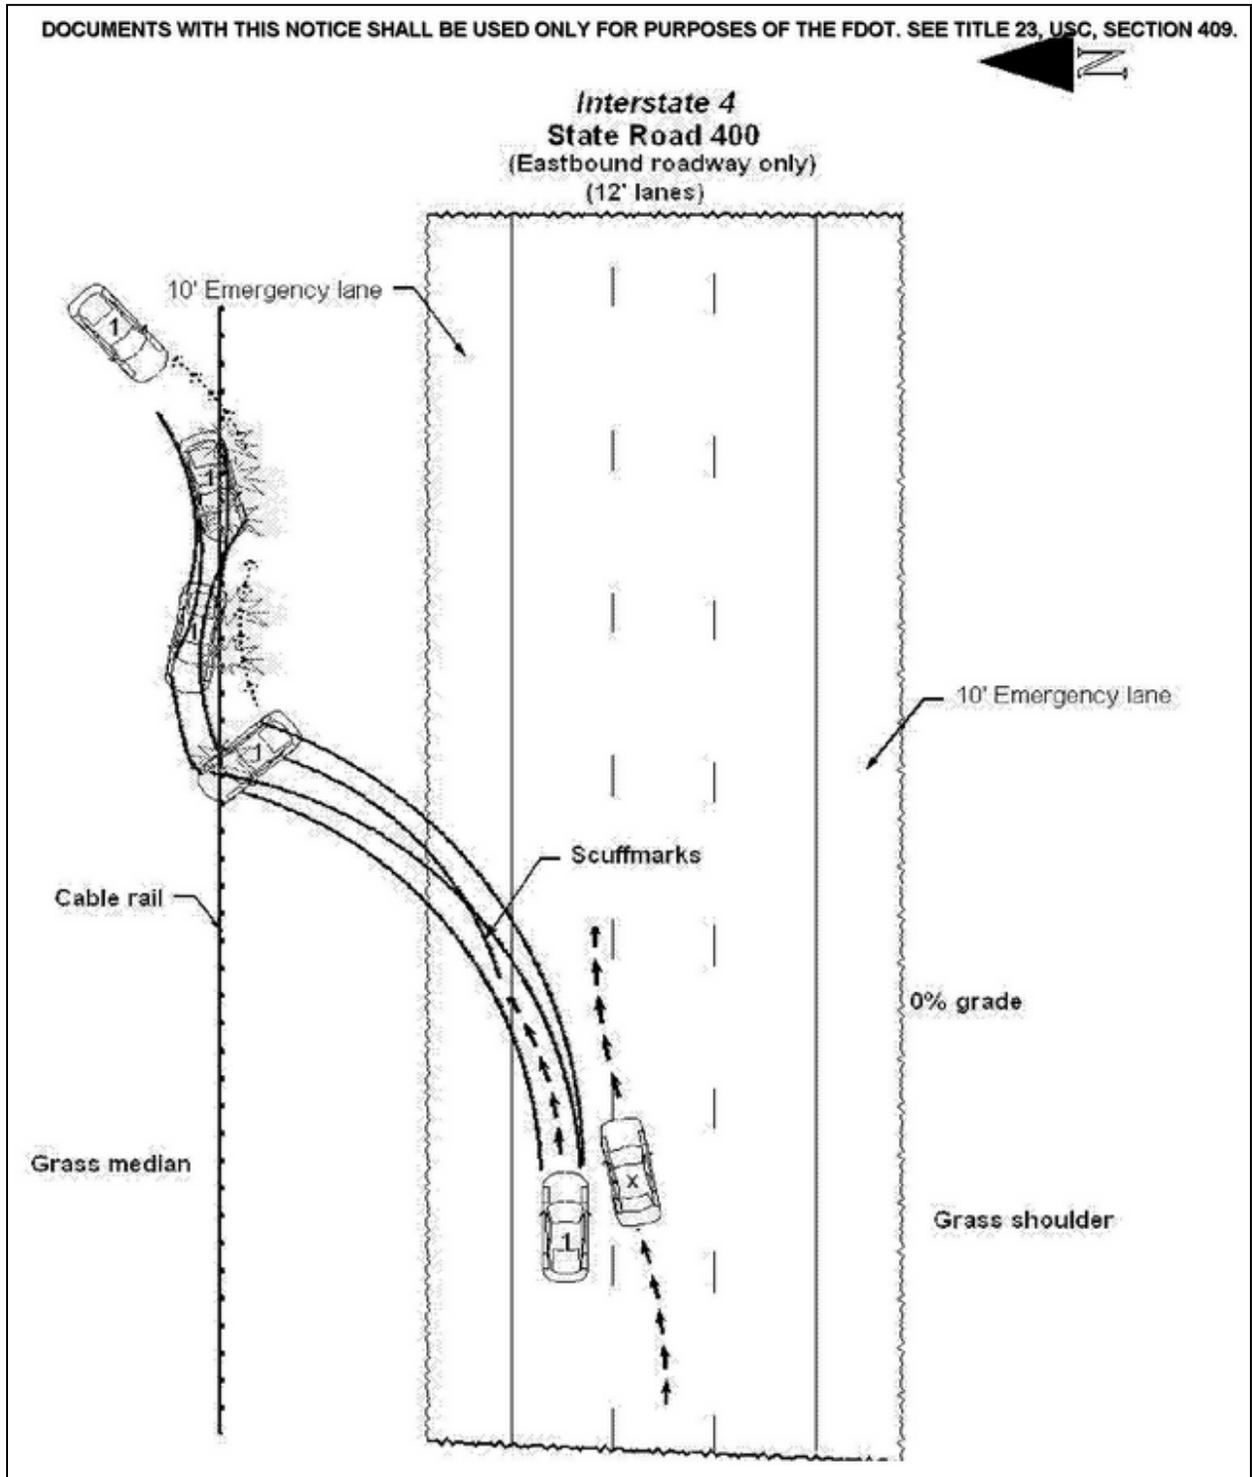
V-1 was eastbound on State Road 400 in the inside lane. A vehicle that was eastbound on State Road 400 in the middle lane, alongside V-1, changed lanes toward V-1. D-1 swerved to her left and slid off the roadway into the grass median. V-1 rotated in a counterclockwise manner, sliding into the cable rail in the median. The left side of V-1 struck a cable support. V-1 traveled partially through the cable rail, continuing to rotate counterclockwise. V-1 slid down the cable rail, underneath the cables, making contact with the rail supports with the rear and left side of V-1, before rotating out, traveling backward, into the median, coming to rest. V-1 was a non-contact vehicle that left the scene.

Figure 3-2: Example of a Barrier Crossover Under-ride Crash (Crash # 776553840)

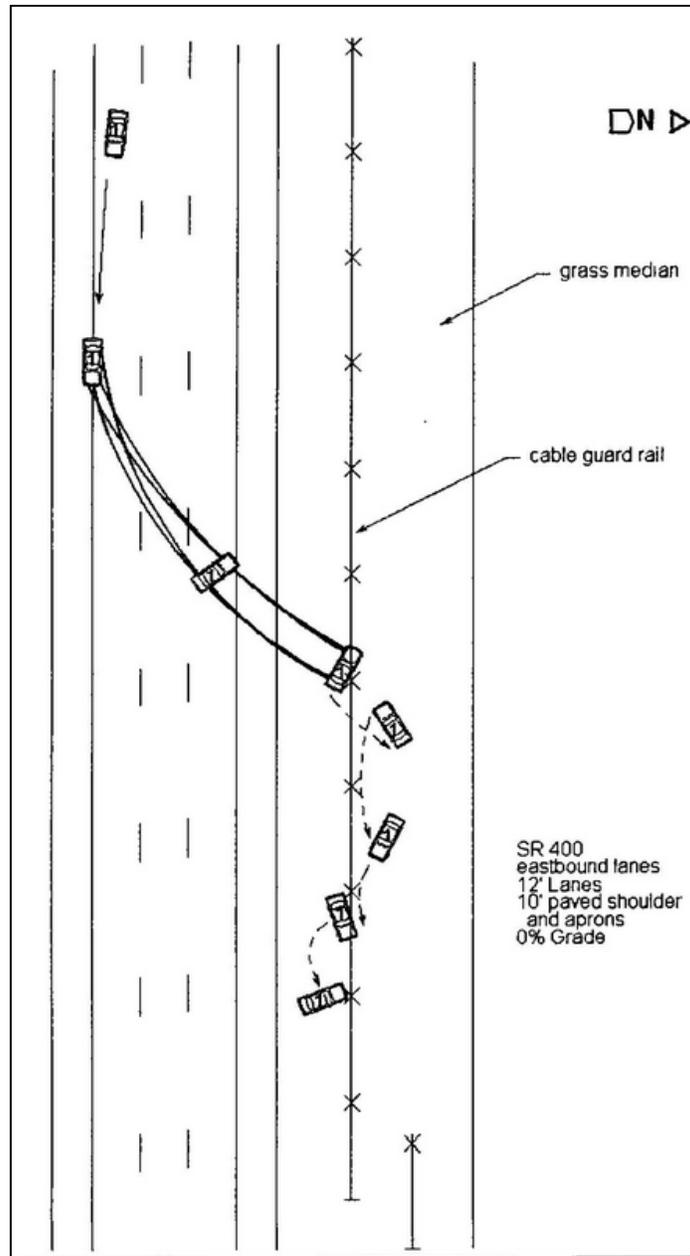
V-1 was eastbound on SR 400 in the outside lane. V-1's right side tires entered the south edge of the roadway. D-1 over corrected to the left causing V-1 to travel across the eastbound lanes rotating counterclockwise. V-1 entered the median striking the cable guard rail with V-1's right side. V-1 traveled through the guard rail. V-1's front rotated to face eastbound. V-1 traveled eastbound toward the guard rail. V-1 traveled through the guard rail a second time rotating counterclockwise coming to final rest on the south side of the guard rail facing northwest. D-1 stated that she was originally in the center lane and was operating her GPS. When she looked up again she was close to a truck. She then traveled into the outside lane and onto the south edge of the roadway and lost control of her vehicle.

Damage to the cable guard rail west of the 40.3 mile marker. Approximately 125 feet damaged.

Figure 3-3: Example of a Barrier Crossover Penetration Crash (Crash # 771491090)

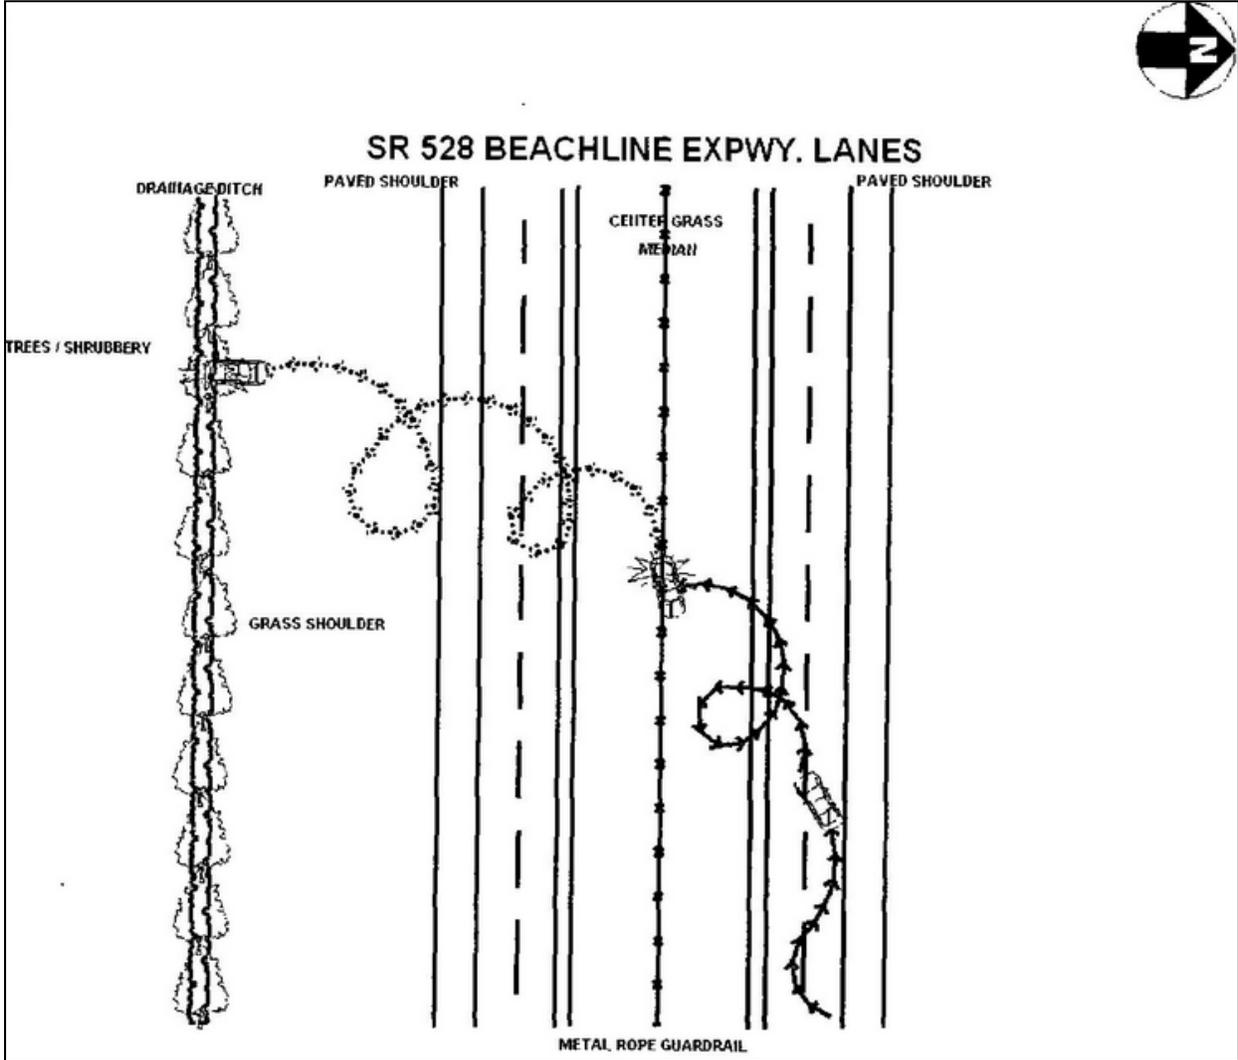
V1 WAS TRAVELING WEST ON SR 528 IN THE RIGHT LANE NEAR THE 22 MILE MARKER. V1 DRIVER STATED THAT SHE ATTEMPTED TO PASS A DUMP TRUCK, SHE WENT FROM THE RIGHT TO THE LEFT LANE, THEN TRIED TO GO BACK TO THE RIGHT LANE, RAN UPON THE UNEVEN PAVEMENT, LOST CONTROL OF HER STEERING HIT HER BRAKES, WENT INTO A COUNTER CLOCKWISE SPIN, RAN BACK ACROSS THE LEFT LANE INTO THE CENTER GRASS MEDIAN STRIKING THE METAL ROPE GUARDRAIL WITH THE LEFT SIDE OF HER VEHICLE, OVERTURNED HER VEHICLE CROSSING THE GUARDRAIL, CROSSING THE EASTBOUND LANES AND PAVED SHOULDER ONTO THE GRASS SHOULDER WHERE IT CAME TO FINAL REST CRASHING INTO SOME SMALL TREES, AND SHRUBBERIES. ROAD CONDITION LEFT LANE HAD BEEN NEWLY PAVED / UNEVEN LANES.

Figure 3-4: Example of a Median Crossover Crash (Crash # 771887130)

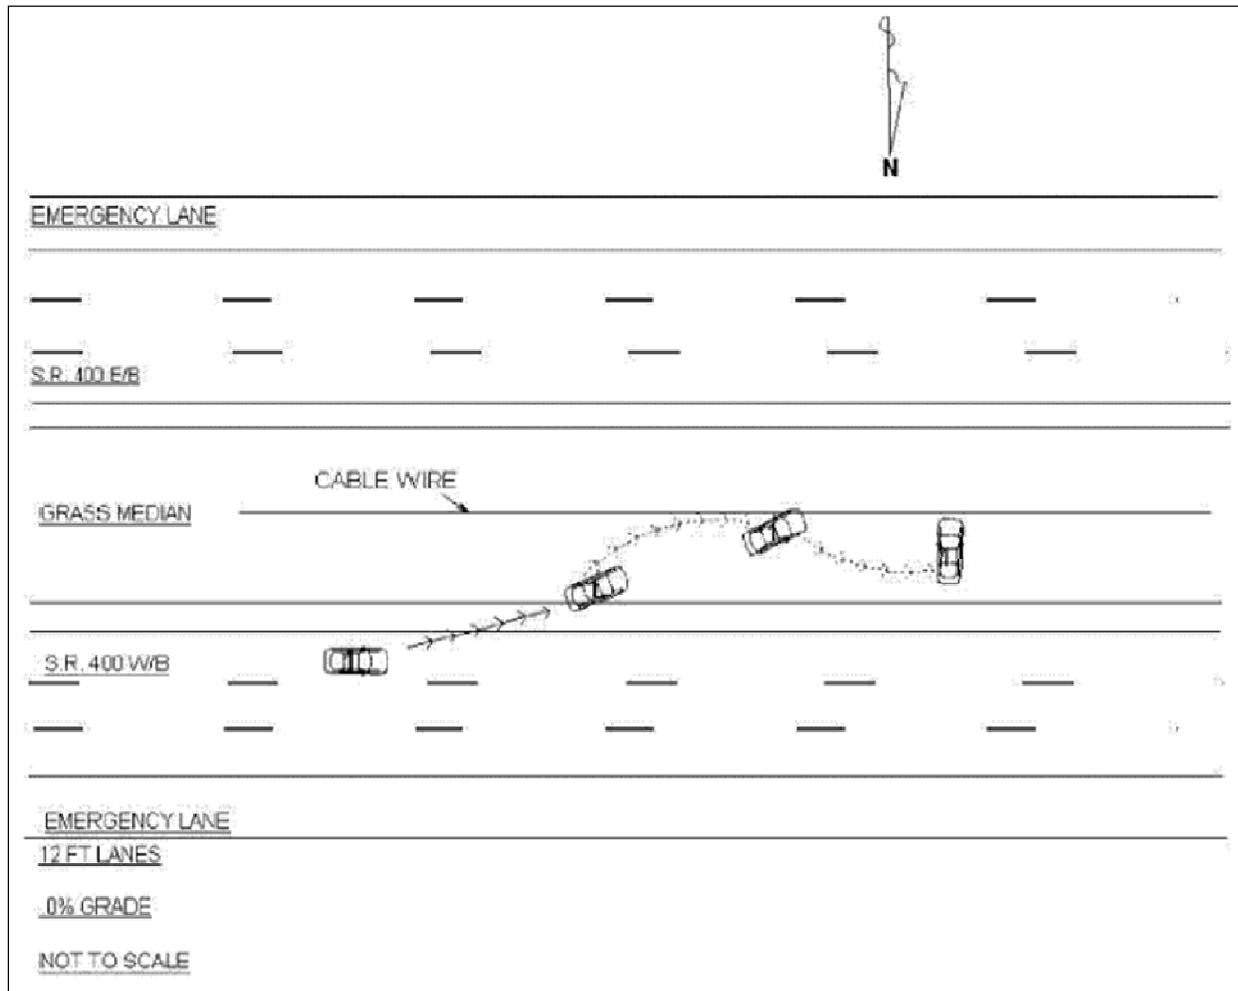
V1 was westbound on SR-400 in the inside lane. For an unknown reason, the driver of V1 lost control of the vehicle. V1 continued in a westerly direction onto the median. V1 then started to rotate clockwise and struck a cable wire with its left front. V1 came to final rest at this time without further incident. V1 came to final rest facing south. Contributing Causes-Careless Driving-V1 failed to maintain control of vehicle. Cable wire stopped the vehicle movement.

Figure 3-5: Example of a Non-Crossover Redirected Crash (Crash # 773972380)

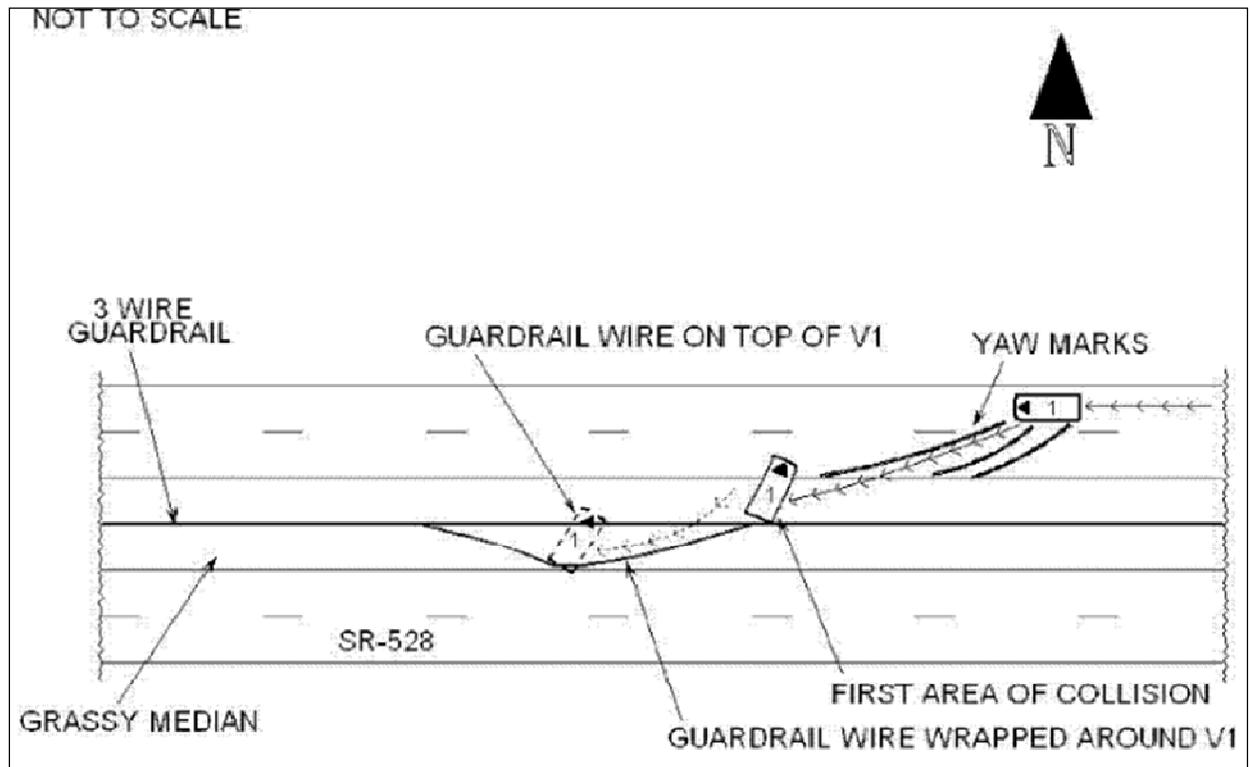
V1 WAS TRAVELING WESTBOUND ON SR-528 IN THE OUTSIDE LANE. THE TIRE TREAD ON V1'S LEFT REAR TIRE SEPARATED CAUSING D1 TO LOSE CONTROL OF THE VEHICLE. V1 ROTATED CLOCKWISE AS V1 SLID ACROSS THE WESTBOUND TRAVEL LANES AND INTO THE MEDIAN. THE RIGHT REAR OF V1 THEN COLLIDED WITH THE WIRE GUARDRAIL. V1 CONTINUED TO SLIDE TO THE SOUTHWEST AS THE WIRE GUARDRAIL SLOWED V1 TO A STOP. V1 CAME TO FINAL REST FACING NORTHEAST IN THE MEDIAN AND WAS ENTANGLED IN THE WIRE GUARDRAIL. NOTE: 2 OF THE 3 GUARDRAIL WIRES TRAVELED OVER THE ROOF OF V1 CAUSING ADDITIONAL DAMAGE.

Figure 3-6: Example of a Non-Crossover Contained Crash (Crash # 776779740)
