# EVALUATION OF INNOVATIVE SAFETY TREATMENTS

## Final Report

### **Florida Department of Transportation**

Contract Number B-D500  
Financial Project I.D. 406865-1-B2-04  
Evaluation of Innovative Safety Treatments  
HNTB Project Number 40502

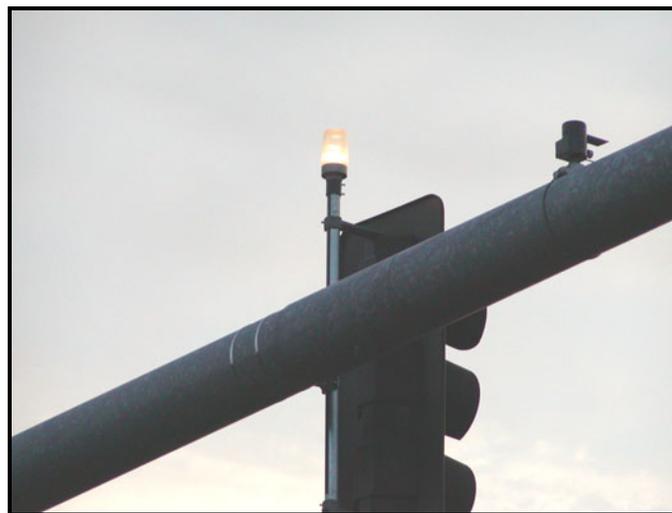
**Photograph 1: Typical Installation of a White Enforcement Light**

The white lights were placed either above or below the signal head (see Photograph 4), so they are visible from a complete circle of 360 degrees. Thus, a single officer positioned downstream from the intersection can safely observe the violation, stop the offending driver, and issue the citation. White lights can therefore potentially replace a police officer, reducing the required police manpower by half. The remaining staff can be allocated to enforcement of additional intersections or increase enforcement hours at the same intersection. Increased enforcement could in turn help change driver behavior and reduce the number of red light violations and associated crashes. Also, using white lights is much safer for police officers and other drivers, as the officer does not have to pursue the violator through the intersection while the cross street has a green indication.

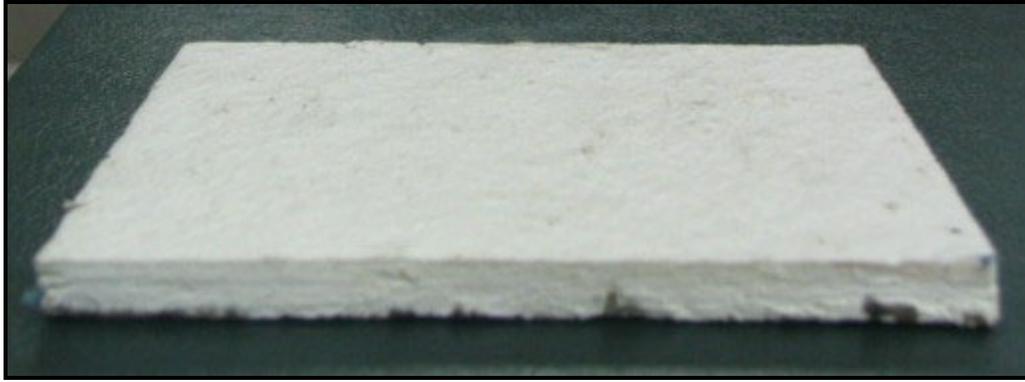
Photograph 2. Sectional view of temporary rumble strip

Four sets of rumble strips were installed in advance of the work zone, in each travel direction. The rumble strips were four inches wide and were installed in four sets of six strips per set (see Photograph 4). The first set was located 100 feet past the first (1500 feet) construction warning sign. The second, third, and fourth sets were installed at 500 feet, 250 feet, and 100 feet downstream of the previous sets, respectively (see Figure 3). The rumble strips were installed perpendicular to the travel direction of northbound and southbound traffic.

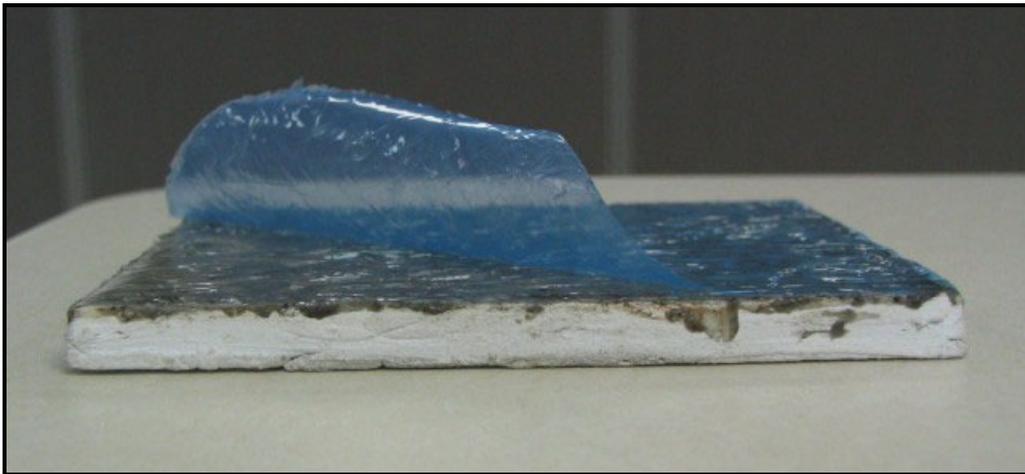
Photograph 3. Adhesive backing on temporary rumble strip

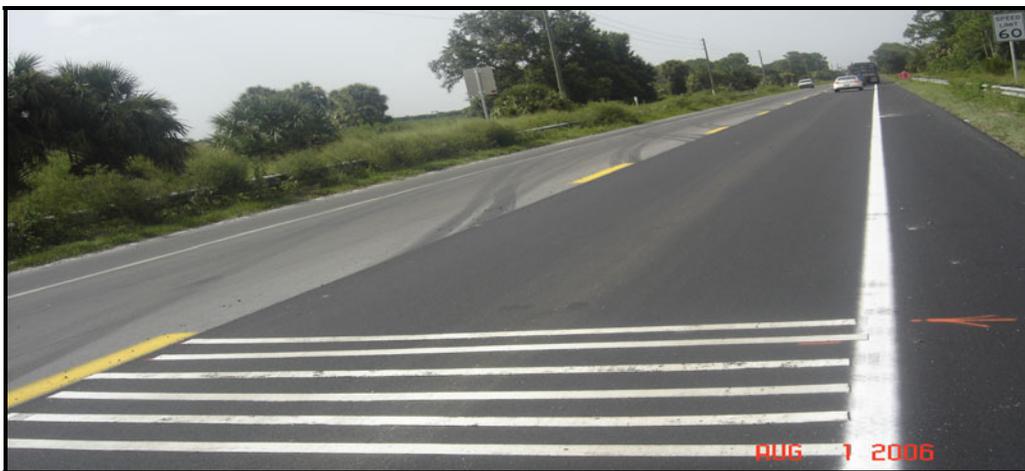
Photograph 4: Typical installation of temporary rumble strips (6 strips per set)

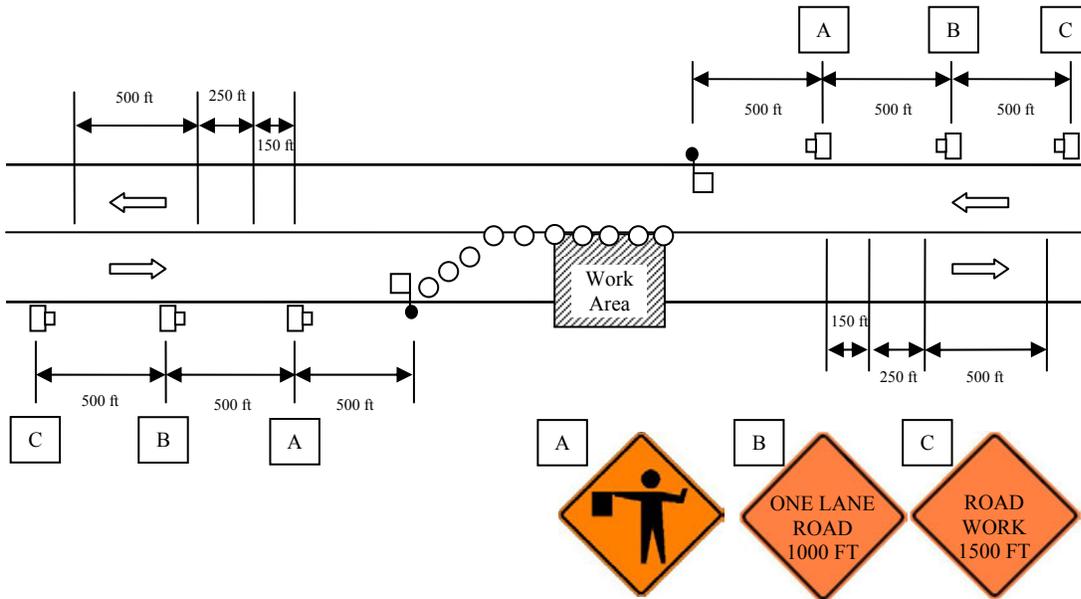
Figure 2. MOT Plan for Control Condition

The Maintenance of Traffic (MOT) plans for the control (without rumble strips) and test (with rumble strips) conditions are shown in Figures 2 and 3, respectively. The MOT plans shown in these figures were derived from Index 603 of the 2004 FDOT Design Standards for Design, Construction, Maintenance and Operations on the State Highway System (2).

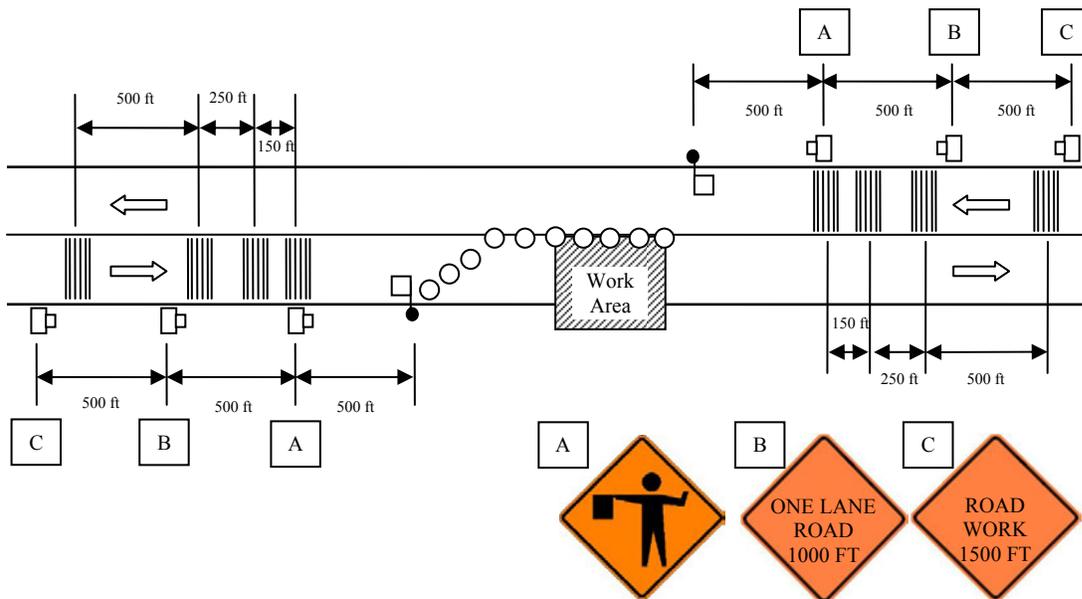
Figure 3. MOT Plan for Test Condition

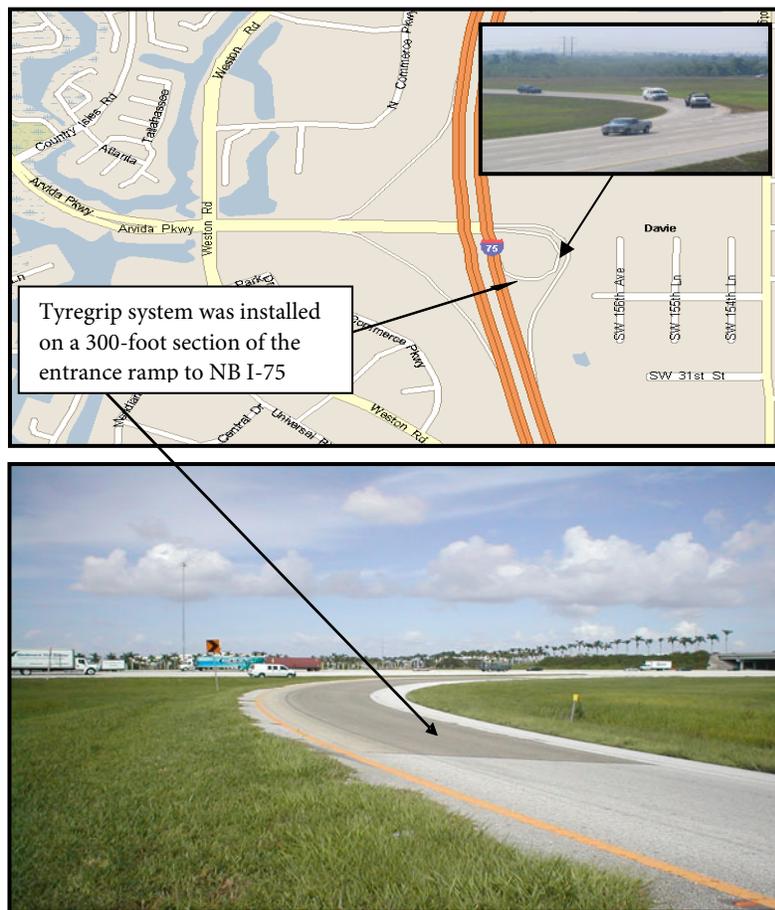
The Tyregrip system was installed on a 300-foot section of the ramp, just upstream of the gore area between I-75 and the ramp, where the majority of the crashes occurred. The subject ramp is a one-lane loop ramp with an advisory speed of 25 mph. Curve warning signs and chevron signs exist in advance of the study section of the ramp. This particular ramp was chosen as a candidate based on its crash history with 12 run-off-road crashes in the three-year period from 2002 to 2004. Eighty-three percent of these crashes occurred under wet road surface conditions.

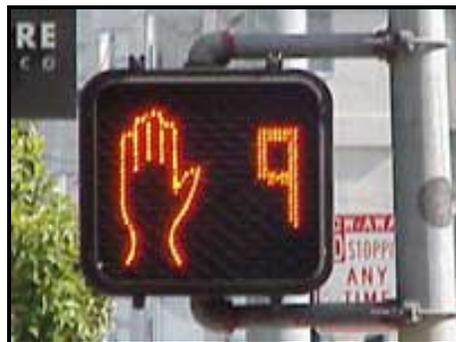
**Photograph 5. Typical Installation of Countdown Pedestrian Signal**

The countdown pedestrian signal is comprised of the same three indications as the conventional pedestrian signal. The flashing “Don’t Walk” indication, however, is complemented by an illuminated number indicating the number of seconds before the steady “Don’t Walk” indication will be illuminated. The signal head counts down the seconds of what would traditionally be the flashing “Don’t Walk” interval and thus provides feedback to pedestrians on the time remaining in their crossing. By advising the pedestrian of the remaining seconds before the “Don’t Walk” indication will be illuminated, the pedestrian can make a decision on his or her ability to safely cross the street in the available time. As such, the countdown signals are expected to improve compliance with pedestrian indications and enhance pedestrian safety.

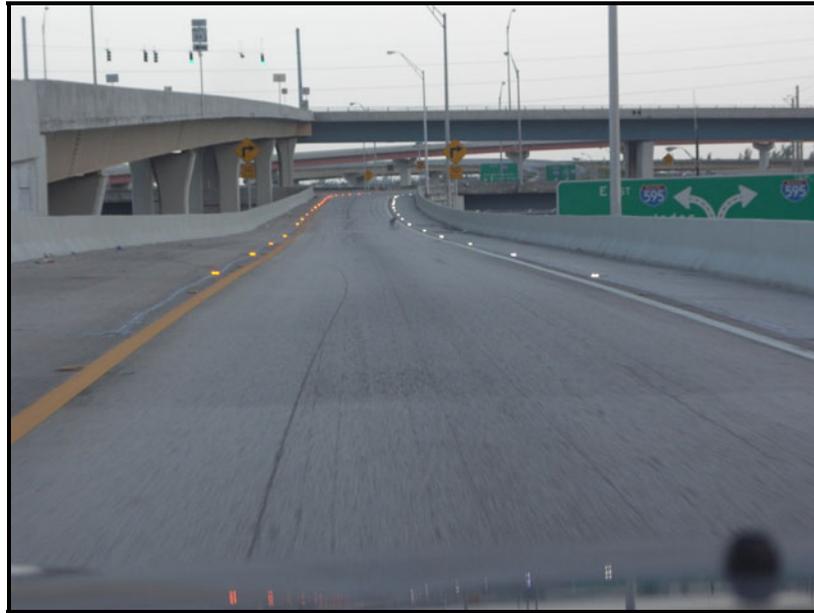
**Photograph 6. In-roadway lights along the Southbound I-95 off-ramp to Westbound SR 84**

In an effort to reduce the frequency of crashes at this intersection, the Florida Department of Transportation District 4 Traffic Operations Office installed (in November 2004) a series of in-roadway lights along the off-ramp (see Photograph 6). The intention was to alert motorists to the approaching sharp right turn at SR 84, so that drivers would reduce their speeds in order to negotiate the turn safely. The in-roadway lights were linked with a speed detection system, which would illuminate the lights when the approaching vehicle's speed was detected to be greater than the pre-set speed of 50 mph. The in-

roadway lights were operated in such a way that they create a ‘strobing’ effect towards the approaching driver to give the motorist the perception that he/she is speeding. The ‘strobe’ effect starts at the beginning of each group of lights, and progresses with each unit in the group illuminating until all are illuminated, then off, and starting the sequence over again. As such, in-roadway lights are expected to reduce travel speeds. It is anticipated that the reduction in vehicular speeds would reduce the potential for crashes.

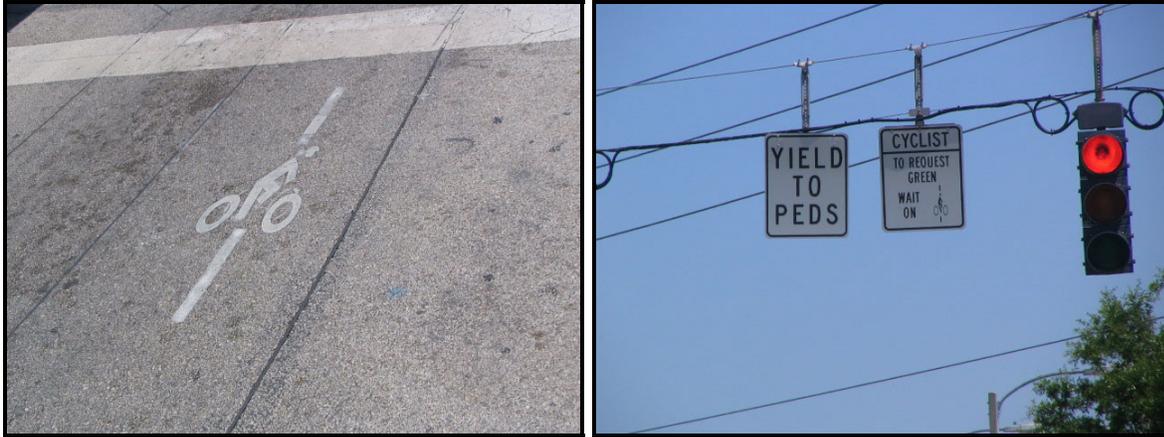
**Photograph 7. Typical Installation of Bike Loop Detection Markings and Signs**

In an effort to improve bicycle detection at signalized intersections, the City of Orlando installed special pavement markings to guide bicyclists to properly place their bicycles on the detector in order to be detected. As a supplement to the pavement markings, signs were also placed at the curb or on mast arms (see Photograph 7). A total of 100 intersection approaches were prioritized based on several factors including roadway functional classification, traffic volume on major and minor streets, and number of bicycle crashes. The first 25 locations from the priority list were then selected for application of this treatment (see Table 6).
