**EVALUATION OF THE RECTANGULAR RAPID FLASH BEACON AT A
PINELLAS TRAIL CROSSING IN ST. PETERSBURG, FLORIDA**

**FDOT Contract BA784
Final Report**

**University of North Carolina
Highway Safety Research Center**

October 2009

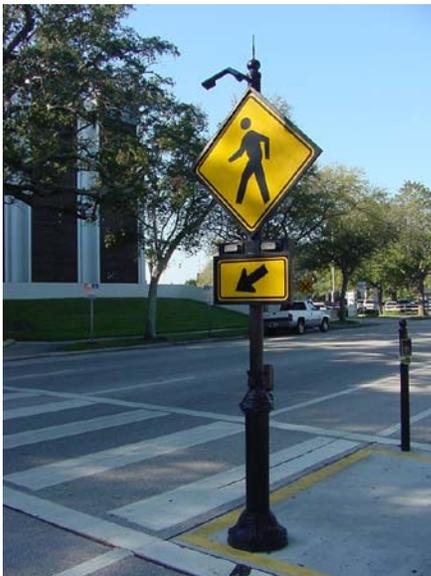
Figure 1. RRFB at an uncontrolled crosswalk.

One countermeasure used at 19 of the St. Petersburg uncontrolled crosswalks is the rectangular rapid flash beacon (RRFB). The unit has two rectangular yellow LED indicators which flash rapidly in a wig-wag sequence. It is solar-powered, radio controlled, and activated by pedestrians (Figure 1). An evaluation of 18 of these 19 locations had been previously performed, and the system wide average motorist yielding compliance rate improved from less than 1% to 82% (Shurbutt, Van Houten, and Turner, 2008). For the current study, it was decided that the RRFB should be installed and evaluated at a location where the Pinellas Trail, a multi-use facility, crosses 22nd Avenue N, a busy four-lane, urban street with 15,000 vehicles per day, and posted speed limit of 40 mph. Depending on season, the Pinellas Trail has approximately 1,300-2,000 trail users per day. It was felt that this would make the trail crossing safer by increasing the yielding of motorists to trail users.

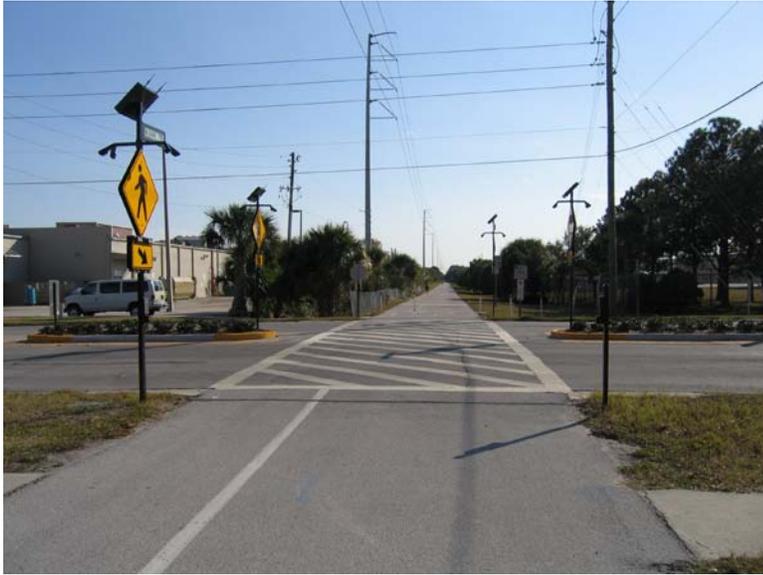
Figure 2. RRFB at the Pinellas Trail crossing.

A more detailed description of the RRFB is provided below. The description is paraphrased from the various Van Houten studies in the literature:

The treatment of primary interest in this experiment was two (2) rectangular LED flashing beacons. The LED flashers on the front and back were each six (6) inches wide, 2.5 inches high, and placed nine (9) inches apart. Each unit was dual indicated (LED's on front and back). Each side of the LED beacon flashed in a wig-wag flashing sequence (left light on, then right) - the two LED's in combination flashed 190 times in the wig-wag flashing sequence during a 30 second cycle. Of the two LED's, the left LED flashed two times (in a slower type of a rapid flash) each time it was energized followed by the right LED, which flashed in a very fast rapid three (3) flash volley when energized. Four (4) signs along with beacons were installed at each crosswalk. Radio frequency transmitters linked the devices so a depression of any of the pedestrian call buttons activated the flashers on all four signs. A separate LED facing the pedestrian flashed to indicate to pedestrians that the system was operating. The system also presented an audible message instructing pedestrians that the light flashing across the street indicates that the device was operating, and instructing them to wait for cars to stop before crossing.

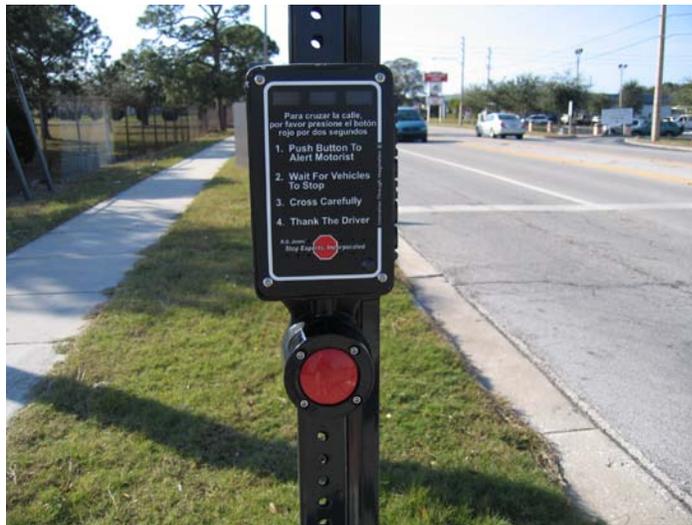
Figure 3. Push button configuration at the trail crossing.

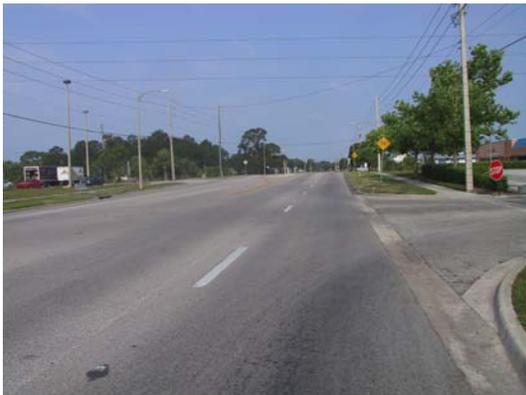
Figure 4. View of roadway before RRFB.

The before condition of the trail crossing (Figures 4 and 5) at 22nd Avenue North did not have a median of any kind, and the consultant recommended that a striped, center refuge island be installed due to the numbers of interacting trail users and motor vehicles at the crossing.

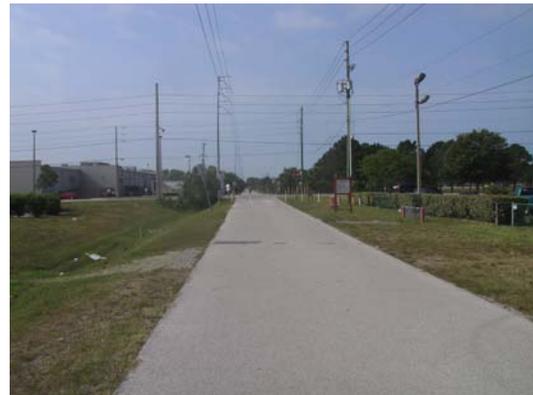
Figure 5. View of trail before RRFB.

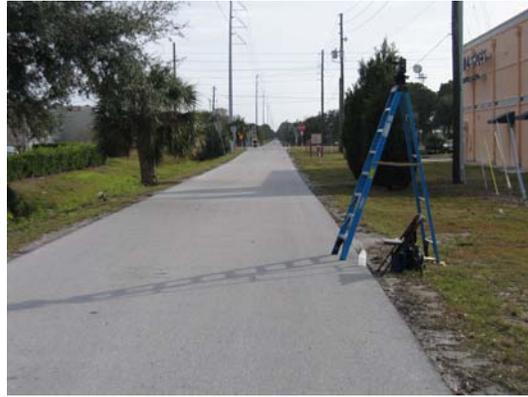
Figure 6. Videotape data set up.

The experimental design was to collect data of trail users before and after the installation of the RRFB. Videotape data were collected by a staff person from HSRC during several time periods before and after installation. A camera was set up on a stepladder beside the trail and several hundred feet from the actual trail crossing, and videotape was collected from both directions of travel (Figure 6). Data were collected at various times of the day on both weekdays and weekends when it was not raining.

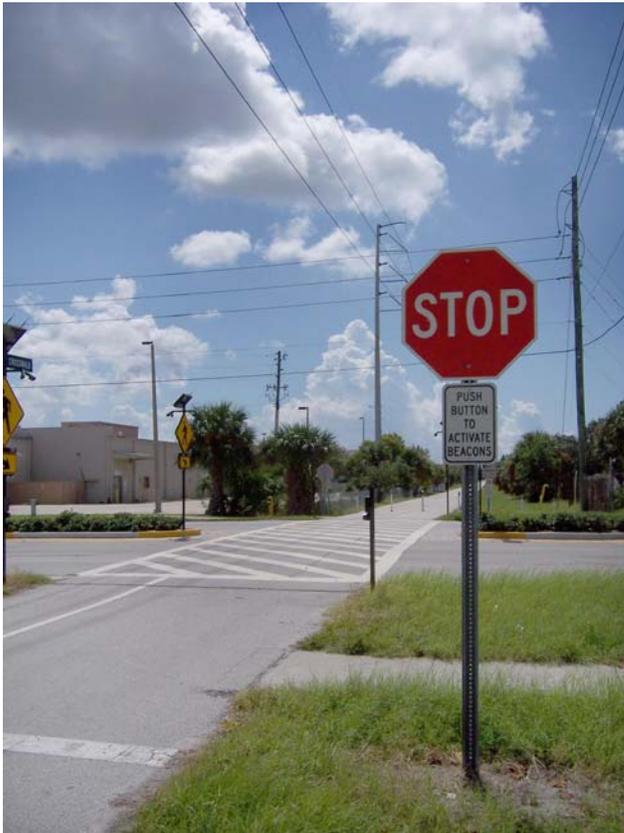
Figure 7. Sign to remind users to push the button.

While motorist yielding improved significantly after installation of the RRFB, an issue from the findings is why the motorist yielding was not greater. One factor is whether the button was pushed to activate the flashers. Based on the videotape analysis in the after period, it is interesting to note that 32% of the trail users pushed the button, 49% did not, and for 19% of the trail users the button had already been pushed. An examination of the on-scene observer after data indicated that many trail users were not pushing the button, and the city installed a sign to see if this would help (Figure 7.) However, not pushing the button remained a problem.

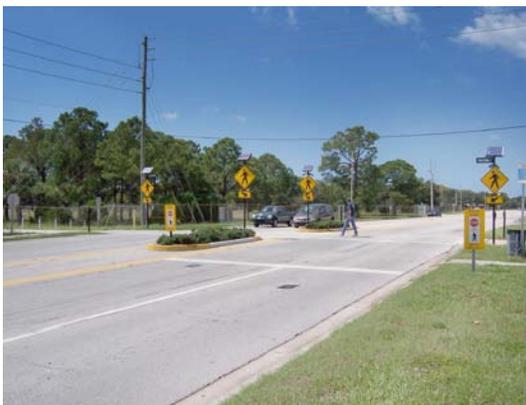
Figure 8. Motorists yielding to trail user.

When the button was pushed in the after period, the flashers were activated immediately. However, motor vehicles traveling along the street might be close enough to the crossing (i.e., in the dilemma zone) where stopping to yield would be difficult. These vehicles tended to pass through the crossing while the flashers were operational. Sometimes it appeared that trailing motor vehicles would simply “follow the leader,” even though it appeared they had adequate time to stop safely. In many cases it would take 5-10 seconds after the flashers were activated to get motorists to a complete stop, and this is reflected in the delay for the after period. It also appeared that motorists came to recognize that the flasher might be on after trail users had cleared the crossing, and the motorists would proceed on through the crossing without stopping if no users were present. This is a legal maneuver.
