Final Report

June 2013

Key Royale Bridge Five Year Evaluation

Principal investigator:
H. R. Hamilton

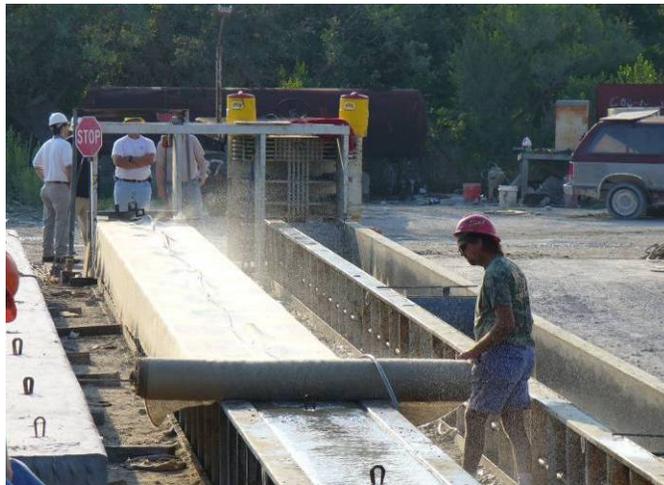
Figure 22—Moist curing at precast yard

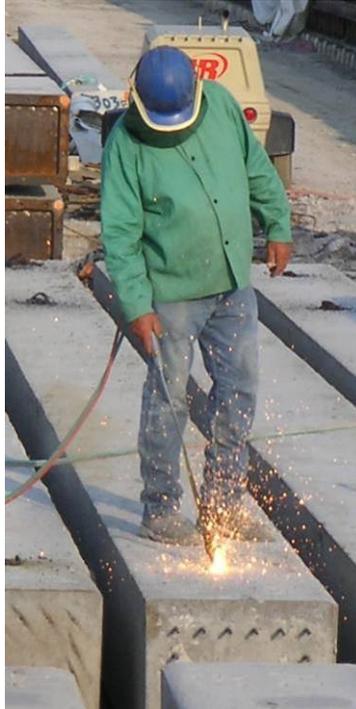
Figure 23—Flame cutting of lifting loop after the pile was removed from the casting bed.

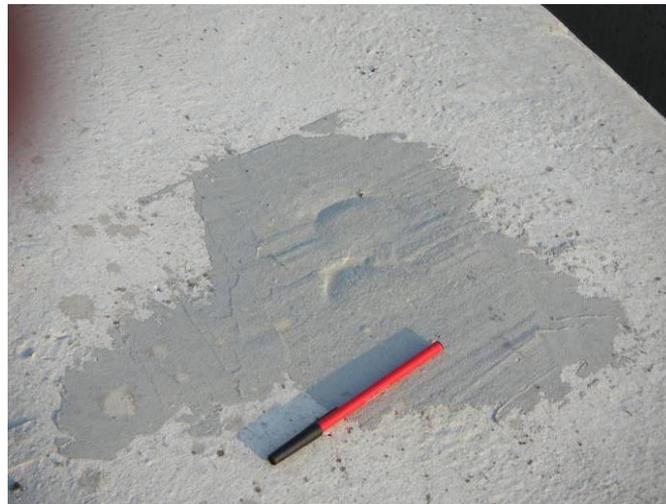
Figure 24—An epoxy was applied to the area for corrosion protection.

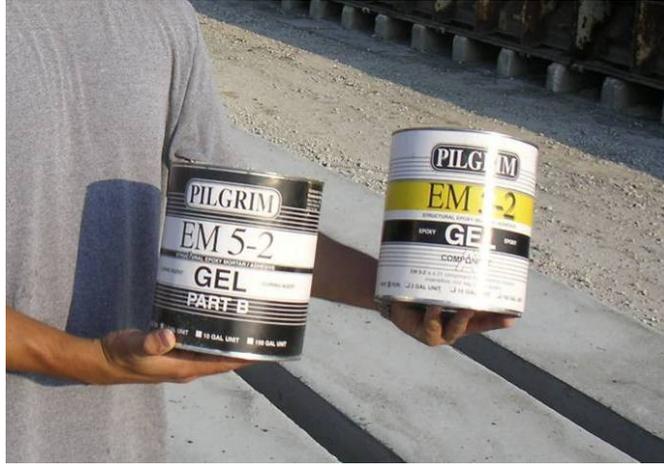
Figure 25–Pilgrim EM 5-2 epoxy was used to provide corrosion protection.

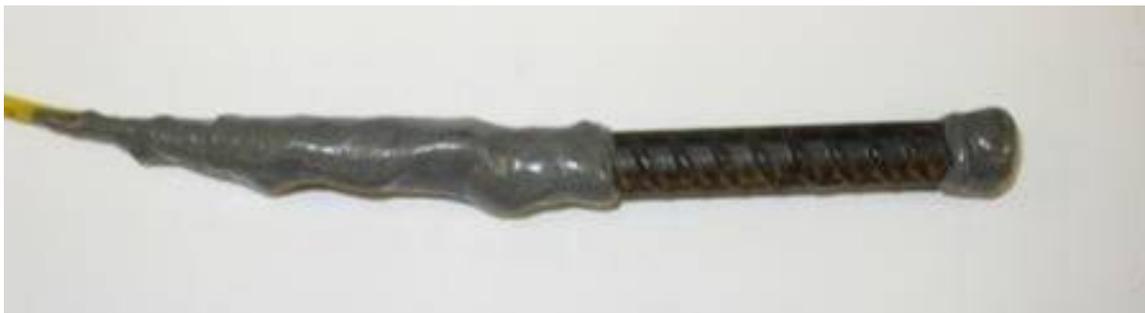
Figure 35–#3 steel electrode with 2-in. length of the electrode exposed

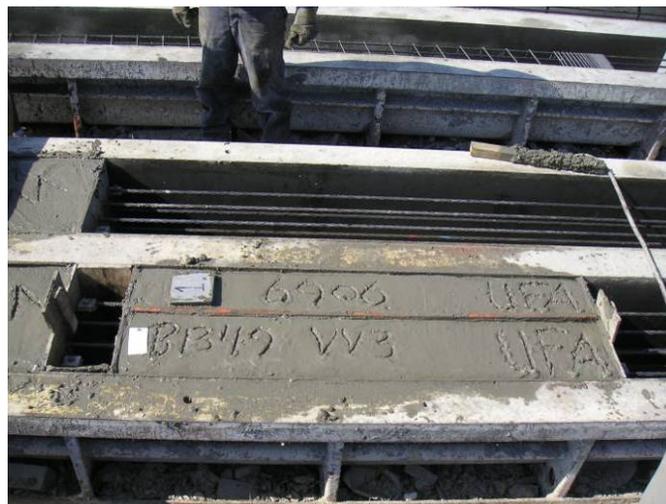
Figure 44–Sample segment and durability segments after concrete had been poured

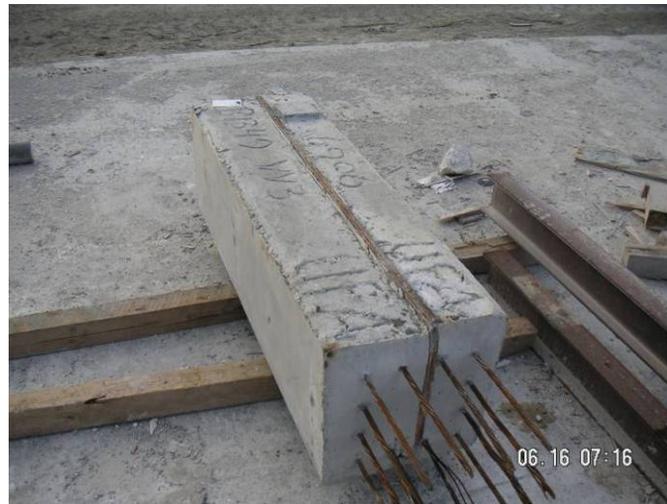
Figure 45–Sample segment and durability segment with prestressing strands exposed

After curing and when the concrete reached sufficient compressive strength, the strands were torch-cut to transfer the prestress. The durability and sample segments were then lifted out of casting bed and placed adjacent to the prestressing bed (Figure 45). The segments were then transported back to UF for testing (The curing condition and lifting method are described in Section 6.3). Eight cores were taken from the each sample segment.

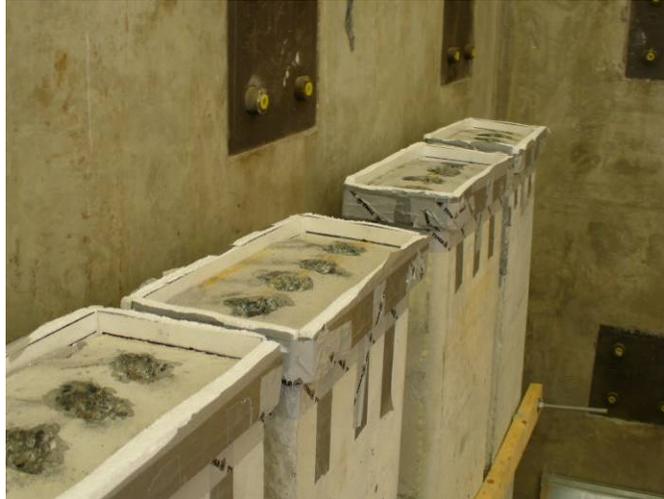
Figure 46–Concrete and prestressing strands were chipped and cut below the concrete surface.

To prevent corrosion of the exposed strands, the ends of the durability segments were repaired (Figure 46). The concrete was chipped out from around the strands below the concrete surface. The strands were then cut as close as possible to the bottom of the depression. The sides were formed and an epoxy fill was placed. Approximately 1-in. of Sikadur 32 high modulus structural epoxy mixed with sand was poured on the end to seal the durability segment (Figure 47).

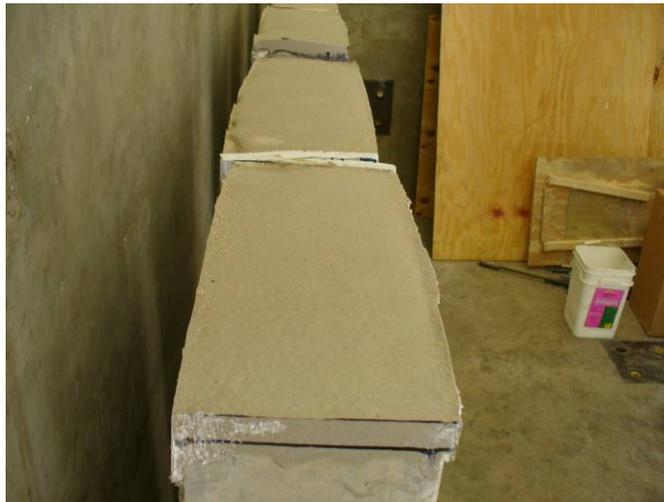
Figure 47–The top of durability segment after application of epoxy to protect strands

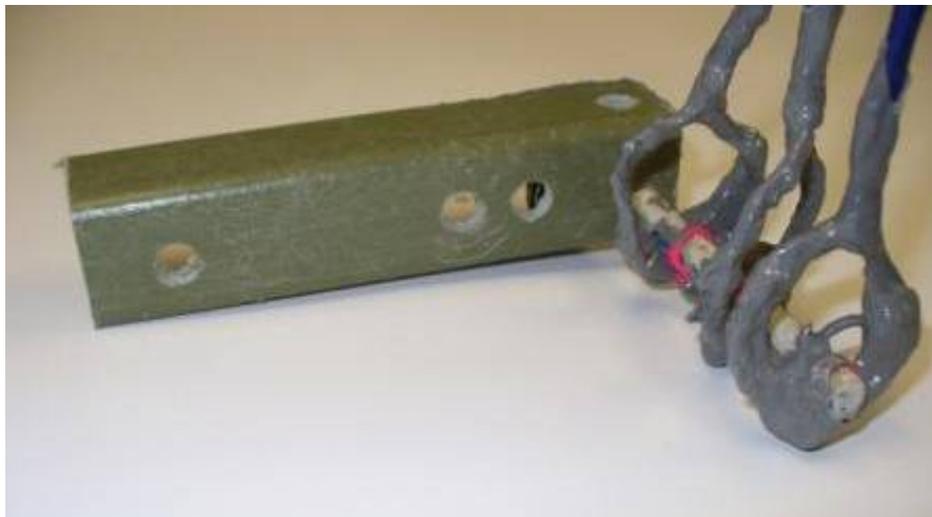
Figure 50–Thermocouples grip system

Thermocouples were installed only in the durability segments. They were placed to measure temperature gradient in the cover zone when corrosion is detected. Three thermocouples were placed in the central portion of the segment (Figure 48), which is in the splash zone, where corrosion is expected to be the most intensive. The fixture holds three thermocouples spaced at 1-in. increments from the surface to the reinforcement. Thermocouples were attached to the strands using a cantilever grip shown in Figure 50.

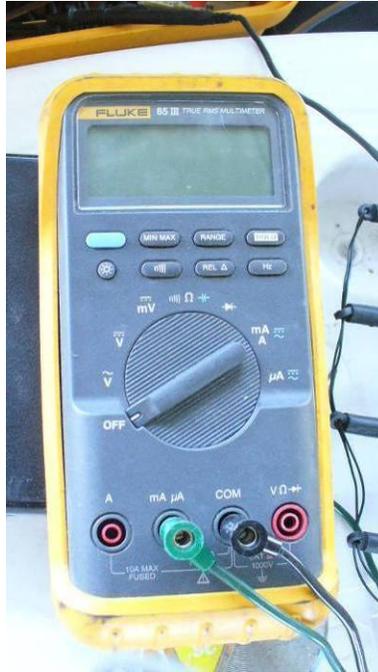
Figure 51–Fluke 85 series III digital multimeter was used to take corrosion readings

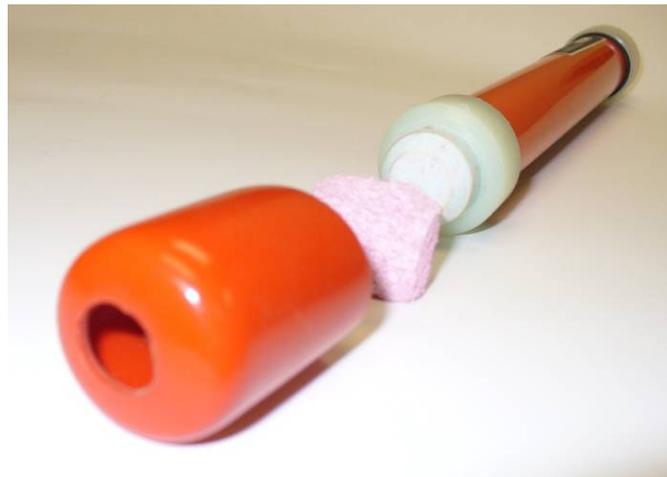
Figure 52–Copper copper-sulfate reference electrode showing method to provide electrical conductivity between external electrode and concrete

The CSE was designed to be used in an aqueous solution; the salt bridge located at the electrode tip requires conductive liquid for the electrode to function. This requirement was satisfied in two ways. The first method was to use a sponge soaked in seawater to bear against the concrete surface and transmit charge across the gap between the concrete and the electrode (Figure 52). The second method was to dip the electrode in seawater to moisten the salt bridge. This was effective at producing stable measurements, provided that the salt bridge was rewetted regularly to keep it moist.

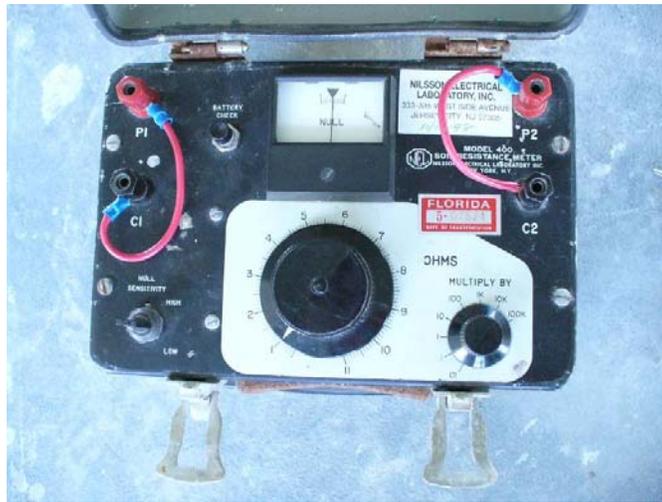
Figure 85–Electrical resistance was measured using Nilsson model 400 soil resistance meter

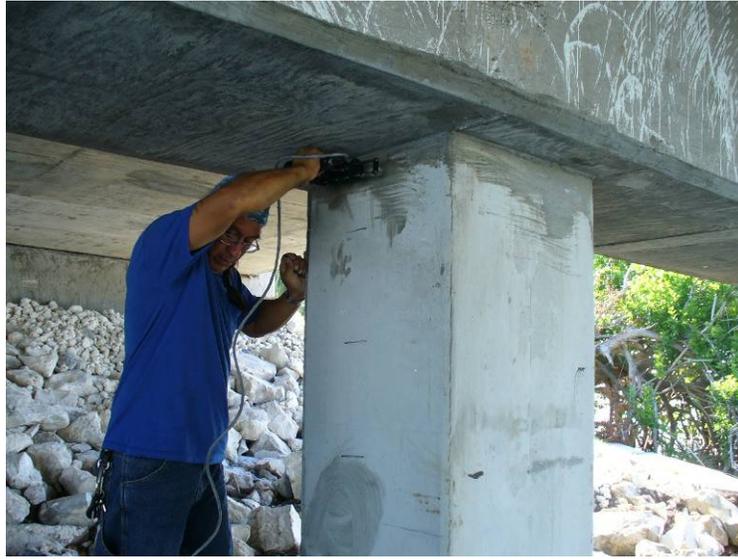
Figure 97–Surface resistivity readings were taken on the bridge piles.

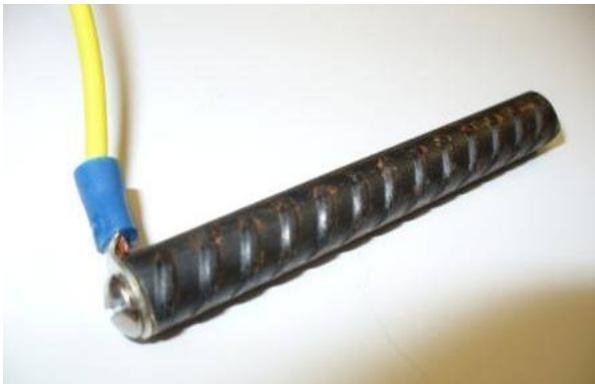
Steel corrosion probe – drilled, tapped and connected with #14 stranded copper wire with other end smoothed

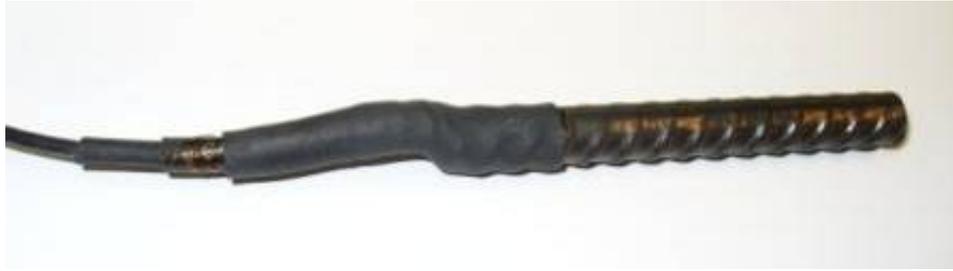
Steel probe – connection with the wire is protected using scotch kote and 2 or 3 layers of the heat shrinks

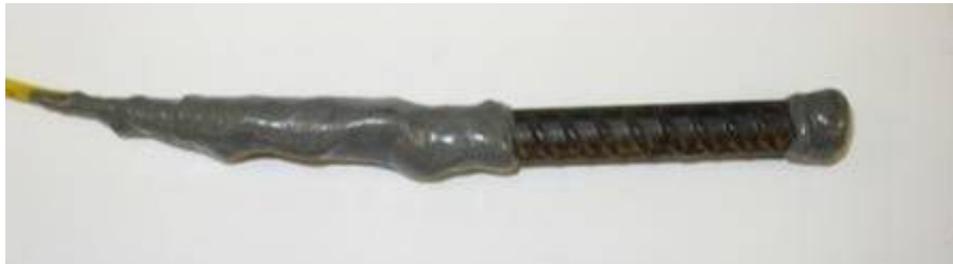
Steel probe – epoxy is placed at the both ends, such that 2-in. length of the probe is exposed to the corrosion action

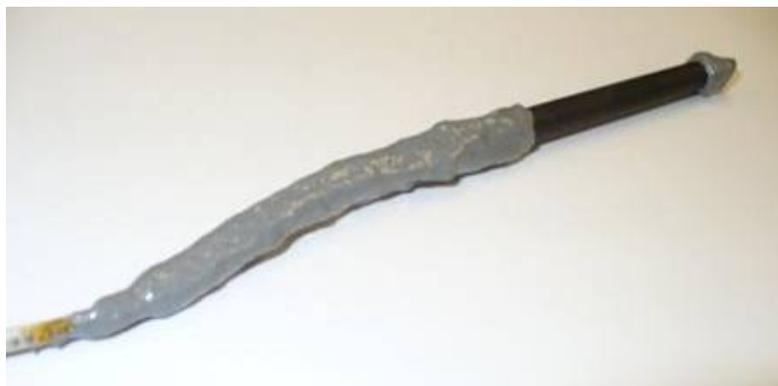
Titanium corrosion probe with 2-in. length of the probe exposed to the corrosion action
