Florida Department of Transportation Research

Long-Life Slab Replacement Concrete

April 2015

BDV25-977-01

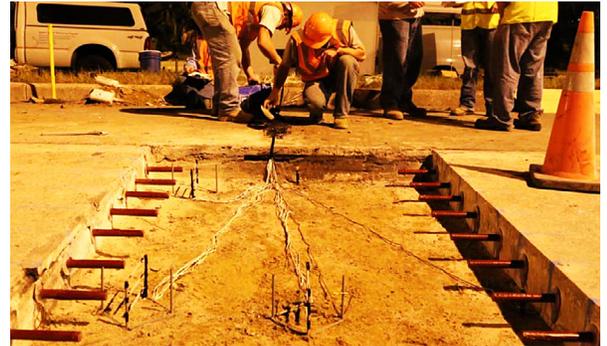
Working at night under bright work lights, workers place temperature and strain gauges in preparation for the pouring of a test slab on US-1 in Jacksonville.
