**FLORIDA DEPARTMENT OF TRANSPORTATION
CORROSION RESEACH LABORATORY**

**Evaluation of Galvanic Battery
Power Supply for Cathodic Protection**

Final Report

**Prepared for
University of South Florida**

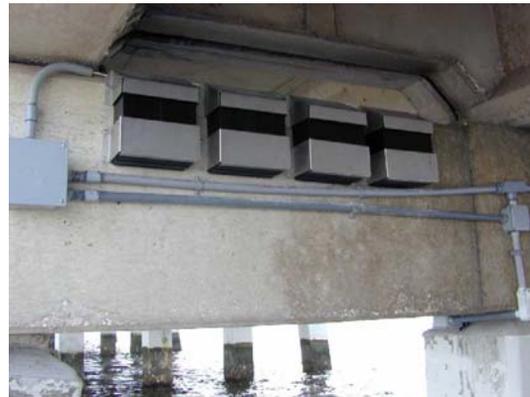
Figure 5: Battery arrangement with mounting brackets for the Multiple Piles Test at Site 2. Number of batteries differ per site.

The first arrangement (Multiple Piles) consisted of several batteries installed in a combination of parallel and serial connections to provide cathodic protection current to one pile bent comprised of four, five, and six piles respectively for sites 1, 2, and 3. Table 1A also shows the number of batteries used per test and the area cathodically protected

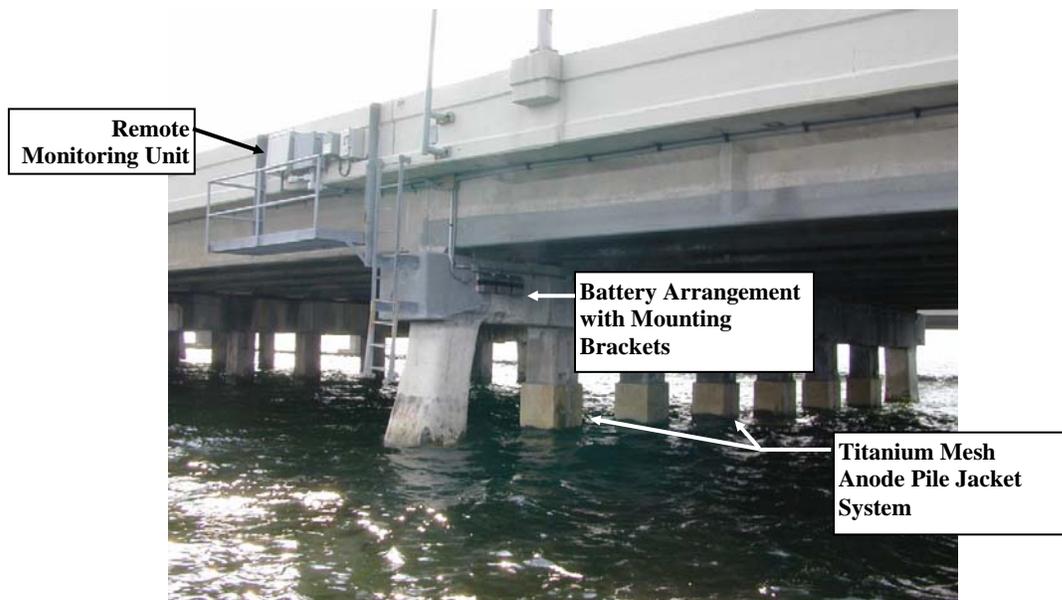
Figure 4B: Bent test at Howard Frankland Bridge in Tampa, Florida (Site 3). Three sets of 2 batteries providing a nominal output of 3V. Each mounting bracket accommodates 2 batteries.

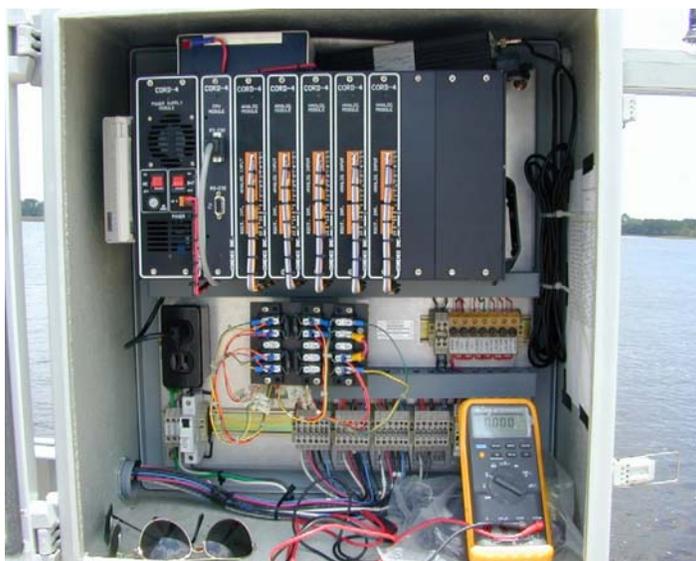
Figure 5B: Remote monitoring unit at Dunn's Creek Bridge (Site 2). A similar unit was installed at Site 3. Different units were installed at Site 1 and the Lab test.

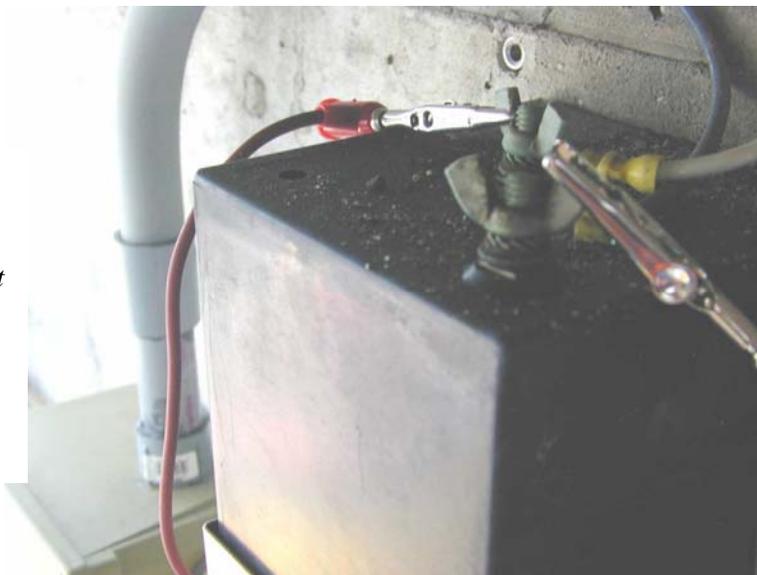
Figure 6B: Close-up of failed battery at Site 2 after removal of upper bracket. Rusted terminals, and dirt and debris accumulated at the top of the battery suggested access of run-off water from the upper deck to the vent holes on top of the battery.

At around week 48 the battery suddenly stopped producing current. The battery was removed and returned to the manufacturer who determined that the malfunction was a result of water intrusion through the vent orifices. A new battery was provided to replace the failed one. The new battery produced a current output of 68 mAmp with an open circuit potential of -0.603 volt. After 15 weeks of operation the current stabilized to 14 mAmp and a voltage potential of -0.568 volts similar to the previous unit.

4. Based on the failed battery at Site 2, it seems that it will be necessary for the batteries to be better protected from water intrusion as this will destroy the battery. The manufacturer should provide a device such as a vent cap or a breathing tube that will allow adequate air intake while better preventing the entrance of water. In addition, the cathodic protection designer should provide for the installation of the batteries at locations where the possibilities of a battery coming in contact with water are minimized. Caution should be observed as location of the batteries too far from the piles may generate a significant cost increase which will need to be considered during the power supply selection process.
