Report No. BC-965

**STUDY OF THE FEASIBILITY OF VIDEO LOGGING WITH
PAVEMENT CONDITION EVALUATION**

The Florida Department of Transportation

July 10, 2003

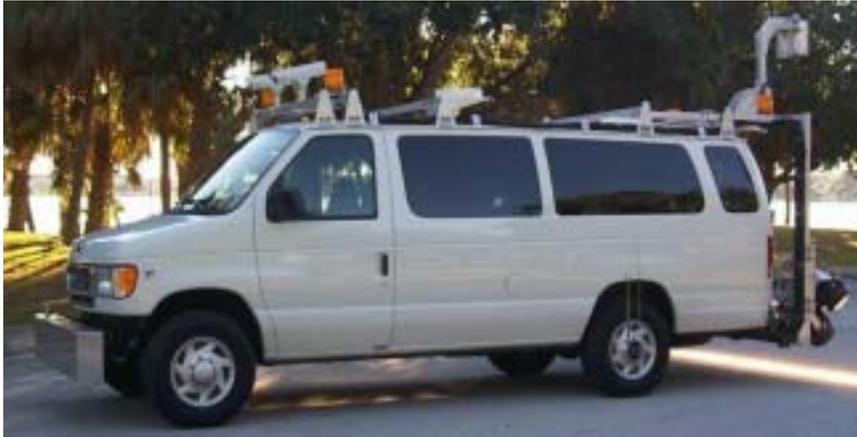
Fig. 3.1 FDOT Survey Vehicle

The main features and functionalities of the FDOT evaluation vehicle produced by International Cybernetics Corporation (ICC) (Fig. 3.1) are described in this Chapter.

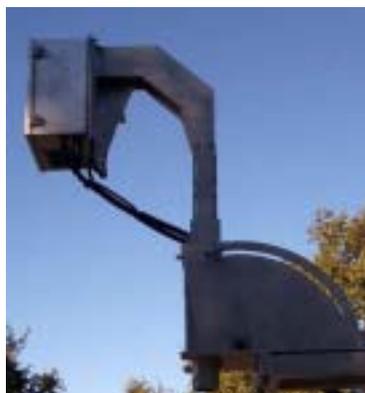
Figure 3.3 Downward Camera of the FDOT Survey Vehicle

- Line scan camera (Figure 3.3) to provide quality pictures with a linear resolution of 2048 pixels, which is later compressed for data storage purpose.
- A rigid mounting to minimize disturbance to imaging during vehicle movement.

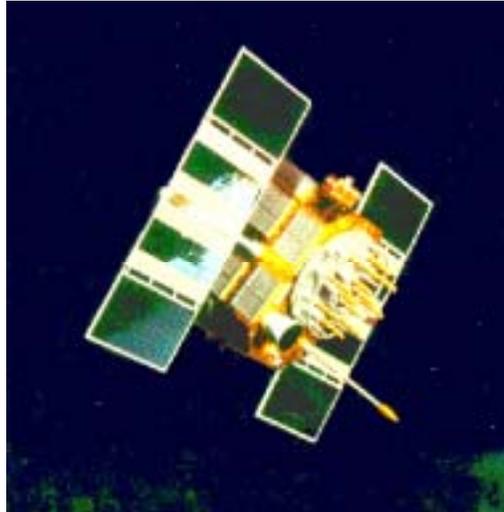
Figure 3.5 GPS satellite

- **Space Segment.** The Space Segment of the system consists of the GPS satellites (Figure 3.5). These space vehicles (SVs) send radio signals from space. The nominal GPS Operational Constellation consists of 24 satellites that orbit the earth in 12 hours. The orbiting of satellites closely resonates with the earth's rotation period (2 orbits per day) so that the orbit track repeats itself within each 24-hour day gaining approximately 4 minutes each. There are six orbital planes (with nominally four SVs in each), equally spaced (60 degrees apart), and inclined at about fifty-five degrees with respect to the equatorial plane. This constellation provides the user with between five to eight SVs visible from any point on the earth.

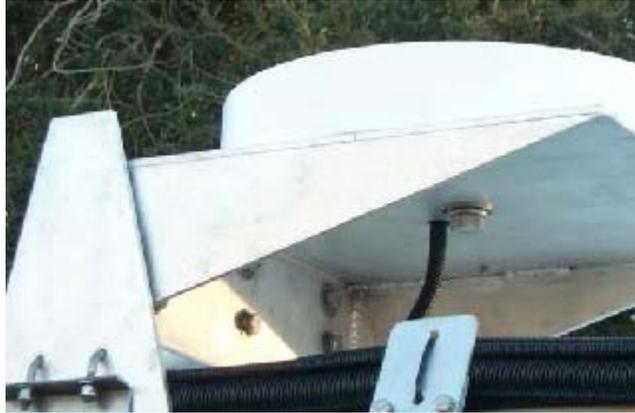
Figure 3.8 Differential GPS Receiver Antenna

Differential positioning technique is used to correct the bias errors at one location with measured bias errors at a known position. A reference receiver, or base station, computes corrections for each satellite signal and relays the information to users. FDOT survey vehicle uses a differential GPS system produced by *Applanix Corp.* (Fig. 3.8).

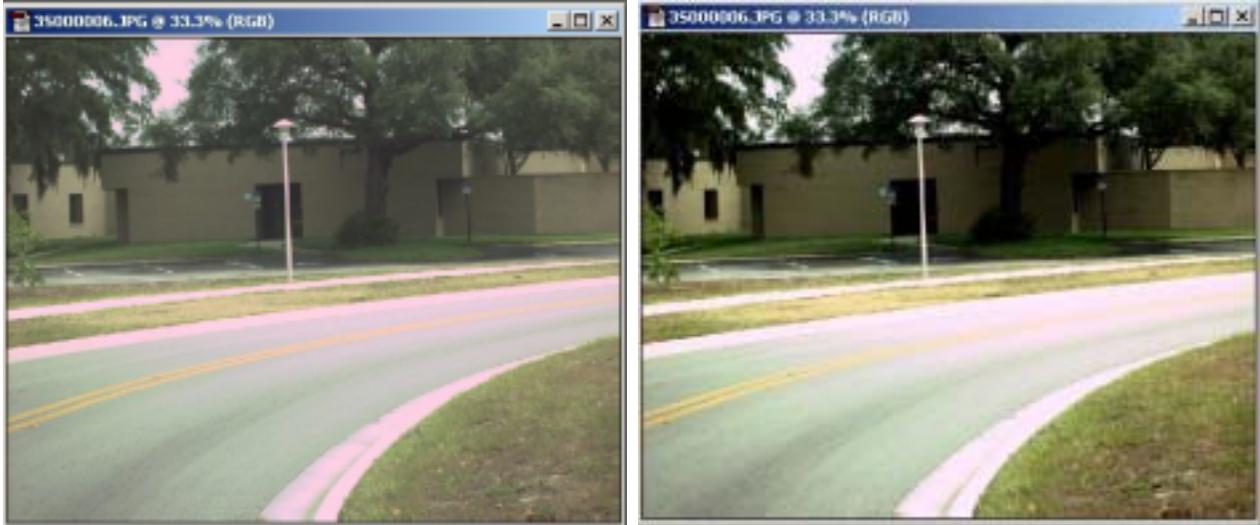
Fig. 4.3 illustrates a comparison of a raw sideview image and the corresponding adjusted image.

(a) Raw image

(b) Adjusted image

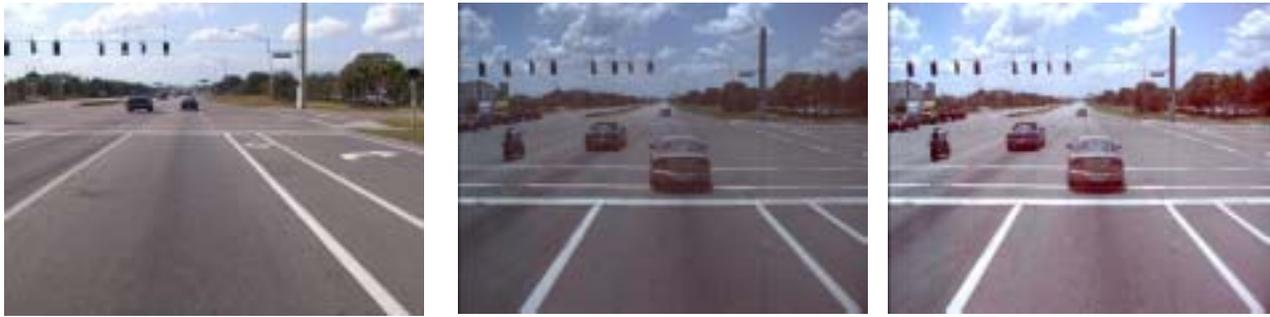
(a) 2001 FDOT image on Fowler/Spectrum Blvd.

b) Image from FDOT Survey Vehicle

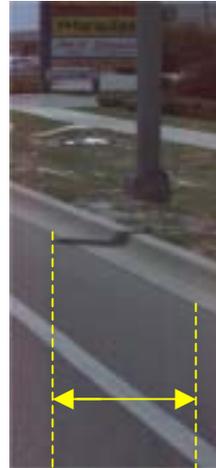
Figure 4.5 Occurrence of an unusual pink color on two front-view images except where shadows are cast on the road

In addition to the above problem, an unusual pink color appeared on video images captured by the frontview camera due to over-exposure to sunlight. As shown in Figure 4.5, this condition does not occur where shadows (shown with yellow arrows) are cast on the road.

(b) reduction of pink color under shadows

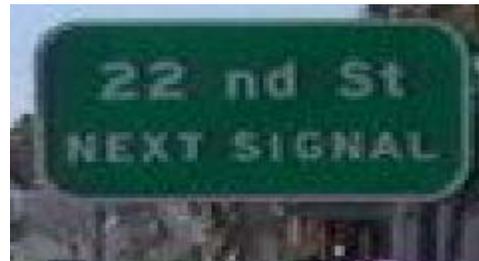
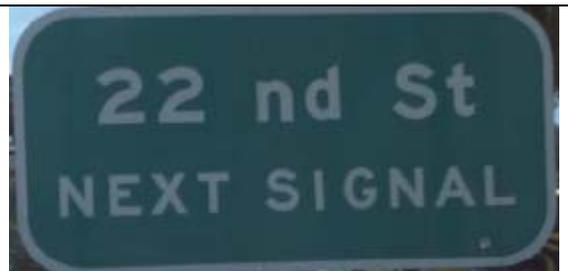
Fig 4.6 Comparison of side-view images of the survey vehicle with existing images

(a) Existing 2001 images from FDOT files (zoomed in)

(b) Current images from FDOT Survey Vehicle

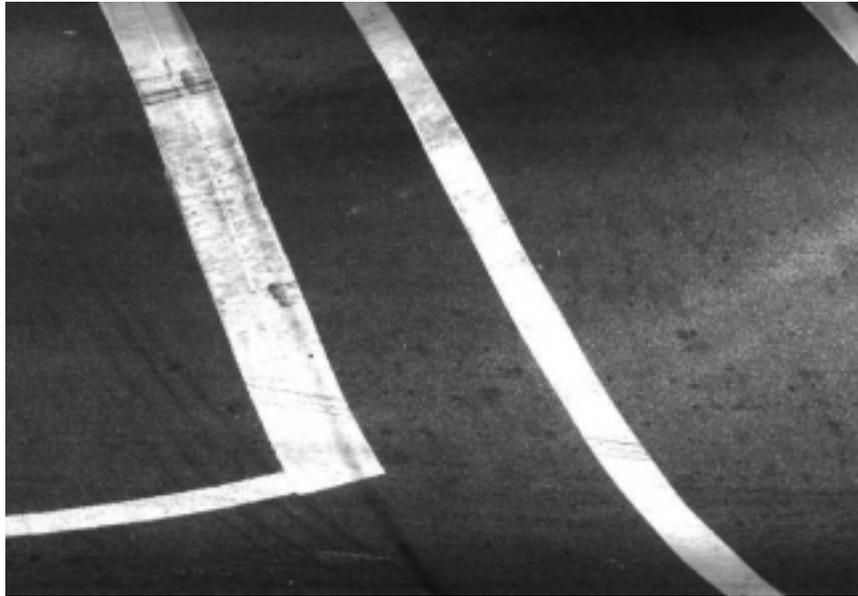
Figure 4.9 Distortion in downward images on curves

Some distortion was observed in the downward images both during curved and straight runs. On curves this effect is caused because of the very nature of line-scan imaging. The line-scan camera takes 2 mm wide image strips of the pavement at a time and combines these strips to form one image frame. Hence when the van traverses a curve, the inner part of the focused area will overlap in several consecutive frames because of the relatively slow linear speed of the inner part of the focused patch.
