**THE ROLE OF POLYETHYLENE DUCT
CRACKING IN FAILURE OF POST
TENSIONING CABLES IN FLORIDA
SEGMENTED BRIDGES
(BD220)**

**Florida Department of Transportation Research Center
605 Suwannee Street, MS 30
Tallahassee, Florida 32399**

**Florida Atlantic University
Boca Raton, Florida 33431**

January 20, 2005

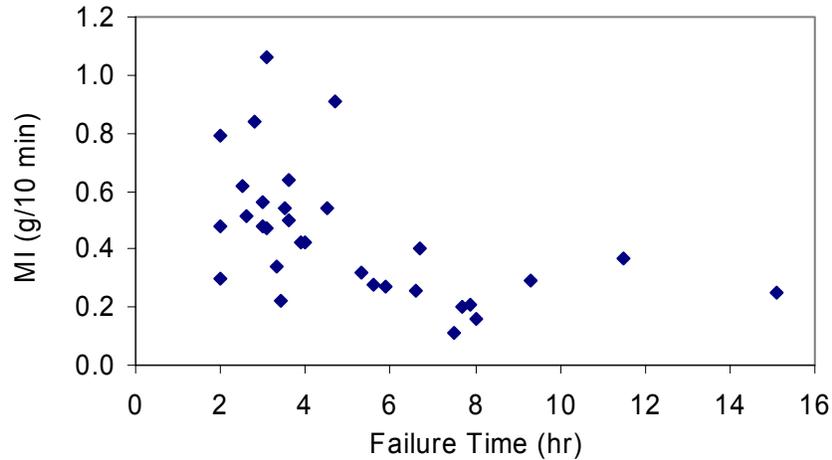
The correlations between, first, SCR and MI and, second, SCR and density were evaluated using data obtained from SSK Bridge samples. In this regard, the graph in Figure 1 plots MI value against failure time for specimens in the SP-NCTL test and indicates an inverse relationship between these two parameters.

Figure 1. Failure time versus MI of field duct samples from the SSK Bridge.

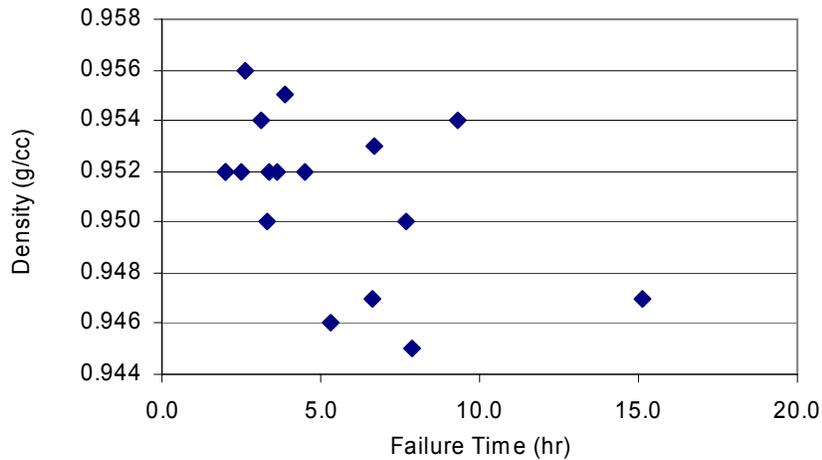
Correspondingly, Figure 2 shows a plot of density versus failure time. The correlation in this case is relatively poor, although the general trend is one where samples with high density values tend to have shorter failure times than those with low density.

Figure 2. Density versus failure time of field duct samples from the SSK Bridge.

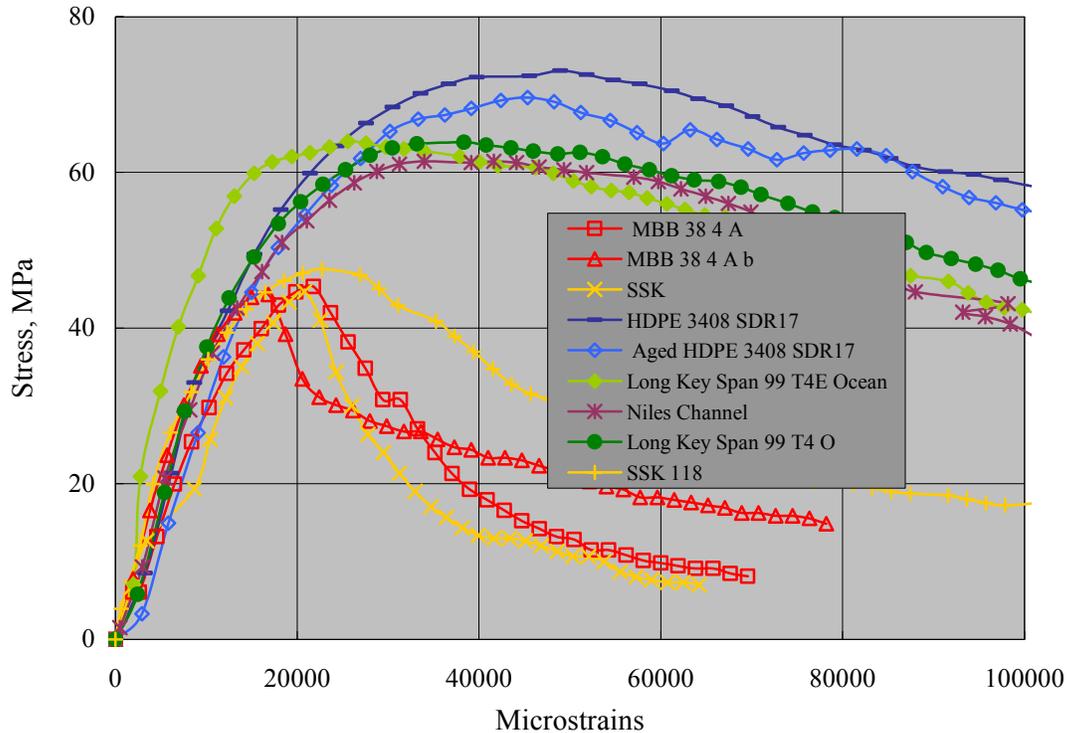
ultimate stress and strain-to-fracture (specimens of the FAU-3408 HDPE did not fracture but strained to the limit of the three-point bend test fixture). Response of the other materials was generally similar with differences probably falling within the range of experimental scatter.

Figure 7: Plot of stress versus microstrain for three-point bend tests on various HDPE specimens.

Several of the duct samples employed in the 3-point bend tests (see Figure 7) have been analyzed using PALS. Figure 10 shows the results of this as a plot of the PALS void size sensitive parameter versus area under the stress-strain curve from the 3-point bend tests (Figure 7). A general correlation is seen between the two parameters with large void size corresponding to less stress-strain curve area. Since generation of a PALS spectra is relatively straightforward and requires only about one day to complete, the method has the potential for providing a relatively quick, inexpensive technique for assessing duct quality and performance properties.

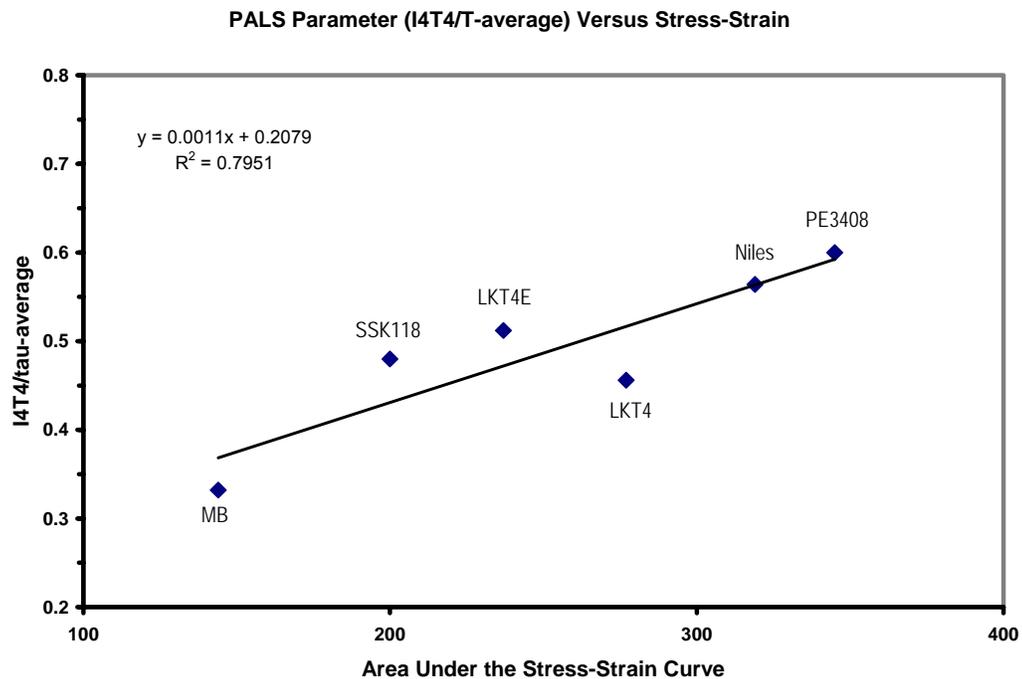
Figure 10: Plot of the void size indicating PALS parameter versus area under the stress-strain curve for different duct samples.

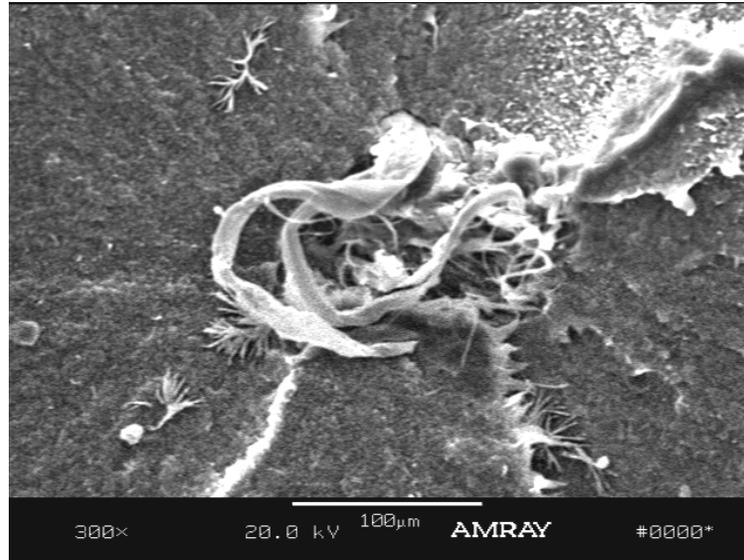
Many of the cracks initiated, in conjunction with a tensile stress, at points at impurities or air bubble voids. The multiple small cracks that were generated at various initiations grew with time and eventually joined together to form a single long crack. The impurities were observed in all cracked ducts and seemed to be the dominant cause of crack initiations. It was not possible to determine the chemical composition of the impurities; however, the fracture morphology of these features was different from that of the polyethylene duct material itself, as shown in Figure 11.

Figure 11: An example of an impurity in a duct sample from which a crack initiated.

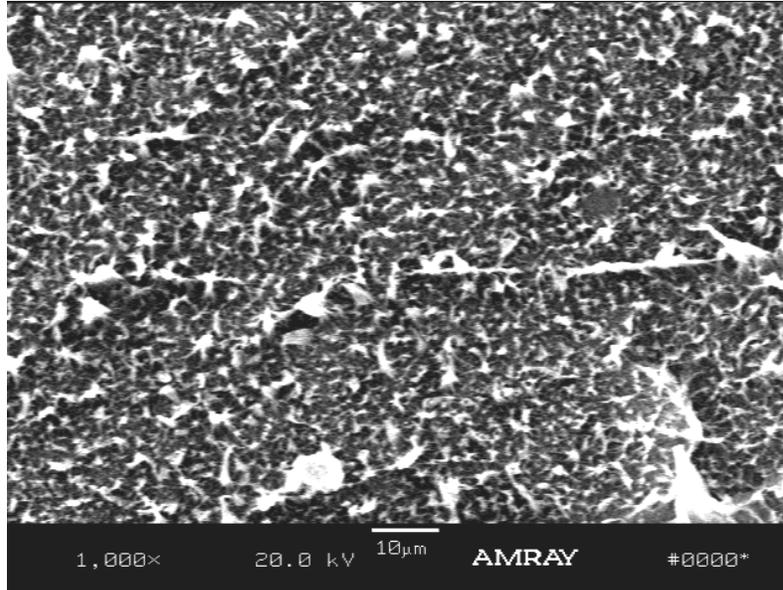
Identification of the cracking mechanism (slow crack growth) was essential for selecting proper tests in the material property evaluation portion of this study. The two stress crack resistance tests, environmental stress crack resistance (ESCR) and single point tensile load (SP-NCTL), are specifically designed to assess susceptibility to steady slow crack growth.

Figure 12: An example of a fibril structure on the fracture surface of a cracked duct sample.

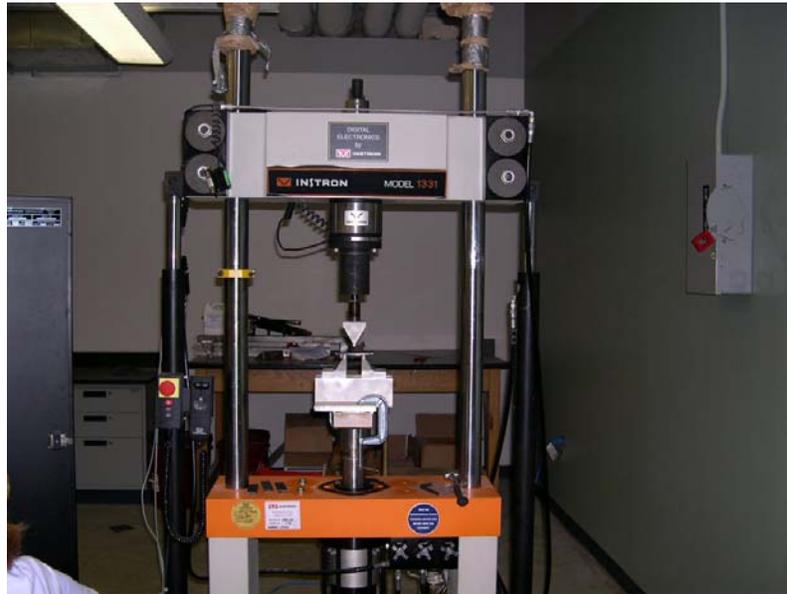
The fatigue tests were performed based on a three point bending configuration with a two inch span. Figure 13 shows a general view of the fatigue test system and Figure 14 of the mounting device and specimen.

Figure 13: General view of the fatigue test machine and specimen.

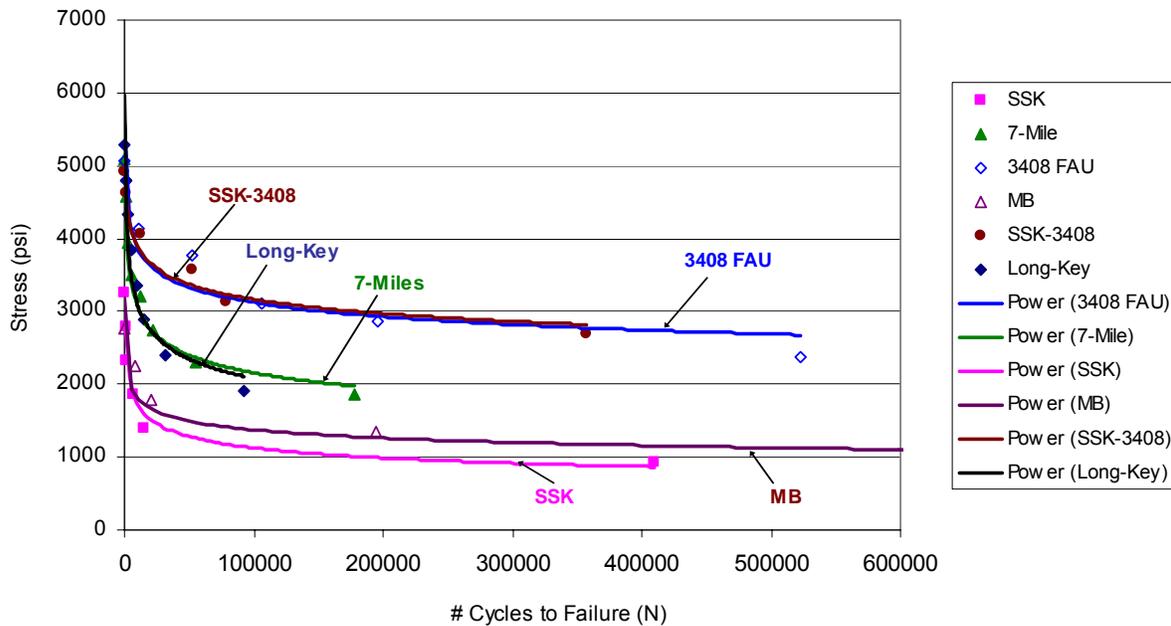
similarly and exhibit the highest resistance. Results for the Seven Mile and Long Key Bridge duct specimens are intermediate. It should be noted that the order of the fatigue resistance of these six ducts is identical to that of the SCR measured by the SP-NCTL test. Also, while the 3-point bend results indicated poorest performance by the MB and SSK specimens, it did not distinguish between the PE, Seven Mile, and Long Key Bridge specimens (Figure 7).

Figure 15: Fatigue S-N curves for the six tested duct materials.

Finite Element Analysis (FEA): For the purpose of better understanding the results of the tendon simulation experiments and relating the fatigue data (Figure 15) to tendon cracking, a finite element tendon model was developed using ANSYS. The model was a two dimensional representation of the cross-section of a SDR 21 HDPE duct with an interior grout void that comprised either 3, 8, or 10 percent of the interior. Triangular, six node elements were used with a general illustration of the mesh being shown in Figure 41. An expanded view of the modeled duct section above the grout void is shown in Figure 42. Stress-strain response of both materials was considered to be linearly elastic with modulus $1.01 \cdot 10^3$ MPa (146 ksi) for the HDPE and $2.80 \cdot 10^3$ MPa (406 ksi) for the grout. A probable source of fatigue stressing is thermal cycling, as noted above.

Figure 50 replots the Figure 15 data in terms of stress range and on log-log coordinates and shows that a stress range of 16.6 MPa corresponds approximately to failure of the MB and SSK specimens at less than 10^3 cycles. Considering that the in-service ducts experienced one thermally induced stress cycle per day, then cracking is projected to have occurred for ducts in these two bridges several years after construction. For the Seven Mile and Long Key Bridges, the cycles-to-failure corresponding to the above fatigue strength (16.6 MPa) is approximately $2 \cdot 10^4$ or 50-plus years. For ducts utilizing the PE-3408

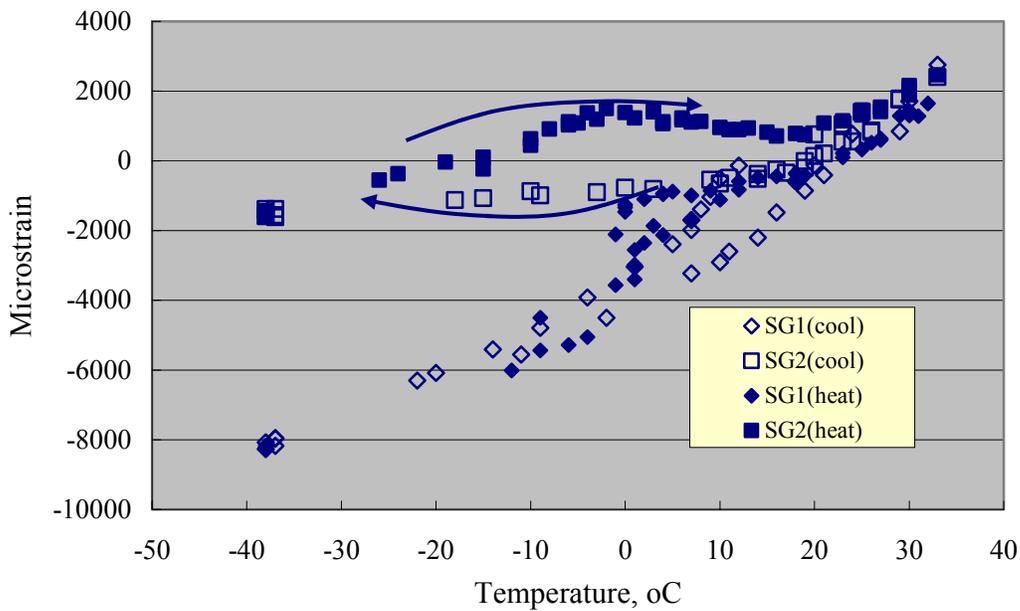
Correspondingly, Figure 27 shows strain versus temperature results for Specimen B4. Here, hysteresis is more clearly defined for both gauges than in the case of Specimen B2, particularly at intermediate temperatures. The arrows reflect the temperature-microstrain trend for SG2. No gages were

Figure 27: Plot of micro-strain versus temperature for Specimen B4 with periods of heating and cooling distinguished.

The data in Figures 23 and 25-29 indicate that decreasing temperature resulted in a strain gage output of decreasing tension in some cases and increasing compression in others (SG1-SG3). This is counter-

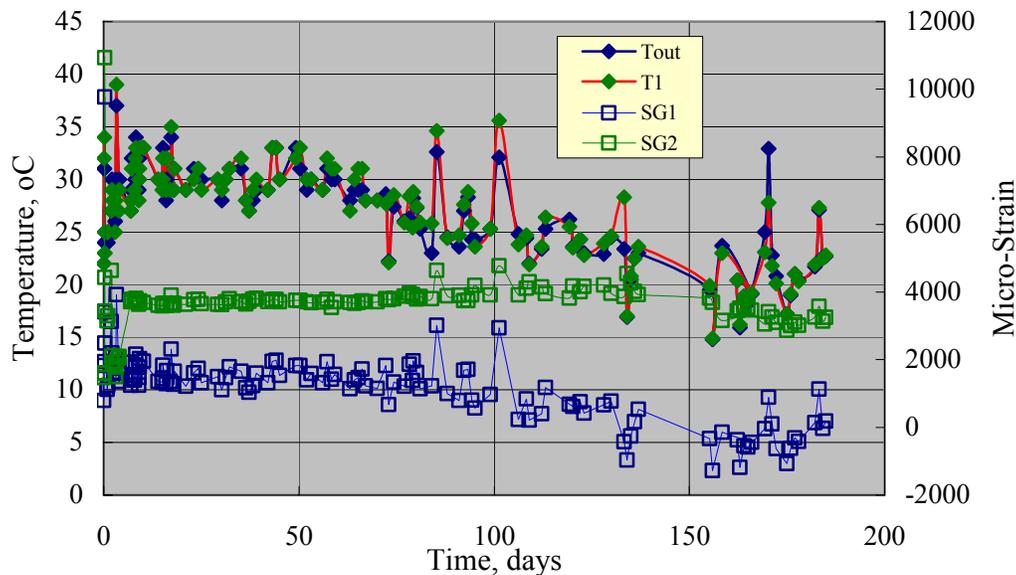
Figure 28: Temperature and strain history for Specimen B3.

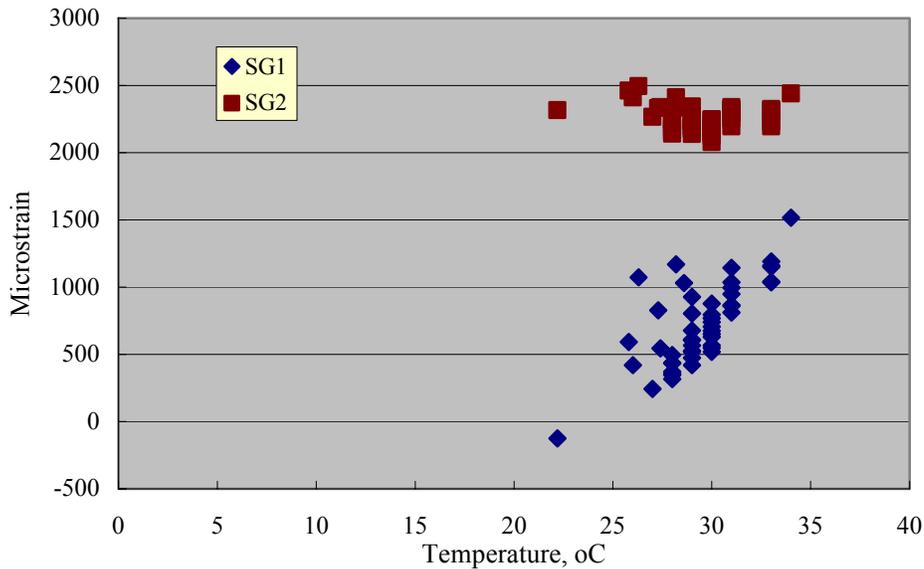
intuitive since decreasing temperature should cause the duct, which is expected to have a higher coefficient of thermal expansion than the grout (see below), to contract about the grout. This should result in a progressively greater tensile stress state in the duct with decreasing temperature.

Figure 29: Plot of micro-strain versus temperature for Specimen B3.

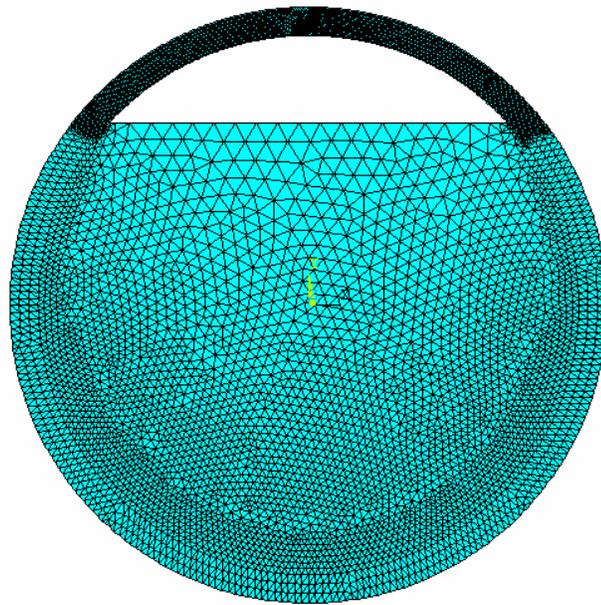
Figure 41: General illustration of the FEA mesh.

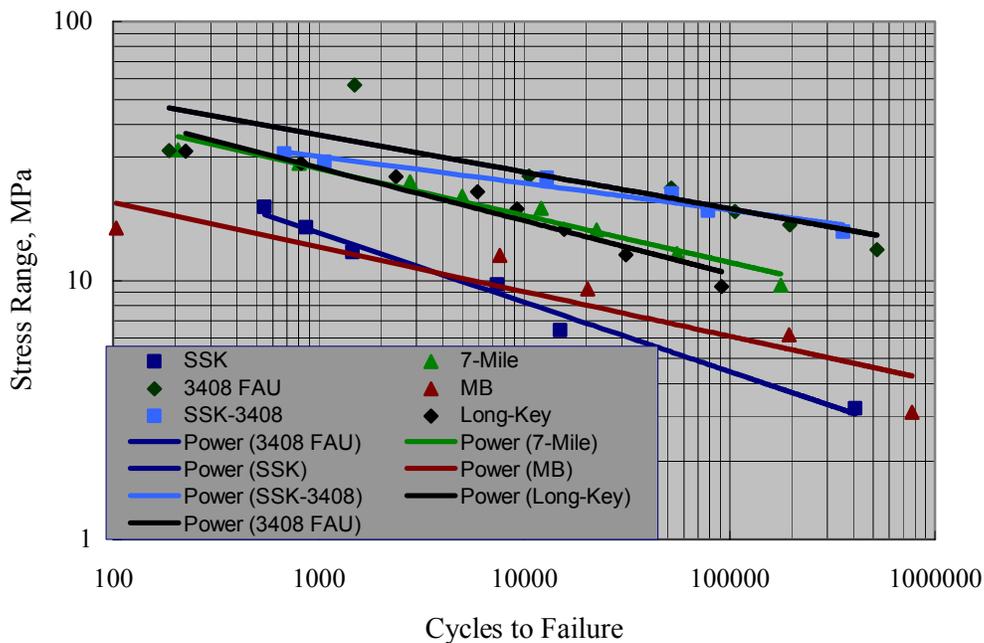
Figure 50: Fatigue data for various duct samples.

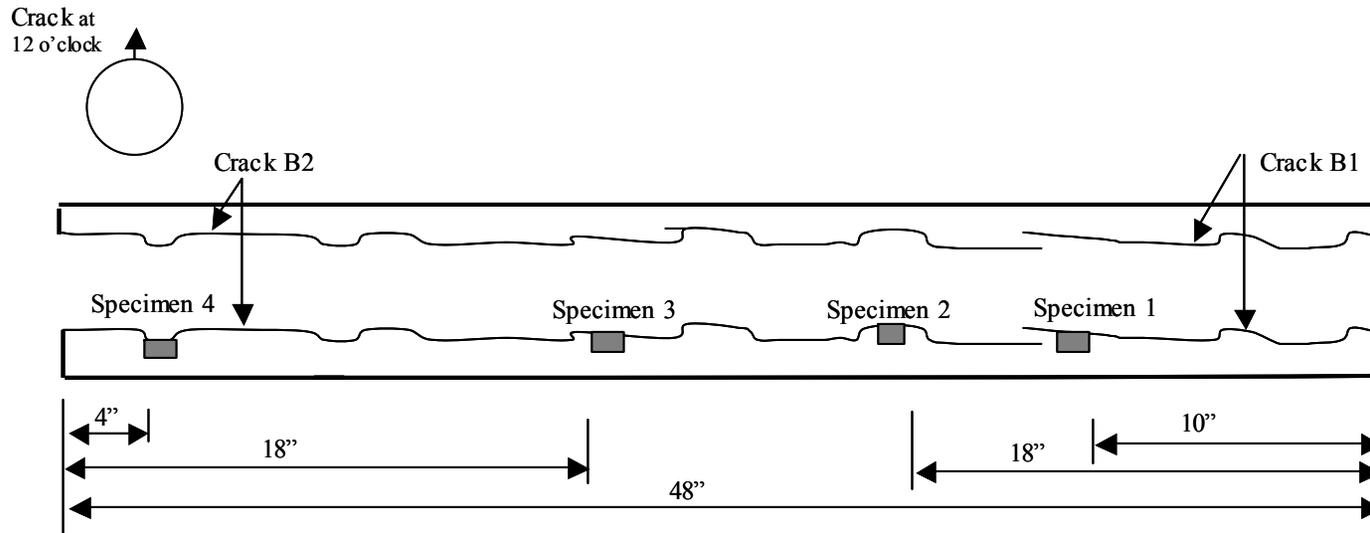
Figure 2 – Schematic drawing of a section of Sample MMB 38-4-A which contains two cracks

Description: There are two cracks in this pipe. The two cracks are one inch apart from each other measured on the inside surface.

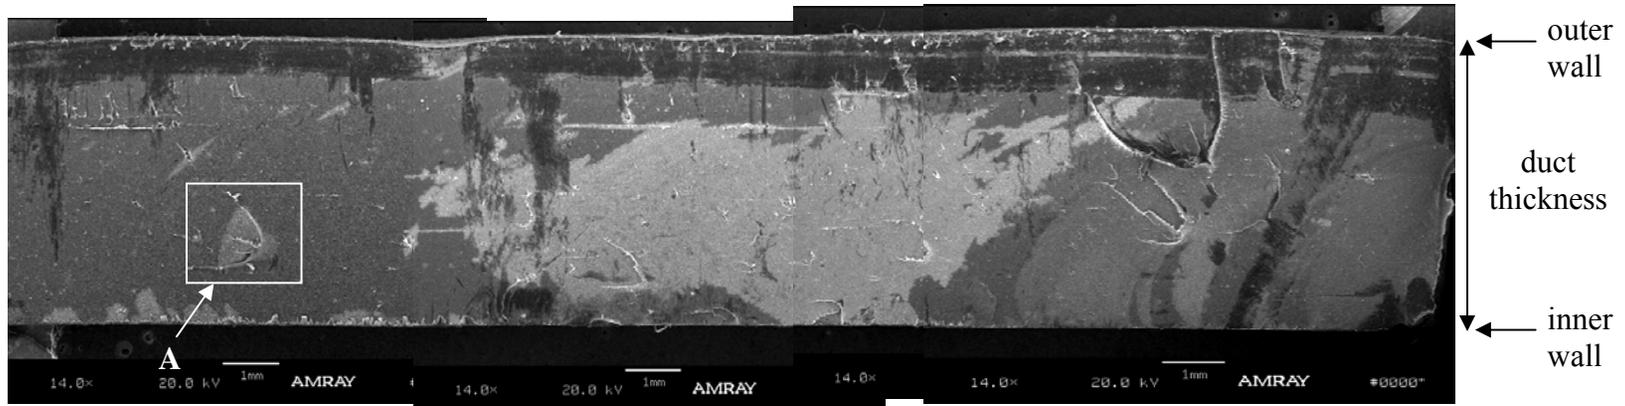
Photo 10. A general view of the fracture surface of Specimen 1 from Sample 67-5-A

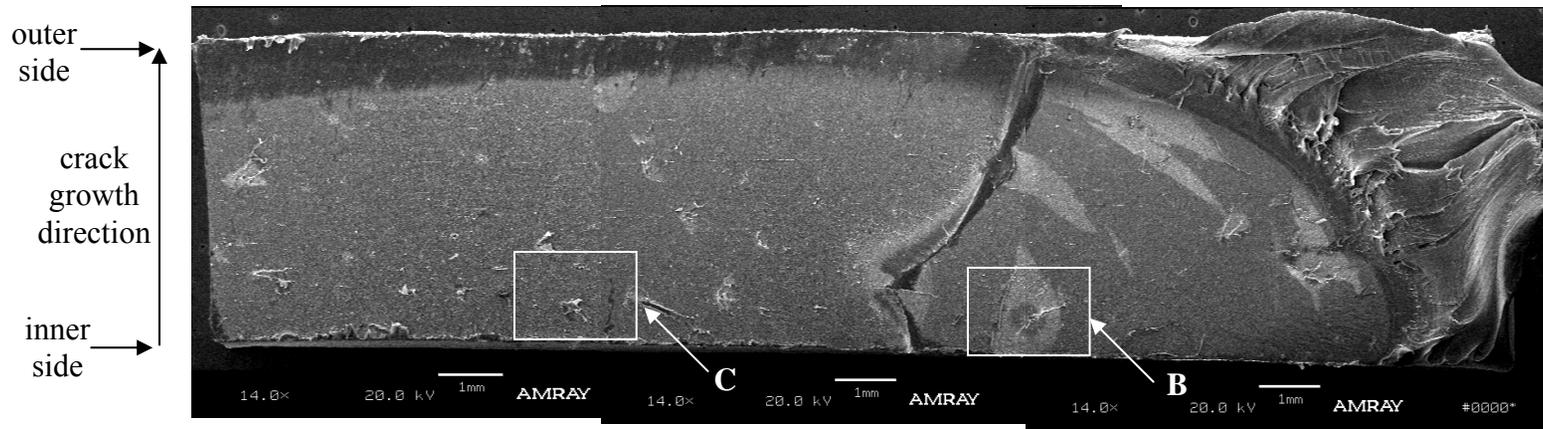
An overview of the fracture surface of Specimen 2 is shown in Photo 14. Based on the crack tip geometry, the crack probably initiated from the inner surface and grew through the thickness of the pipe as well as along the pipe longitudinal axis. Photo 15 shows the fracture morphology of Specimen 2, which is similar to that of Specimen 1, revealing a fibril structure that resulted from a slow crack growth mechanism. Possible crack initiations were observed in this section of the sample at areas “B” and “C”. At both crack initiation areas, an impurity was found (see Photos 16 and 17).

Photo 14. A general view of Specimen 2 from Sample 67-5-A

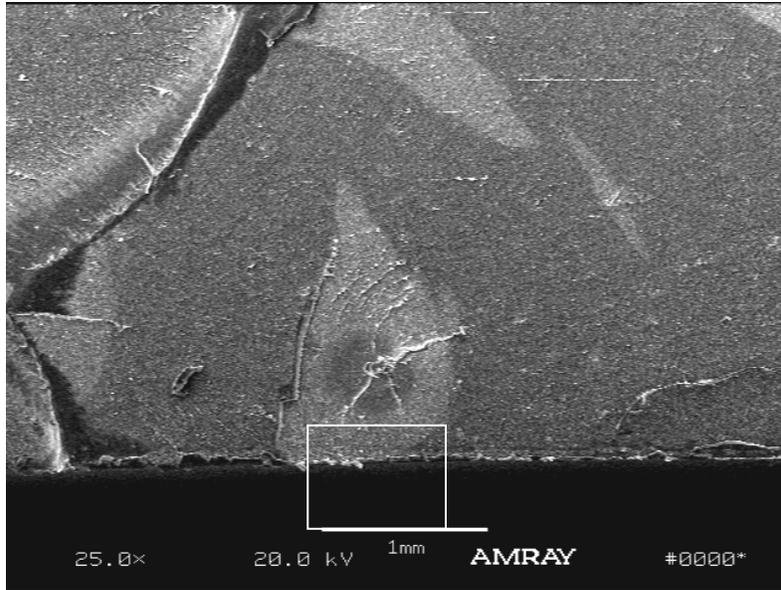
Photo 16. A close-up view of the area “B” in Specimen 2 from Sample 67-5-A

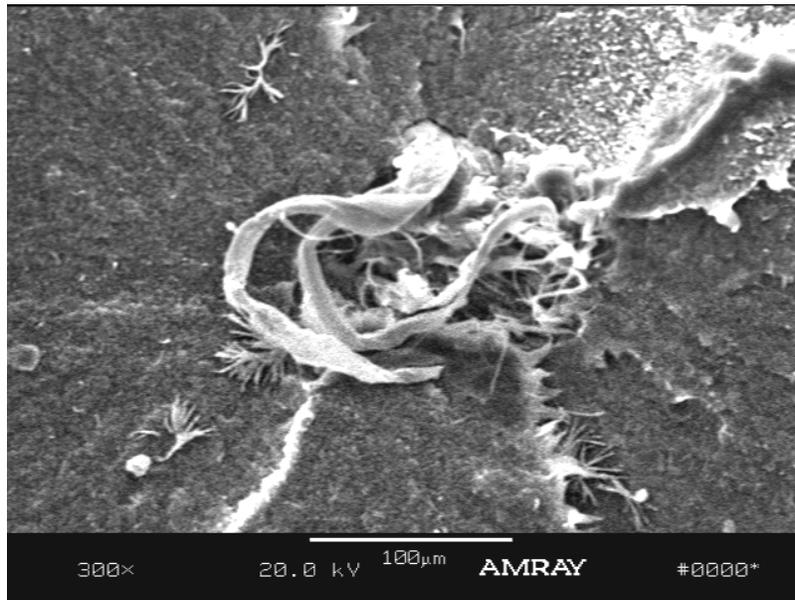
Photo 17. A detailed view of the highlighted area in Photo 16.

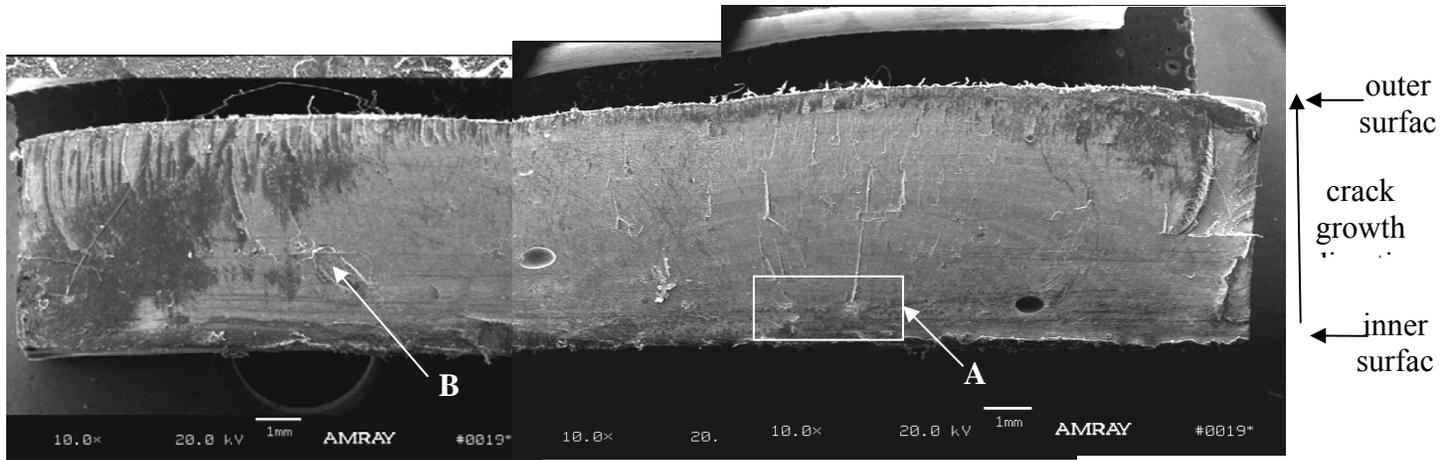
In Specimen 4, two crack initiations could be identified on the right hand side of the fracture surface, as indicated in Photo 28. The enlarged area “A” can be seen in Photo 29. A similar impurity could also be seen on the left hand of the fracture surface, at the area “B”. In addition, two air bubbles were observed in this section of the surface, but they did not initiate the cracking. In addition, a few fatigue lines were observed at the inner duct surface near the area “B”, as shown in Photo 30. The fracture surface of Specimen 4 was covered by the fibril structures, as shown in Photo 31.

Photo 28. A general view of the fracture surface of Specimen 4 from Sample 38-4-A

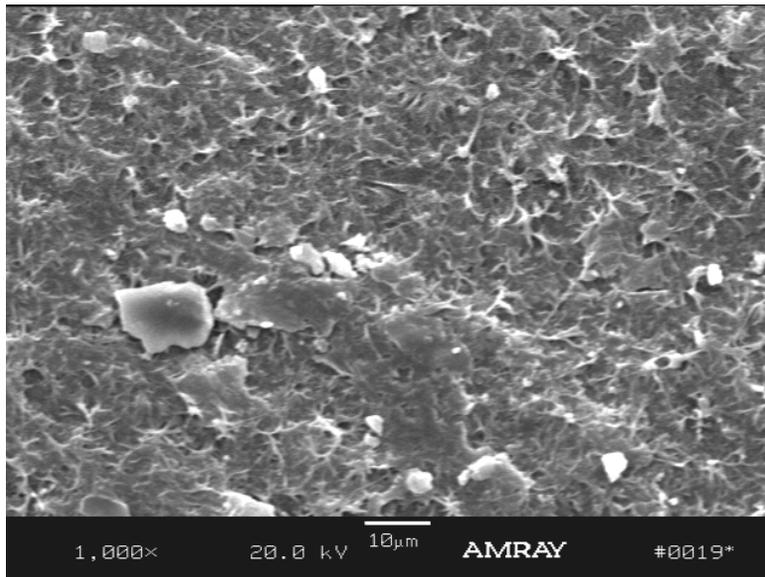
Photo 31. The fracture morphology of Specimen 4 from Sample 38-4-A

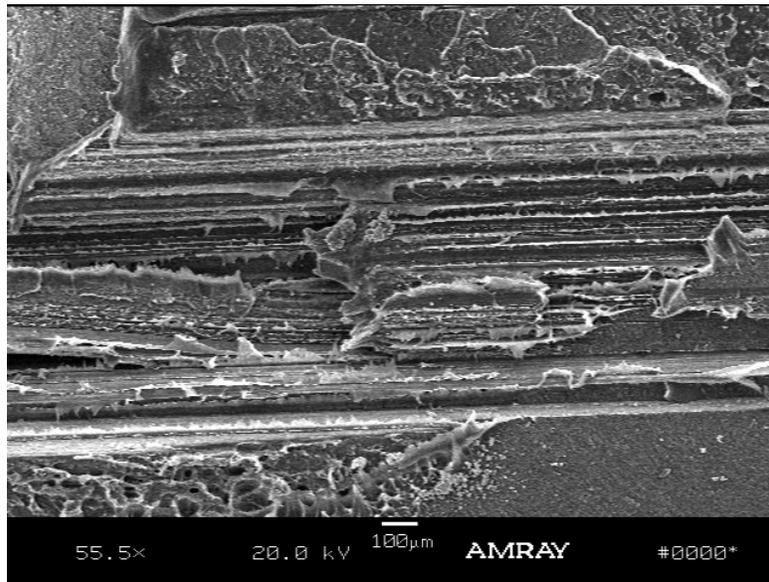
Photo 40. A close-up view on the fatigue line structure in area “B” of Specimen 2 form Sample 126-4-A

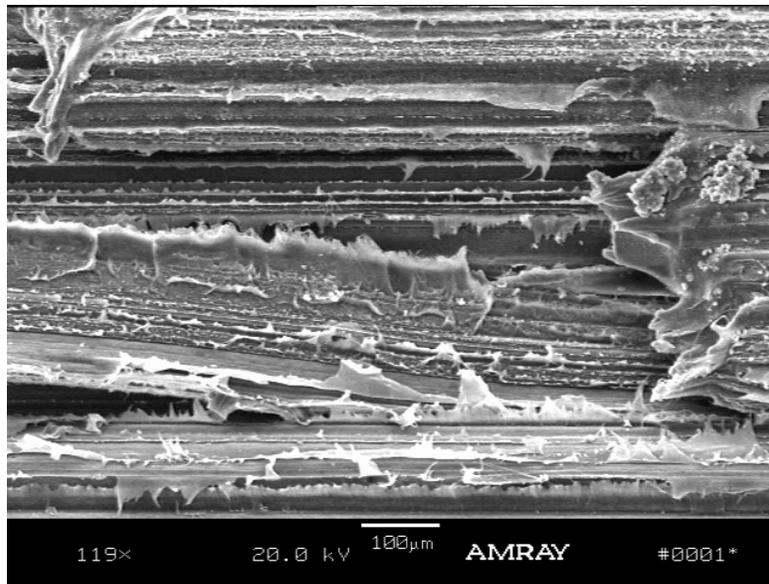
Photo 41. An enlarged view of the fatigue lines on the fracture surface of Specimen 2 from Sample 126-4-A

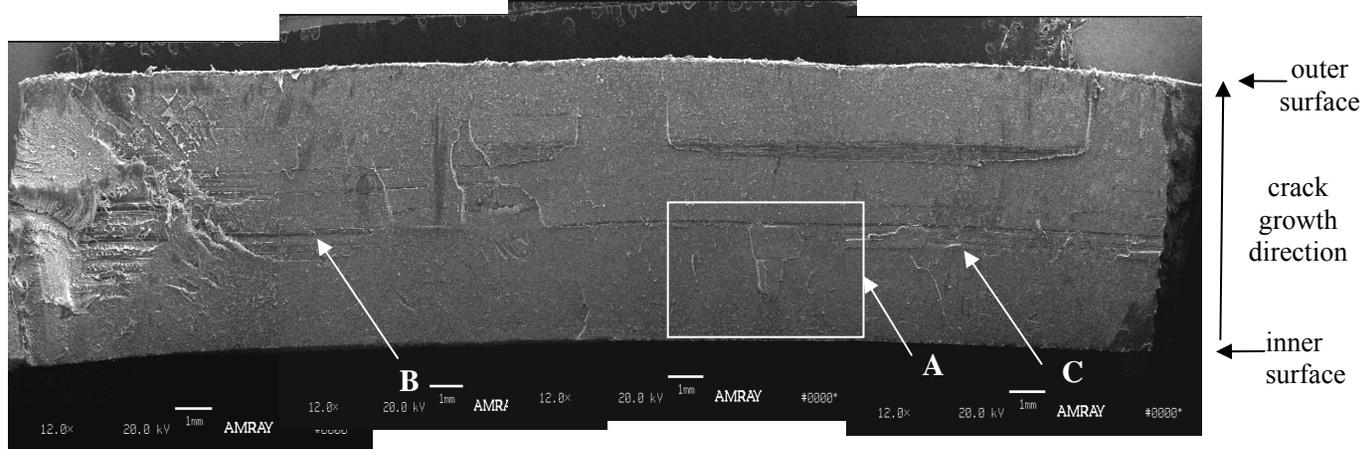
The fracture surface of Specimen 4 can be seen in Photo 46. The fibril structure dominated fracture morphology, as can be seen in Photo 47. A part of the crack was initiated from area “A”, as indicated by the close view of area “A” in Photo 48. The initiation was again caused by an impurity (see Photo 49), as observed in many other examined duct samples. Photos 50 and 51 show fatigue propagation in regions “B” and “C” of the fracture surface, respectively.

Photo 46. A general view of the fracture surface of Specimen 4 from Sample 126-4-A

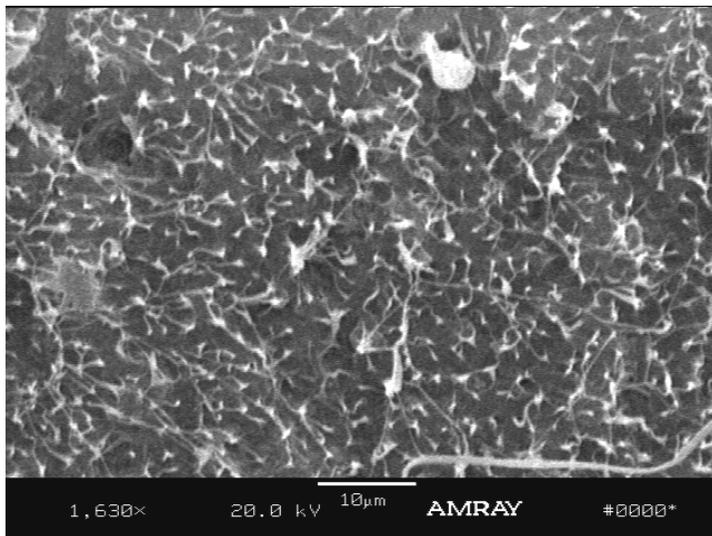
Photo 47. The fracture morphology of Specimen 4 from Sample 126-4-A

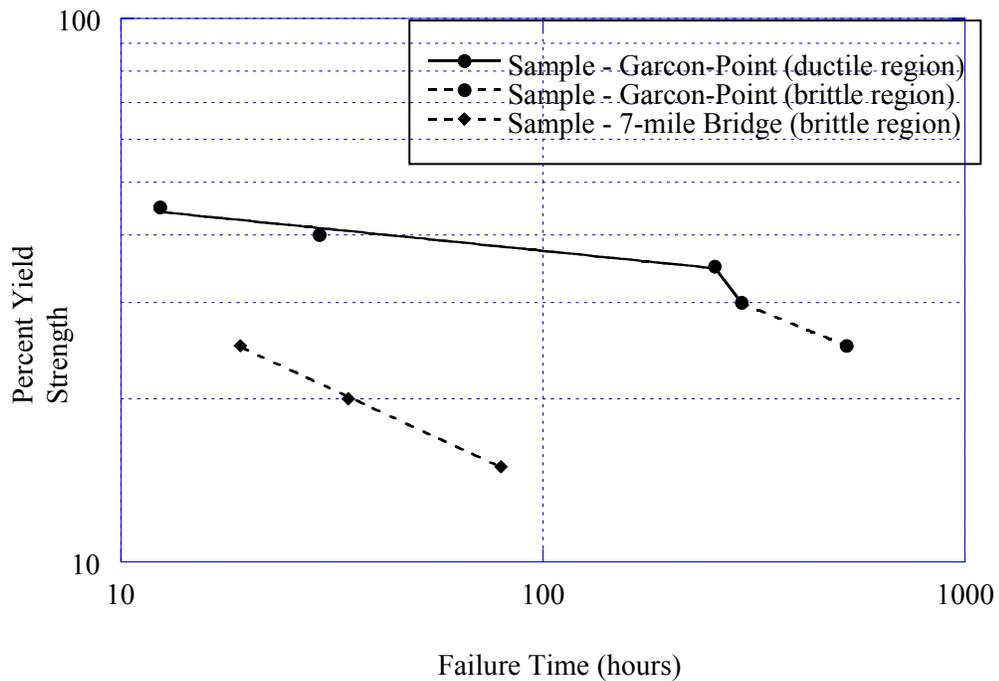
Figure 1 - NCTL test curves for duct samples from the Garcon-Point and Seven Mile Bridges.

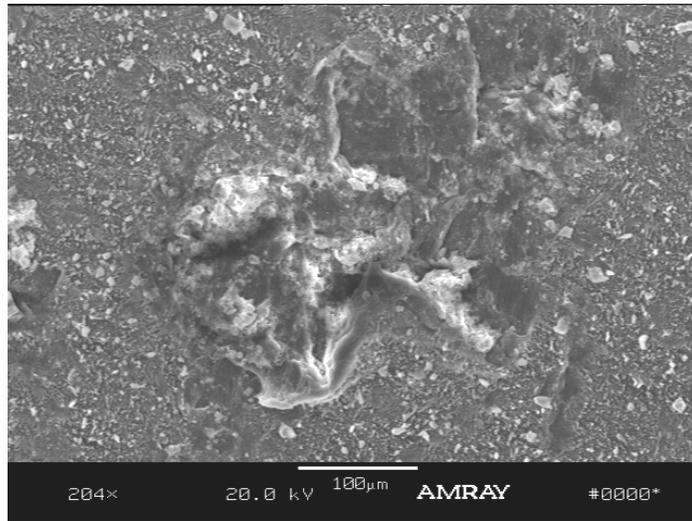
Figure 13: Impurity observed on fracture surface of Specimen 2.

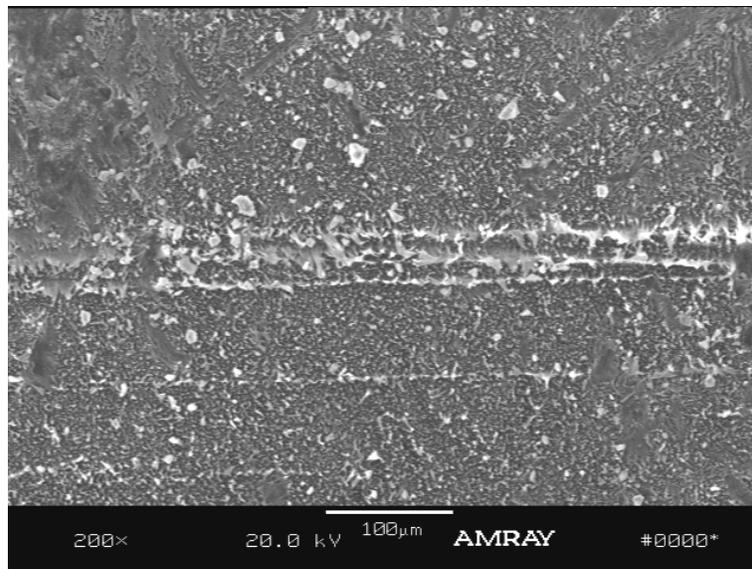
Figure 14: Fatigue lines on the fracture surface of Specimen 2.

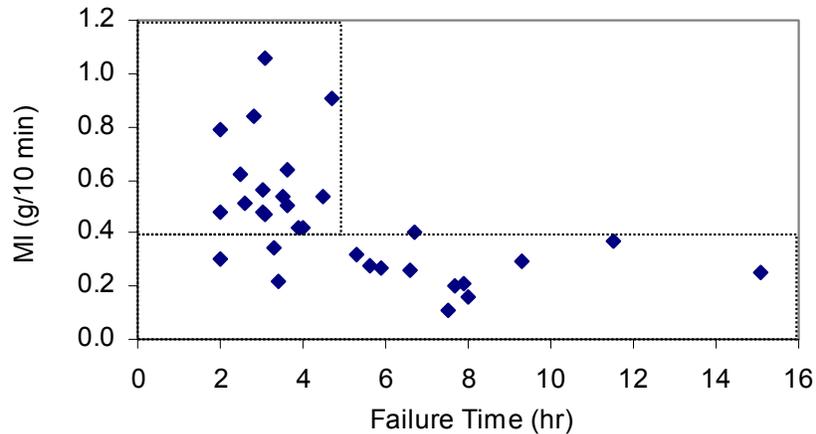
Figure 24: Failure Time versus MI of all evaluated field samples.

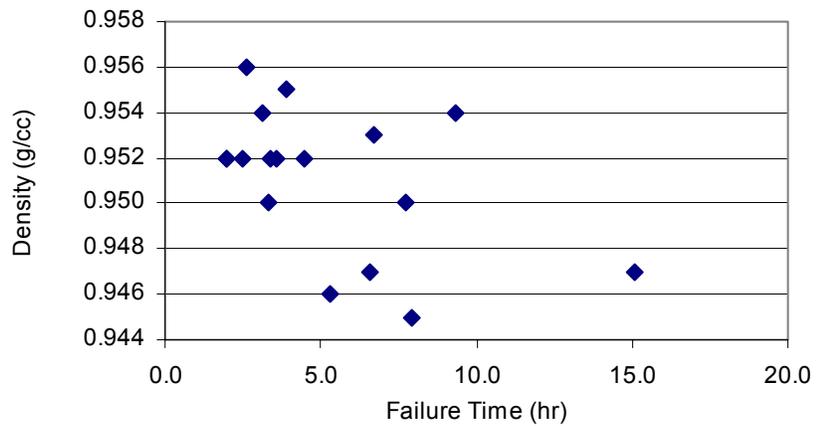
Figure 26: Density versus failure time of all evaluated field samples.
