BDR74-977-06

Florida Department of Transportation Research

Development of Delineator Material/Impact Testing Specific to Managed Lane Use for Optimization of Service Life

August 2016

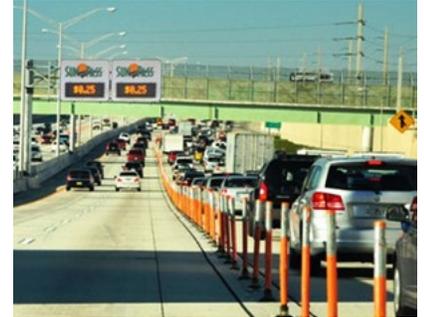
Managed lanes on I-95 are defined by miles of orange delineators.

I-95 Express lanes are separated from general traffic lanes by delineators. These devices take a fair amount of abuse, by being run over or being bumped. They are easy to replace, but a more robust delineator could greatly reduce replacement and crew costs and improve safety by reducing the exposure of crews to the hazards of roadway work.
