FDOT Research Project #BD433

Status and Management of Bats Roosting in Bridges in Florida

Jeffery A. Gore
Karl R. Studenroth, Jr.

March 2005

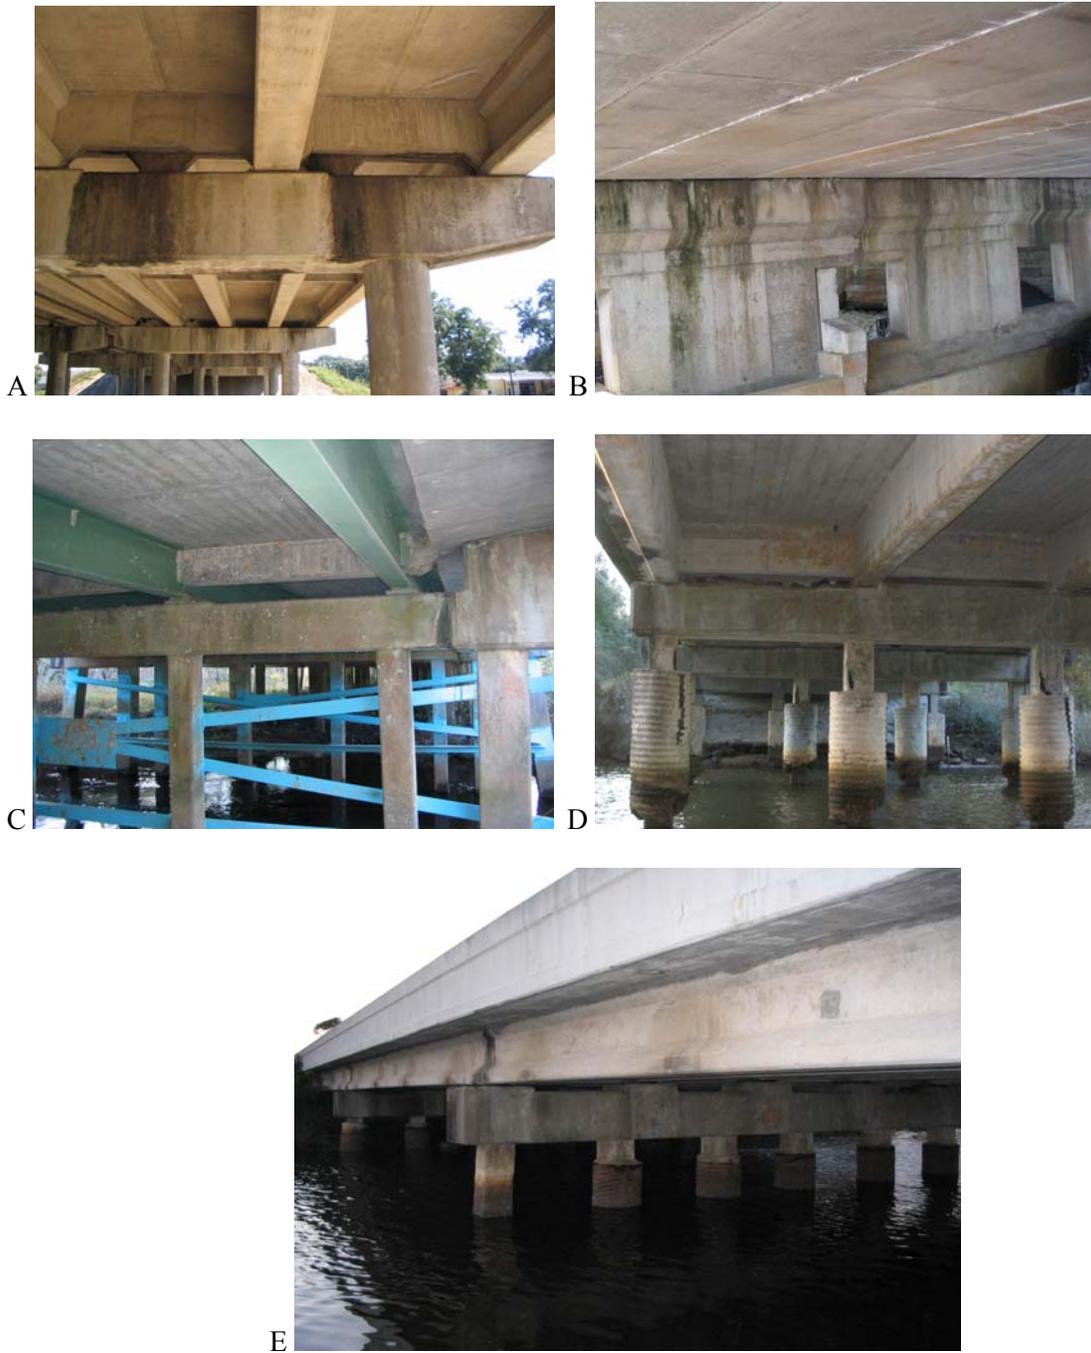
Figure 2. (A) Prestressed concrete multibeam bridge. (B) Prestressed concrete slab bridge. (C) Steel multibeam bridge. (D) Concrete tee beam bridge. (E) Continuous concrete multibeam bridge.

Like the concrete multibeam and T beam bridges, prestressed concrete slab bridges (Fig. 2) sometimes provided roosting crevices in the joints where spans met. Some slab bridges were constructed with multiple slabs in each span. These bridges sometimes offered suitable crevices in joints running between the parallel slabs (Fig. 2). The only concrete slab bridges that we randomly surveyed were made of prestressed concrete, but regular concrete slab bridges (N = 1,079) can also offer crevices for bats as we found in 1 bridge (Table 5). These bridges tend to be older and have only 1 span composed of a single slab; therefore, like most T beam bridges, they do not have between-span crevices suitable for bats. Concrete slab bridges also come in a continuous slab design, but these are not common (N = 536) and generally do not have joints between slabs.

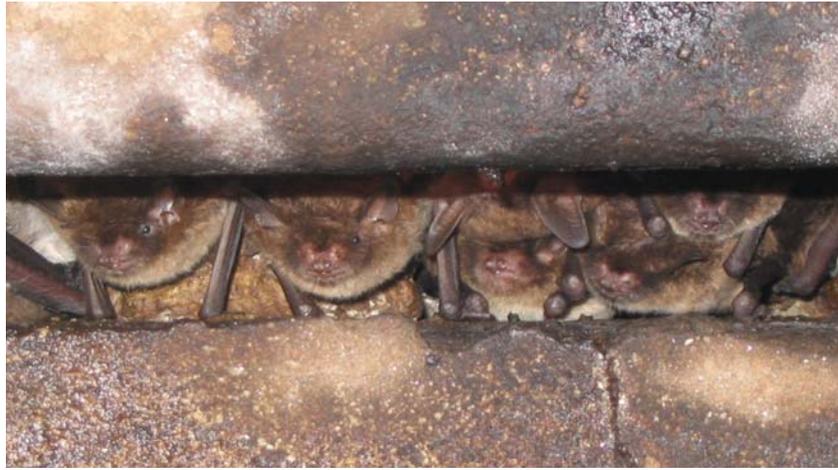
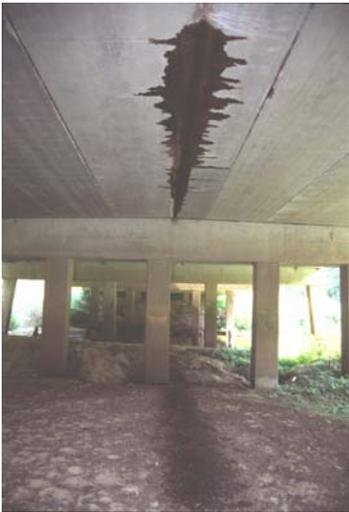
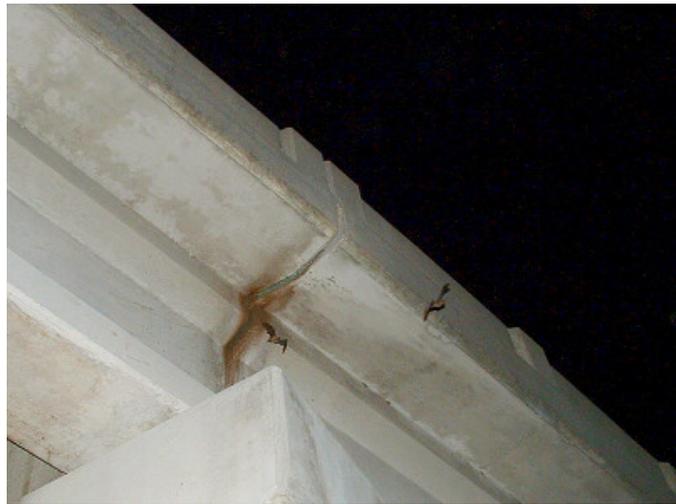
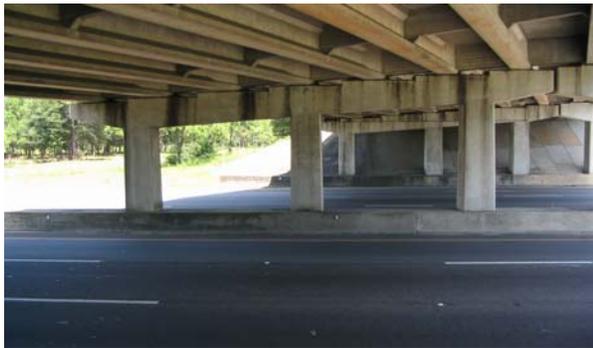
Figure 3. (A) Bats roosting in crevice formed by joint between 2 concrete slabs in a bridge span. (B) Guano below a bat roost and stains along roost in a concrete slab bridge. (C) Bats flying from expansion joint. (D) Guano and stains on support pier below an expansion joint in a concrete multibeam bridge.

At each bridge visited we looked for evidence of use by roosting bats, such as guano (feces), staining, odors, carcasses, or the roosting bats themselves (Fig. 3). If we could not see or hear bats, we still recorded a bridge as a bat roost if, based on our expertise, the presence of guano, stains, odors, or dead bats indicated regular use by bats. We labeled bridges being used by roosting bats as occupied bridges. Because the bats often roosted within inaccessible crevices in the bridges, we were not always able to see them well enough to confirm species or numbers of individuals. The crevices bats used were not structural defects, rather the roost crevices were the narrow spaces created by the expansion joints that are built between bridge sections to accommodate the expansion of the material with increasing temperature. Rarely, bats also roosted in small drainage holes built into the concrete deck of the highway. We noted when species identification was confirmed versus suspected. Exact counts were often not possible; therefore, we estimated the minimum size of colonies and grouped estimates into 3 size classes: small (<25 bats), medium (25-500 bats), and large (>500 bats).

from predators and weather, but they also importantly provide thermal conditions needed by the bats to conserve energy when roosting (Keeley and Tuttle 1999). In our 1995 study, we found bats most often use crevices in bridge joints that are closed at the top (J. A. Gore, unpublished data). In 2003, we found bats in at least 2 bridges where the expansion joint used was open at the top, either by design or loss of a seal, and the bats could be readily observed from above through the bridge deck. We also found several bridges where big brown bats were roosting in joints between concrete guardrail posts above the deck of the bridge. Expansion joints come in a variety of designs (Hartle et al. 2002), but we found bats used various configurations as long as the joint provided a concrete surface and suitable space. Some joints are armored with metal, but we found no bats on the metal portions of armored joints. Metal would be difficult for bats to grasp and would transmit heat too readily to be a good roosting surface. Bats used both the long shallow joints that paralleled sections of concrete slab spans and the shorter, deeper joints that ran transverse to the roadway and connected spans as they met above support pillars or piers (Fig. 3).
