Structures Research  
Report 2008/51187

University of Florida  
Civil and Coastal Engineering

Final Report

## Development of Low-Profile Barrier Features for Space- Restrictive Applications

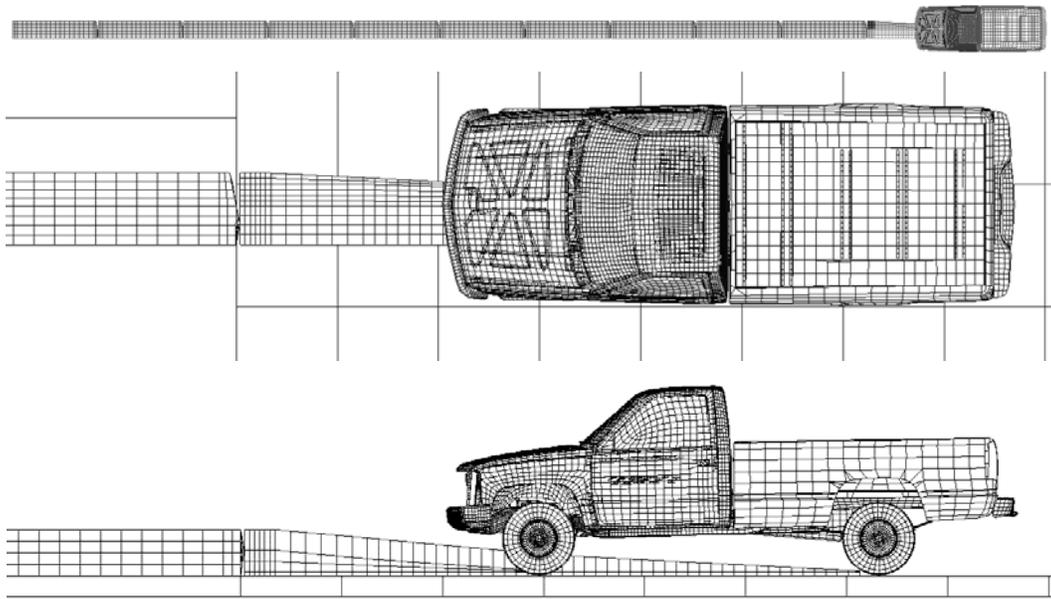
Figure 19. Finite element model of test 2-31 (2000 kg truck)

Numerical models corresponding to NCHRP 350 test conditions 2-30 and 2-31 are shown in Figures 18 and 19, respectively. Each of these tests corresponds to a head-on impact condition (0-degree impact angle). Test 2-30 is conducted with the centerline of the 820C vehicle offset from the centerline of the tip (nose) of the end-treatment, whereas in test 2-31, the centerline of the 2000P vehicle is aligned with the centerline of the end-treatment.

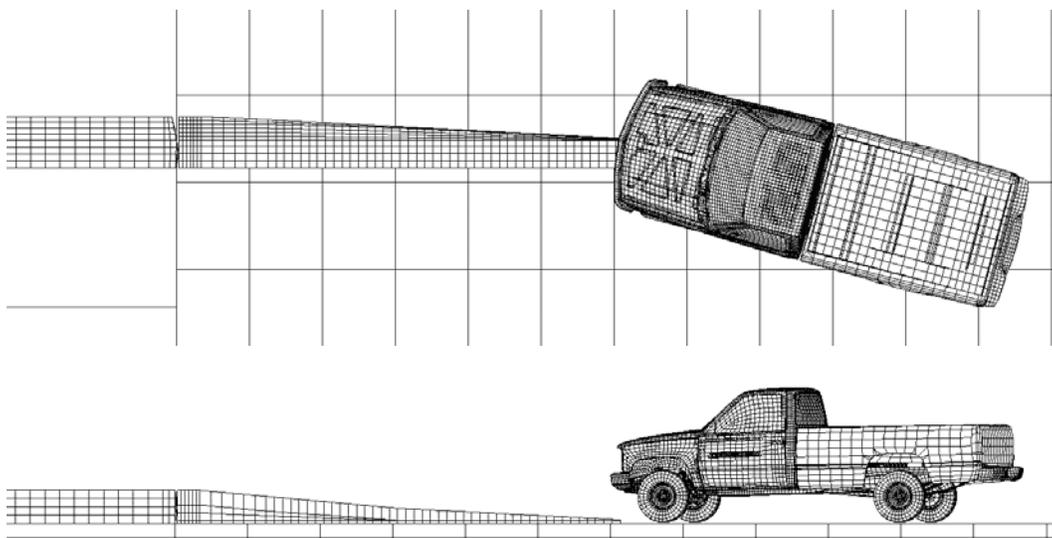
Figure 21. Finite element model of test 2-33 (2000 kg truck, 15-deg. angle)

In Figure 20 and 21, models corresponding to NCHRP 350 test conditions 2-32 and 2-33 are shown. Each of these cases consists of a vehicle striking the end-treatment at an oblique

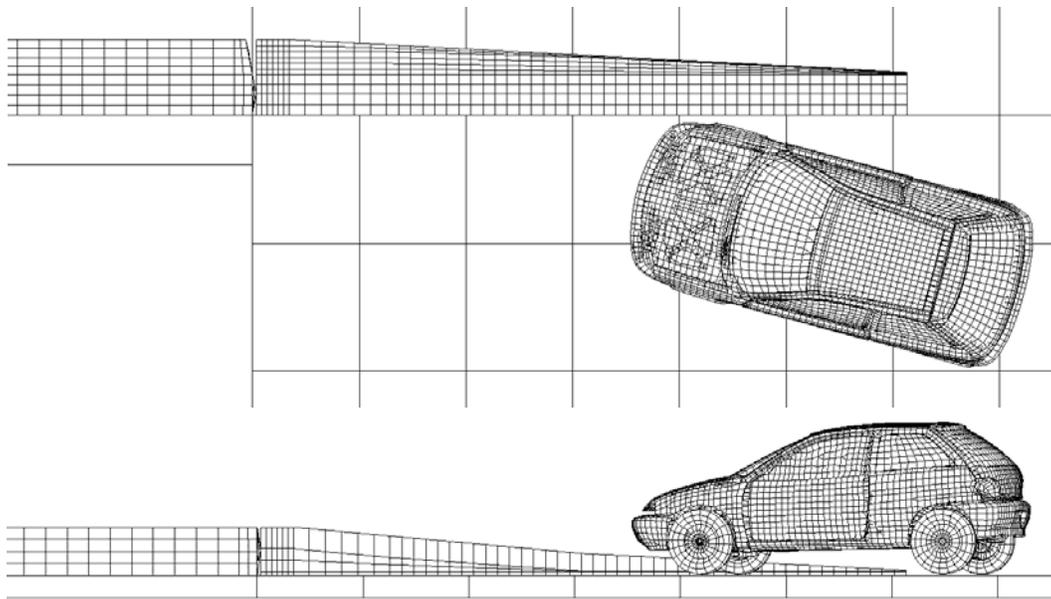
Figure 22. Finite element model of test 2-34 (820 kg car, 15-deg. angle)

In Figure 22, the model corresponding to NCHRP 350 test condition 2-34 is shown. Test 2-34 involves a 15-degree oblique impact of a 820C vehicle striking the end-treatment at the critical impact point (CIP). With regard to selecting the CIP for test 2-34, NCHRP Report 350 states:

In Figure 22, the CIP is located at a distance 6 ft.-10 in. from the tip of the end-treatment. At this point, the height of the end-treatment (essentially 6 in.) matches the height of the FDOT Type-F concrete curb. It has been established through computer simulation and physical testing that typical 820C vehicles are capable of mounting and traversing 6 in. curbs. Selecting the CIP for test 2-34 to coincide with this height therefore reasonably ensured that the front right tire of the 820C would mount and traverse the end-treatment, resulting in a critical condition in terms of vehicle roll angle and stability. In fact, later full-scale crash tests confirmed this to be the case. In the 2-34 full-scale crash-test, the right-front tire mounted the end-treatment at the impact point and traversed its width. This, in turn, resulted in the left-front tire following a trajectory up and over essentially the tallest part of the end-treatment, producing a worst case scenario in regard to *potential* for vehicle rollover. Vehicle rollover did **not** occur during the physical crash test.

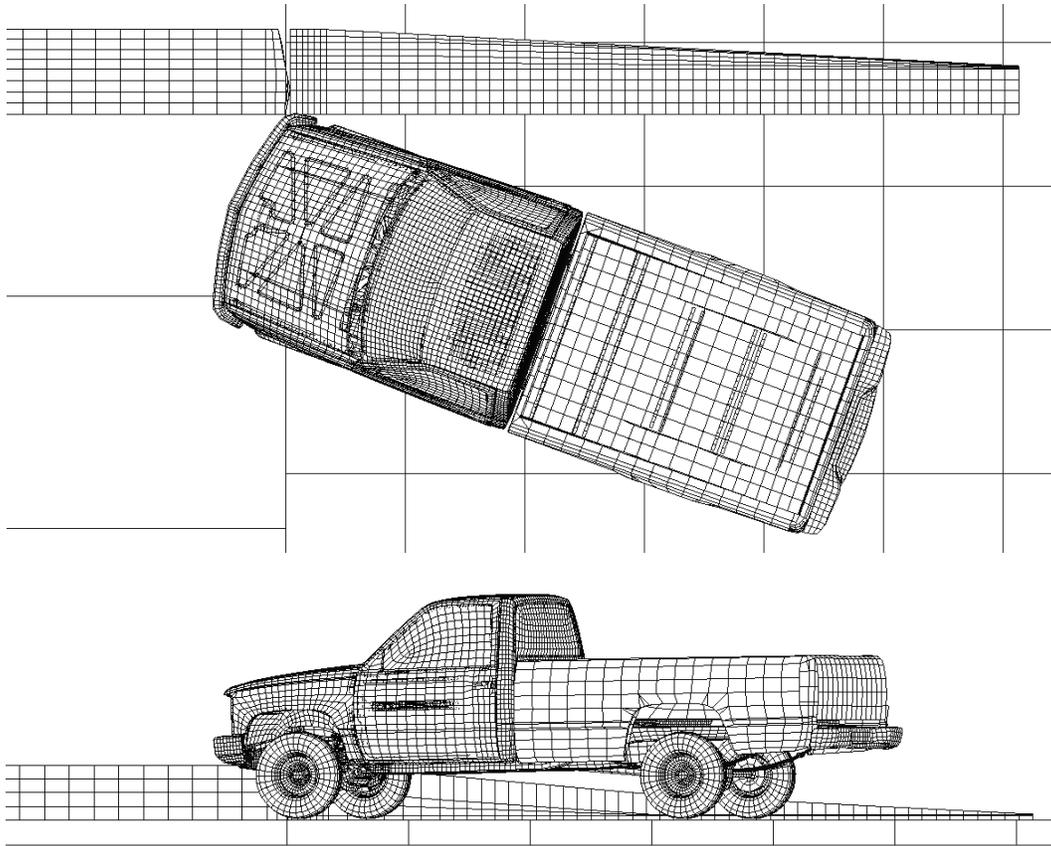
Figure 23. Finite element model of test 2-35 (2000 kg truck, 20-deg. angle)

In Figure 23, the model corresponding to NCHRP 350 test condition 2-35 is shown. Test 2-35 involves a 20-degree oblique impact of a 2000P vehicle striking the end-treatment at the beginning of the LON. With regard to test 2-35, NCHRP Report 350 states:

As noted earlier, given that 18 in. was previously determined (during an earlier study) to be the minimum barrier height capable of redirecting a 2000P vehicle, there is no expectation that any portion of an end-treatment less than 18 in. in height will be capable of redirecting this same vehicle. Consequently, no part of the end-treatment is considered to contribute to the LON of barrier that is required to protect a particular work-zone. Therefore, the beginning of the LON coincides with the end of the end-treatment and the beginning of the low-profile barrier segments. This same location then becomes the point of impact for test 2-35 (Figure 23).

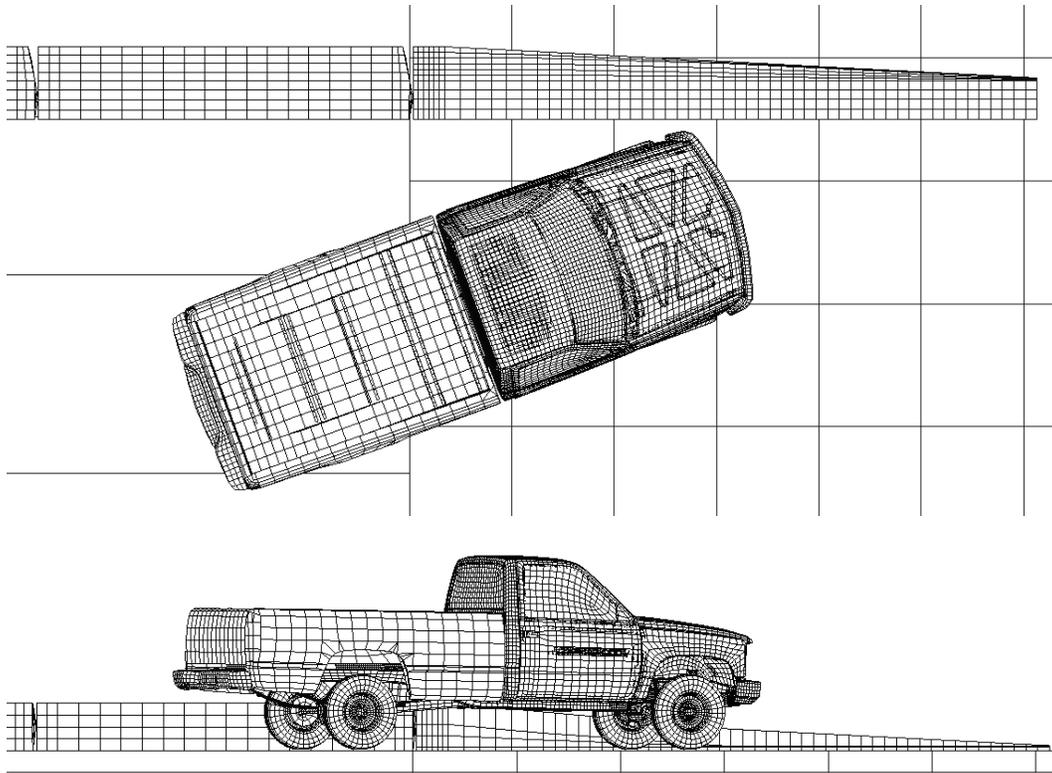
Figure 24. Finite element model of test 2-39 (2000 kg truck, 20-deg. reverse angle)

In Figure 24, the model corresponding to NCHRP 350 test condition 2-39 is shown. Test 2-39 involves a reverse-angle 20-degree oblique impact of a 2000P vehicle striking the end-treatment at the location midway between the beginning and end of the end-treatment. Results obtained from the models described above, as well as additional simulations that were conducted (e.g., to consider variations in frictional coefficients), indicated that the tapered end-treatment concept had good potential for passing the required matrix of NCHRP Report 350 crash tests.

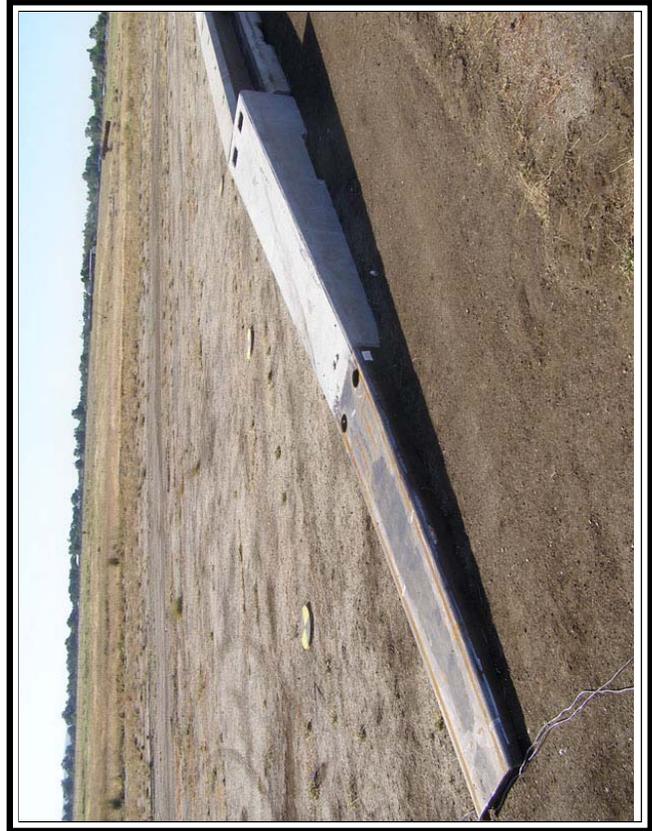
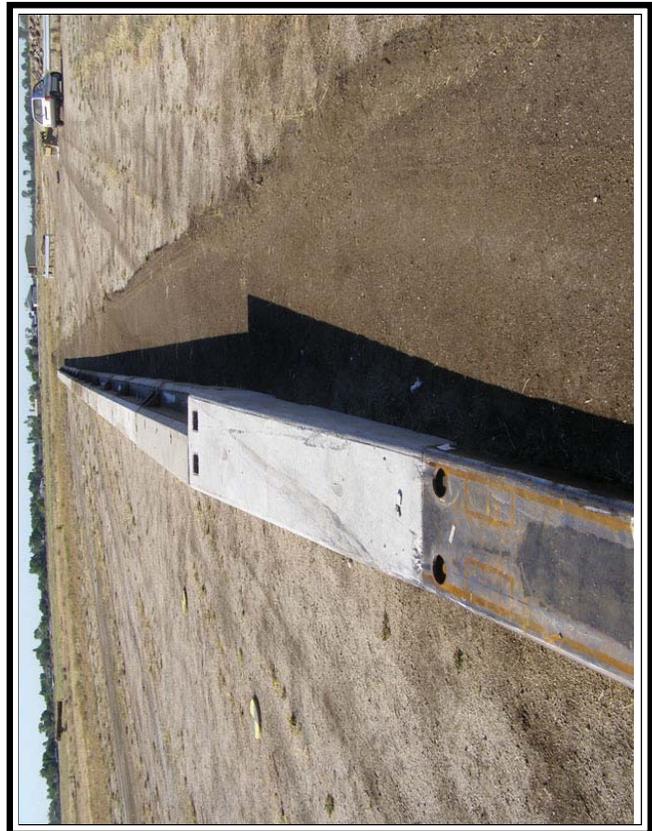
Figure 3. Test Article Damage - Florida Curb End Treatment Test 71-1776-004

The test article damage is shown in the post-test photographs of Figure 3. There was negligible dynamic and permanent deflection of the test article. According to the FHWA July 97 memorandum, test article damage was categorized as "Category A. None" and no replacement parts would be needed for repair. <sup>(3)</sup> There was no debris expelled by the test article.

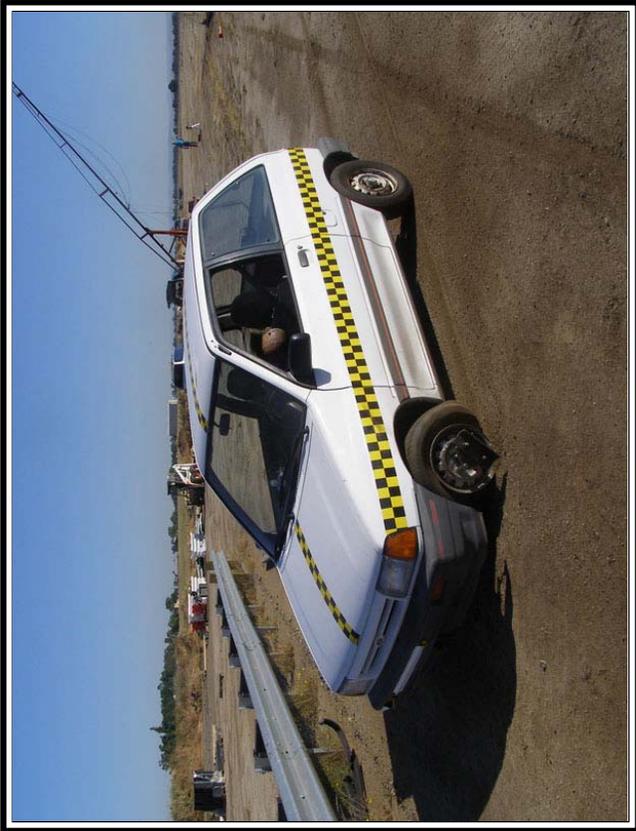
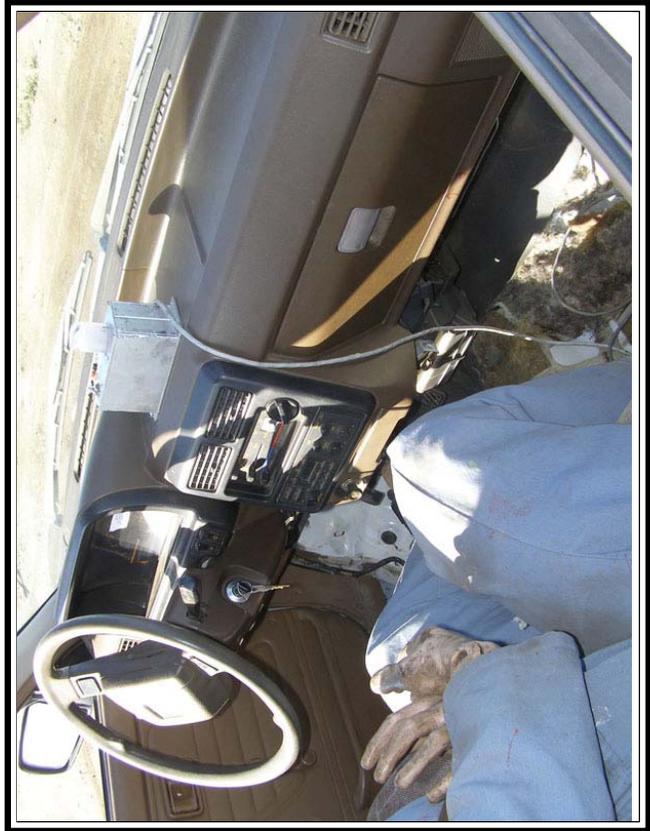
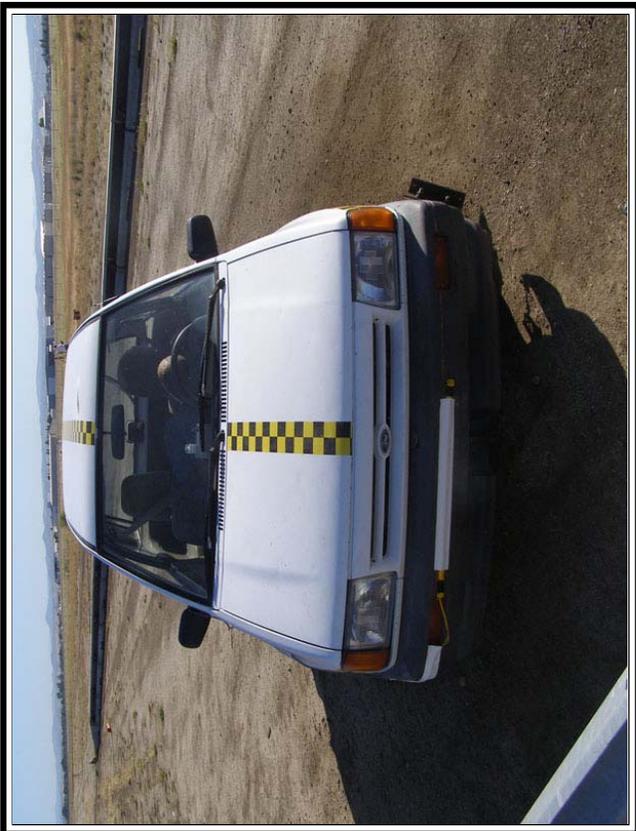
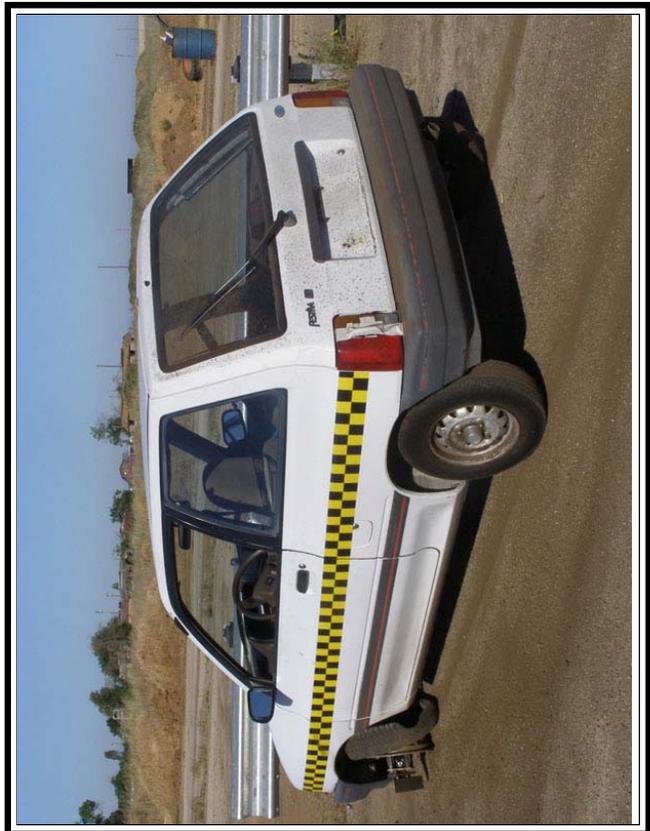
Figure 4. Vehicle Damage - Florida Curb End Treatment Test 71-1776-004

The vehicle damage is shown in Figure 4. There was essentially no damage to the test vehicle other than scrapes along the undercarriage and a flat tire consequently the damage was categorized as not applicable (N/A) on the Vehicle Damage Scale (VDS) and the Collision Deformation Classification Scale (CDC).<sup>(4)(5)</sup> There was negligible deformation of the occupant compartment based upon pre- and post-test measurements. The Occupant Compartment Deformation Index (OCDI) was categorized as AS000000. The pre-test vehicle geometries are shown in Figure 5.

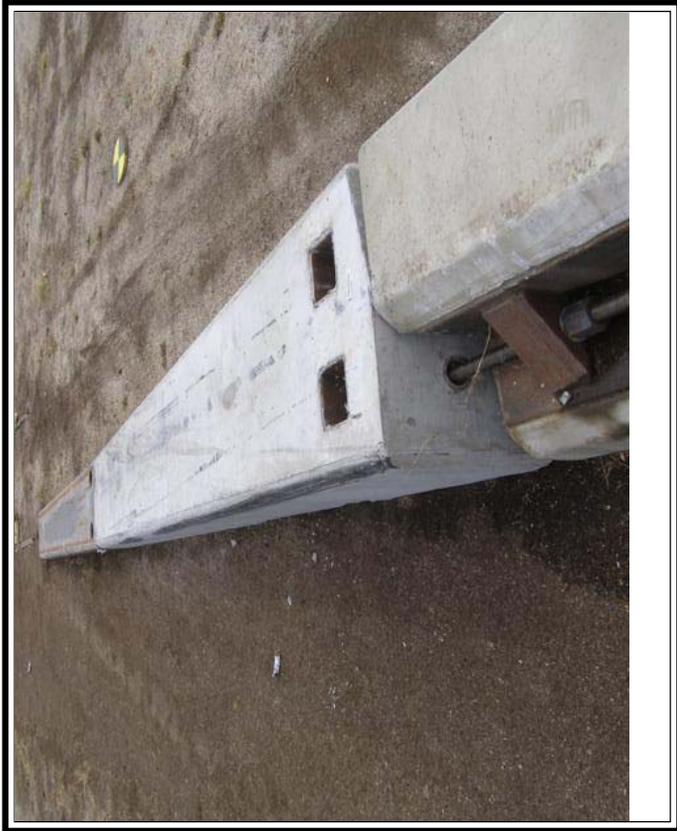
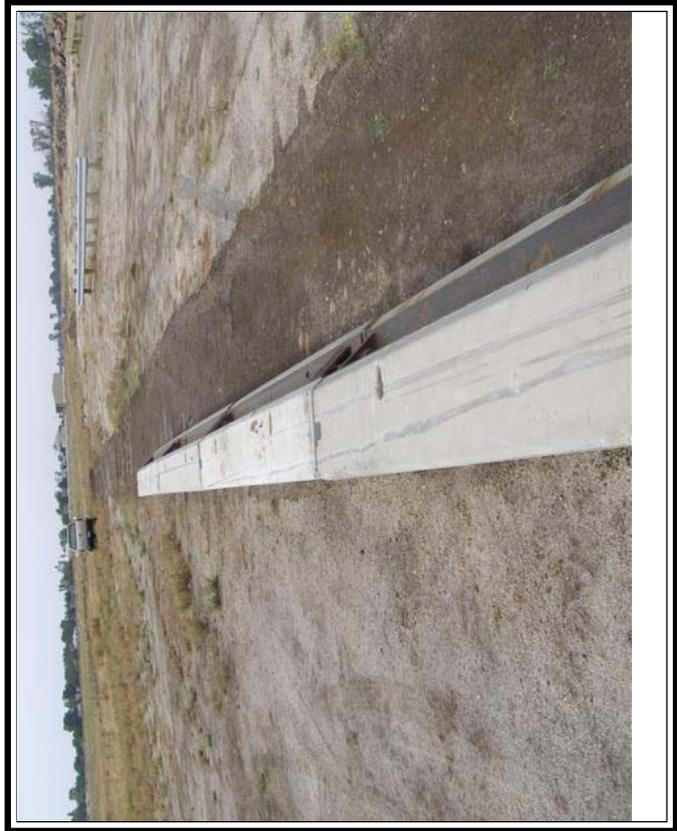
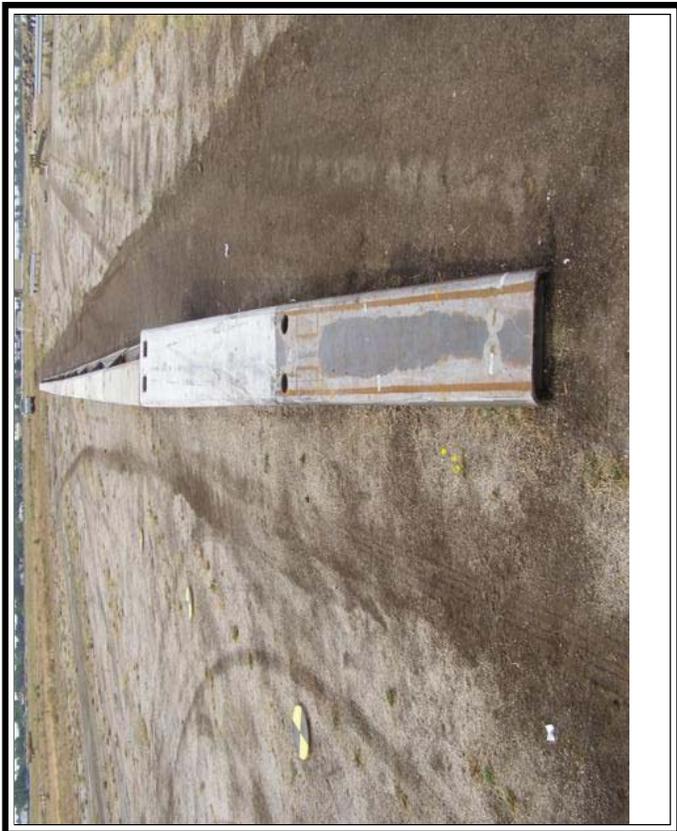
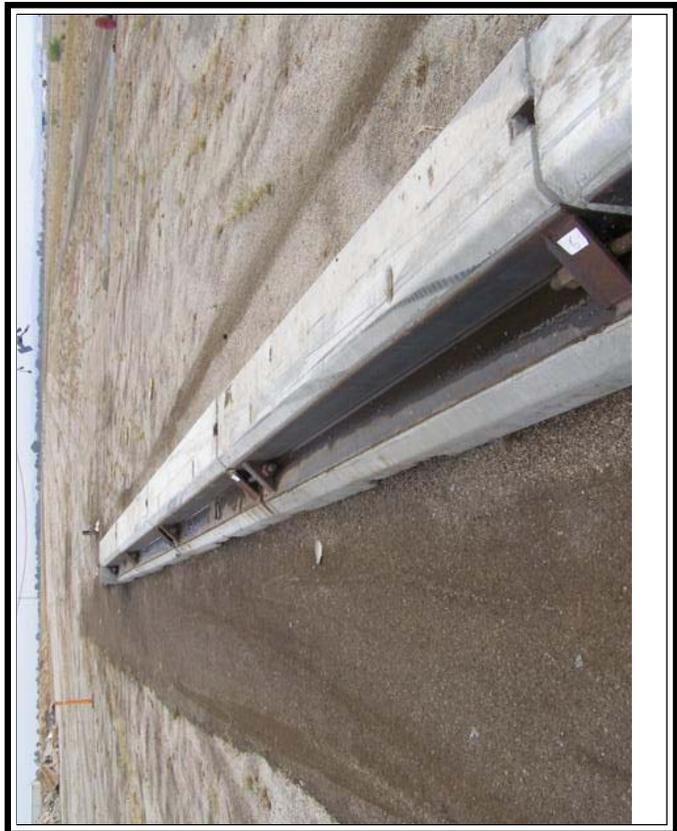
Figure 8. Test Article Damage - Florida Curb End Treatment Test 71-1776-005

The test article damage is shown in the post-test photographs of Figure 8. There was negligible dynamic and permanent deflection of the test article. According to the FHWA July 97 memorandum, test article damage was categorized as "Category A. None" and no replacement parts would be needed for repair. There was no debris expelled by the test article.

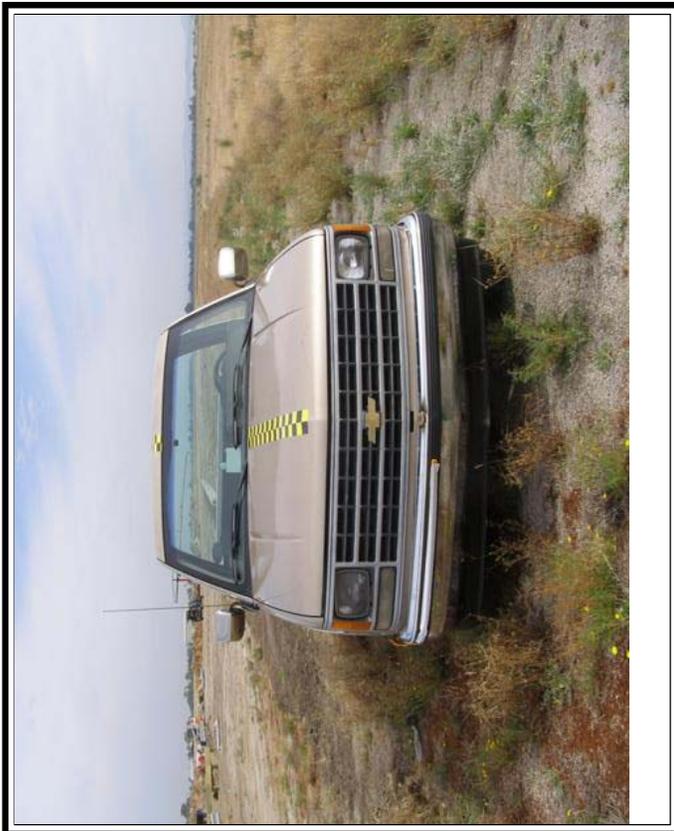
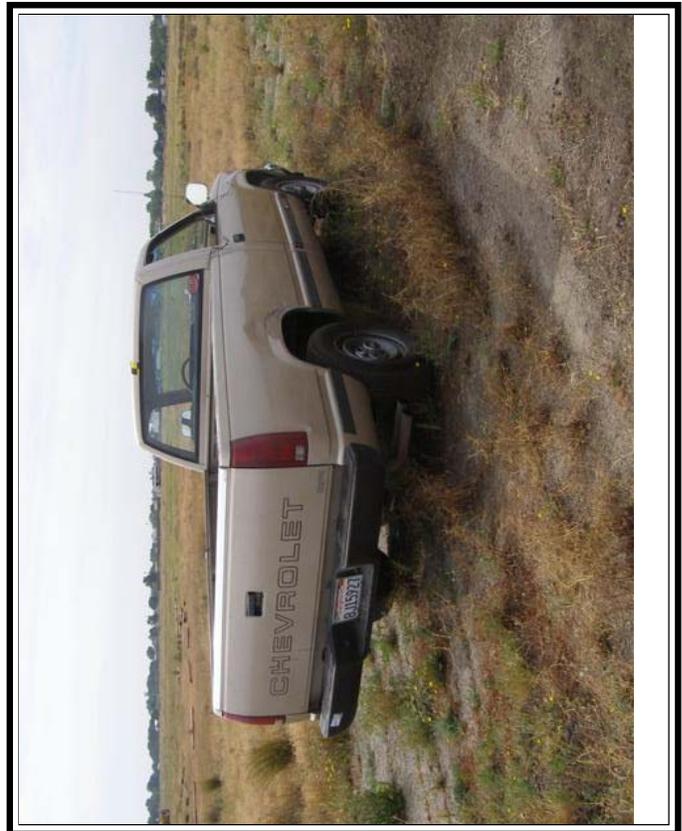
Figure 9. Vehicle Damage - Florida Curb End Treatment Test 71-1776-005

The vehicle damage is shown in Figure 9. There was essentially no damage to the test vehicle other than scrapes along the undercarriage consequently the damage was categorized as not applicable (N/A) on the Vehicle Damage Scale (VDS) and the Collision Deformation Classification Scale (CDC). There was negligible deformation of the occupant compartment based upon pre- and post-test measurements. The Occupant Compartment Deformation Index (OCDI) was categorized as AS0000000. The pre-test vehicle geometries are shown in Figure 10.

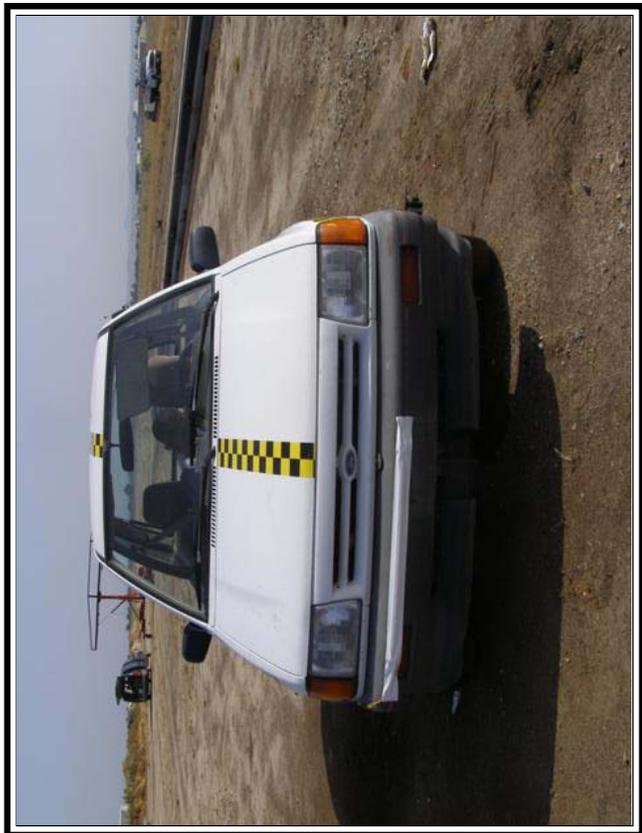
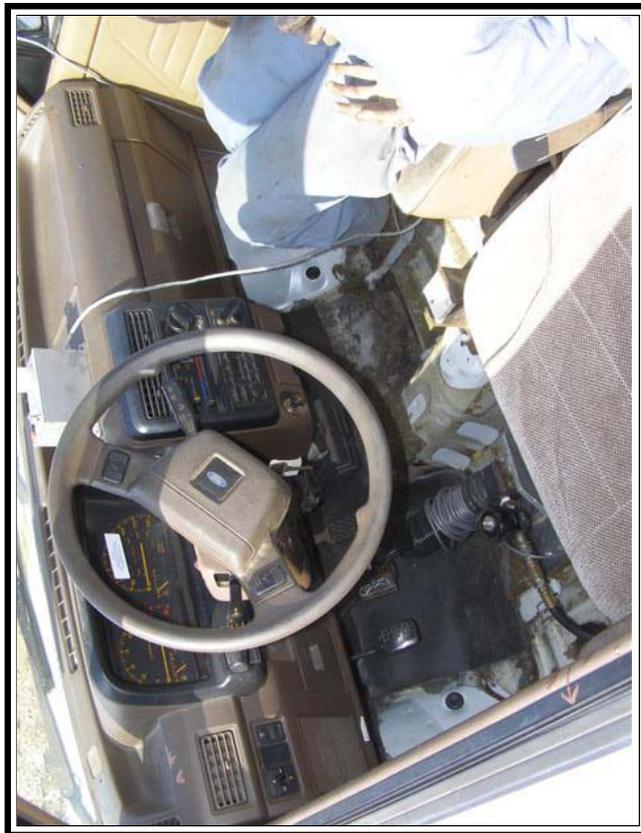
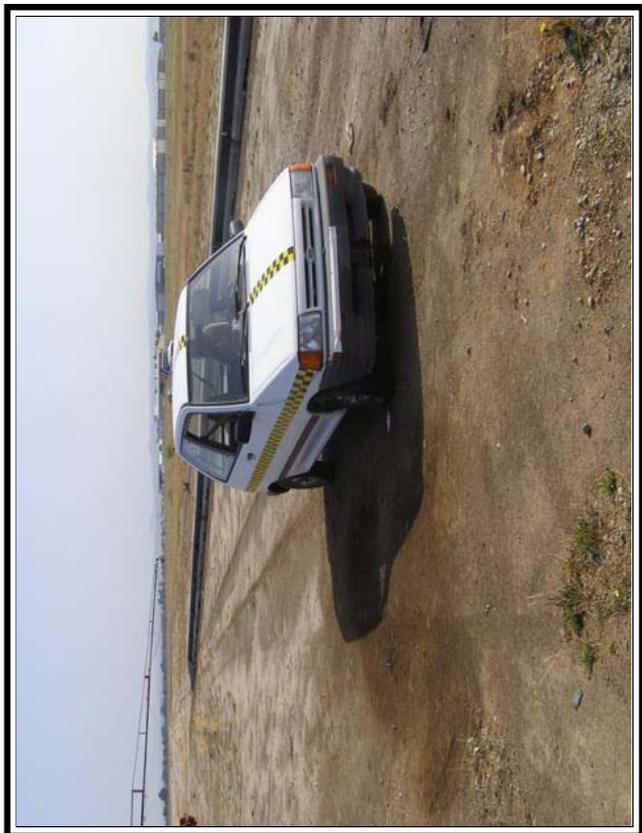
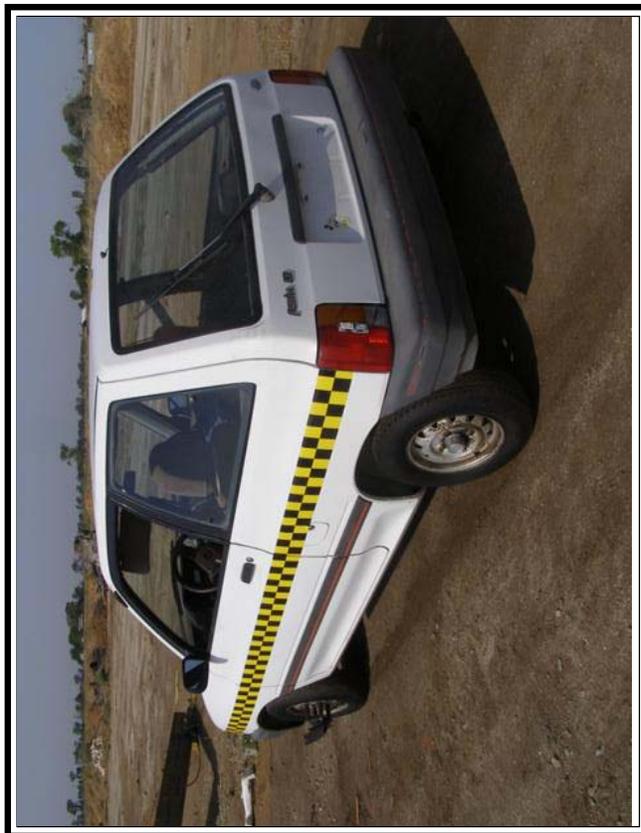
Figure 14. Vehicle Damage - Florida Curb End Treatment Test 71-1776-002

The vehicle damage is shown in Figure 14. There was essentially no damage to the test vehicle other than a flat tire consequently the damage was categorized as not applicable (N/A) on the Vehicle Damage Scale (VDS) and the Collision Deformation Classification Scale (CDC). There was negligible deformation of the occupant compartment based upon pre- and post-test measurements. The Occupant Compartment Deformation Index (OCDI) was categorized as AS0000000. The pre-test vehicle geometries are shown in Figure 15.
