Final Report

**Analysis and Estimation of Service Life of Corrosion Prevention Materials Using Diffusion,
Resistivity and Accelerated Curing for New Bridge Structures -
Volume 1: Corrosion Prevention Materials (Monitoring and Forensic Examination)
(BDK79-977-02)**

**Florida Department of Transportation Research Center
605 Suwannee Street
Tallahassee, Florida 32399**

December 2013

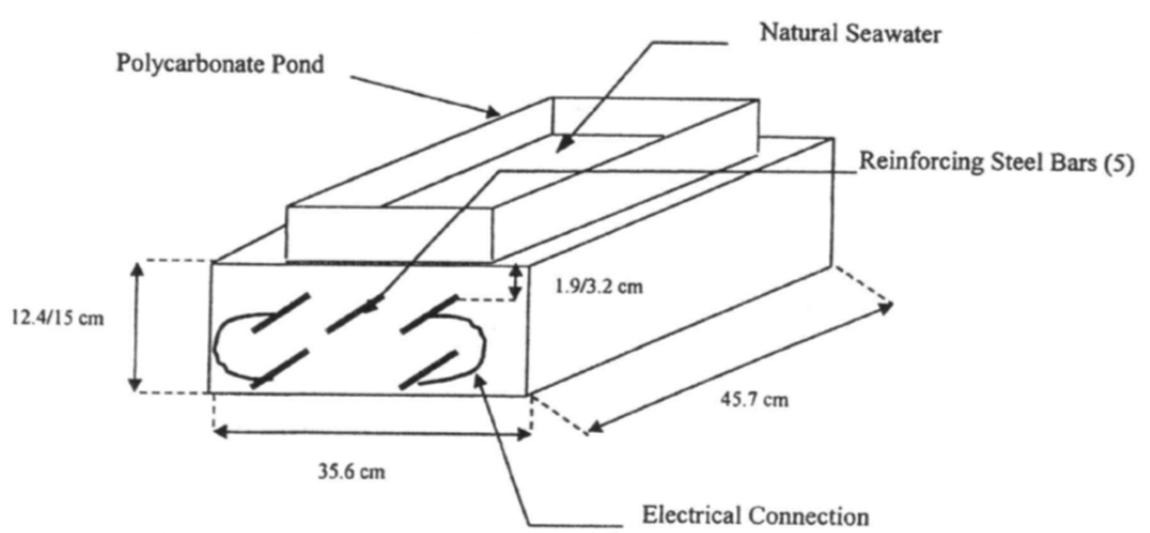
Figure 2.1: Schematic illustration of the specimen geometry

top bars, while a limited number of specimens were 15.2 cm thick with 3.2 cm cover. Table 2-5 lists the number of reinforced samples casted for each mix and height/cover. The slab geometry is as illustrated in Figure 2.1.

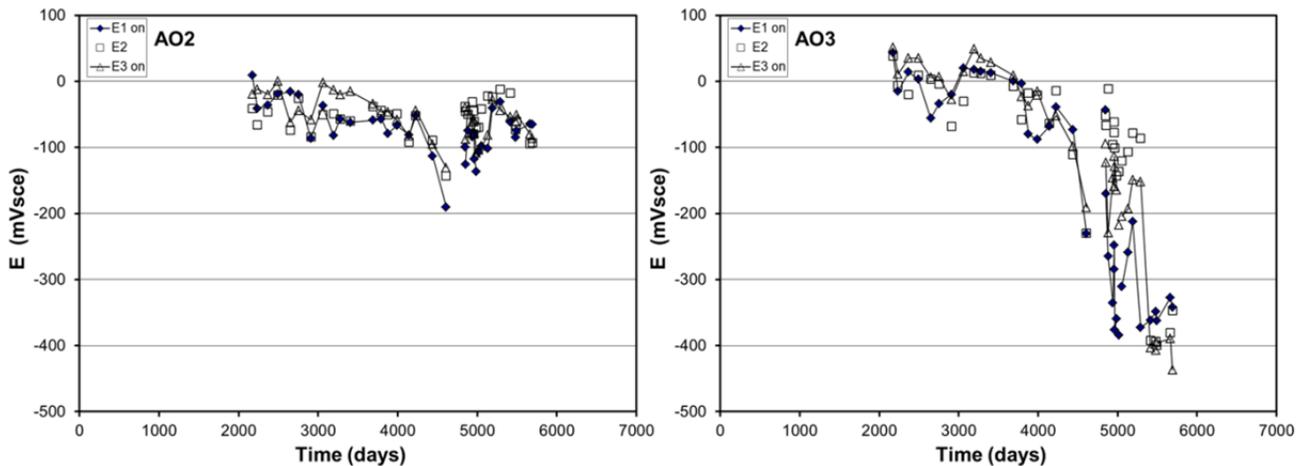
Figure 2.2: Typical potential evolution on AO specimens (1.9 cm cover)

Figure 2.2 to Figure 2.7 show measured potential vs. time plots. Each plot has 3 series. ‘E1 on’ and ‘E3 on’ correspond to the measured potential of the coupled rebars on the left and on the right on each specimen, respectively. E2 corresponds to the measured potential on the center rebar. Figure 2.2 shows the potential evolution on specimens AO2 and AO3. Both of these specimens were terminated around day 5700. It can be observed that corrosion initiated on the three rebars on specimen AO3. But based on the terminal potential values, none of the rebars on specimen AO2 appear active. However, at around day 4500, there was a momentary potential drop; the potential of all rebars recovered (shifted to more positive potential values) soon after this event. Upon opening specimen AO2, the three rebars showed some red rust spots (rather than black/ dark green corrosion products). For AO specimen with 1.9 cm concrete cover, seven out of 12 rebars became active of those terminated, and 1 of 3 rebars from the non-terminated specimen appear active. Figure 2.3 shows the potential evolution on specimen AO5, which is one of the specimens with a cover of 3.2-cm; the other two specimens show similar behavior. A potential transient has been taking place over the last 2000 days, and excursions to values more negative than -100 mVsce have been observed. No rebar has become active on AO specimens with 3.2 cm concrete cover. The appendix corresponding to this chapter contains additional potential vs. time plots for all specimens.

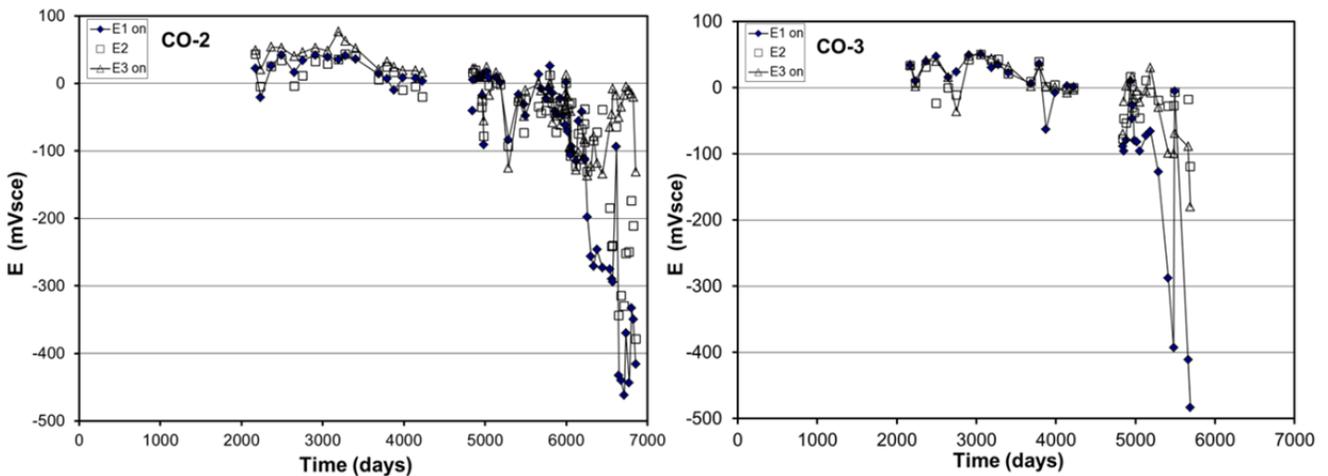
Figure 2.4: Typical potential evolution on CO specimens. (1.8 cm Cover)

Figure 2.4 shows the potential evolution on specimens CO-2 and CO-3 from the CO group. In CO-3, ‘E1 on’, i.e., the potential of the left-coupled rebars reached ~ -500 mVsce. The other two (‘E2’ and ‘E3 on’) showed a more modest potential drop, ‘E3 on’ approached -200 mVsce, whereas E2 reached a value of -110 mVsce. CO-3 specimen was terminated and all rebars showed corrosion spots. All CO specimens have 1.9 cm cover. With respect to rebars in specimen CO-2, two rebars (E2 and ‘E3-on’) have become active, but specimen CO-2 has not been terminated. One other CO specimen was terminated but no rebars were active, and the fourth specimen has not been terminated and none of the rebars have experienced the potential decay.

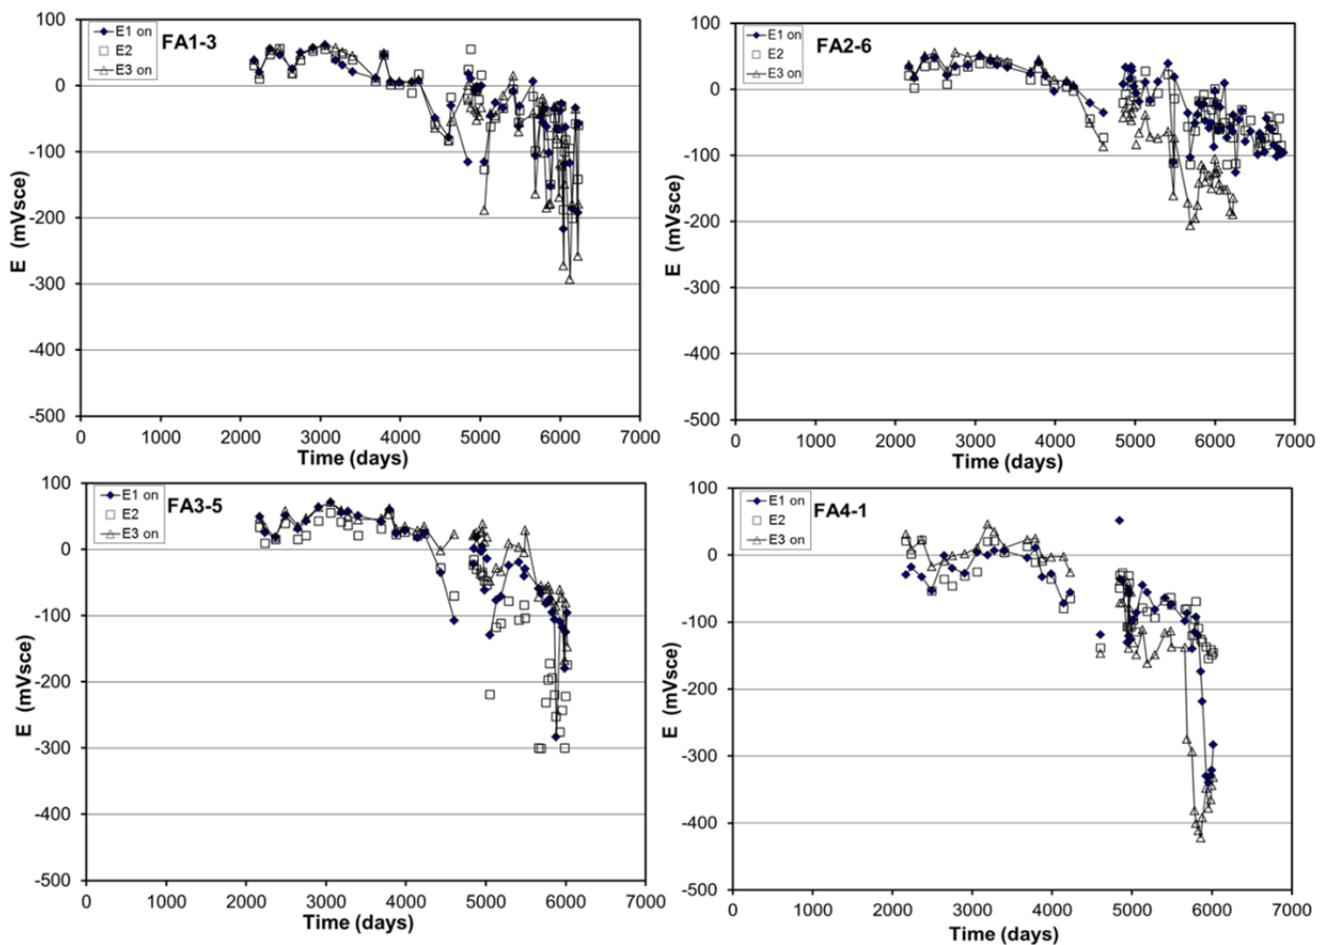
Figure 2.5: Typical potential evolution on specimens with FA and 1.9 cm cover

rebars on FA2-6 (right rebar section terminated ~ day 6250) had initiated corrosion based on the measured potential. The potential of all rebars from specimen FA3-5 had shifted to more negative values, indicating that corrosion likely initiated. On FA4-1, all rebars also experience a negative potential shift. Moreover, the left and right rebar pairs monotonically decayed to values more negative than -300 mVsce. No significant potential shift was observed on specimens with 3.2 cm cover for groups FA1 (e.g. FA1-5) and FA2 (e.g. FA2-6). Using the potential criteria, several rebars from the FA3 group have become active, three out of nine rebars with 3.2 cm concrete cover (e.g., FA3-1 in Figure 2.6) and eight out of twelve rebars with 1.9 cm concrete cover. Similarly, seven out of nine rebars prepared with FA4 mix have become active. For the FA4 group no specimen was prepared with 3.2 concrete cover.

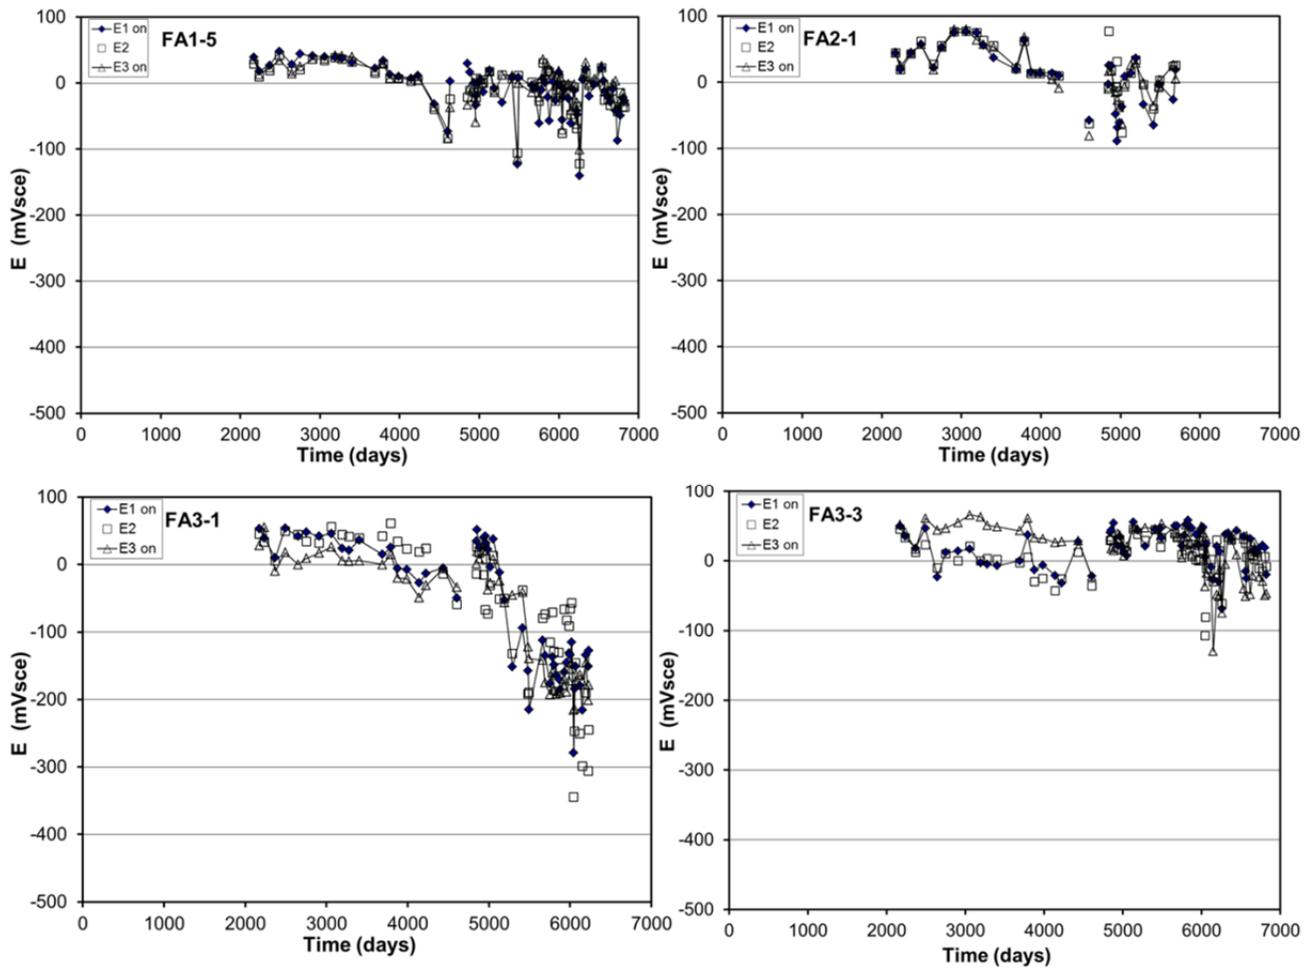
Figure 2.6: Typical potential evolution on specimens with FA and 3.2 cm cover

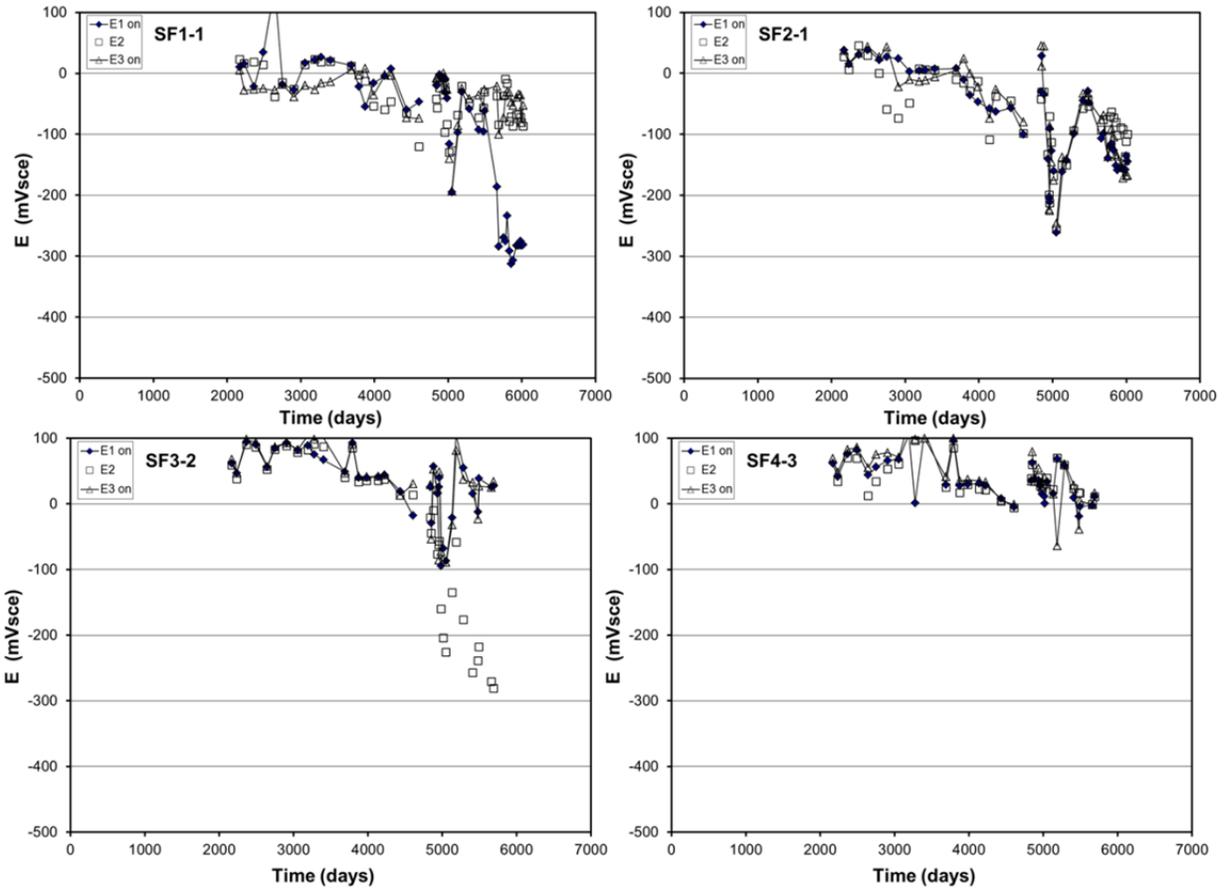
Figure 2.7: Typical potential evolution on specimens with SF

Figure 2.7 shows the potential evolution on selected SF specimens (one per concrete mix). Four rebars out of nine became active from the SF1 specimens by day 7000. Six rebars out of nine became active by day 7000 for the specimens of group SF2, three are from a specimens not yet terminated. The non-corroding rebars correspond to a specimen that was terminated on day 5700. Although the last set of potential values measured on specimen SF2-1 ranged between -150 and -180 mVsce, the top rebars on the left and right side showed black/dark green rust spots upon visual inspection. One out of nine rebars on SF3 specimens and no rebar from those in the SF4 group have become active based on potential transients. All specimens for SF1, SF2, SF3 and SF4 have a concrete cover of 1.9 cm.

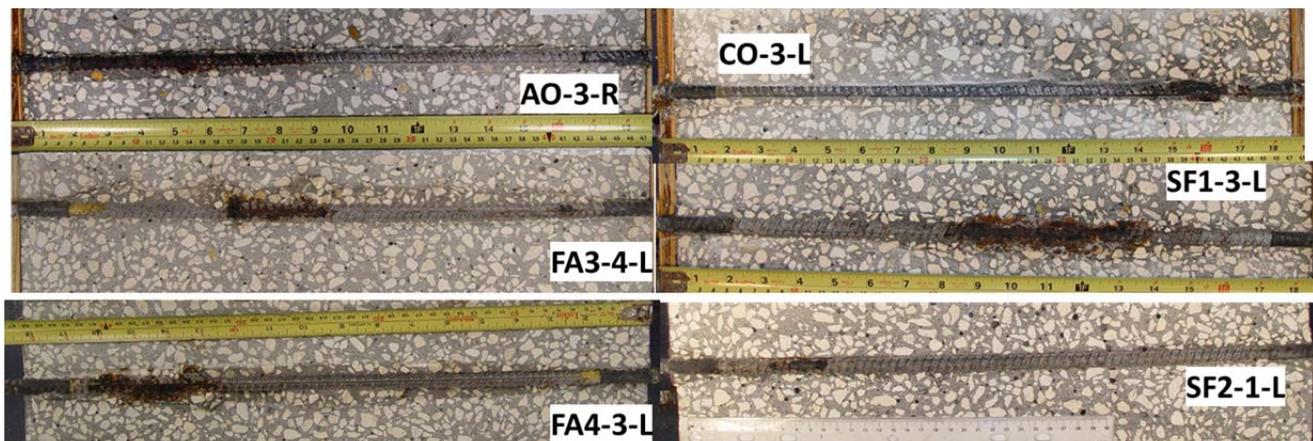
Figure 2.8: Example of terminated rebars undergoing corrosion

All rebars from the terminated samples were subjected to visual inspection. Figure 2.8 show typical photos for four instances in which corrosion was actively taking place. The pictures correspond to rebars from samples AO-3, CO-3, FA3-4, FA4-3, SF1-3 and SF2-1 and showcase worst case scenarios (i.e. some of the larger corrosion spots). Only one of the terminated specimens suffered from delamination AO3. The Appendix corresponding to this chapter contains photographs for all terminated specimens grouped per specimen mix composition. In some cases either no corrosion was found or only red-rust, and in others dark gray spots (but not similar to those associated with on-going corrosion).

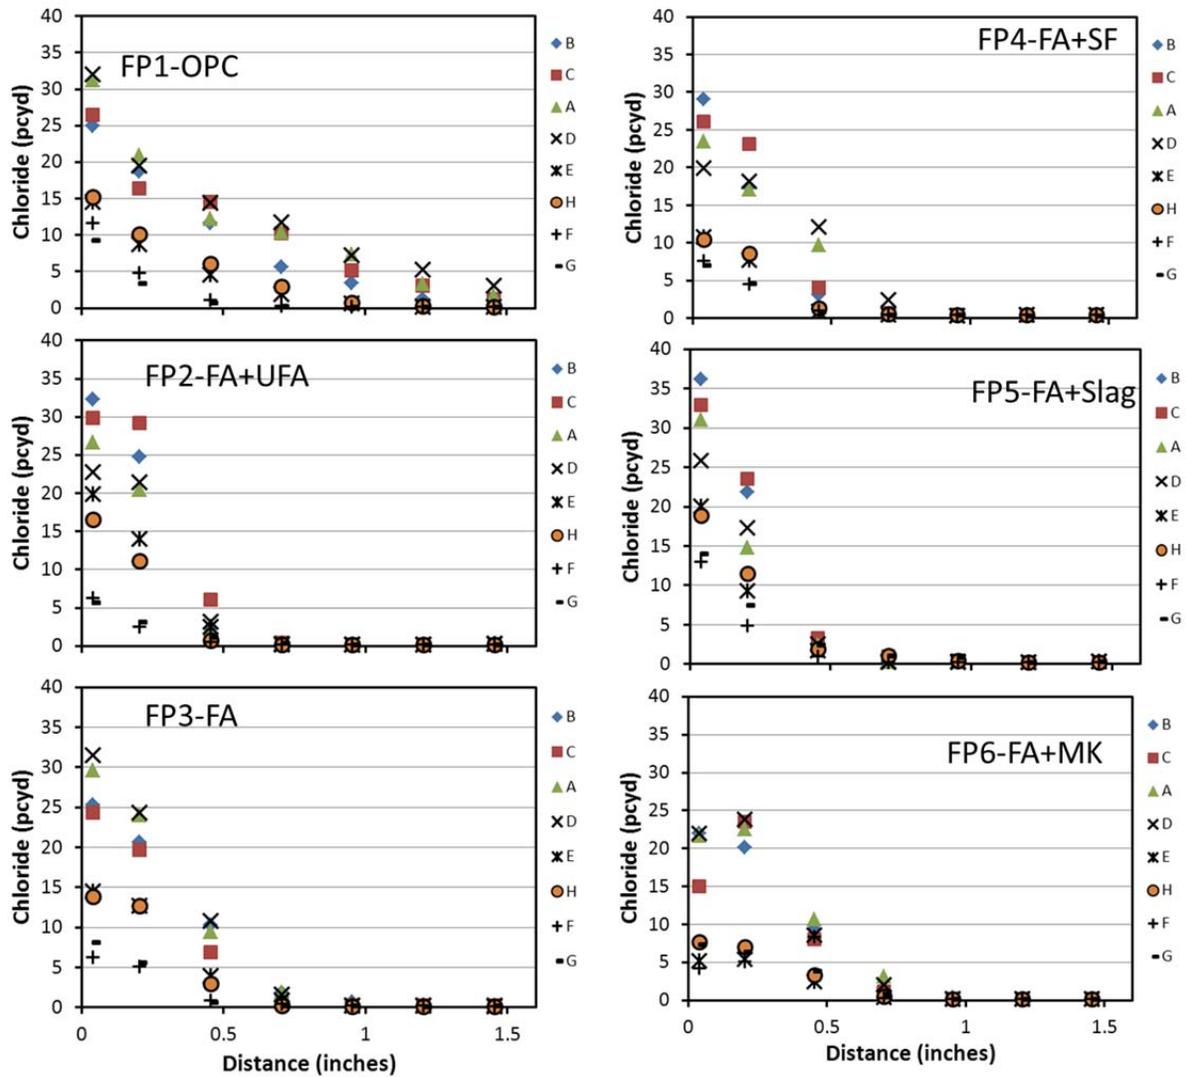
Figure 3.2: Chloride profiles obtained after 5 years of exposure (cores)

(about 2 lb/cyd) and larger for the mix with FA+UFA (close to 10 lb/cyd). Skin effect was observed at some elevations on cores from fenders piles with FA+MK and FA+SF.

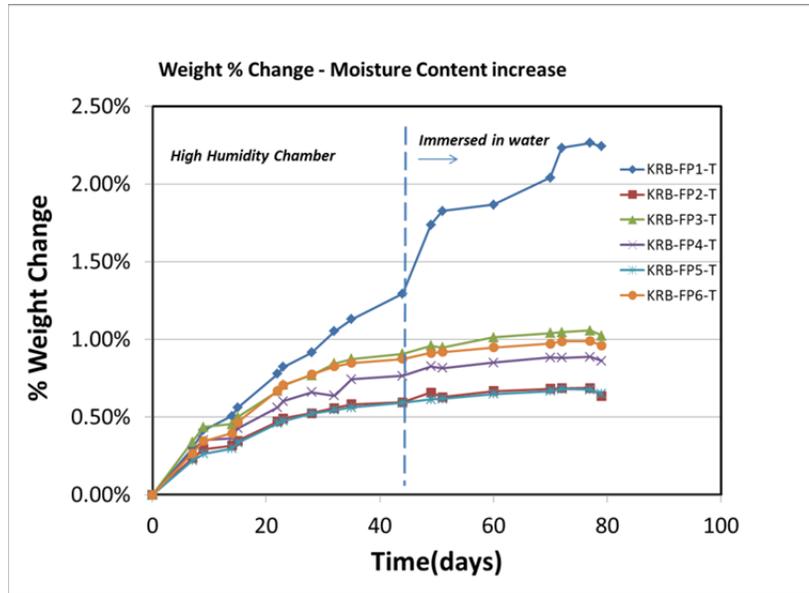
Figure 3.4: Moisture vs. time

After the specimens were placed in the oven at 50°C, the specimens were then placed in a high humidity environment for 44 days and then immersed in water. Figure 3.4 shows how the weight percent change, i.e, how the moisture increased with respect to the dry weight. Figure 3.5 shows how the resistivity evolved with time during this same period of time. Figure 3.66 shows the measured resistivity vs. wt% change for the data shown in Figure 3.4 and Figure 3.55. It is evident that the lower resistivity and larger wt% change was observed for the OPC specimen.

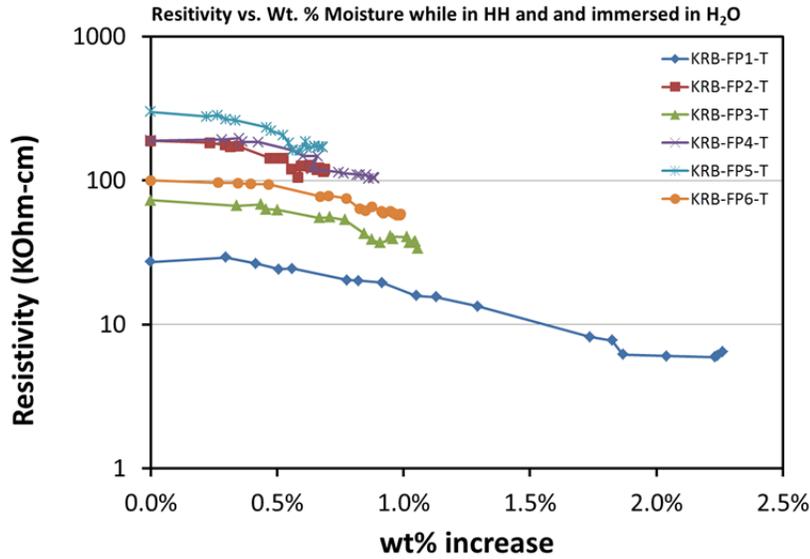
Figure 3.6: Resistivity vs. wt% change (FP1-OPC, FP2-FA+UFA, FP3-FA, FP4-FA+SF, FP5-FA+BFS,FP6-FA+MK)

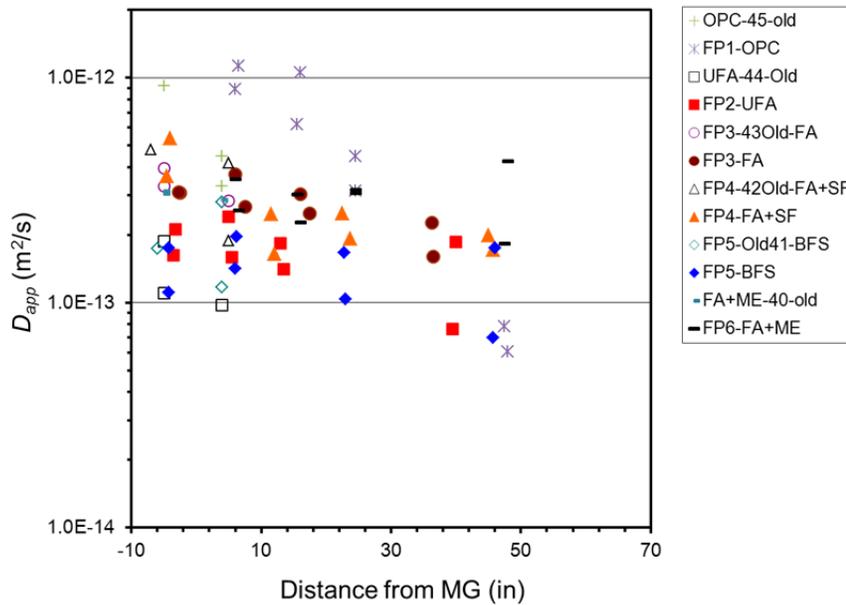
Figure 3.9: D_{app} vs. elevation

Figure 3.9 shows the D_{app} calculated values vs. elevation. These elevations reflect the elevations at which the cores were obtained. D_{app} values are shown for both the currently reported visit and from a previous visit. The values obtained at higher elevations appear to suggest lower D_{app} values at these locations. However, at these higher elevations the moisture content is likely lower. Moreover, the chloride at the surface was lower for the D_{app} corresponding to the higher elevations.

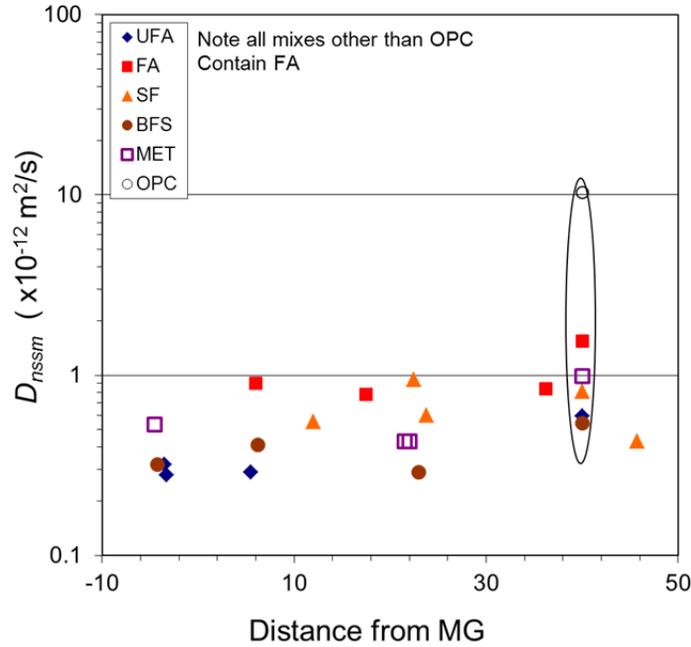
Figure 3.10: D_{nssm} vs. elevation

structure of the OPC mix when compared to the other concrete compositions (as suggested by the resistivity values). With time the pore interconnectivity and pore percentage likely is lower on those concrete with FA as the pozzolanic reaction progresses. Additionally the observed D_{nssm} values were in general somewhat larger than the D_{app} measured on the corresponding cores, but differed by less than a factor of two. Moreover, for most compositions the values were lower than $1 \times 10^{-12} \text{ m}^2/\text{s}$ for both D_{app} and D_{nssm} , indicating low to extremely low permeability concrete.

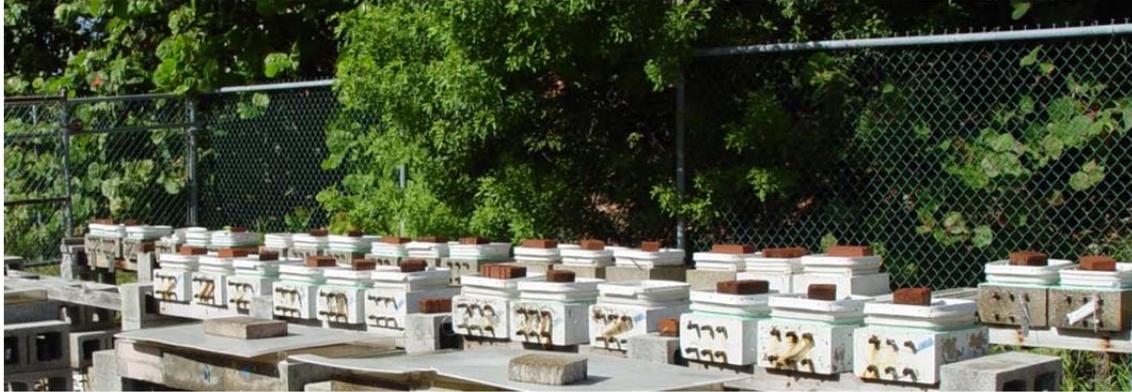
Figure 4.6: Photograph of SDS specimens under exposure in the outdoor test yard

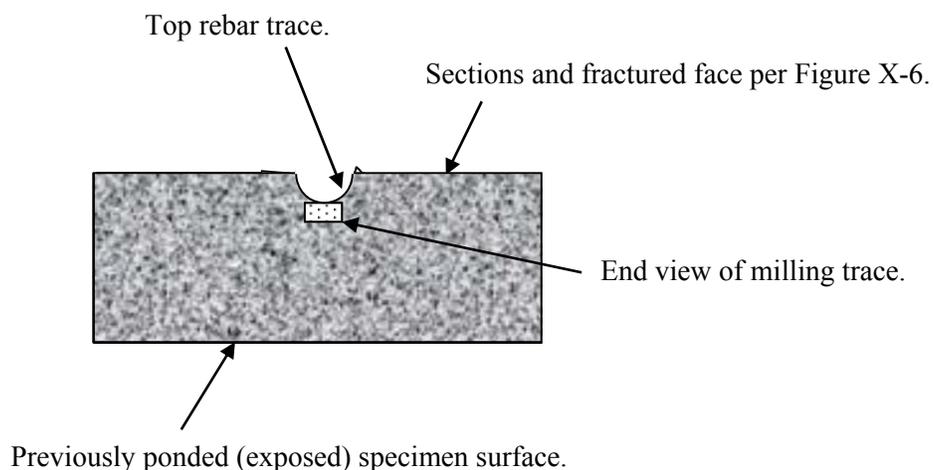
Figure 4.8: Schematic illustration of the of the milling process above the rebar trace

Concrete samples for $[Cl^-]$ determinations were acquired from SDS specimens according to two methods. The first method involved acquiring a 35 mm diameter core from the top concrete surface at the mid spacing between two adjacent top layer bars. This was then sliced parallel to the top surface at 6.4 mm intervals and separately grinding the individual slices to powder. The second involved individually mounting the concrete sections from the top portion of each specimen on a mill and milling a cut approximately 0.8 mm deep along that portion of the rebar trace that was void of corrosion products using a 10 mm diameter square end mill. Figure 4.8 **Error! Reference source not found.** illustrates this process schematically. For both methods (coring and milling), the powder samples were analyzed for $[Cl^-]$ using the FDOT wet chemistry method.

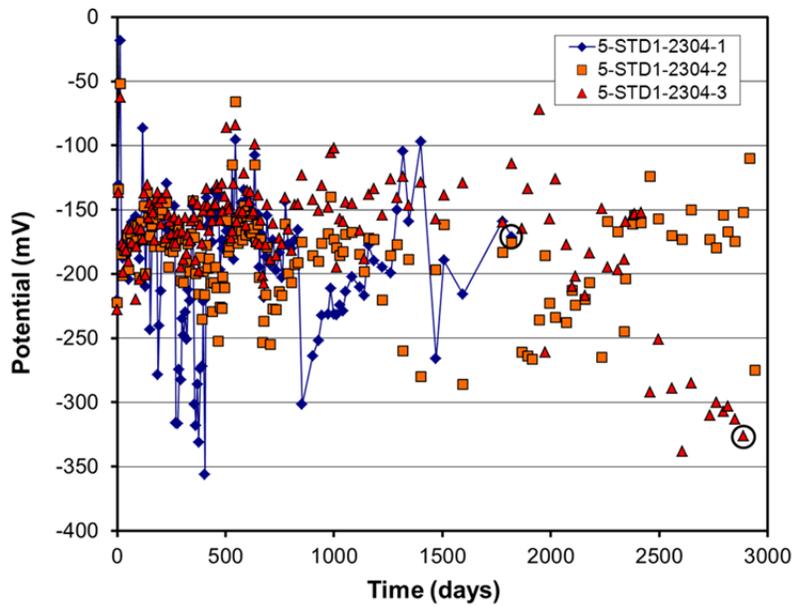
Figure 4.13: Potential evolution on specimens with 2304 rebar in STD1 concrete

shown below): a) Corrosion initiated on two or three top row rebars of one of specimen 5-STD1-2304-1; b) On specimen 5-STD1-2304-3 corrosion initiated, but not on a top row rebar, rather on a rebar on the second row.

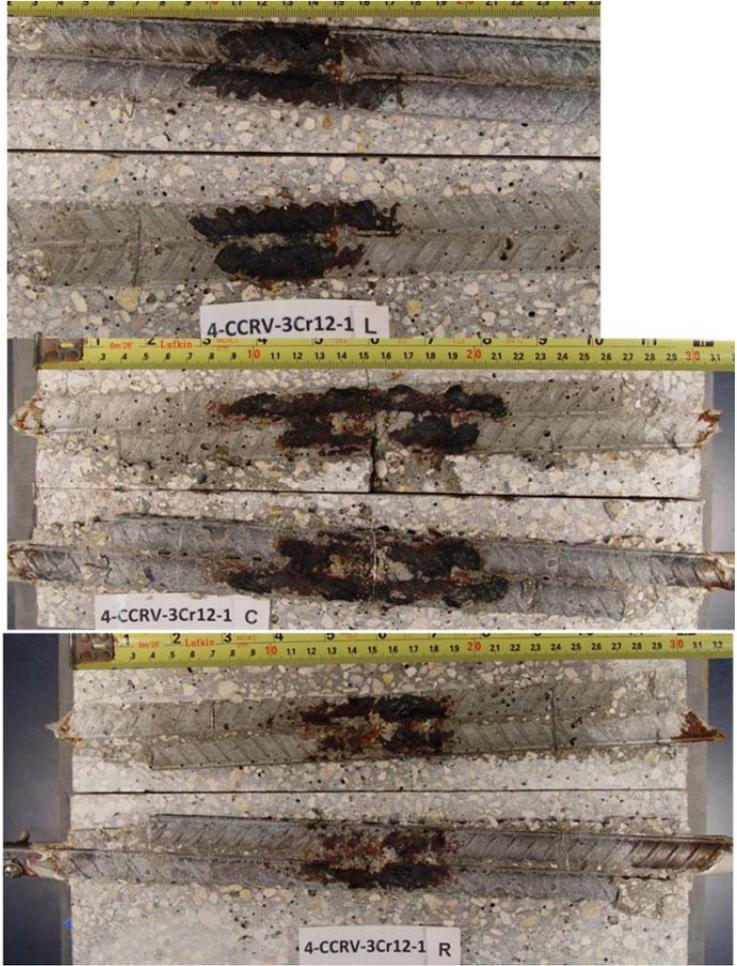
Figure 4.20: Photographs of specimen and top rebar and bar trace of specimen 4-CCR-3Cr12-1 subsequent to dissection

Three specimens of type CCRV were terminated, one with 3Cr12, one with SMI SS clad and the third with 316SS. Recall that CCRV are slabs with a bar splice that formed a crevice (two overlapped rebars) but also with a simulated concrete crack. Figure 4.20 to Figure 4.26 show the surface condition upon exposure. Only the specimen with 3CR2 showed significant buildup of corrosion products. The picture on the left shows that a crack has appeared above the left rebar by the time the specimen was terminated. Below in another section; pictures are shown of the top surface for the other two specimens with 3Cr12. The specimens with SMI and 316 showed no corrosion, rather a pristine surface condition was observed for both. CCRV terminated specimens with SMI and 3Cr12 rebars had been exposed to NaCl cycles for 1900 days and CCRV-316 for 2500 days.

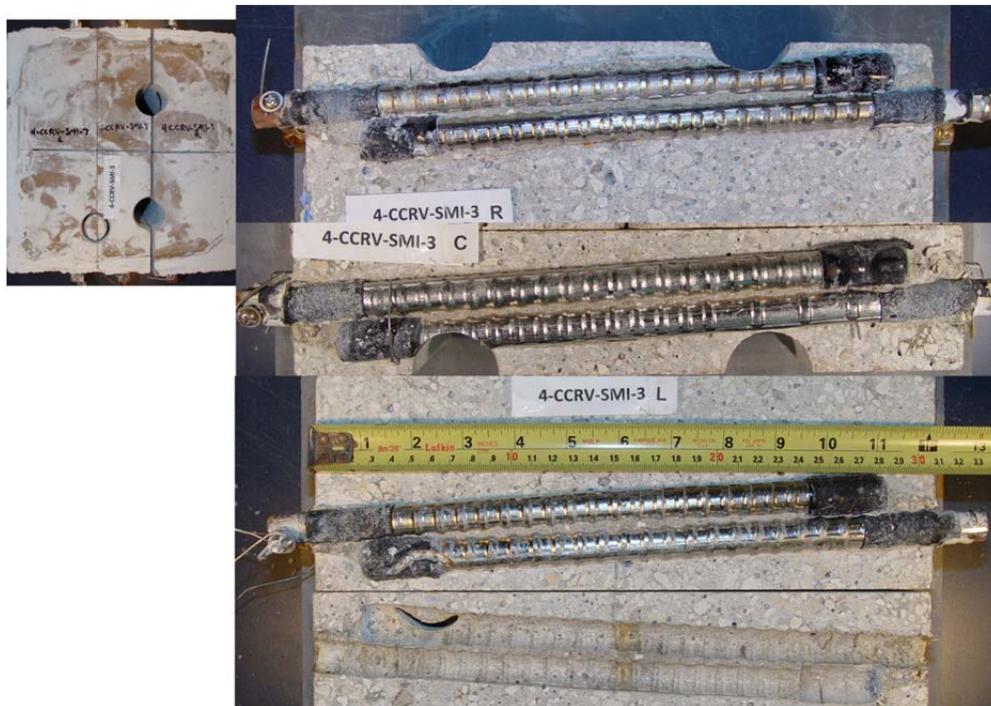
Figure 4.22: Photographs of specimen and top rebars and bar trace of specimen 4-CCR-SMI-3 subsequent to dissection

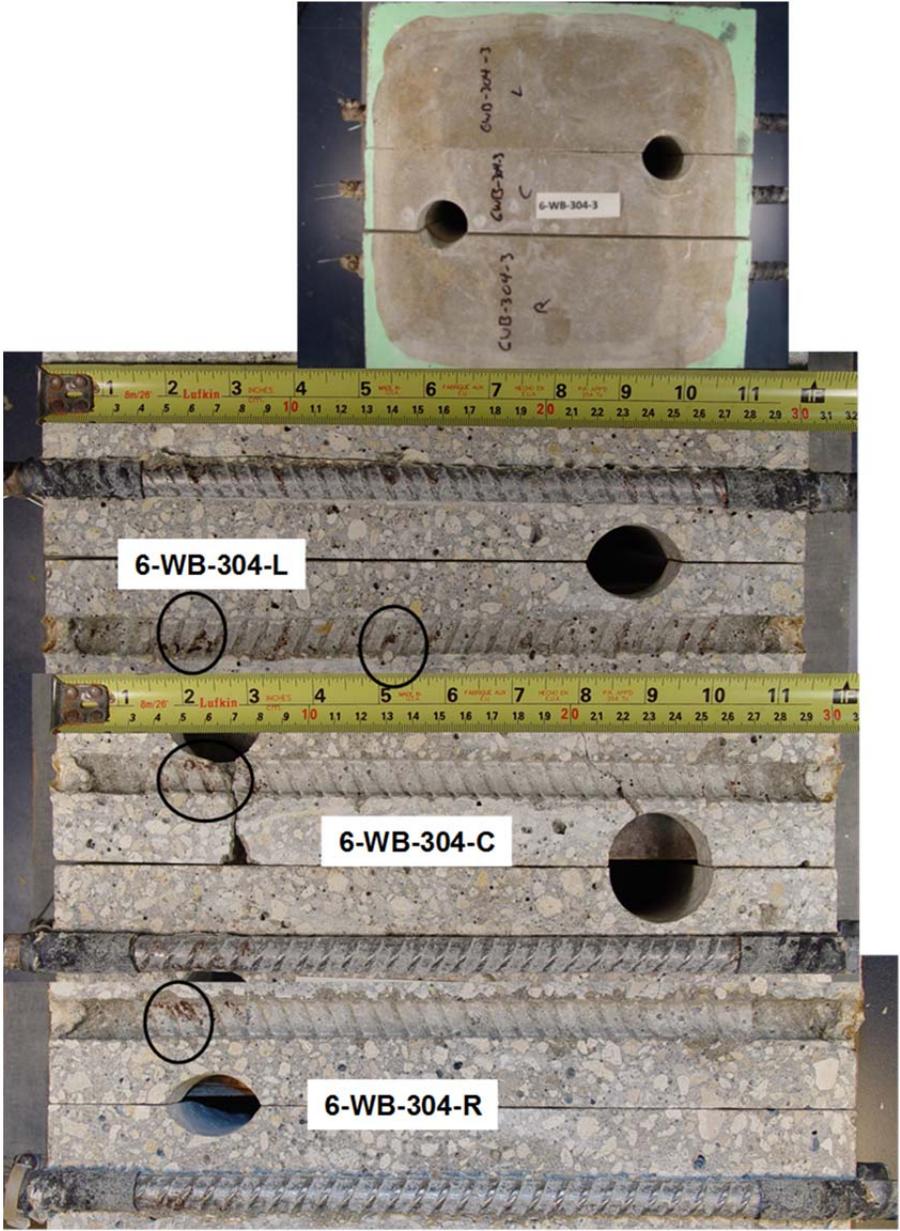
Figure 4.23: Photographs of top rebars and bar trace of specimen 6-WB-304-1 subsequent to dissection

Two specimens of type WB were terminated, one contained 304 rebars and the other 316 rebars. Figure 4.23 shows photographs after cutting and subsequent to the dissection that took place for 6-WB-304-3. This specimen had been exposed outdoors to NaCl solution cycles for ~1300 days by the type the specimen was terminated. All three rebars show small corrosion spots, most of the spots were superficial and the corrosion products had turned red by the time the specimens were opened.

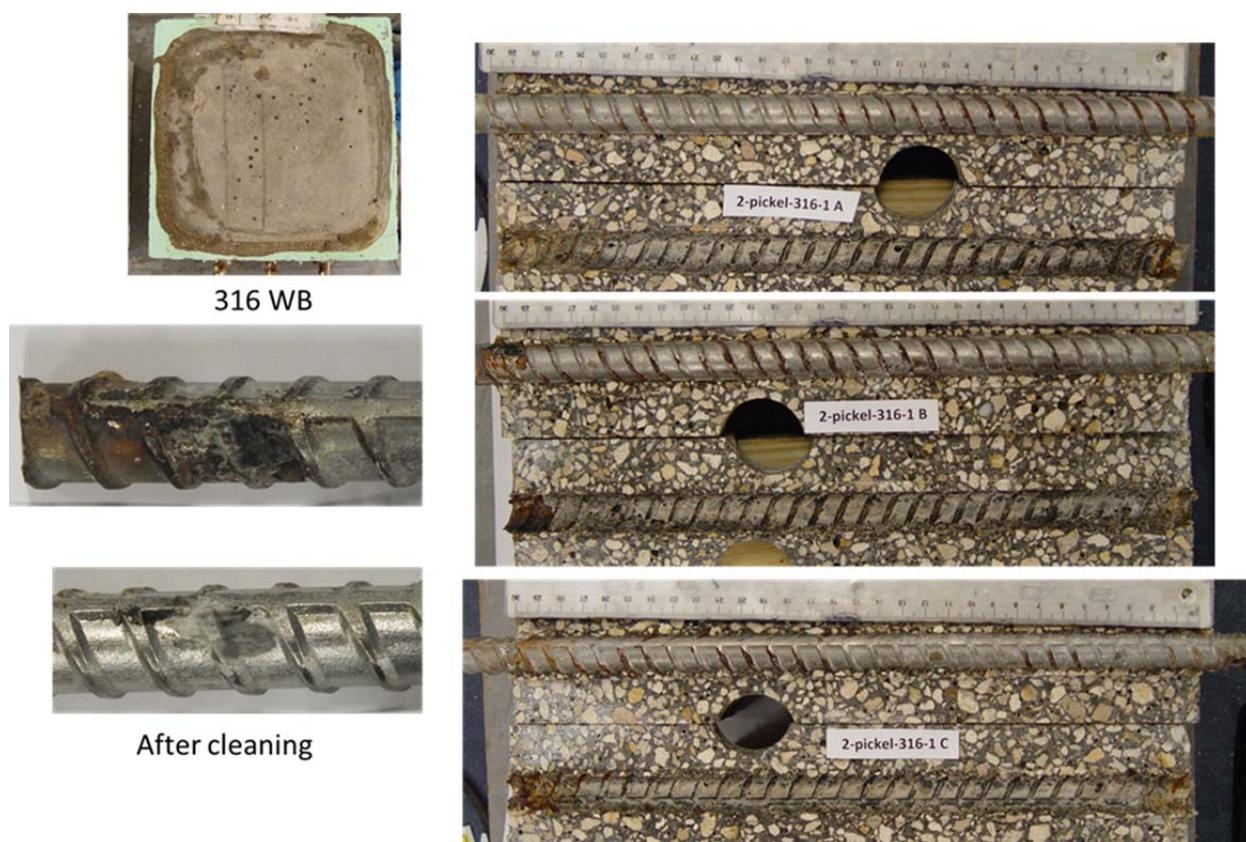
Figure 4.24: Photographs of top rebars and bar trace of specimen 2-WB-316-1 subsequent to dissection. The figure also shows close-ups of the larger corrosion spot before and after cleaning it

Figure 4.24 shows photographs after cutting and subsequent to the dissection that took place for 2-WB-316-1. This specimen had been exposed outdoors to NaCl solution cycles for 3600 days by the time the specimen was terminated. All three rebars show corrosion, however the corrosion spots were found along the ribs of the rebars. With rebar A (left) and B (center) rebar having a greater coverage compared to rebar C (right rebar). Similar to what was discussed for WB-304 specimen, the corrosion products had turned red by the time the specimens were open. Rebar B (center) also had a large corrosion spot close to edge and it is believed that a differential aeration cell (easier access to oxygen) might have contributed for more aggressive corrosion at this site. For this spot, the corrosion products were black/dark green and were easy to observe on the rebar trace. Upon removing the rebar, dark corrosion products were visible at the rebar surface. On the left column are close-ups before cleaning and after cleaning. In this case the corrosion had penetrated a couple of millimeters.

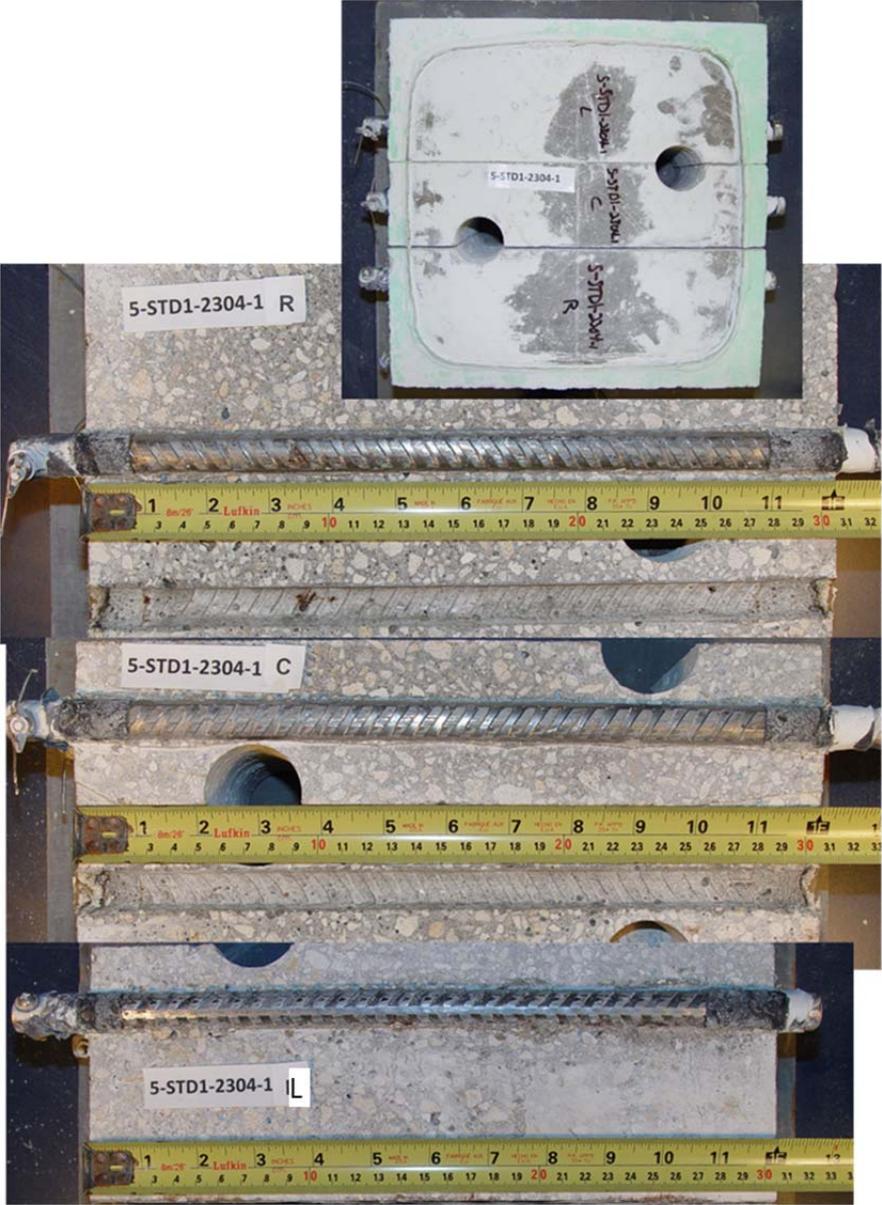
Figure 4.25: Photographs of top rebars and bar trace of specimen 5-STD1-2304-1 subsequent to dissection

dissection on 5-STD1-2304-3, no corrosion spots were observed on the top row rebar as can be observe on Figure 4.25. However, one of the bottom row rebar shows a large corrosion spot close to the edge. No corrosion was observed underneath the shrinkage wrap. It is believed that a differential aeration was present at this location. By day 2900 the chloride concentration was as high or higher at the bottom rebar level than was observed at the top rebar depths at day 1700. It is not clear why corrosion initiated at this rebar and not at one of the rebars on the top layer.

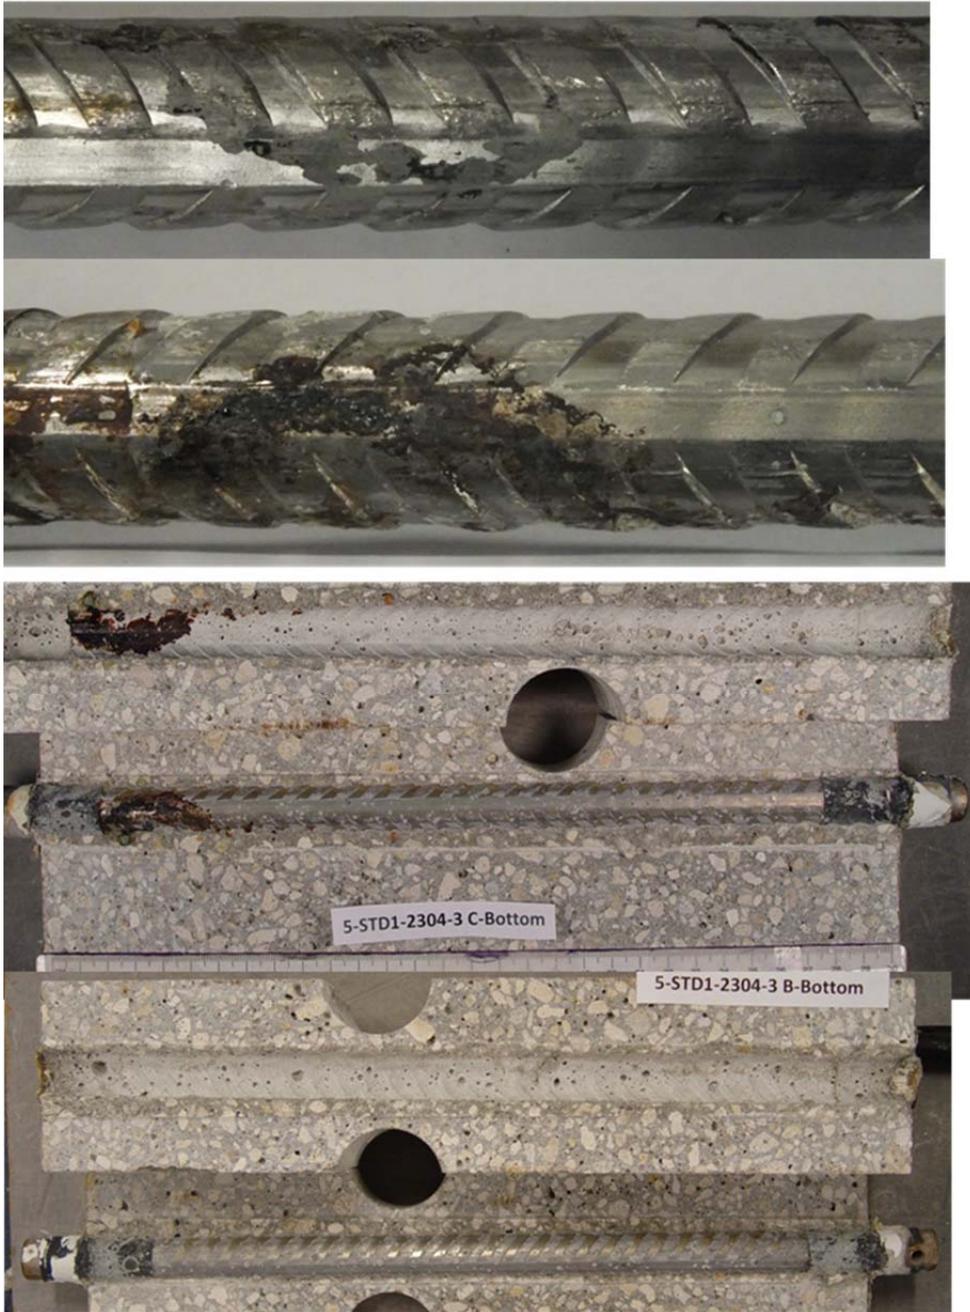
Figure 4.27: Photographs of two bottom rebars and bar trace of specimen 5-STD1-2304-3 subsequent to dissection. Close-up or large corrosion site before and after cleaning is also included

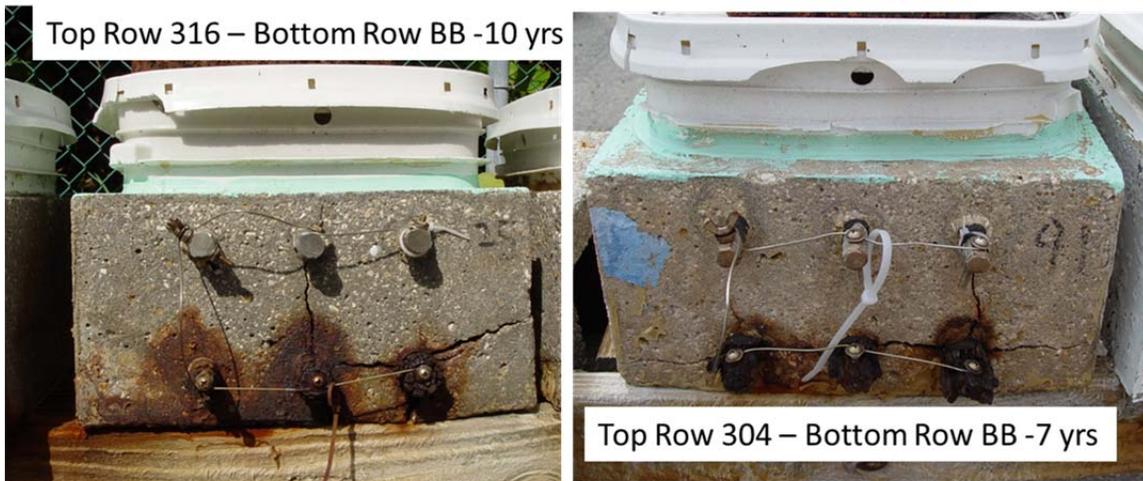
Figure 4.28: Current state for specimens 2-BCAT-316-2 and 6-BCAT-304-1

Specimens of type BCAT are shown in Figure 4.28. It is evident that the corrosion of the BB rebars on the bottom layer have progressed to such extent that crack have reached the top layer rebars on both shown specimens. The condition is worst for the specimen with 316, as it has been exposed for 10 years compared to 7 years of exposure for the specimen with 304 rebars. These photographs are a reminder that when the design of a structure calls for a high performance corrosion resistant alloy (e.g. 316 or 304 or comparable) on the outer layer only and BB on the interior layers, the concrete used in structure should still be of good enough quality to prevent corrosion of the BB on the inner layers.

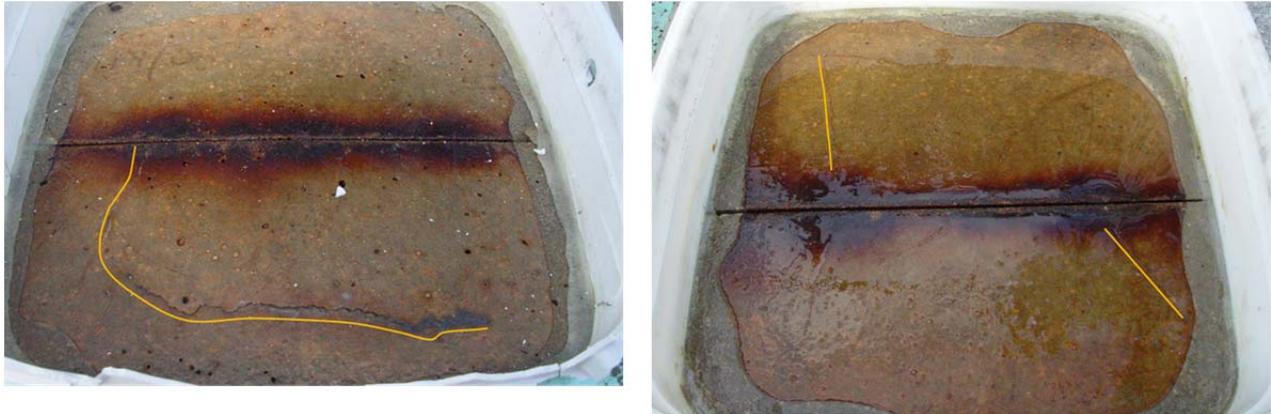
Figure 4.29: Pictures of the surface cracks on 3-CCR-3Cr12 specimens

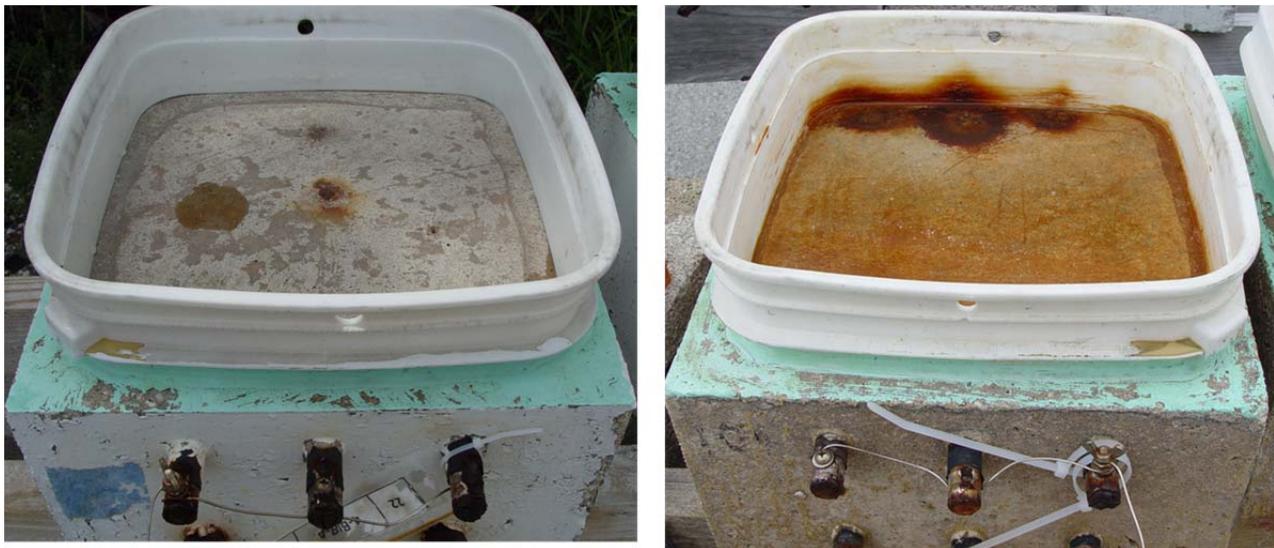
Figure 4.30: Pictures of the corrosion spots on the surface of 4-BCCD-SMI (left) and 6-CVNC-SMI-3 (right)

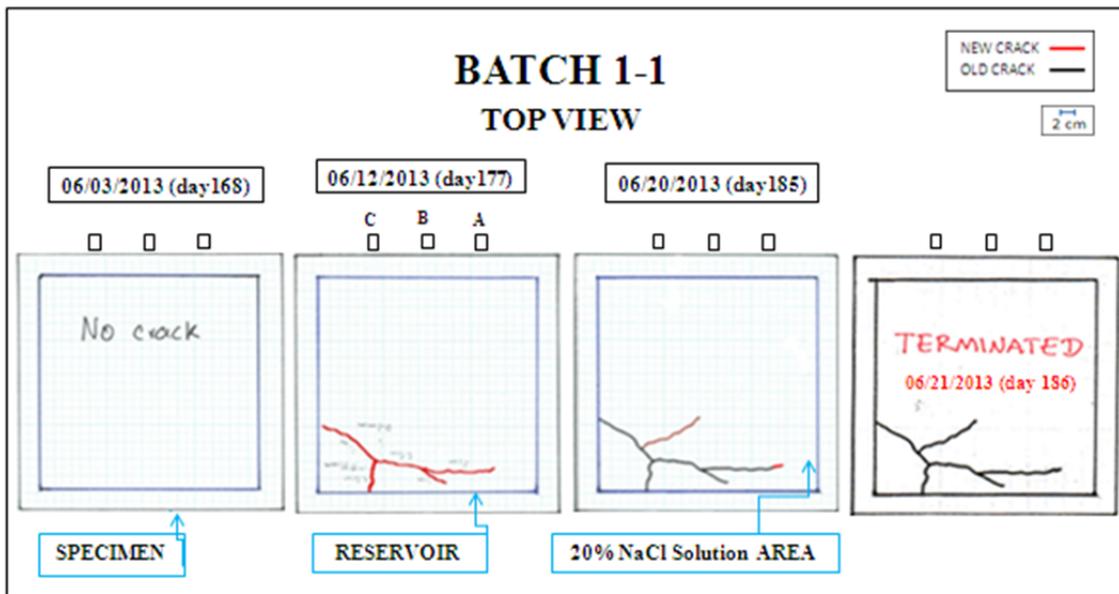
Figure 5.7: Diagram of the crack evolution over time for specimen batch 1-1
