Final Report

**Analysis and Estimation of Service Life of Corrosion Prevention Materials Using Diffusion,
Resistivity and Accelerated Curing for New Bridge Structures -
Volume 1: Corrosion Prevention Materials (Monitoring and Forensic Examination)
(BDK79-977-02)**

**Florida Department of Transportation Research Center
605 Suwannee Street
Tallahassee, Florida 32399**

December 2013

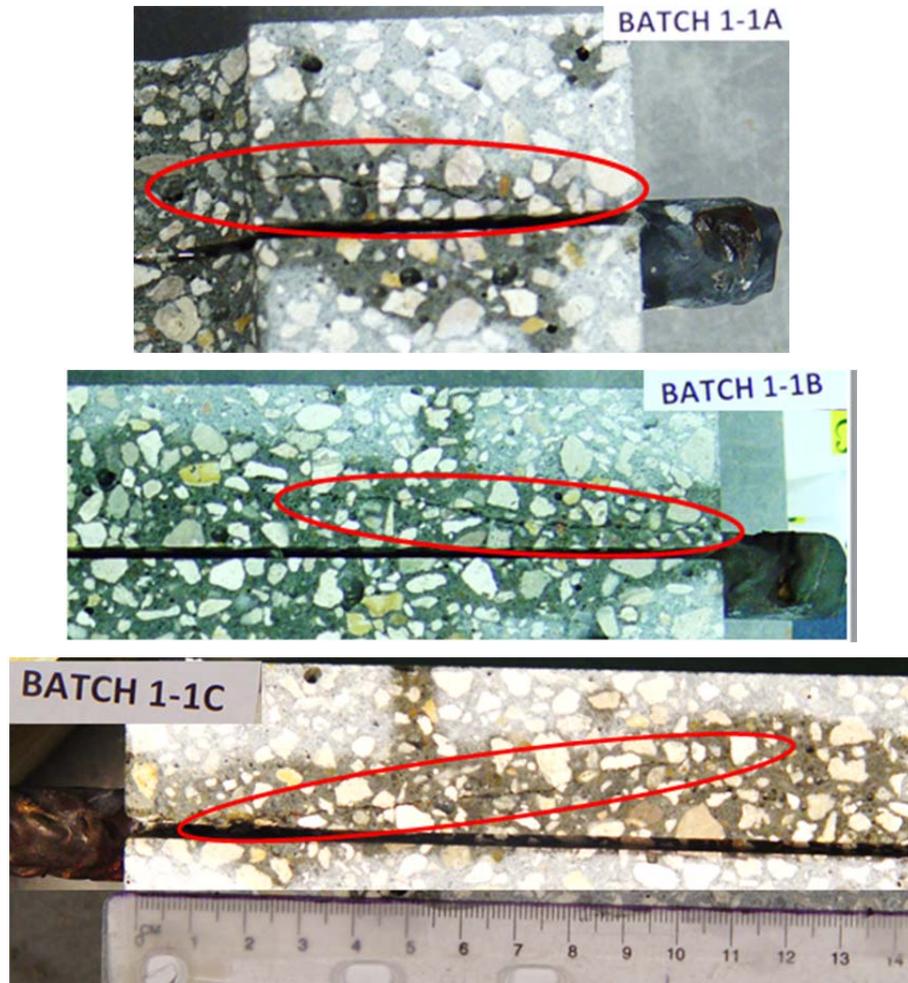
Figure 5.8: Lateral cracks pictures for specimen Batch 1-1

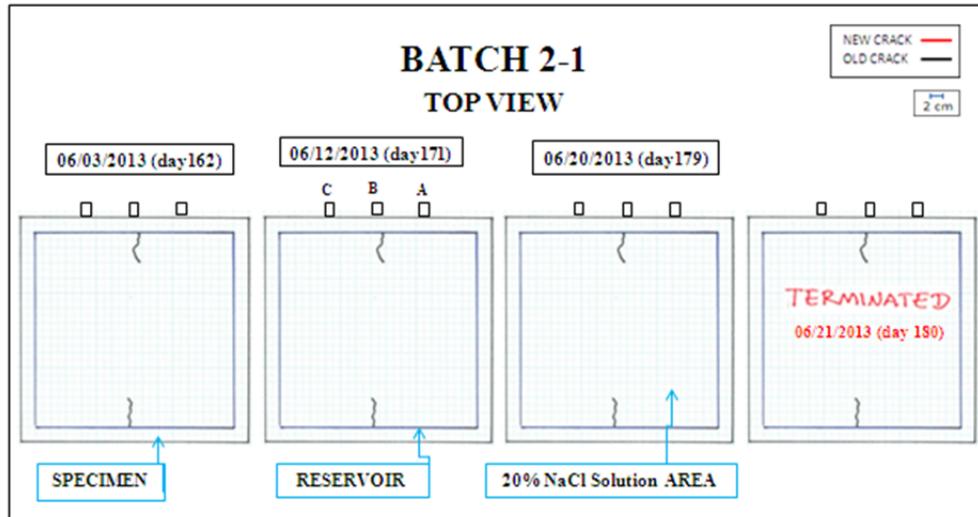
Figure 5.9: Diagram of the crack evolution over time for specimen batch 2-1

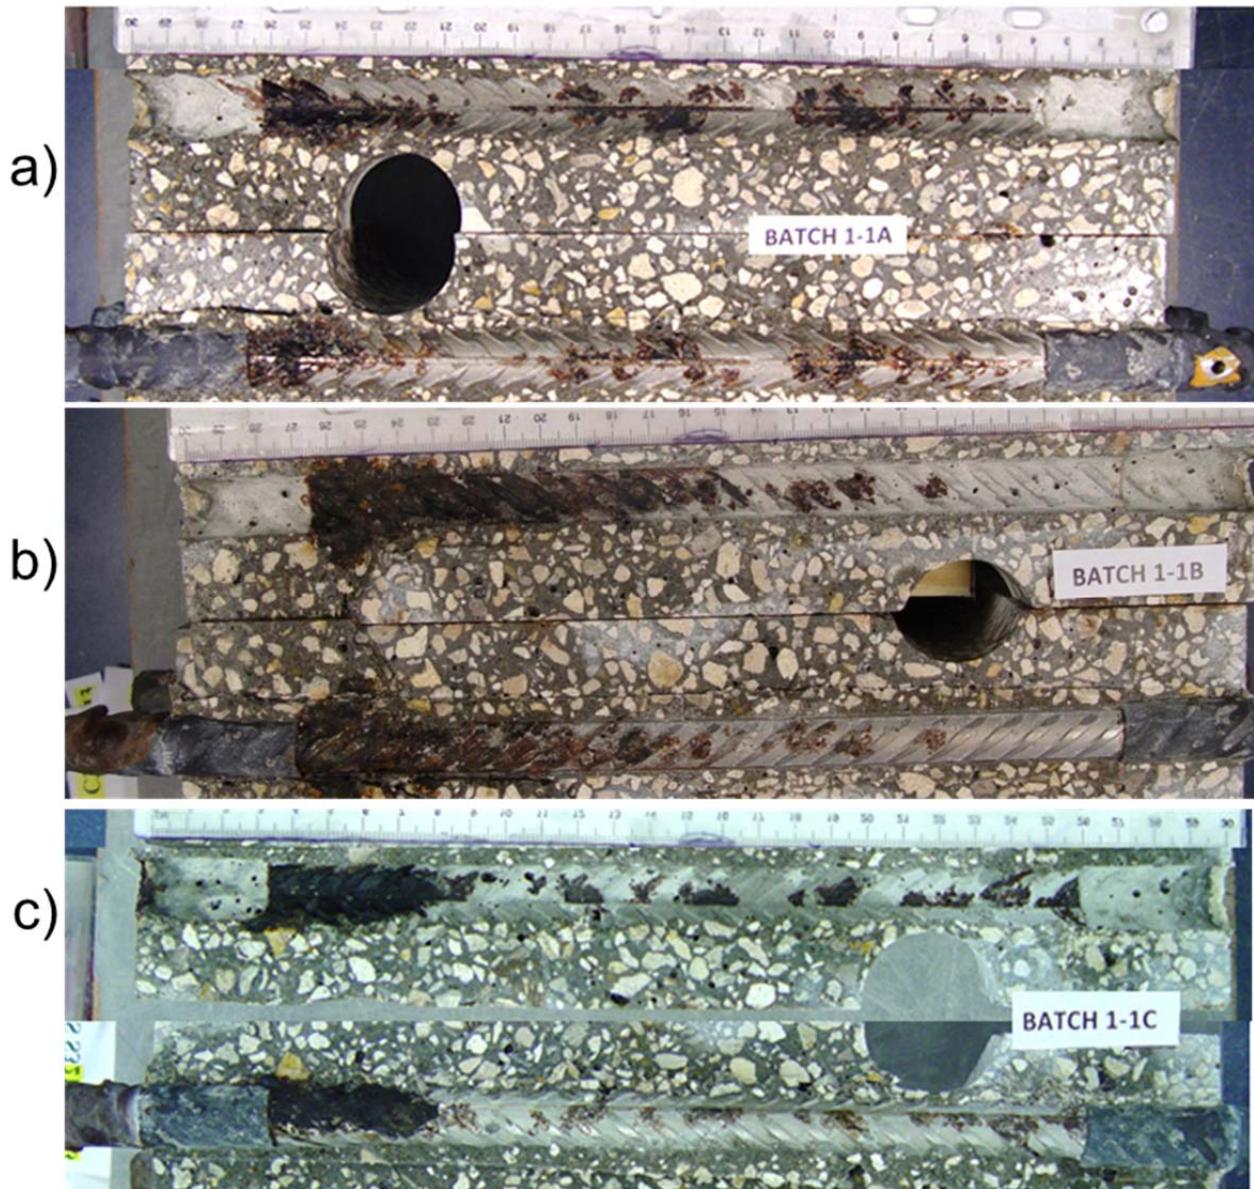
Figure 5.12: Autopsy and visual examination of rebars of specimen batch 1-1

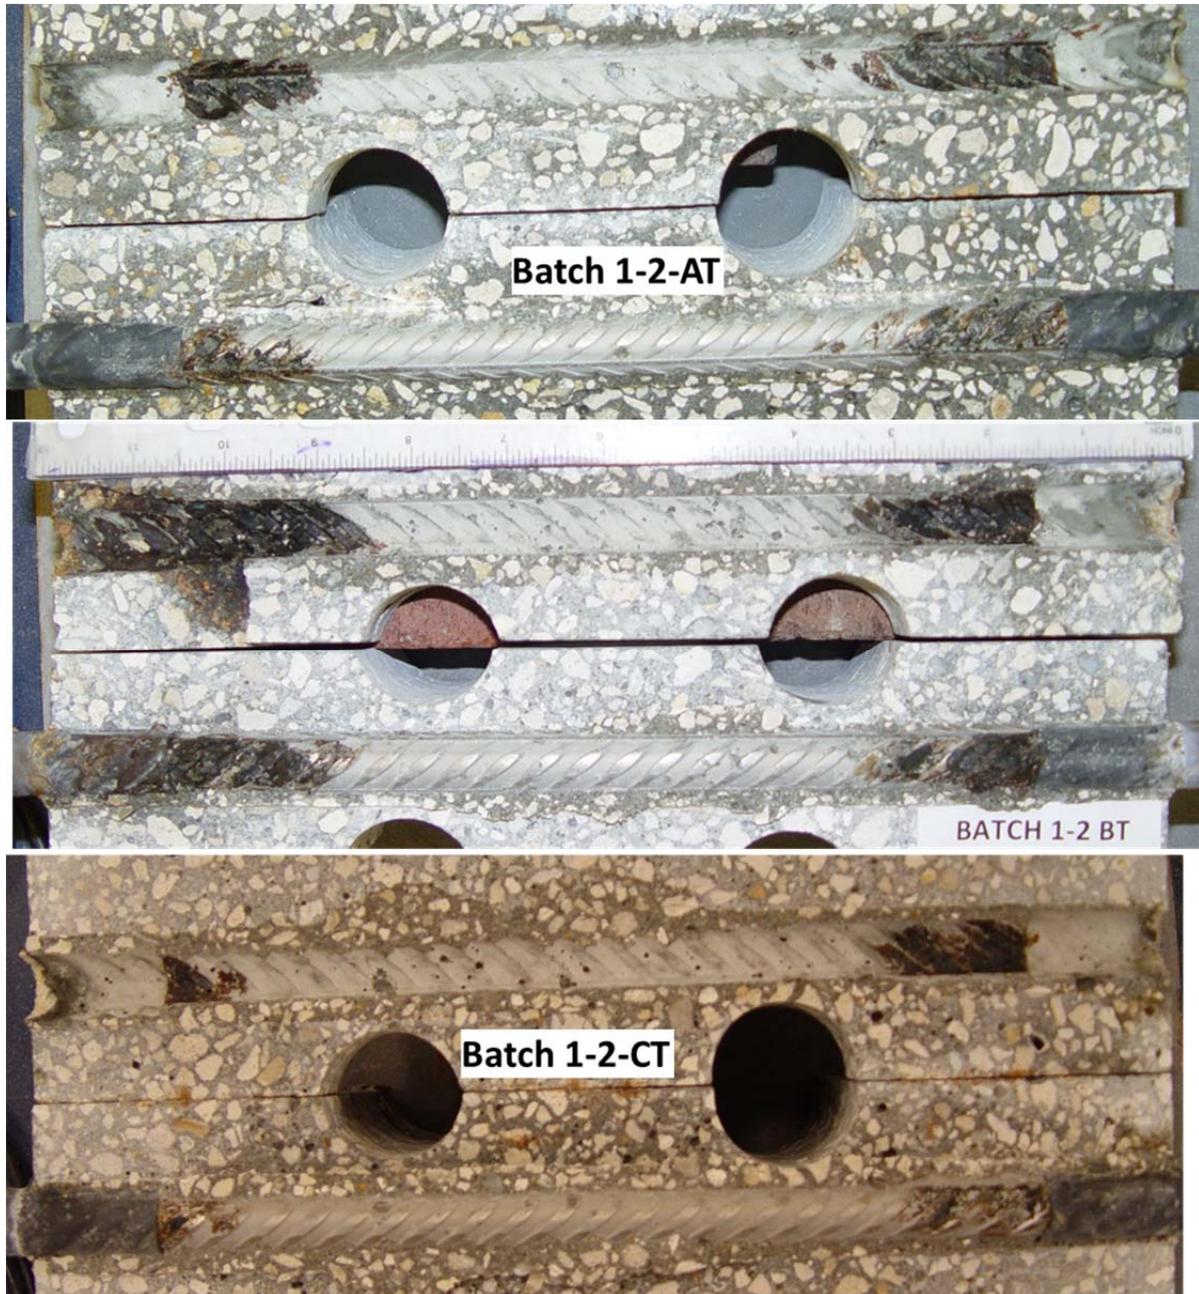
Figure 5.13: Autopsy and visual examination of rebars of specimen batch 1-2

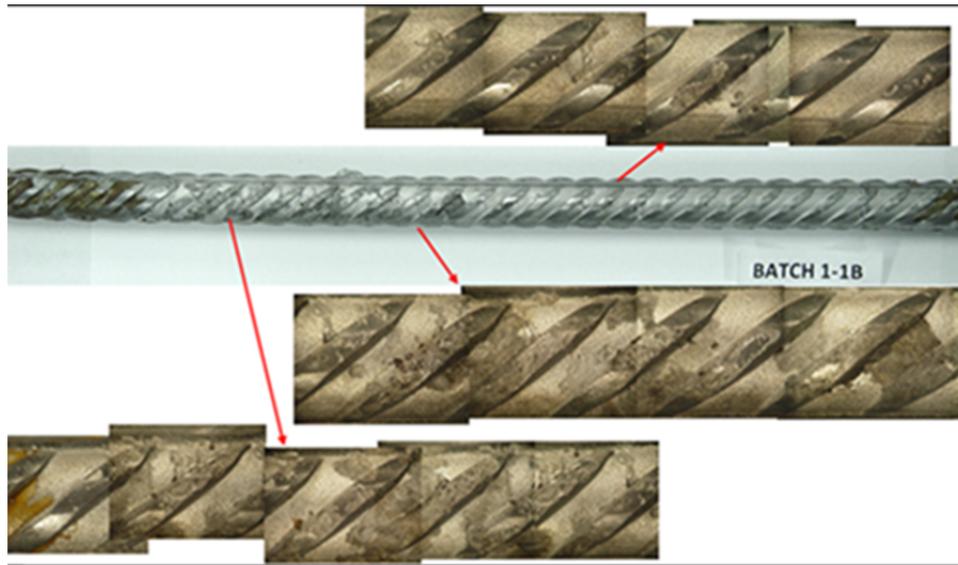
Figure 5.15: Close-up picture of sample batch 1-1B rebar before and after cleaning

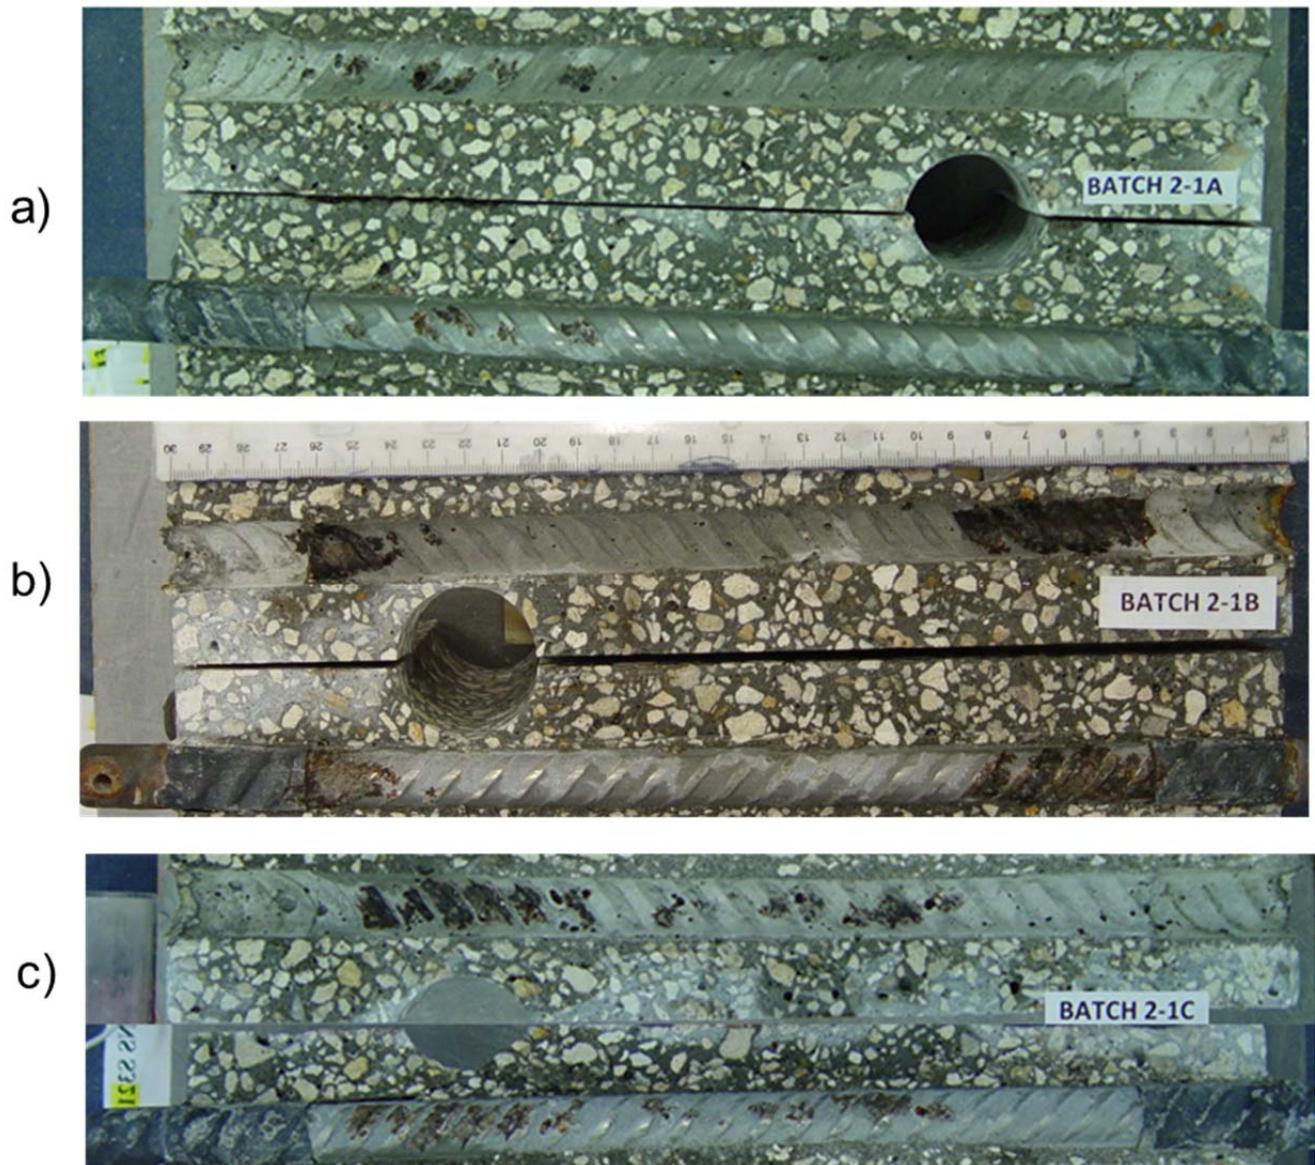
Figure 5.16: Autopsy and visual examination of batch 2-1

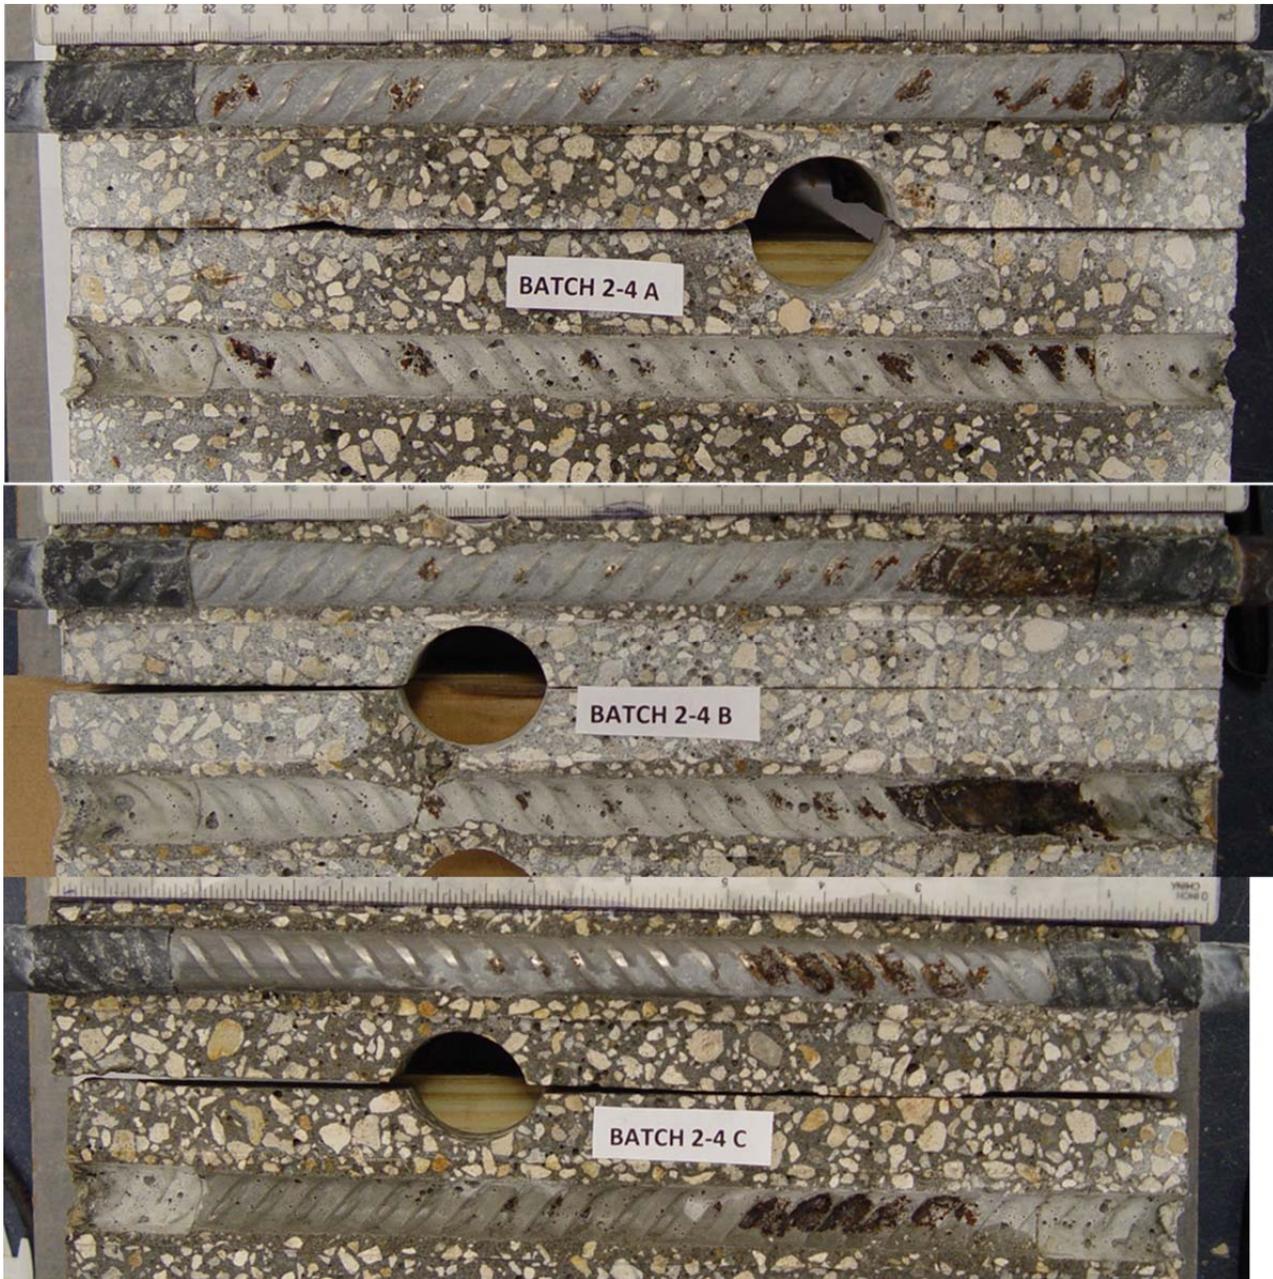
Figure 5.18: Autopsy and visual examination of top row rebars on specimen batch 2-4

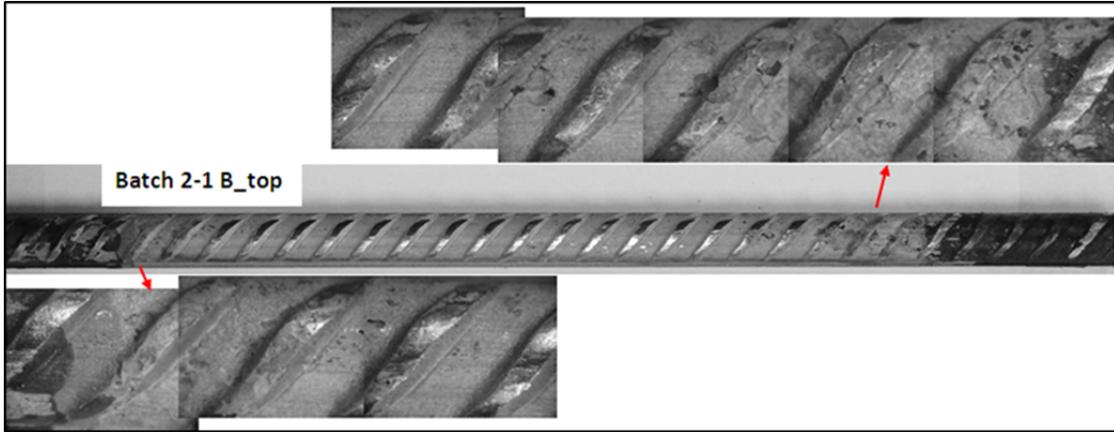
Figure 5.19: Close-up picture of sample batch 2-1B after cleaning

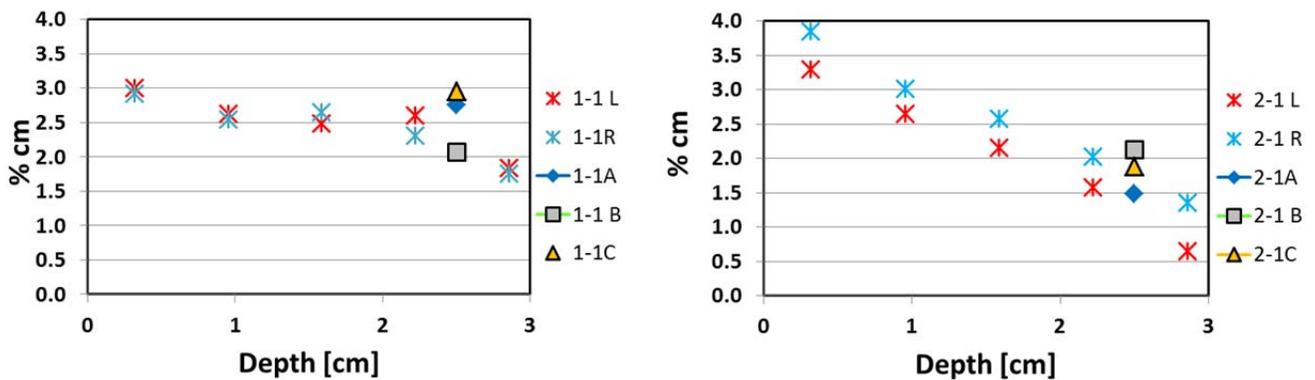
Figure 5.20: Chloride profiles for specimens batch 1-1 and 2-1 and at the rebar trace

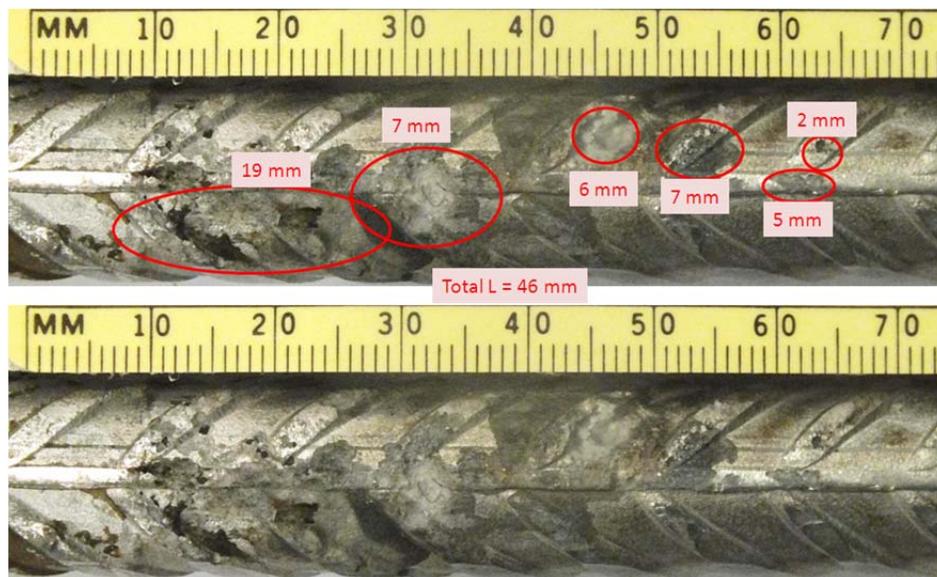
Figure 5.21: Observed length L and value explanation process for specimen 1-1 rebar C

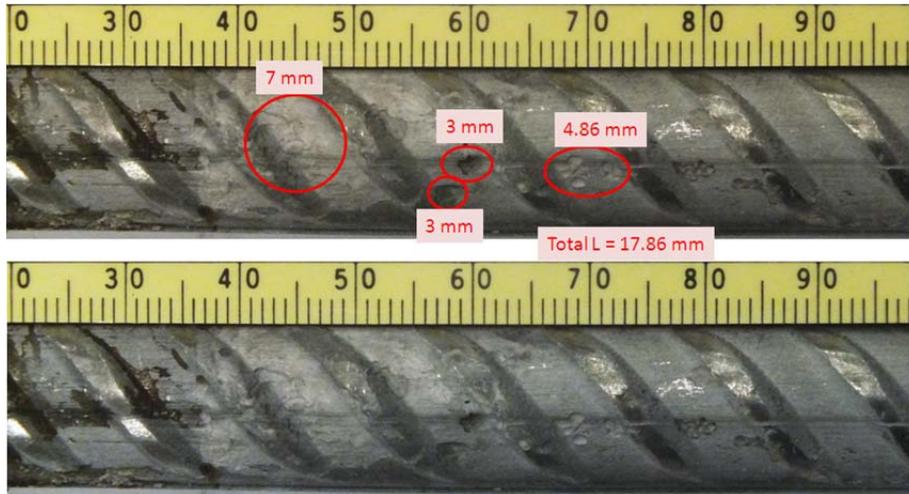
Figure 5.22: Observed length L and value explanation process for specimen 2-2 rebar B

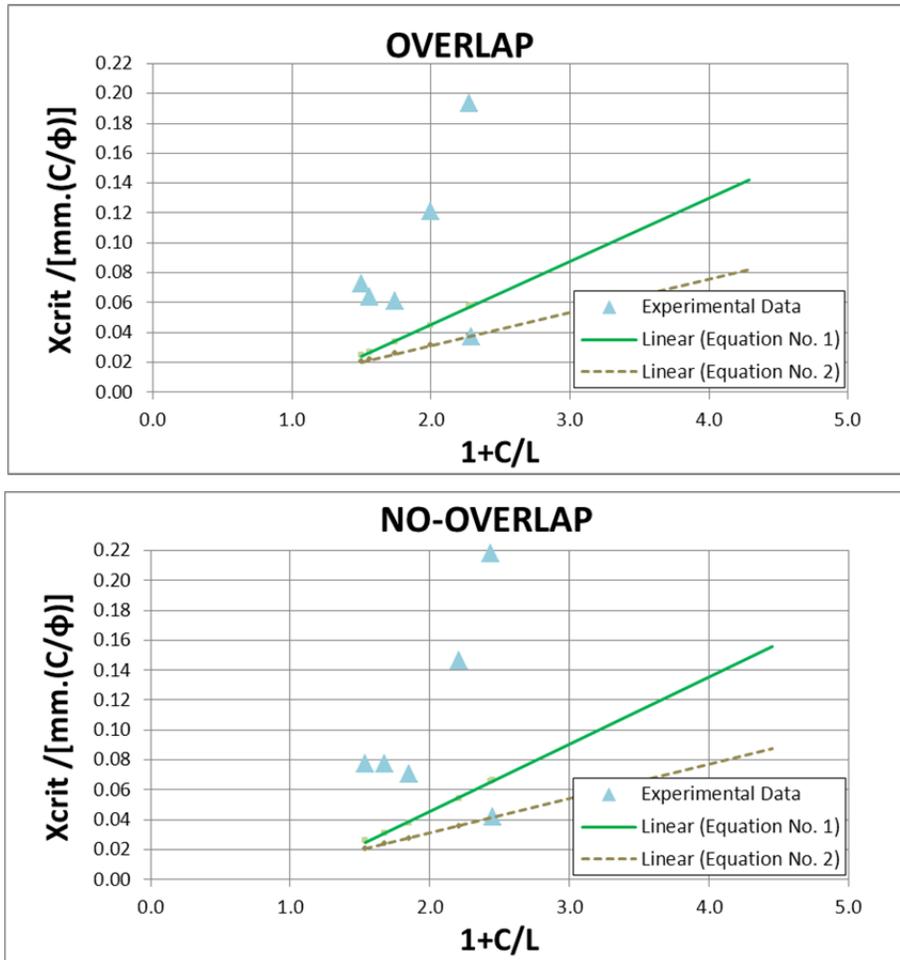
Figure 5.23: Plot of the X_{crit} values for equations (1), (2) and experimental results as a function of C/L ratio

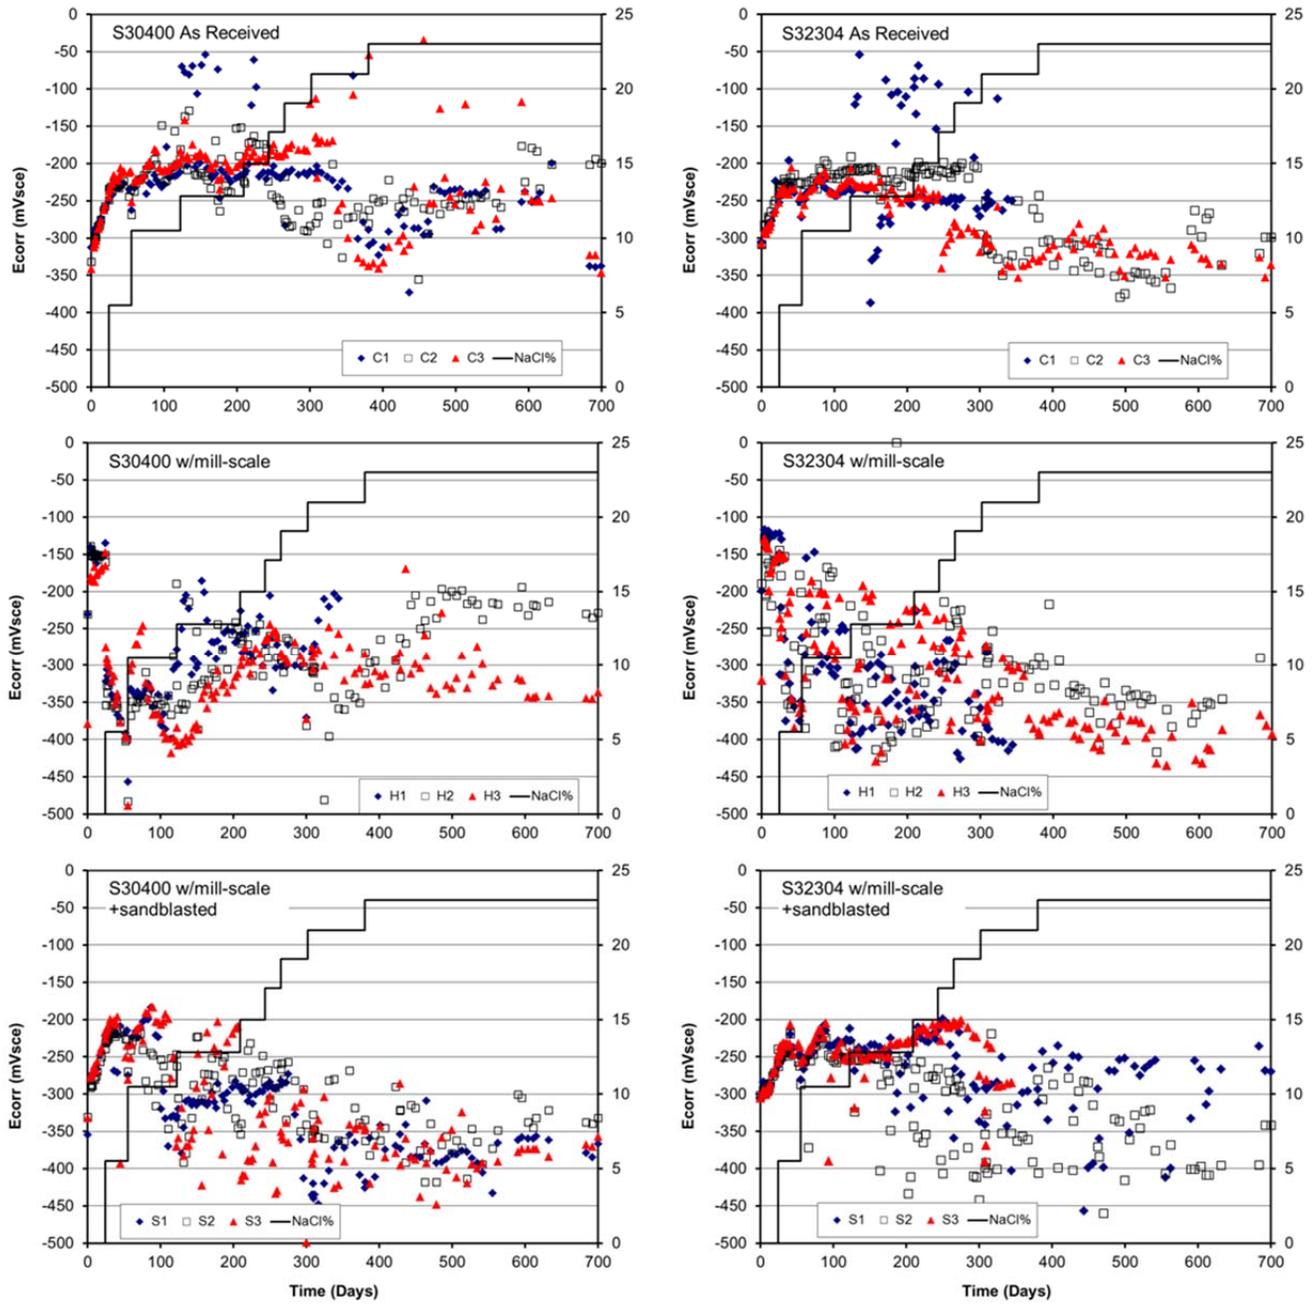
Figure 6.2: Potential vs. time on UNS S32304 and UNS S30400 (C, H and S surface conditions) NaCl% series stepwise additions of Sodium Chloride

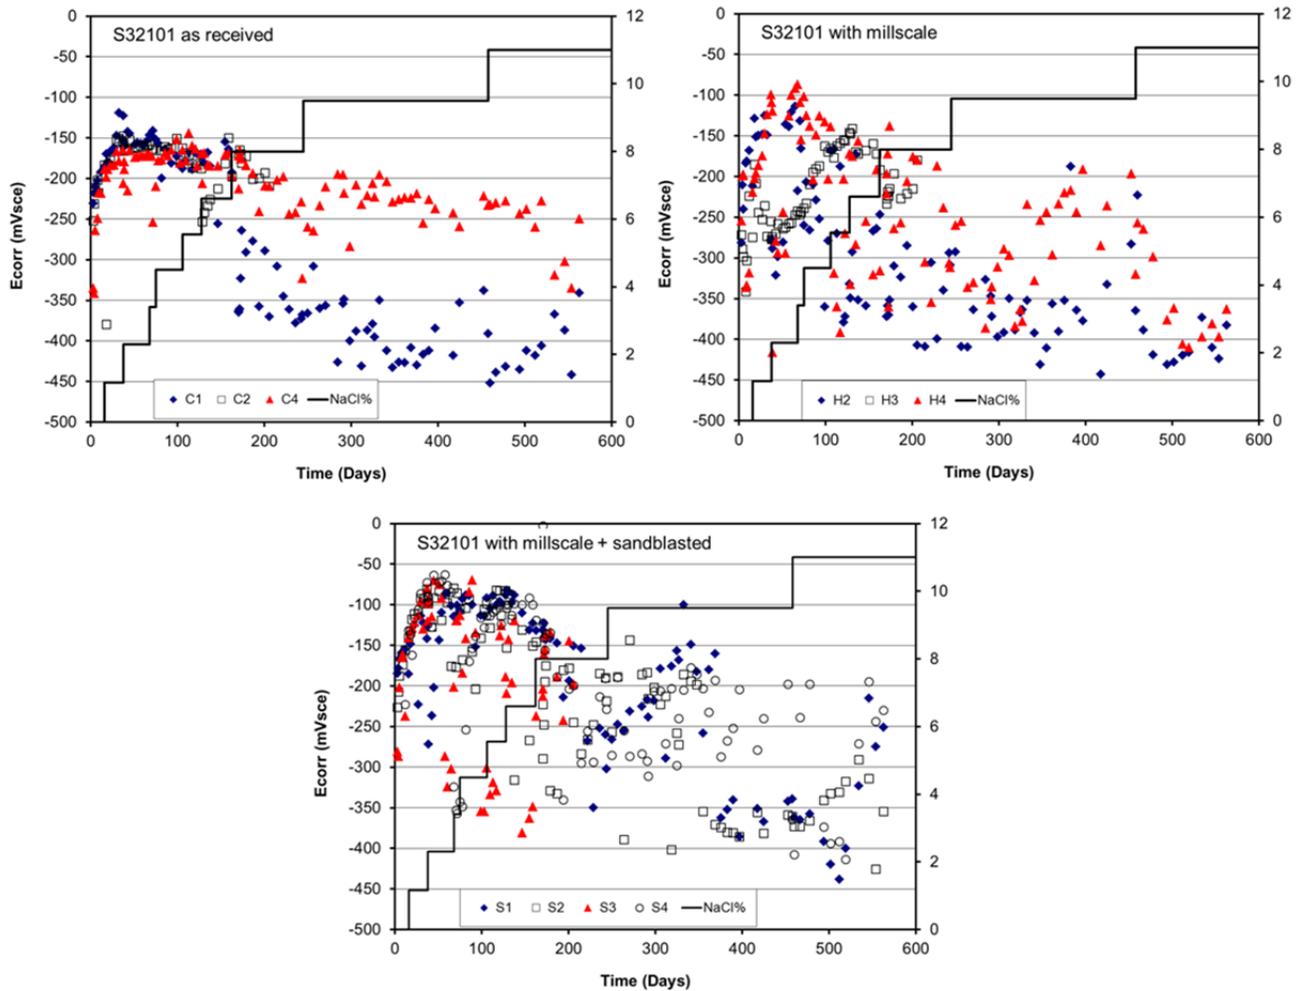
Figure 6.3: Potential vs. time on S32101 (C, H and S surface conditions)

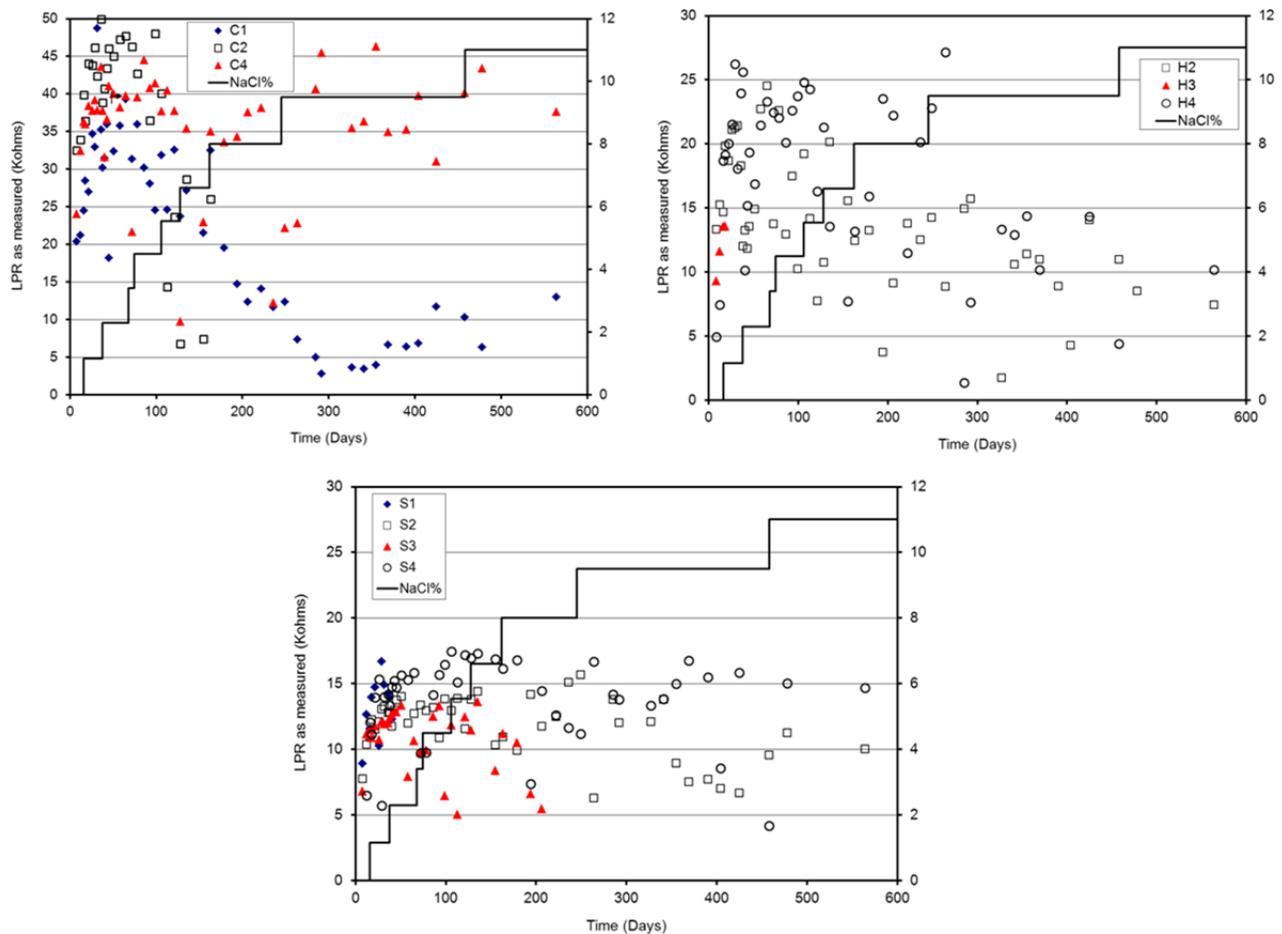
Figure 6.4: Rc as measured on UNS S32101 rebar samples for the 3 surface conditions

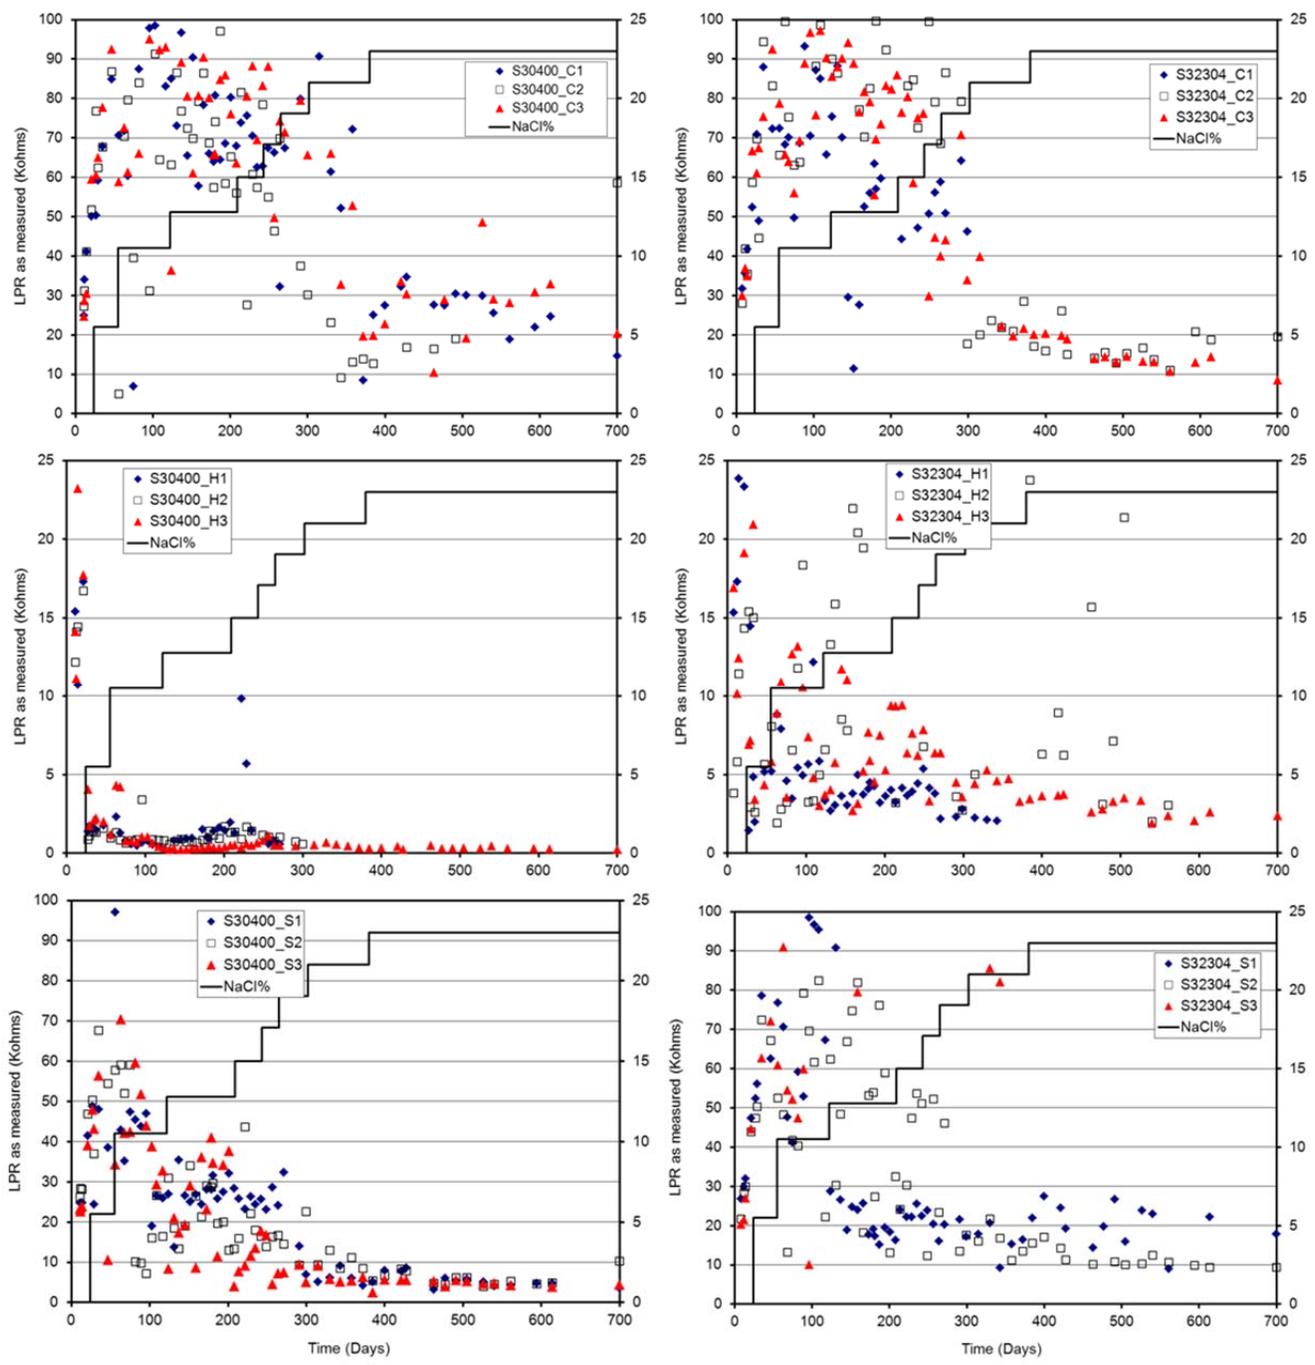
Figure 6.5: Rc vs. time measured on UNS S30400 and UNS S2304 samples (C, H, S surface conditions)

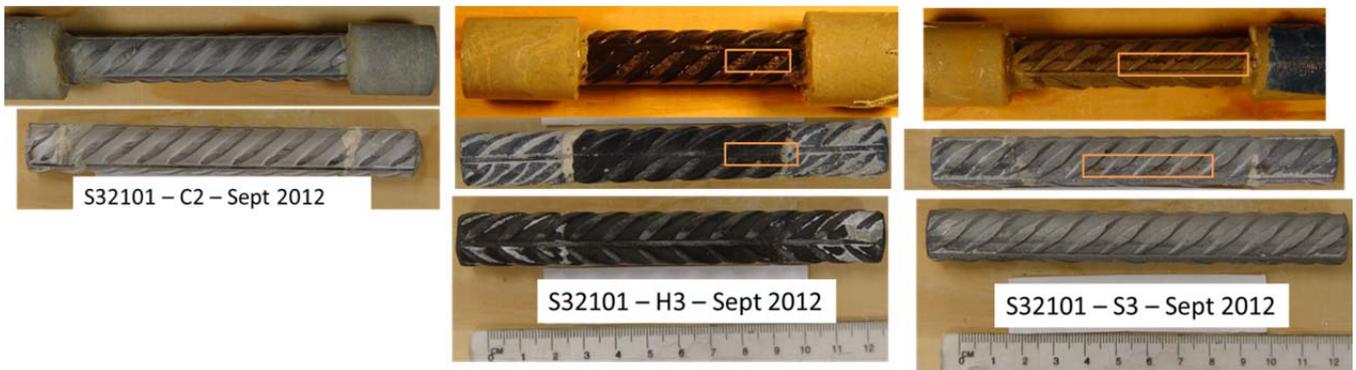
Figure 6.6: Terminated UNS S32101 specimens. Upon removal from solution, after removing mortar and finally after cleaning

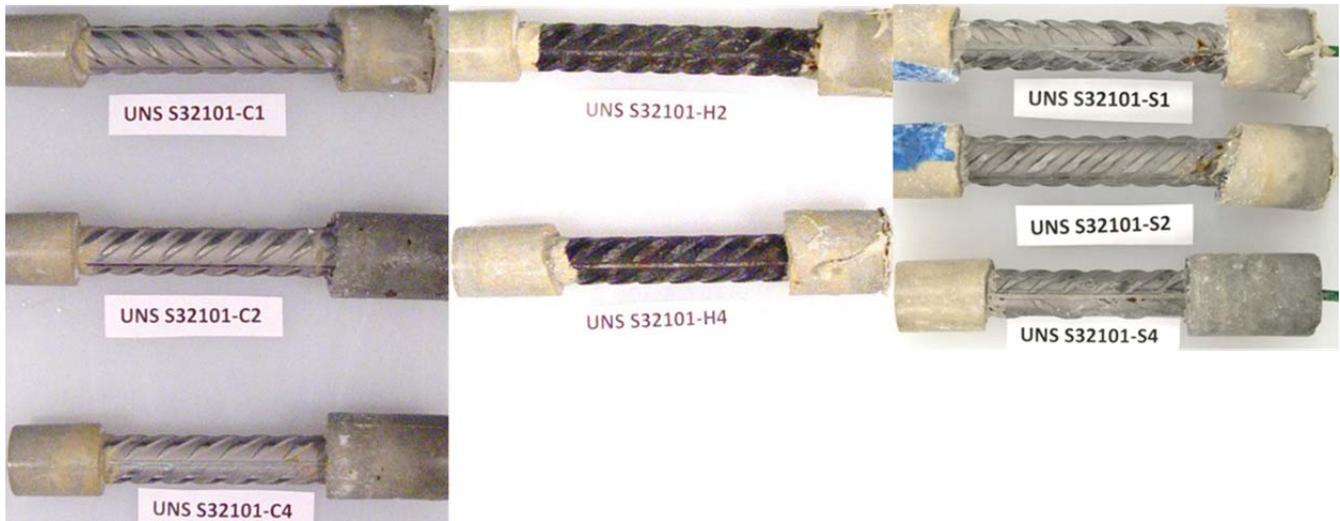
Figure 6.9: Visual inspection on UNS S32101 terminated specimens after removal from solution

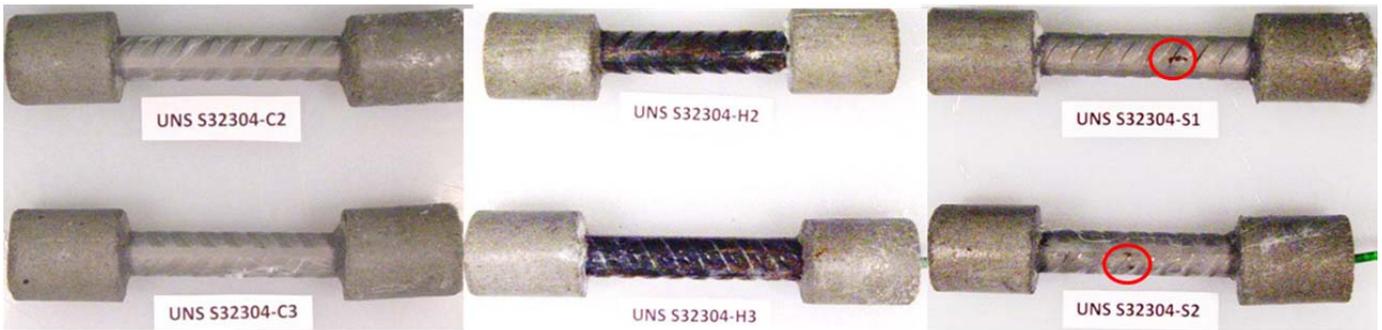
Figure 6.10: Visual inspection on UNS S32304 terminated specimens after removing from solution

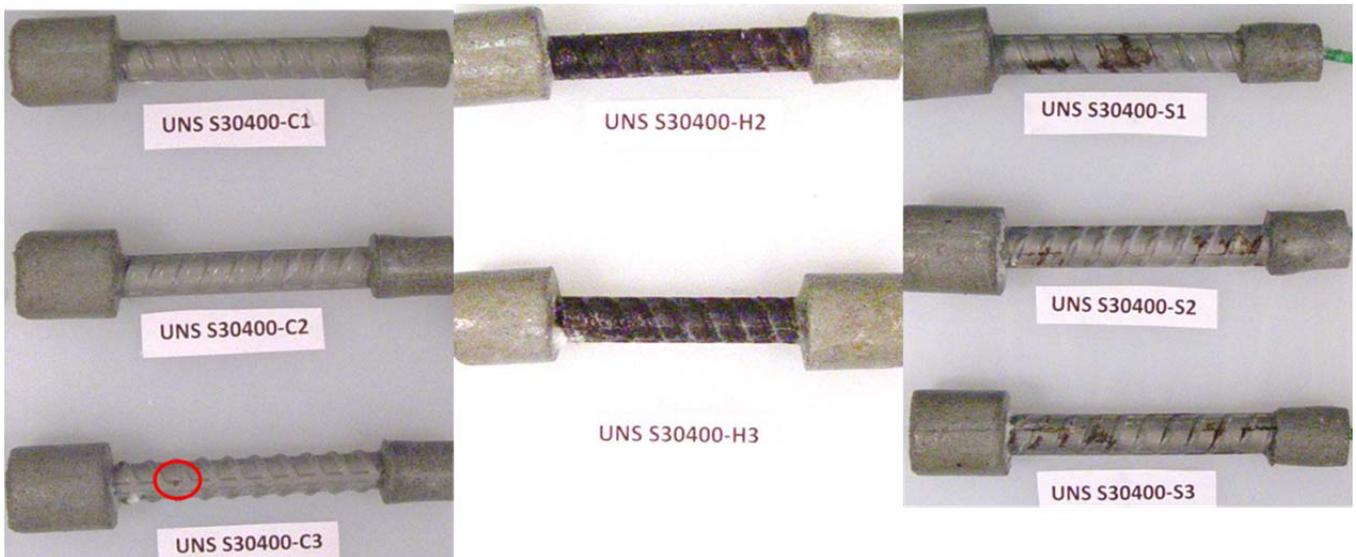
Figure 6.11: Visual inspection on UNS S30400 terminated specimens after removing from solution

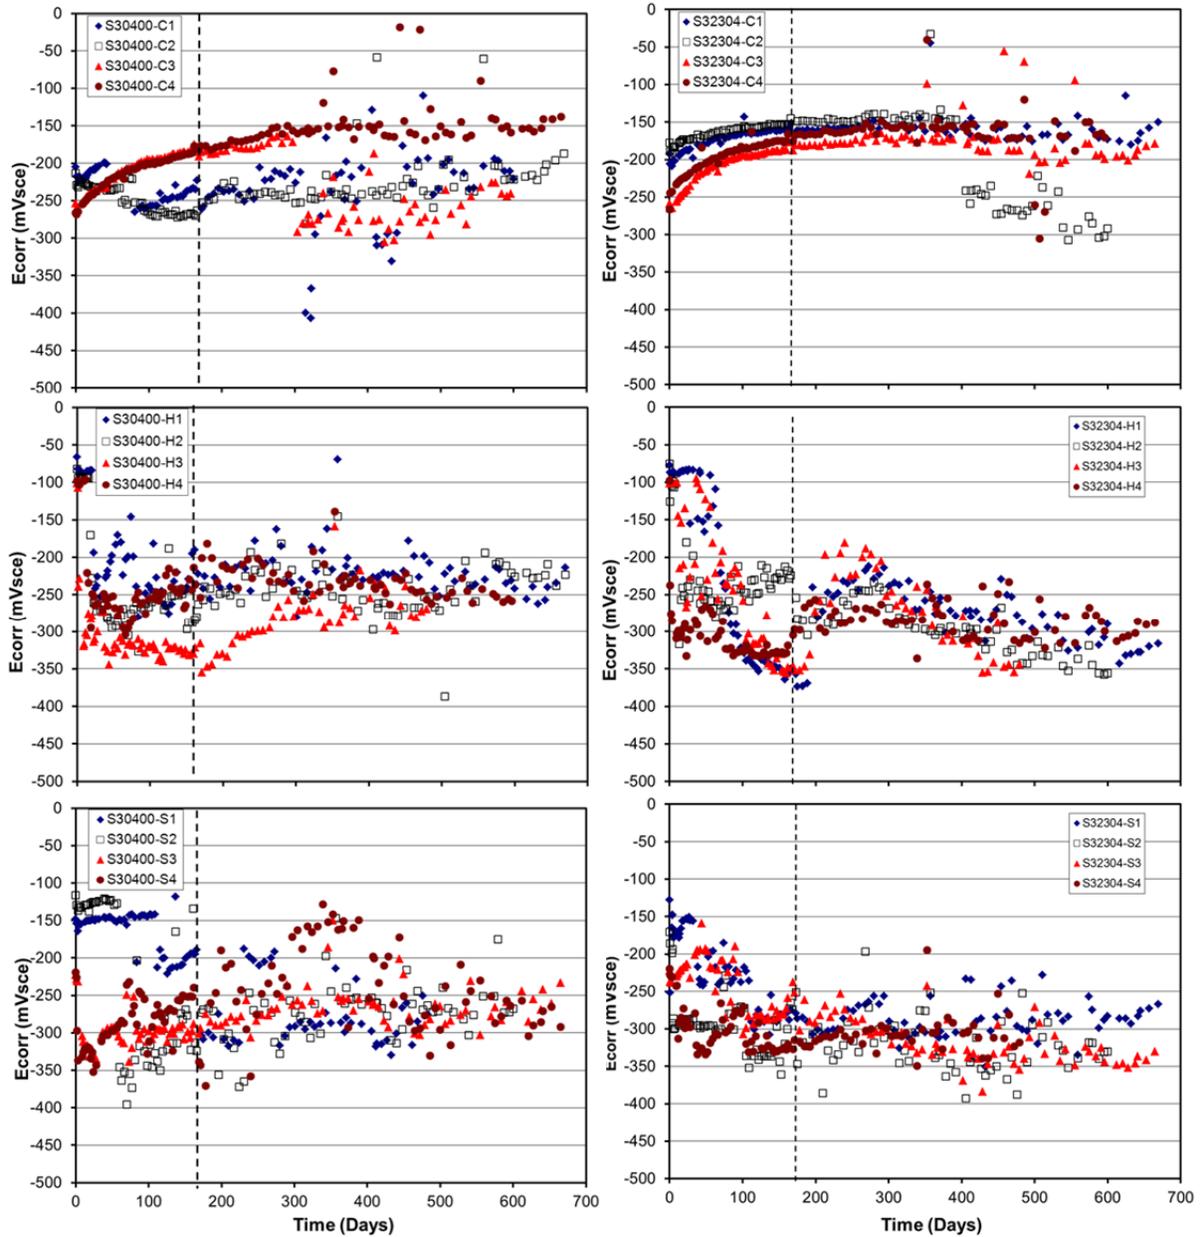
Figure 6.13: Potential evolution on mortar samples with UNS S32304 and UNS S30400 upon exposure to 15% NaCl solution. Wet/dry cycles began on the day indicated by the vertical dash line

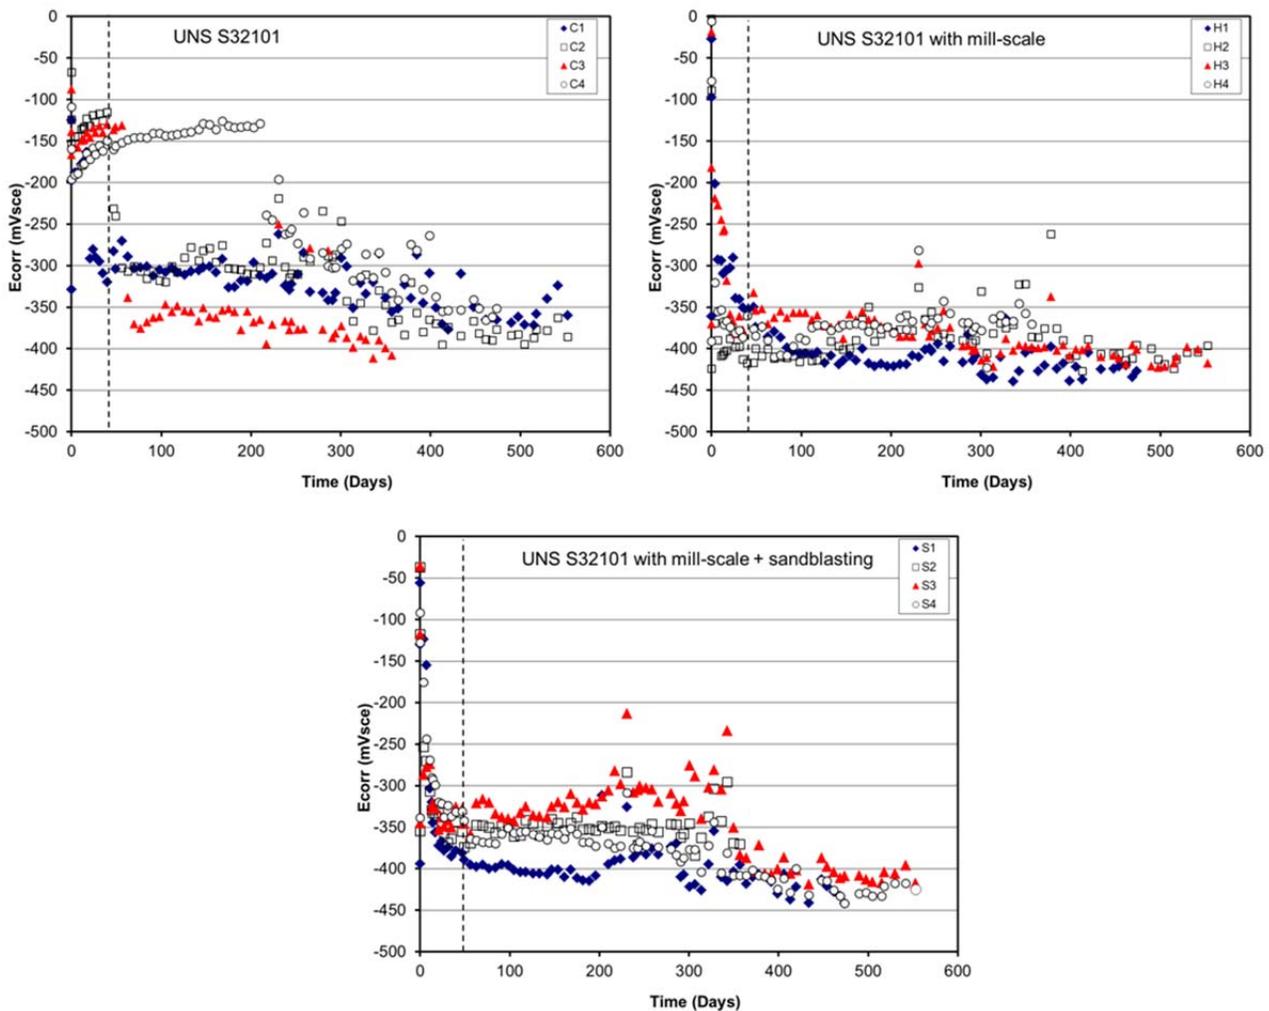
Figure 6.14: Potential vs. time for UNS S32101 embedded in mortar. Wet/dry cycles (4 days wet/ 3 days dry) began on the day 40 indicated by the vertical dash line
