Final Report

**Analysis and Estimation of Service Life of Corrosion Prevention Materials Using Diffusion,
Resistivity and Accelerated Curing for New Bridge Structures -
Volume 1: Corrosion Prevention Materials (Monitoring and Forensic Examination)
(BDK79-977-02)**

**Florida Department of Transportation Research Center
605 Suwannee Street
Tallahassee, Florida 32399**

December 2013

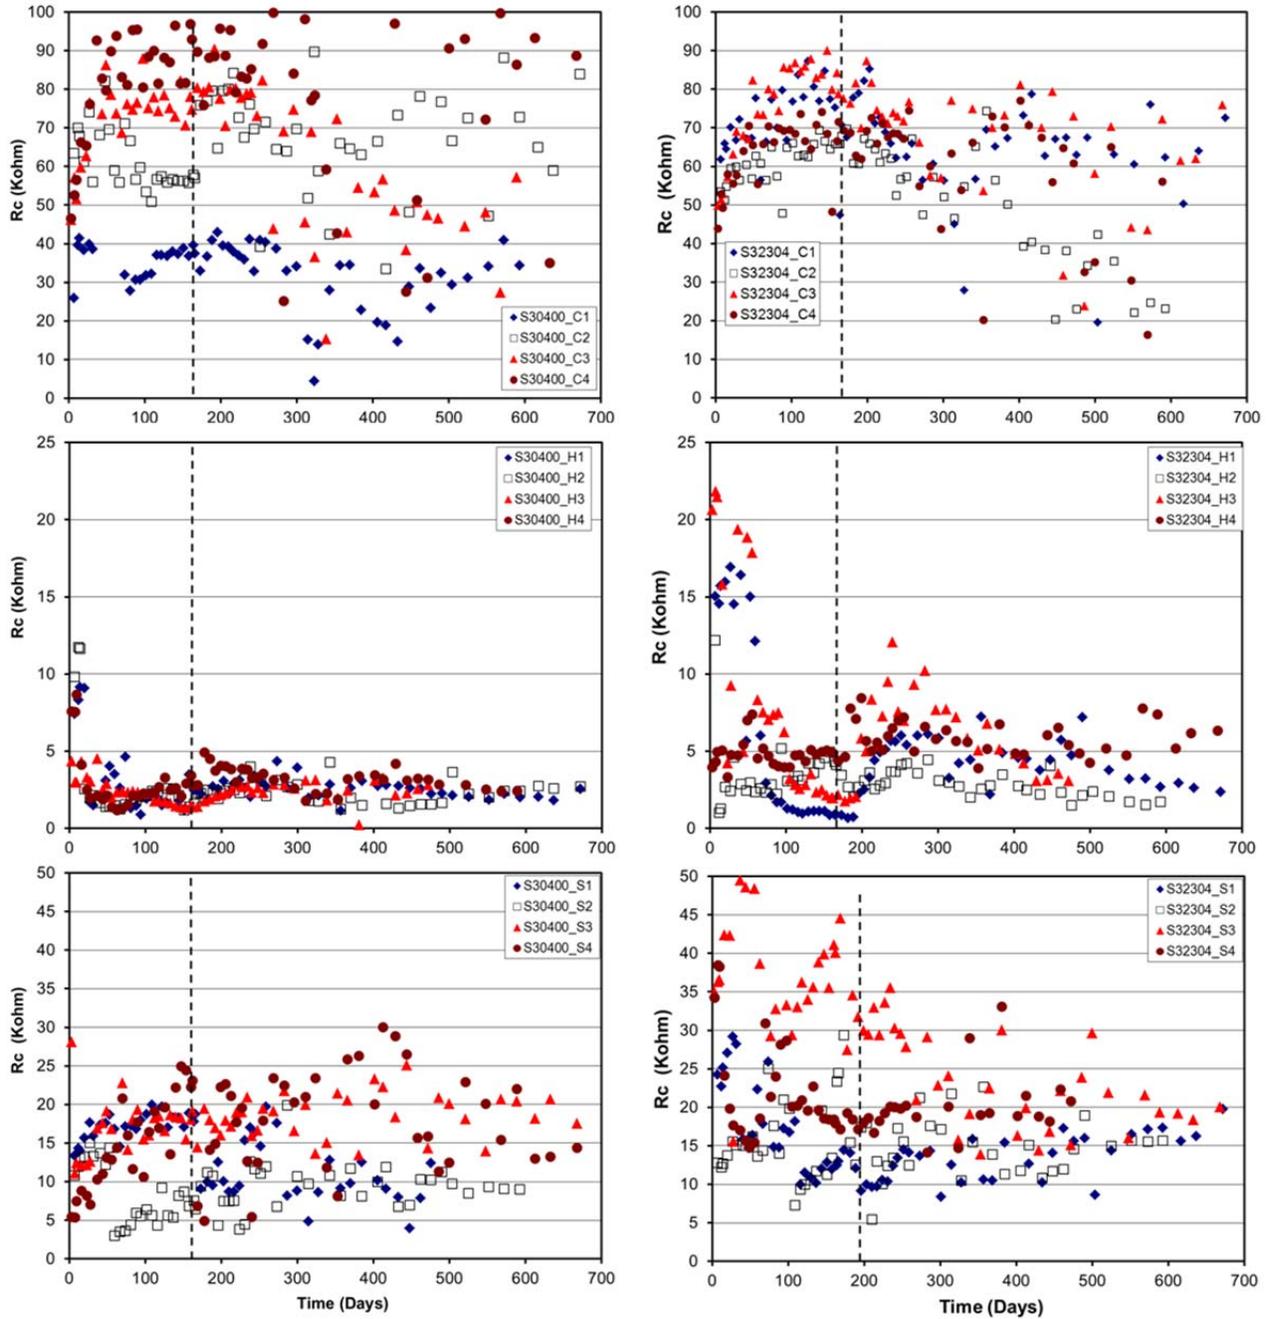
Figure 6.16: Rc measured on UNS S32304 and UNS S30400 embedded in mortar with w/c=0.5. Wet/dry cycles (4 days wet/ 3 days dry) began on the day indicated by the vertical dash line

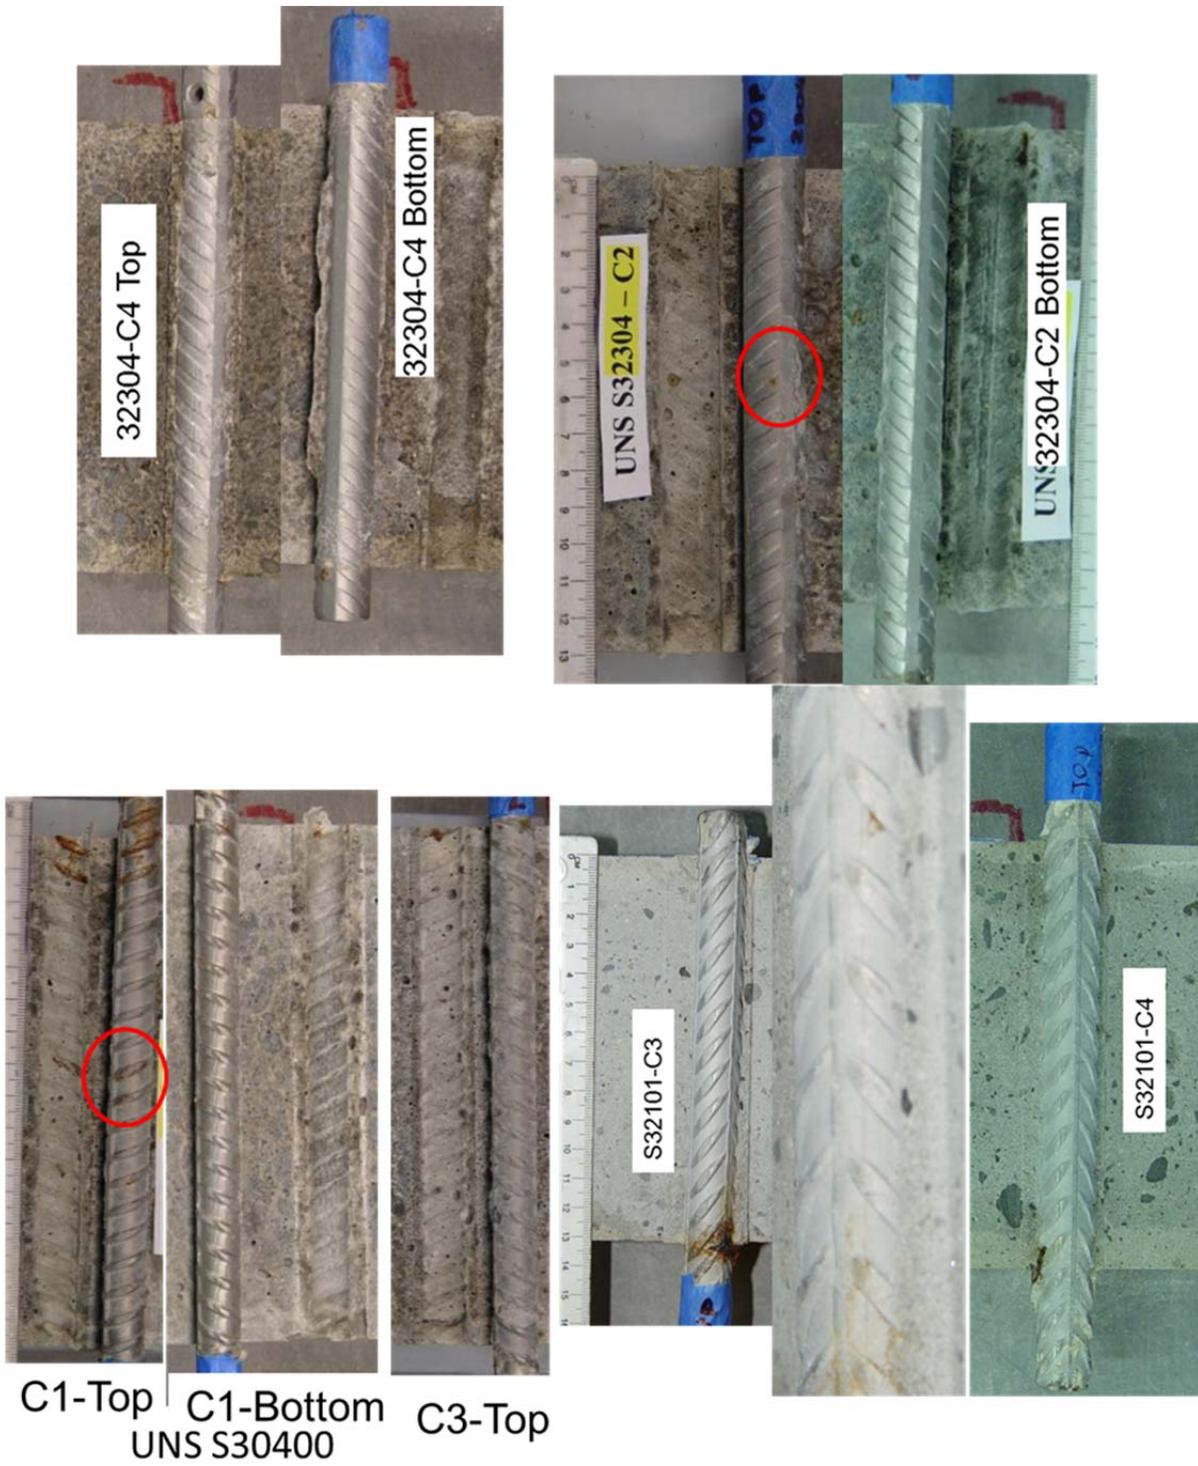
Figure 6.18: As received (C) specimens for the different CRA alloys embedded in mortar w/c=0.5

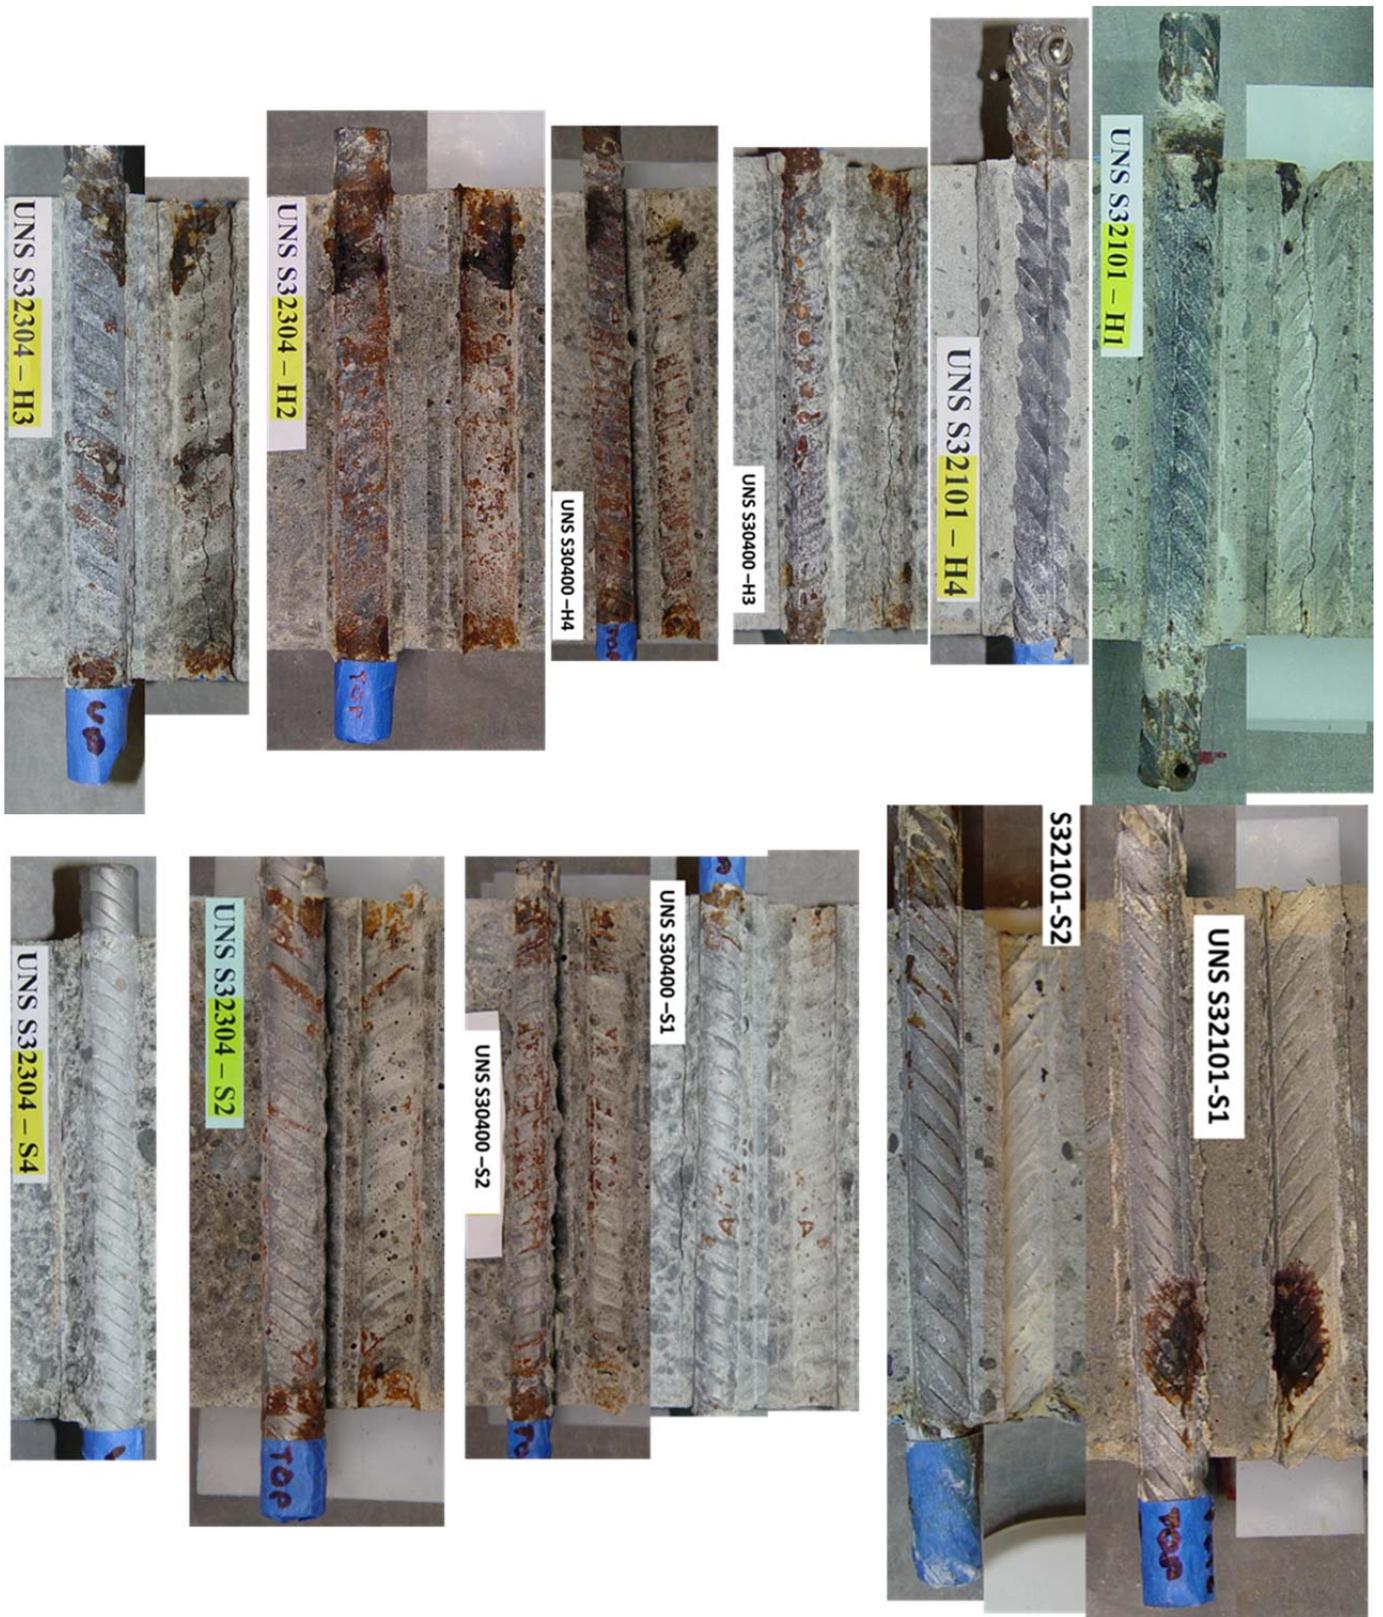
Figure 6.19: Visual examination after exposing rebar for H and S surface condition for the three CRA types

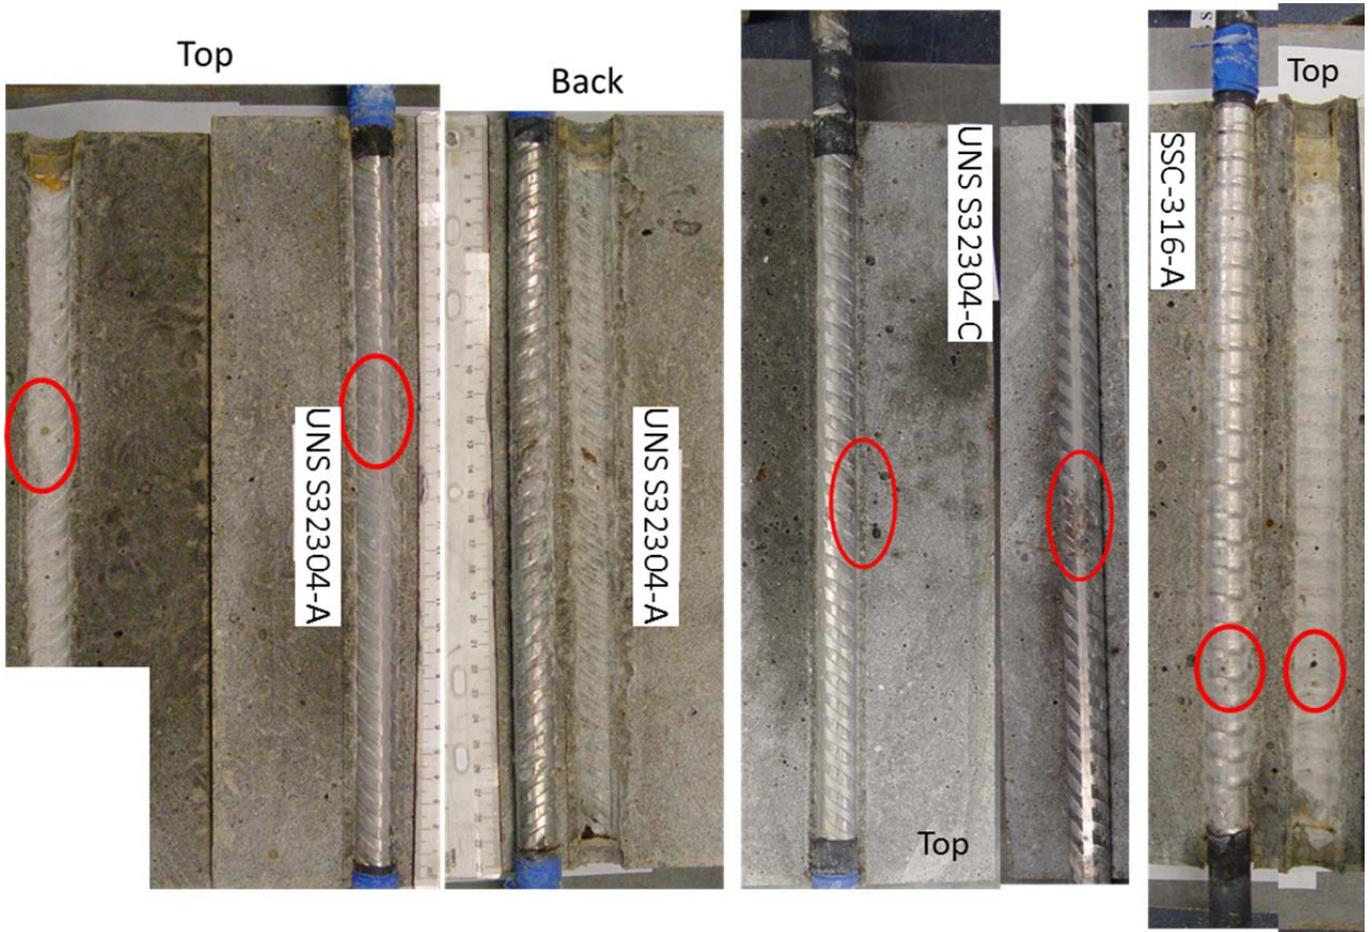
Figure 6.20: As received (C) specimens for the different CRA alloys embedded in mortar w/c=0.41

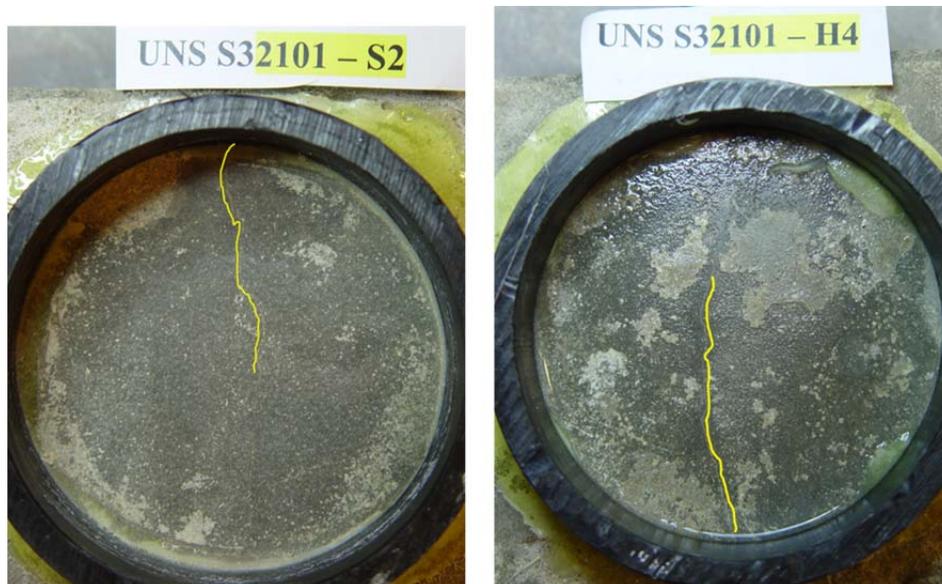
Figure 6.21: Cracks observed on S32101-H and S32101-S

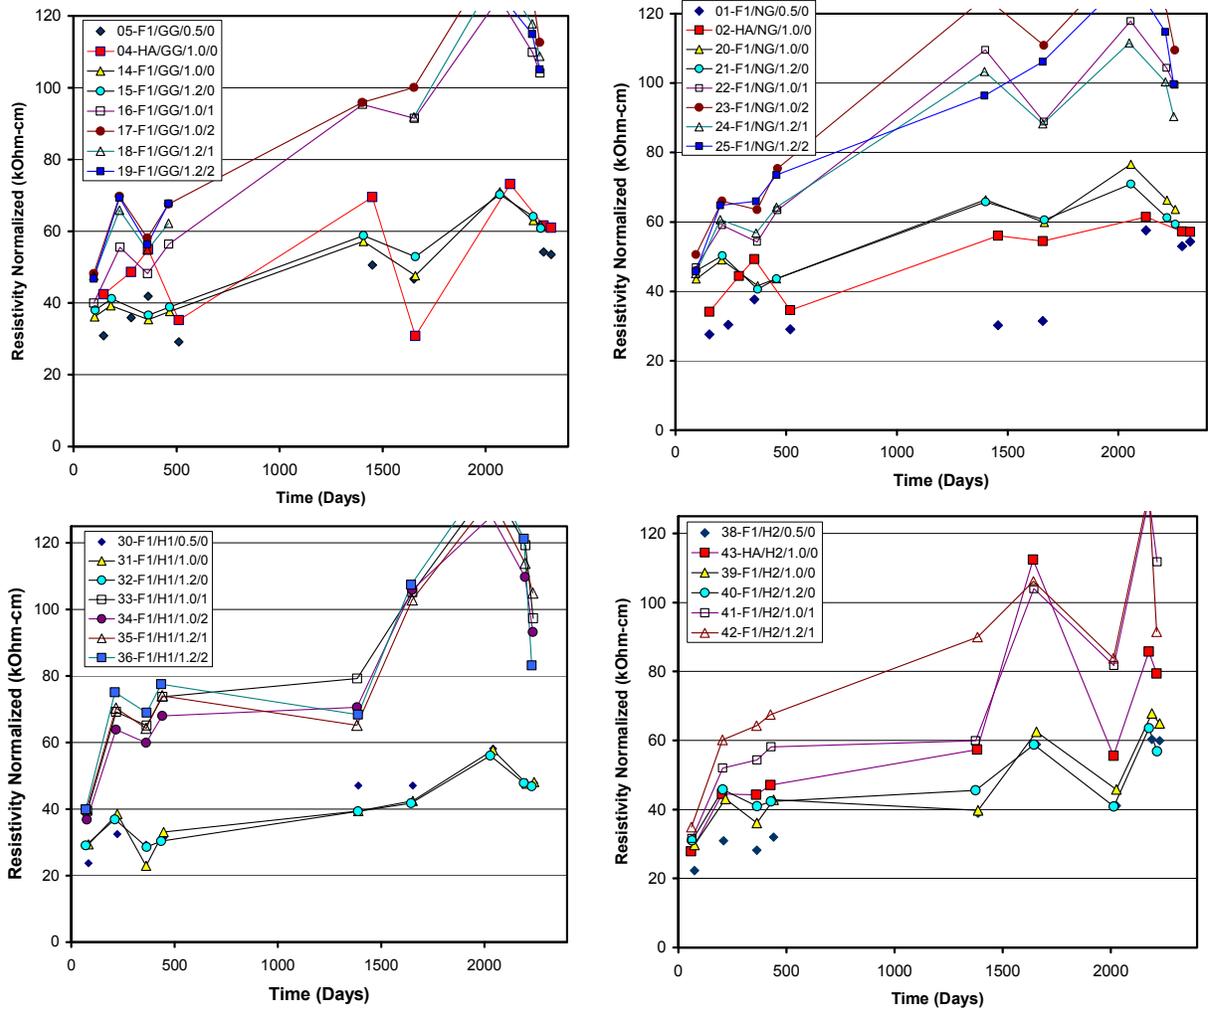
Figure 7.6: Typical evolution of resistivity with time. Concrete mixes prepared with granite, H1 and H2 aggregates and various EqA and Li contents

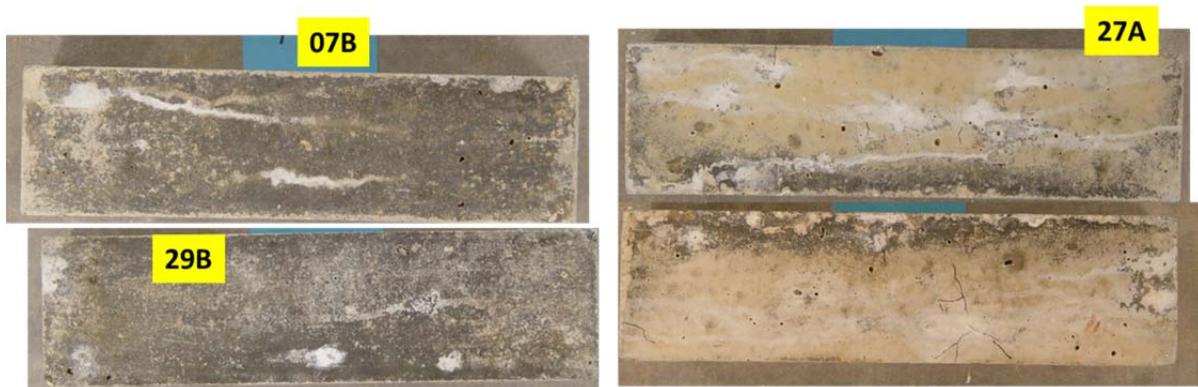
Figure 7.9: Specimens with FL2 aggregate selected to be terminated

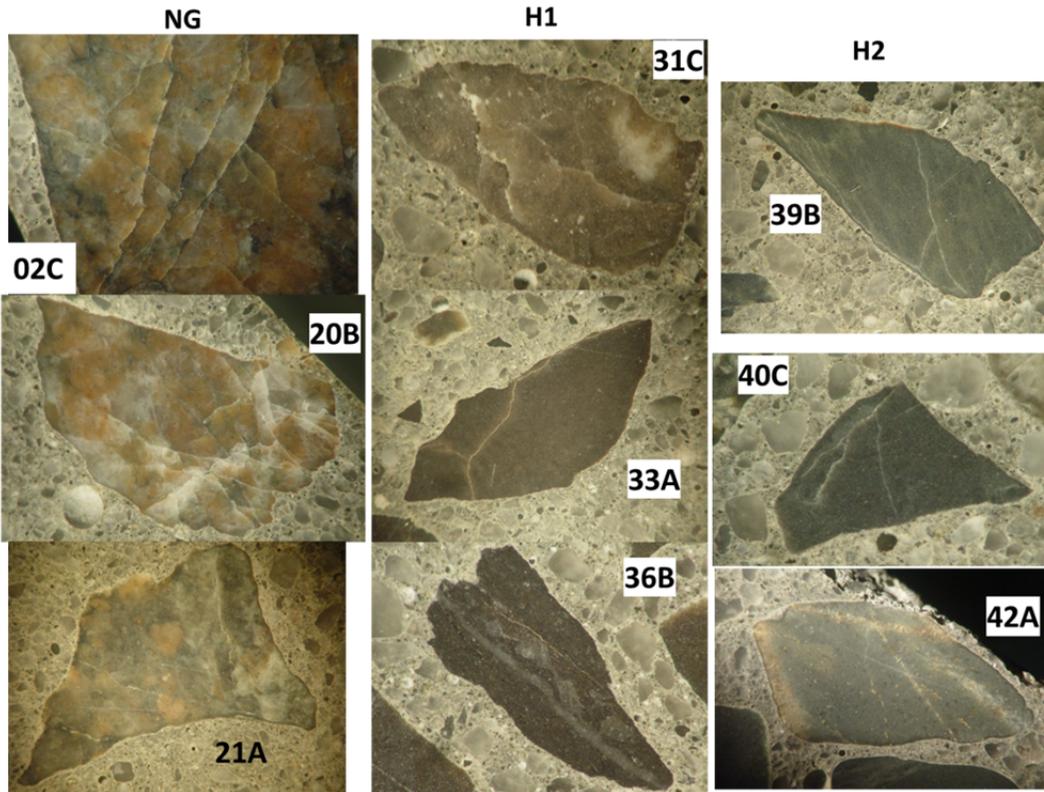
Figure 7.11: Typical cracks patterns observed on specimens with NG, H1 and H2

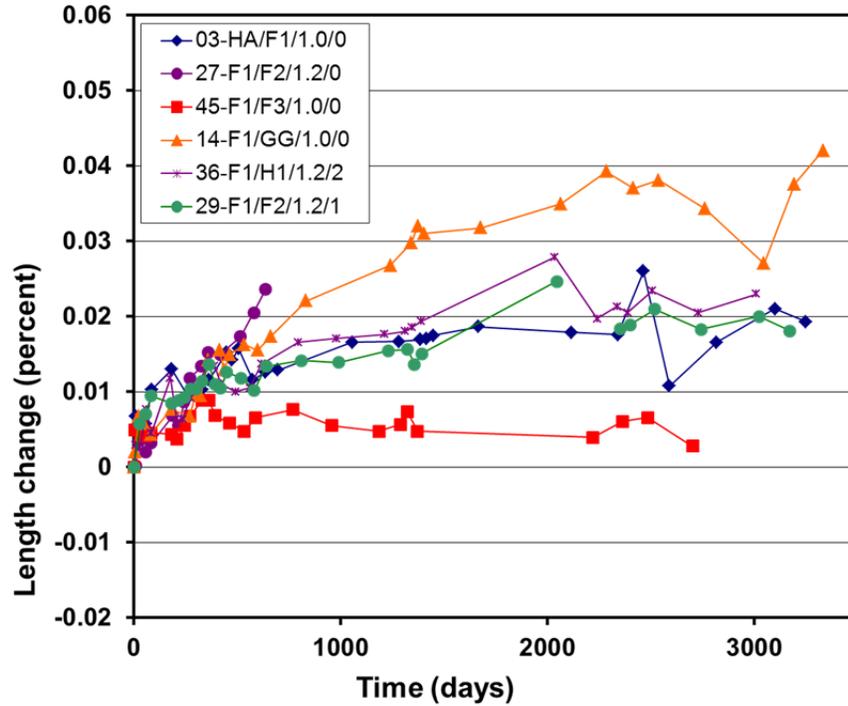
Figure 7.12: Length change vs. time on specimens with different coarse aggregate

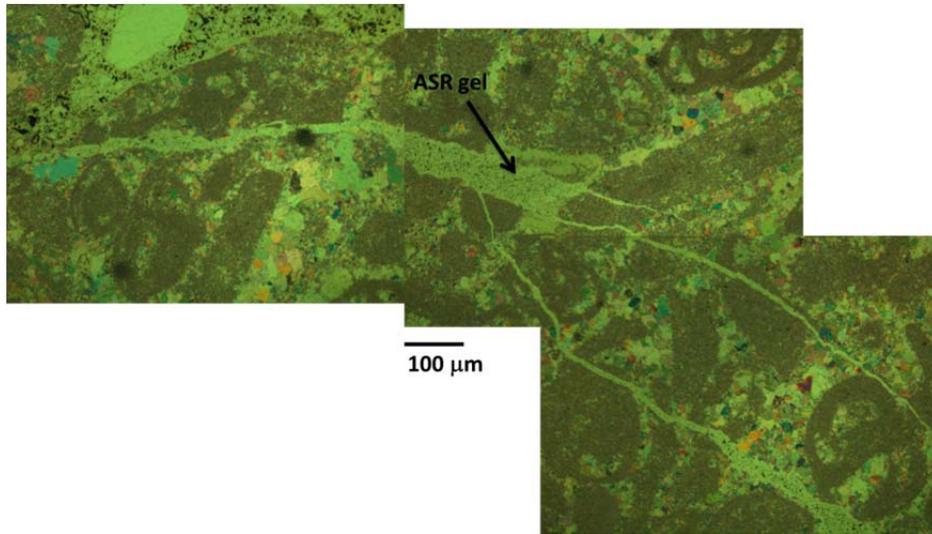
Figure 7.13: Evidence of ASR gel on thin section of specimen 27A

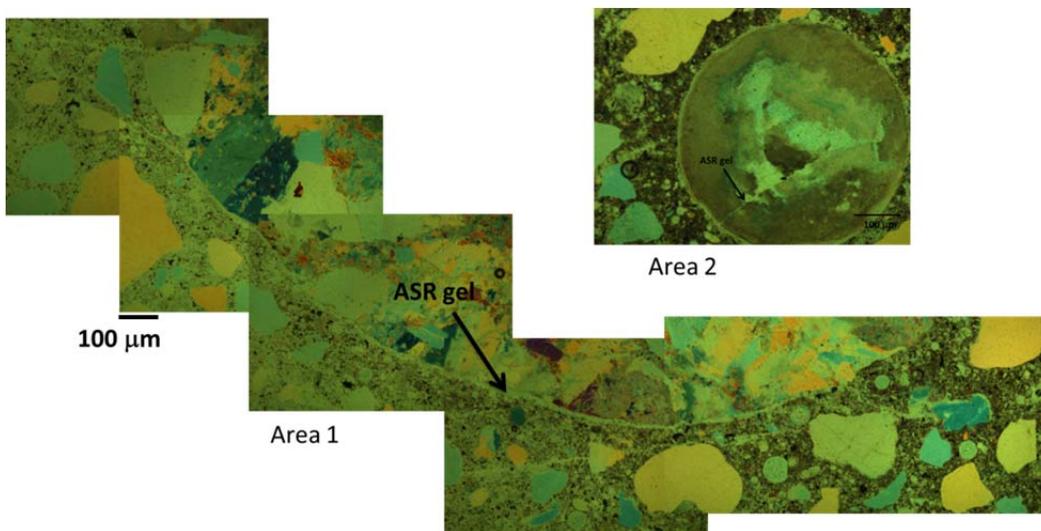
Figure 7.16: Evidence of ASR gel on thin section of specimen 39B with H2 coarse aggregate

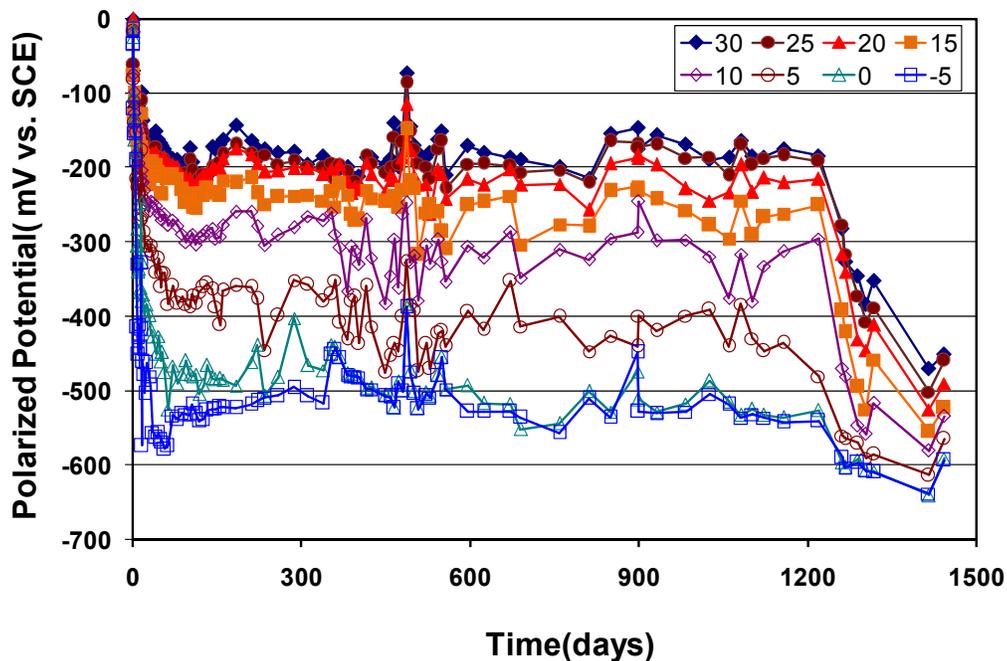
(a) Polarized potentials of left rebar in specimen K2 at eight (8) levels

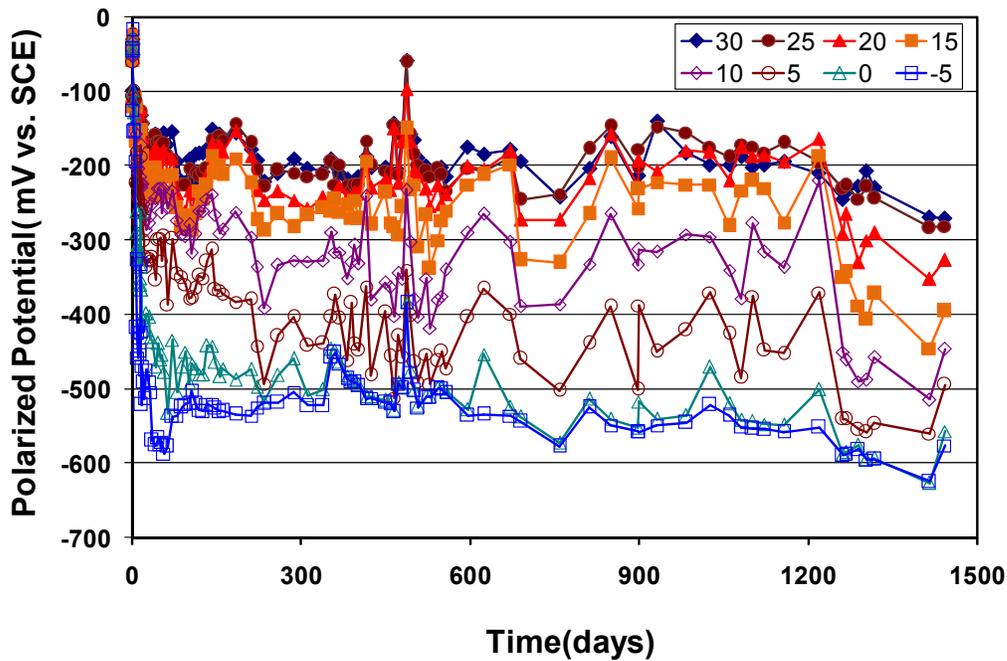
(a) Polarized potentials of left rebar in specimen K3 at eight (8) levels

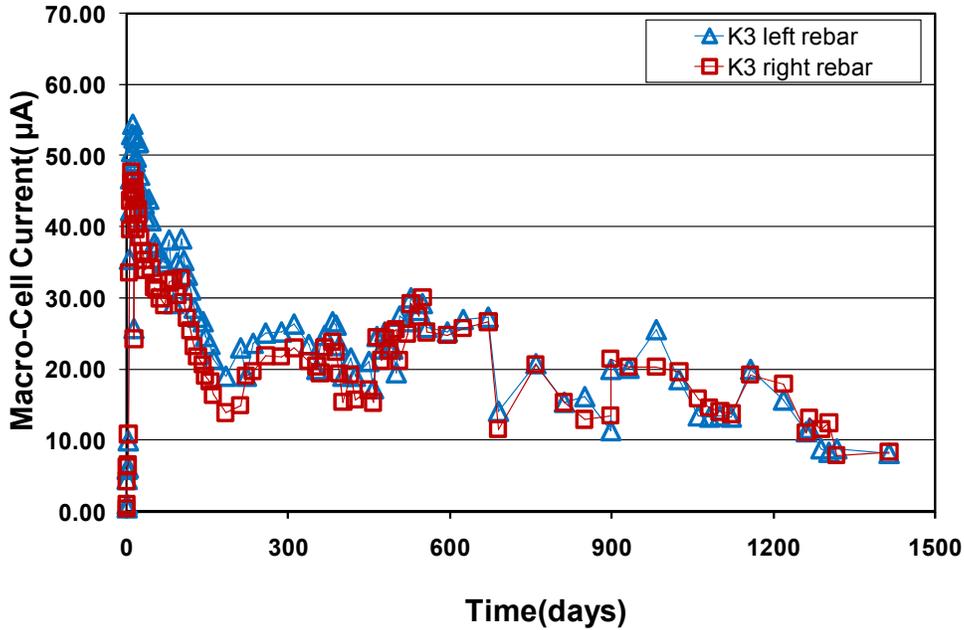
(c) Macro-cell current from left rebar and right rebar in specimen K3

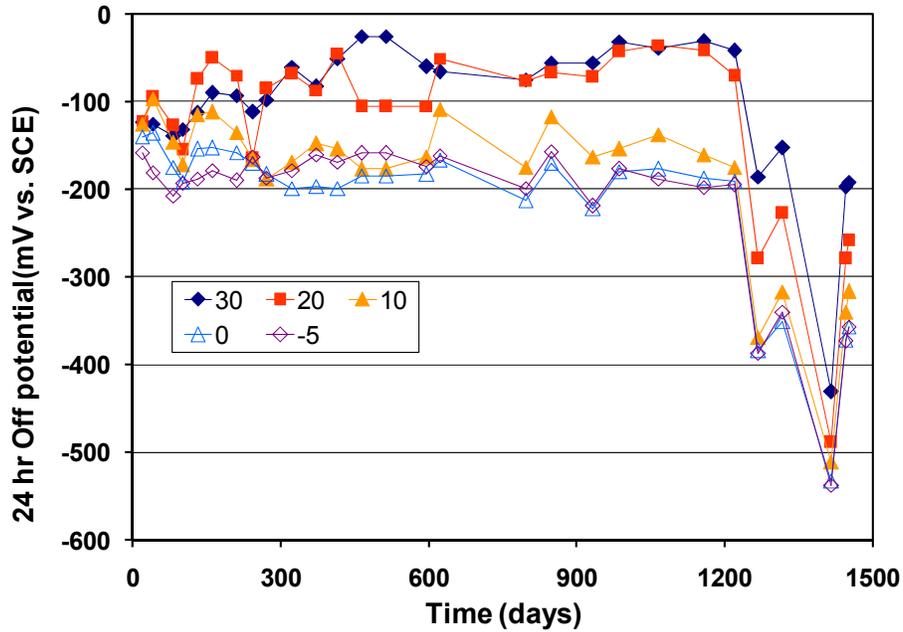
(a) 24 hr off potentials of left rebar in specimen M1

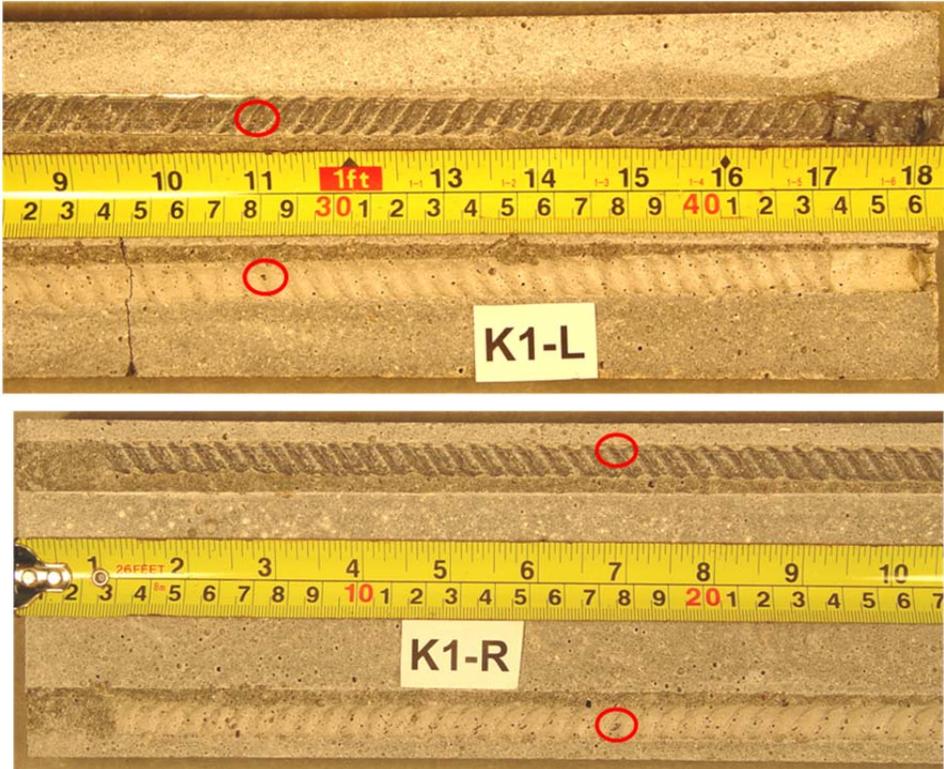
Figure 8.19: K1 right rebar low portion–corrosion spots at level 17.5 cm from the bottom of specimen (12.5 cm from the water line)

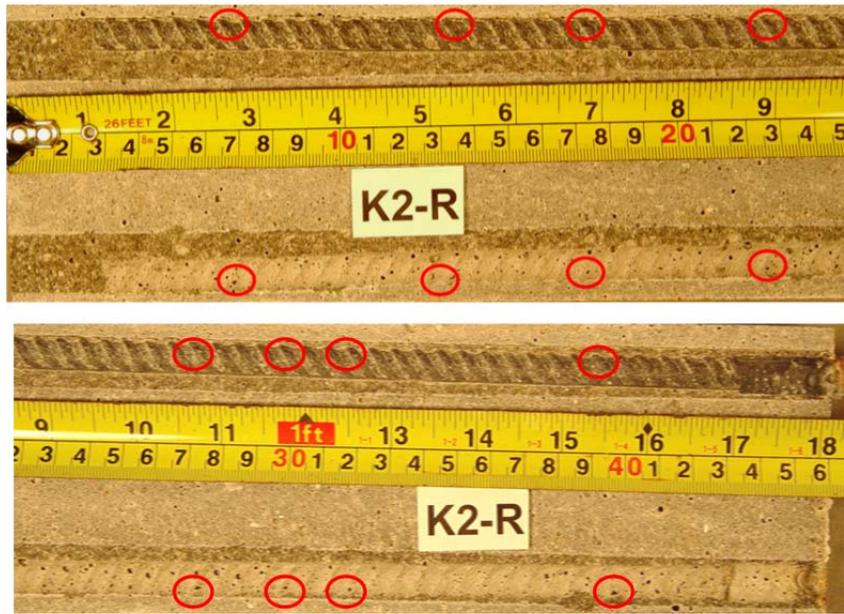
Figure 8.20 K2 right rebar–corrosion spots on rebar

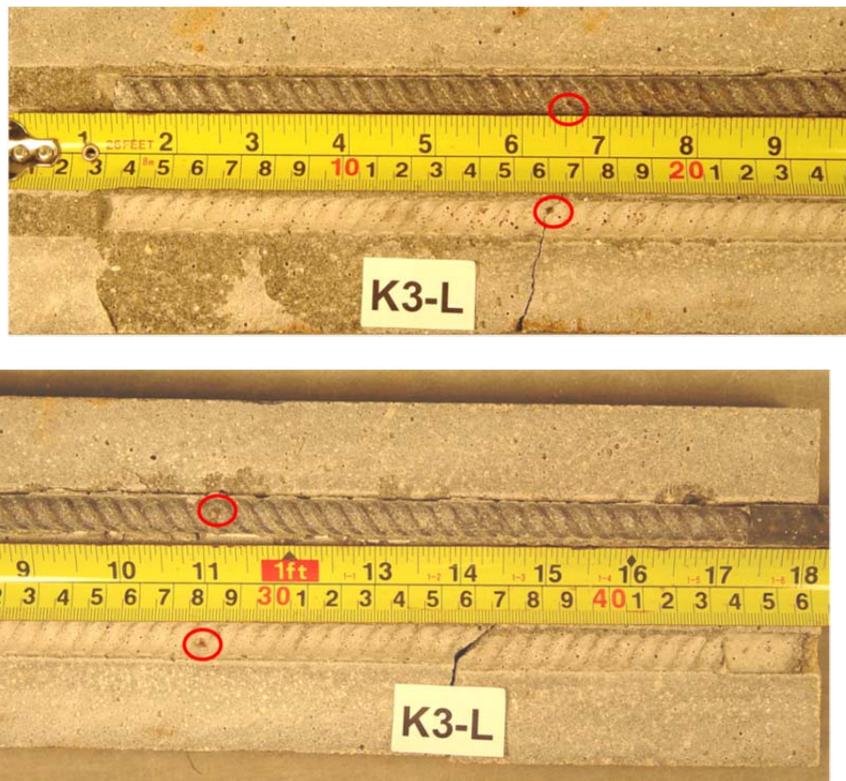
Figure 8.21: K3 left rebar–corrosion spots at 16.5 cm and 28.3 cm from the bottom of specimen (11.5 cm and 23.3 cm from the water line)

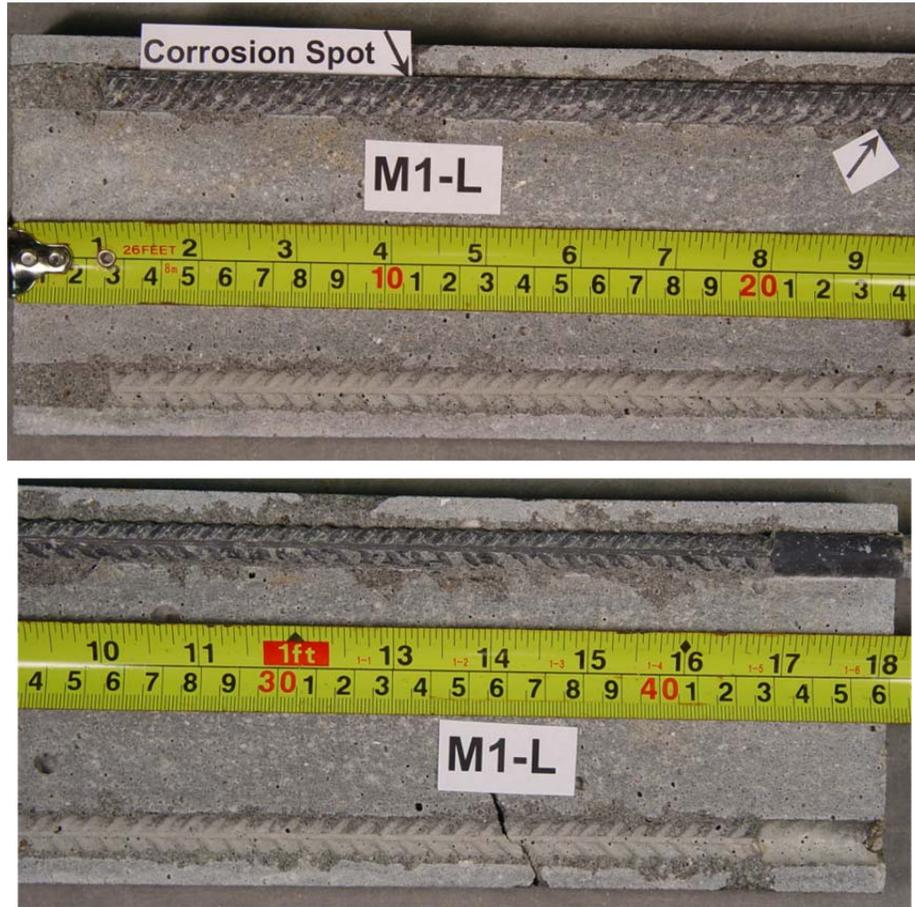
Figure F.14: M1 left rebar – corrosion spots on left rebar at 10.0 cm from the bottom of specimen (5.0 cm from the water line)

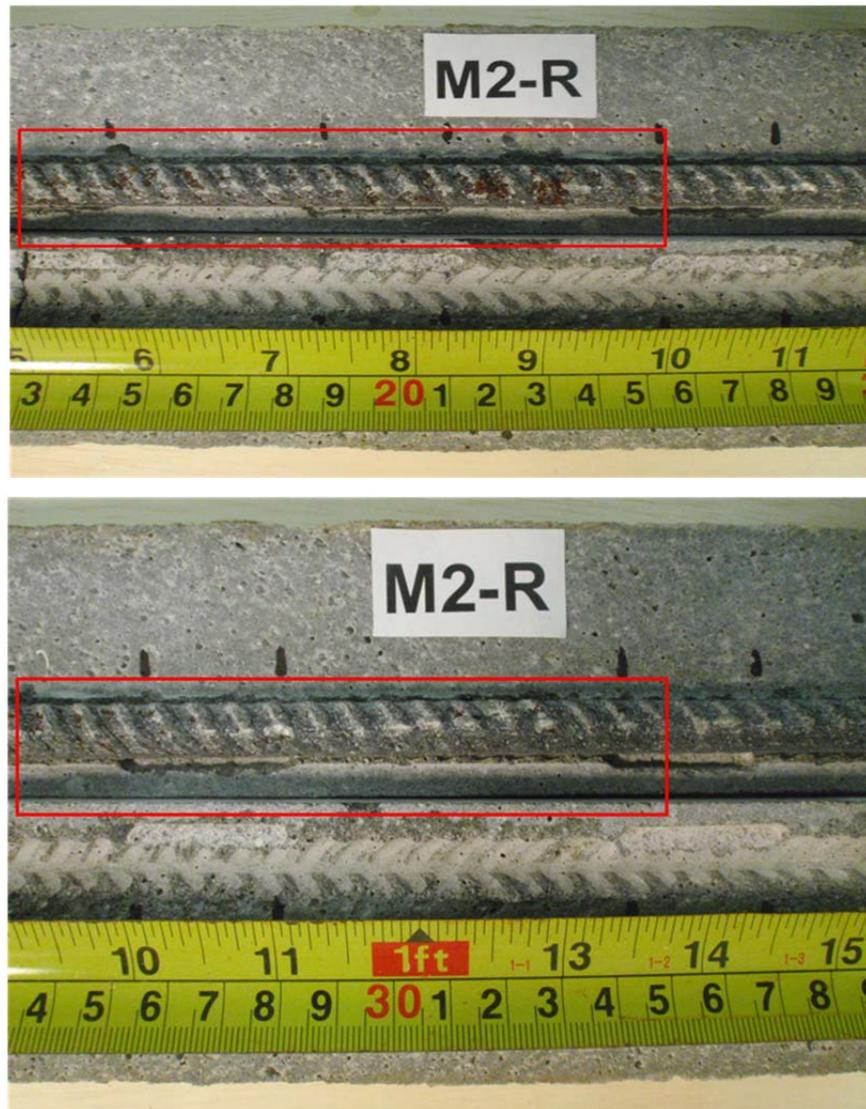
Figure F.16: M2 right rebar - corrosion spots on right rebar at 12.50 cm~35 cm from the bottom of specimen (7.50cm~30cm from the water line)
