Spring 2013

**RESEARCH** Showcase

# Jet-Grouted Piles—A New Foundation for Florida

# **Extending Bridge Life with Carbon Fiber Reinforced Polymers (CFRP)**

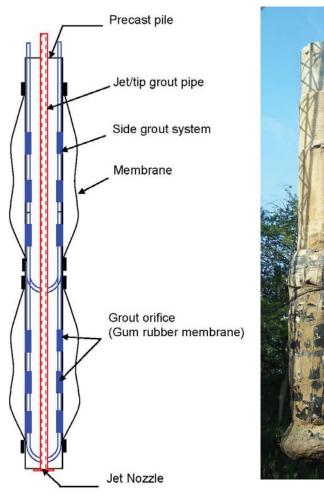
The jet-grouted pile consists of a precast concrete pile, side grout systems, and a waterjetting system. The first step for installing the pile is setting the pile in the ground using the water-

jetting system. Pipes for this procedure are cast into the pile. Once the pile obtains the proper depth, engineers use other cast-in pipes to inject side grout. After the side grout has attained sufficient strength, usually seven to ten days, engineers inject tip grout through the water-jetting pipes.

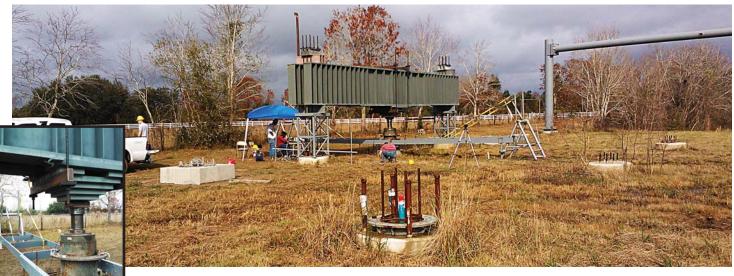
Test field for full-scale testing. In the foreground is the round cap of a drilled shaft foundation, one of several visible in the photo. The square cap to the left is on top of a jet-grouted foundation awaiting testing. The reaction frame at the center top is

photo. The square cap to the left is on top of a jet-grouted foundation awaiting testing. The reaction frame at the center top is centered over a drilled shaft foundation, the subject of the full-scale, top-down test. Between the reaction frame and the drilled shaft foundation is a hydraulic jack capable of lifting thousands of tons and a load cell used to convert force into an electrical signal (inset). At the top right of the photo is a mast arm structure used for torsional-lateral stability tests.

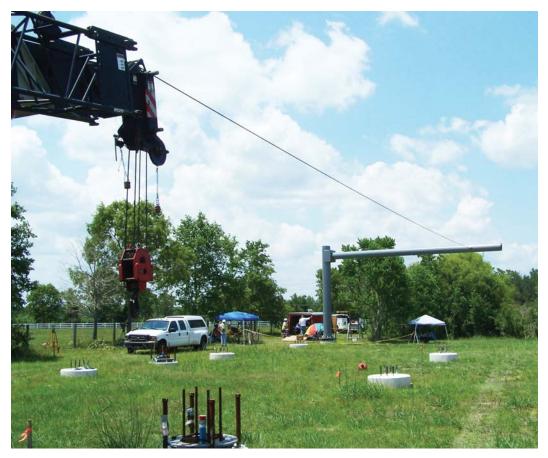
Bottom: During an axial static load test, engineers increase hydraulic pressure to a preassigned level and monitor load cell response. The wooden frame (foreground) suspends devices to measure test pile movement.

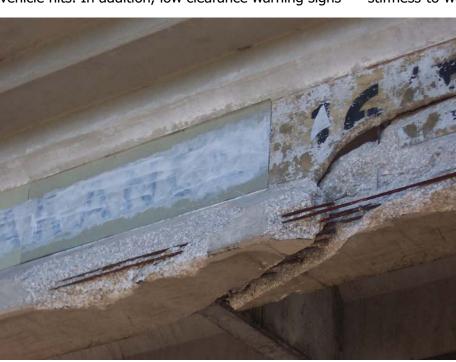
Right: A bridge with impact damage repaired with CFRP wraps.

Left: Damage similar to this occurred to the Chaffee Road Bridge in Jacksonville in 2001 when it was struck by an over-height vehicle.

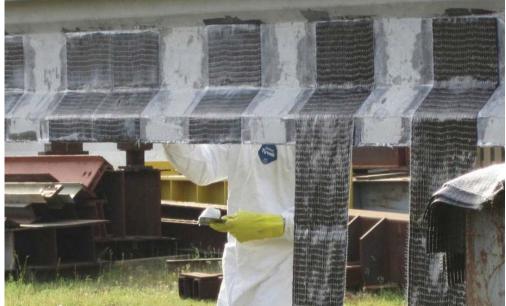
A technician works on wet layup application of CFRP fabric laminate on a prestressed concrete girder at the Marcus H. Ansley Structures Research Center as part of FDOT research project BDK82 977-03.
